Laboratory and In Situ Simulation Tests of the Excavation Damaged Zone Around Galleries in Opalinus Clay

Vincent Labiouse · Tim Vietor

Abstract In the context of nuclear waste disposal in clay formations, laboratory and in situ simulation experiments were performed to study at reduced scale the excavation damaged zone (EDZ) around tunnels in the indurated Opalinus Clay at Mont Terri, Switzerland. In the laboratory, thick-walled hollow cylindrical specimens were subjected to a mechanical unloading mimicking a gallery excavation. In samples cored parallel to bedding, cracks sub-parallel to the bedding planes open and lead to a buckling failure in two regions that extend from the borehole in the direction normal to bedding. The behaviour is clearly anisotropic. On the other hand, in experiments performed on specimens cored perpendicular to bedding, there is no indication of failure around the hole and the response of the hollow cylinder sample is mainly isotropic. The in situ experiment at Mont Terri which consisted in the overcoring of a resin-injected borehole that follows the bedding strike of the Opalinus Clay showed a striking similarity between the induced damaged zone and the

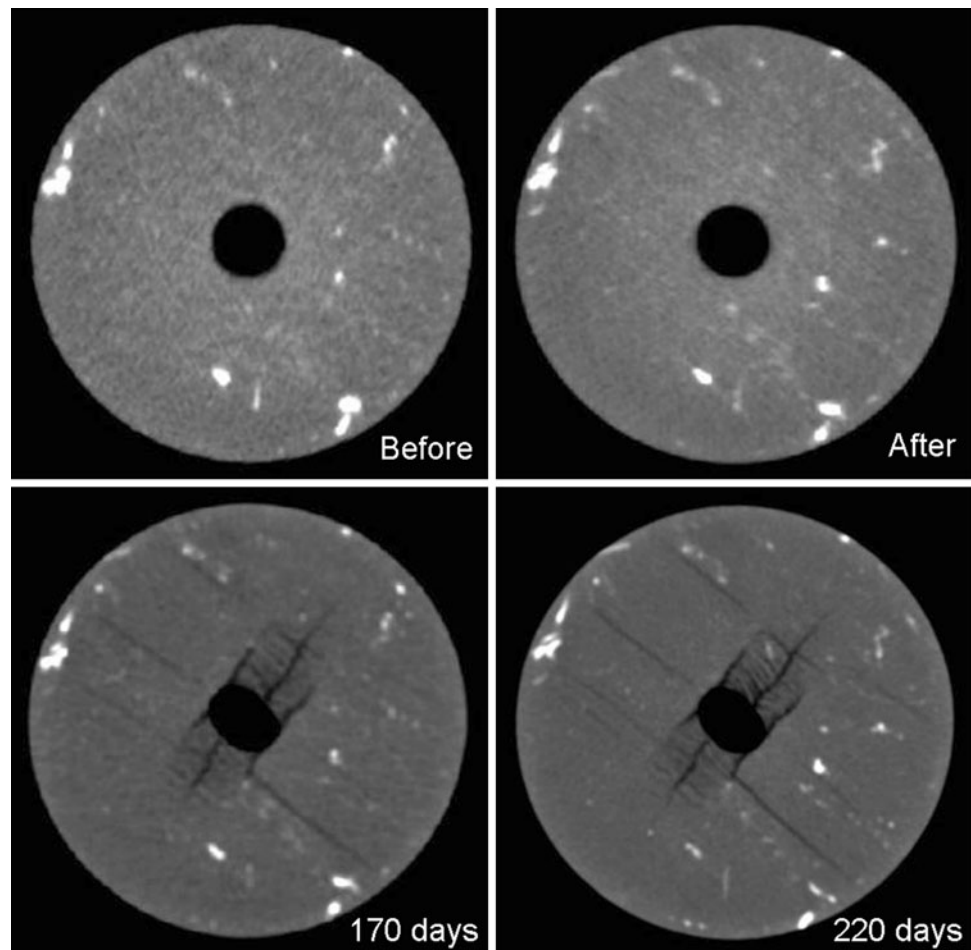
are scans of the sample inside the cell before (left) and after (right) the mechanical unloading. Hardly any change is observed, except a very small oval-shaped deformation of the borehole and a slight decrease in rock density (i.e. darker grey) close to it, which could let think that a damaged zone had been induced by the mechanical unloading. The lower pictures are scans of the same sample carried out 170 and 220 days after its removal from the testing cell (left and right pictures, respectively). A further ovalisation of the central hole is noticed and fractures are now discernible close to the wall in a zone extending perpendicularly to the bedding planes.

Fig. 2 Medium resolution X-ray Computed Tomography (XRCT) scans of the hollow cylinder specimen N°12 prepared in an Opalinus Clay drill core parallel to the bedding planes. The upper scans were performed through the testing cell before (*left*) and after (*right*) the mechanical unloading. The lower images are scans 170 days (*left*) and 220 days (*right*) after the removal of the sample from the testing cell. Images courtesy of Lausanne Cantonal Hospital (CHUV)

or after the test. The evolution of the damaged zone observed in the lower images of Fig. 2 may result from pore water pressures redistribution and/or desiccation when the sample was let to dry at room atmosphere after its removal from the testing cell, and this despite the resin impregnation.

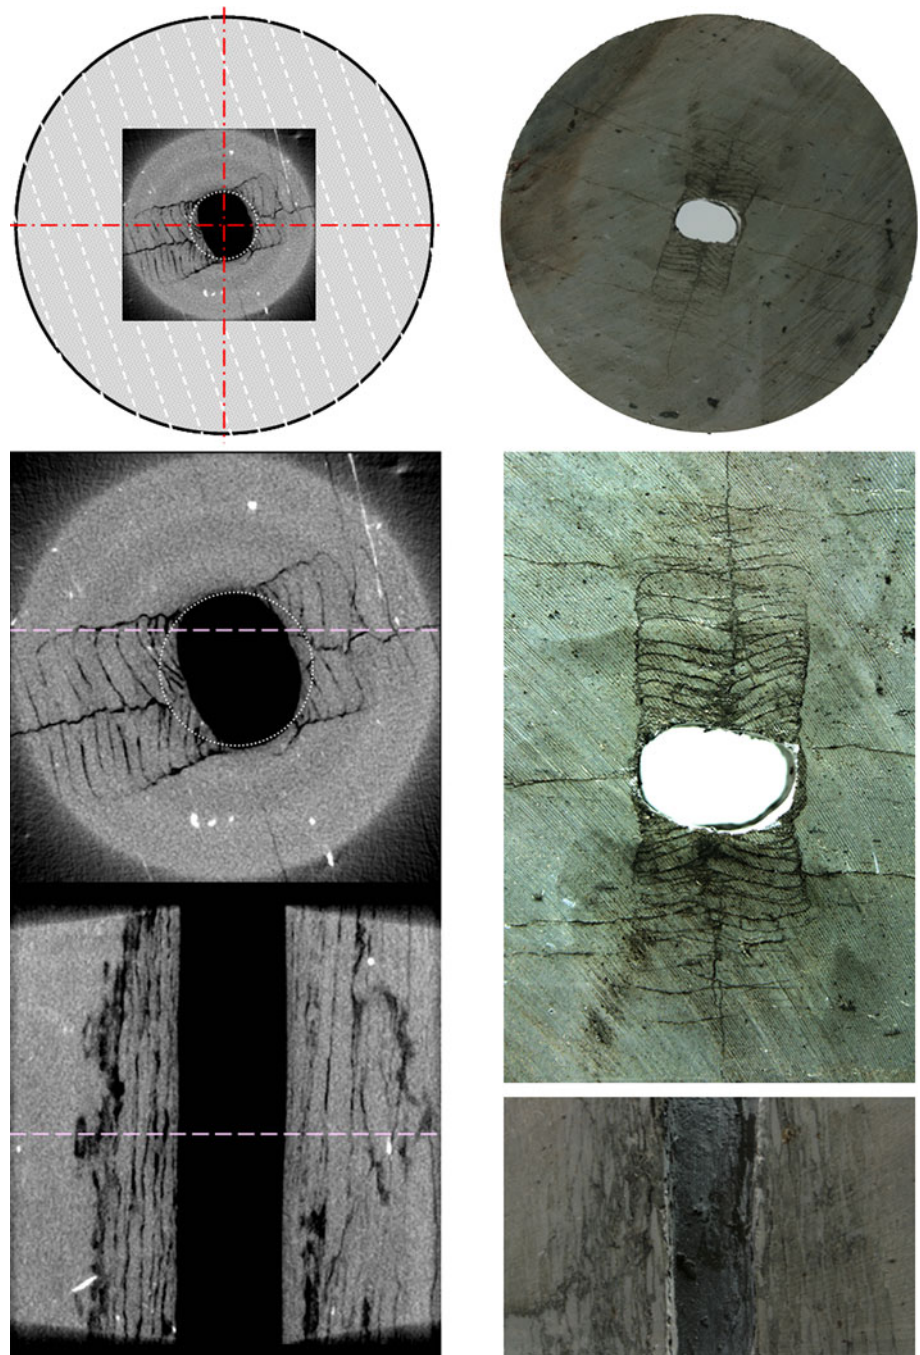
Eight days after the removal of the sample from the testing cell, a high-resolution XRCT of the central part of the Opalinus clay sample N°12 was performed by Phoenix (Hannover, Germany). The technique revealed the fracture pattern induced around the central hole (Fig. 3, left pictures). The cross sections show cracks mainly along the bedding planes (indicated by the white lines). The bedding planes split and buckle into the hole, inducing the rotation of fragments and slab-like breakouts in two regions that extend from the borehole in the direction normal to the bedding. The slab thickness is regular, but seems to

increase away from the borehole. The width of the damaged region is similar to the diameter of the borehole. In the axial direction, the fractures constitute a connected network (Fig. 3, lower left).

To confirm the fracture pattern observed in the CT scans, the sample was impregnated with a mixture of Araldite and Laromin and then sawed into pieces (Fig. 3, right pictures). The bedding controlled excavation damaged zone is clearly discernible in sections normal to the hole axis. The cut along a diametral plane confirms also the axial connectivity of the induced fractures (close-up view in the lower right picture).

Fig. 3 High resolution XRCT scan of the central part of the Opalinus Clay hollow cylinder specimen N°12 cored parallel to the bedding planes (*left pictures*, courtesy of Phoenix, Hannover). Pictures of the sample after its impregnation with resin and saw cutting: general view (*upper right*) and close-up views in a plane normal to the hole axis (*middle right*) and a diametral plane (*lower right*). Bedding-controlled fracture pattern induced by the mechanical unloading

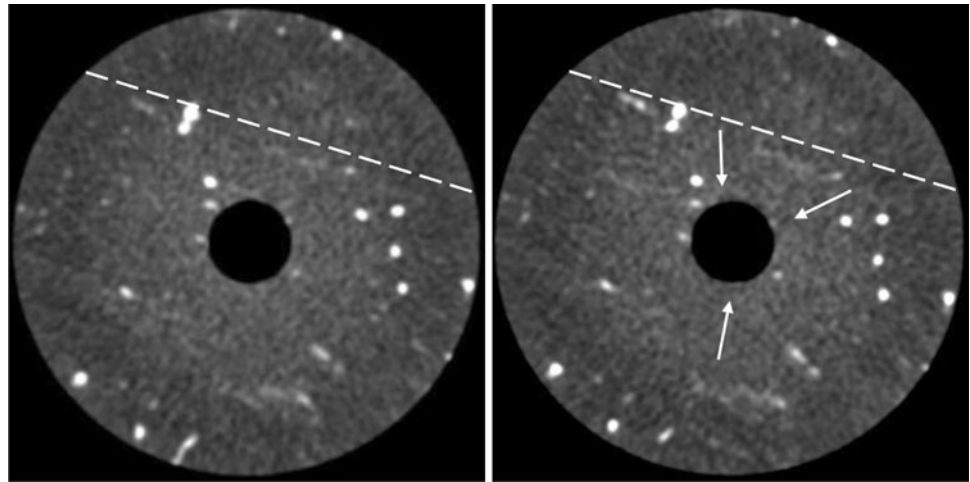
Fig. 4 Medium resolution XRCT scans of the Opalinus Clay sample N°2/5 cored parallel to the bedding planes, before (*left*) and after (*right*) mechanical unloading. When looking carefully (*arrows*), slightly darker (i.e. less dense) zones can be noticed close to the hole wall in the direction normal to the bedding (*white dashed lines*). Images courtesy of Lausanne Cantonal Hospital (CHUV)

The resolution of the X-ray tomography scans performed at Lausanne Cantonal Hospital is unfortunately too low to reveal fractures. Only a slight change in density can be noted when carefully comparing the images. Figure 4 illustrates for example the same CT slice of the N°2/5 sample before and after mechanical unloading. Less dense zones (i.e. the slightly darker grey zones pointed by the arrows in Fig. 4) are barely discernible near the hole wall in the direction perpendicular to the bedding planes. A visual inspection of the sample after the test allowed distinguishing some early stage features of the fracture pattern observed in the first experiment, but with a much less-developed failure mechanism (Fig. 5).

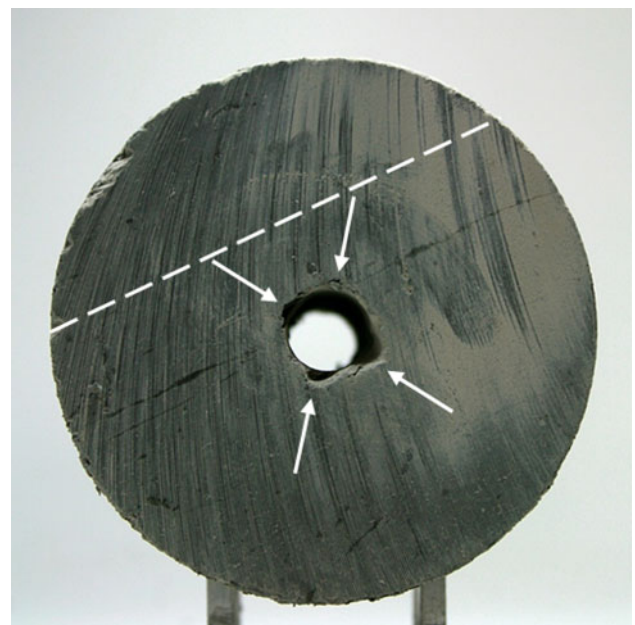
Fig. 5 Picture of the Opalinus Clay sample N°2/5 cored parallel to the bedding planes (*white dashed line*) after its removal from the testing cell and saw cutting. Early stage features of failure indicated by the *arrows*

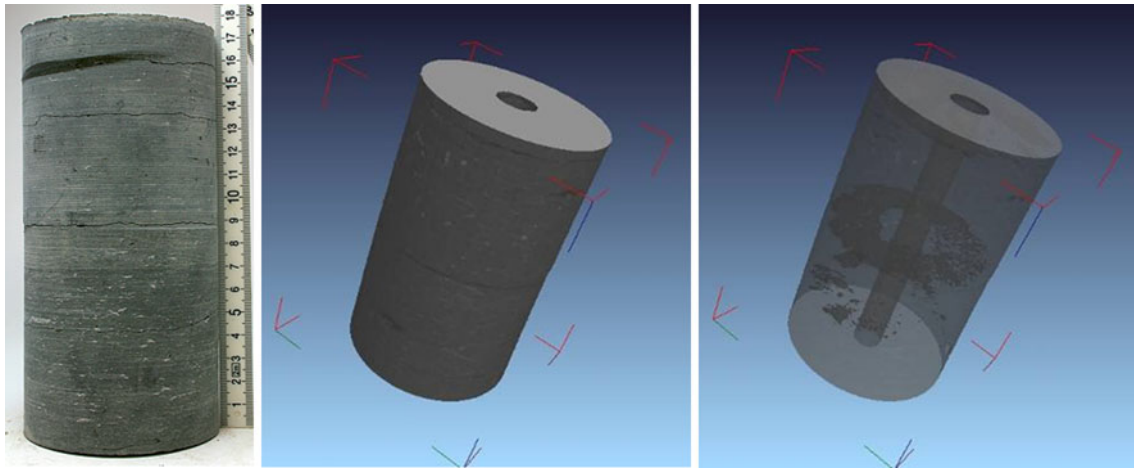
Fig. 6 Picture of the Opalinus Clay sample N °C after preparation (left) and medium resolution XRCT image stacks of the sample in the cell after mechanical unloading (middle and right) represented with

VGS®. The pre-existing crack near the middle of the sample is well discernible. It is parallel to the bedding planes. Scans courtesy of Lausanne Cantonal Hospital (CHUV)

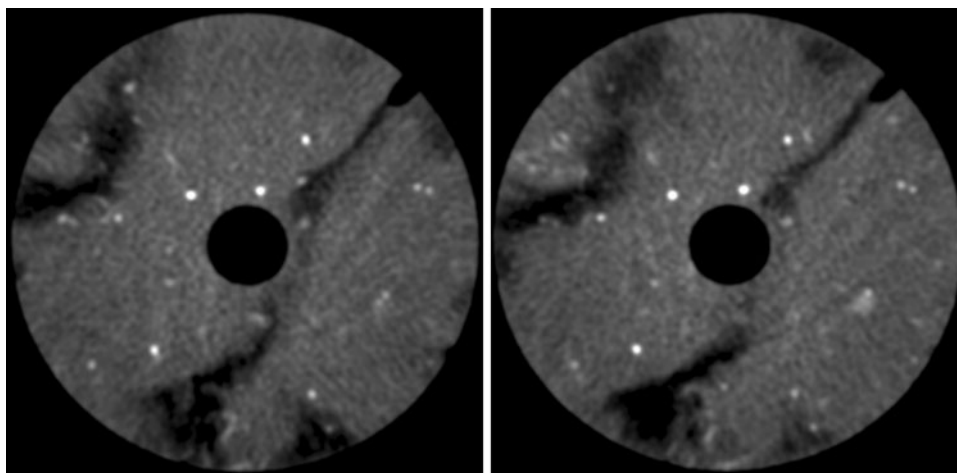
unloading nor the visual inspection of the sample after its removal from the cell did point out a change in the sample, i.e. no oval-shaped deformation of the central hole, no breakout patterns and no change in density close to the hole, contrary to what was noticed for samples cored parallel to bedding. A close-up look at the CT slices near the crack sub-parallel to bedding located in the middle of the sample allowed, however, to observe some density changes related to the mechanical unloading (Fig. 7). They are possibly induced by an opening of some zones and closure of others, but as well by the presence of water along preferential flow paths.

Fig. 7 Medium resolution X-ray CT images of the Opalinus Clay sample N °C before (*left*) and after (*right*) mechanical unloading. The represented slice is crossing the crack that is visible near the middle of the sample in Fig. 6. The *black areas* are zones of the crack that are opened. Scans courtesy of Lausanne Cantonal Hospital (CHUV)

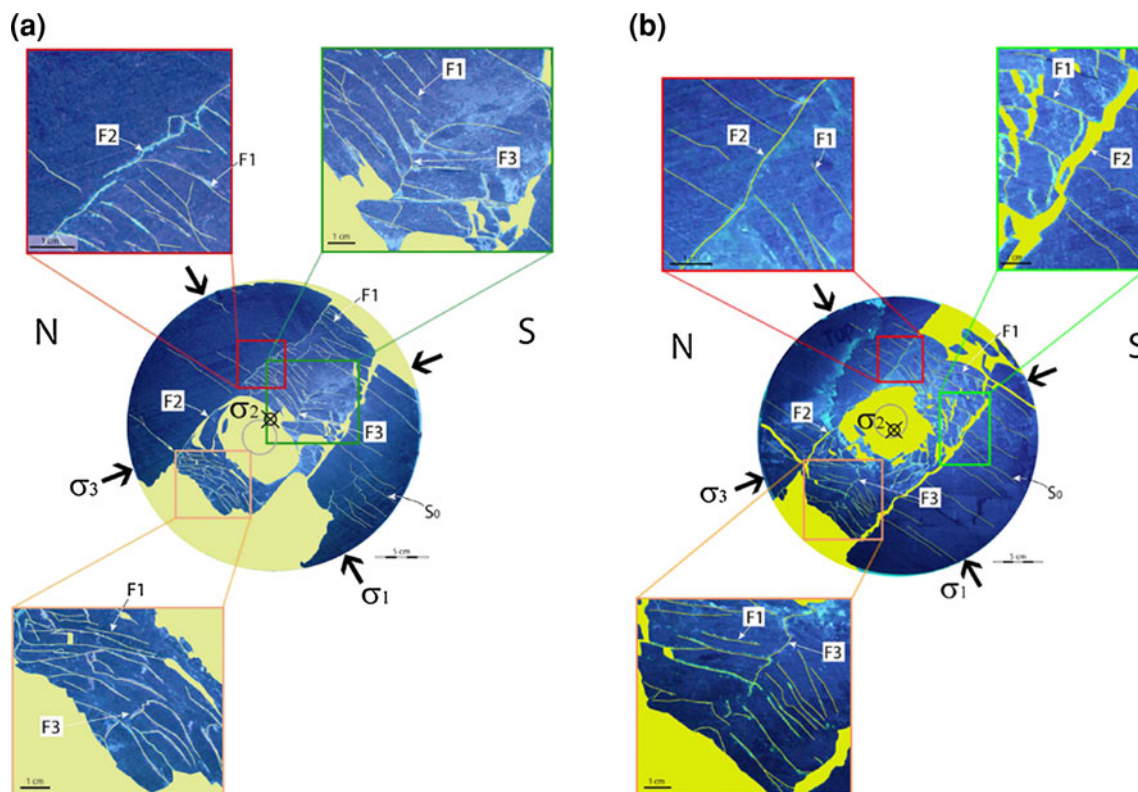
The structure of the two BDZ sections from the dilatometer and the test interval is similar (Fig. 9). The elliptical opening in the centre of the sections represents the original borehole. It results from a larger convergence in

the direction normal to bedding than in the direction parallel to bedding (indicated by S_0 in Fig. 9).

The fractures that constitute the BDZ are concentrated in two regions that extend from the borehole in the directions normal to bedding. Extending beyond the limits of the overcore this central zone of the BDZ is larger than 1 borehole diameter. Its boundaries generally converge away from the borehole resulting in an almond shape with the borehole in the centre. In detail, the outer limits of this central region are curved and tend to rotate out of the bedding normal into a subvertical orientation.

The limits of the strongly deformed regions are formed by a series of short “en echelon” F2 cracks (see the boundary in red square in Fig. 9). These cracks are curved and bent towards the centre of the borehole. The cracks are located at the outer end of the rock fragments in the deformed zone. They allow the rotation of these platelets towards the borehole centre. The outer limit of the deformed zone is thus a complex structure formed by a number of individual F2 cracks. The limiting fracture array of the central zone apparently advances stepwise away from the borehole as the platy bedding fragments break along the F3 cracks in the centre, rotate and bend into the cavity.

Fig. 9 Vertical sections of the overcore at depths of 7.92 m (*left*) and 8.59 m (*right*) with details of the failed regions. The original borehole is subhorizontal and represented by the *oval shaped* opening in the

centre of each section. The bedding dips to the *right*. Original figure from Bardertscher et al. (2008) (color figure online)

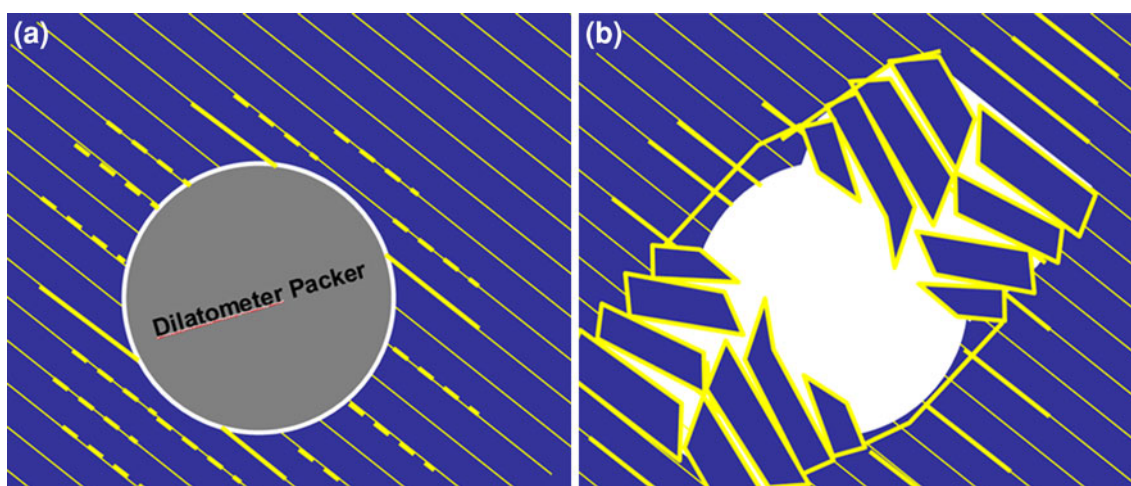
After removal of the test system—the SELFRAC dilatometer probe—the borehole collapses. The removal of the test system completely unloads the borehole wall. This reduces the friction on the shear fractures and the bedding planes (F3 and F1 cracks) and thus allows shear displacements and rotations of the fragments into the cavity. In addition, the loaded and partly damaged bedding planes are now resaturated. This allows free swelling to take place which forces apart the damaged bedding planes and thus further reduces the stability. Long axial fragments are formed that are surrounded by long axial cracks. Most of them follow the bedding planes. The rotation and convergence of fragments in the borehole vicinity unload deeper bedding planes and allow their buckling and failure. This process affects progressively deeper regions and the borehole collapses completely.

Fig. 10 BDZ status during long-term hydrotesting (*left*) and after collapse (*right*)

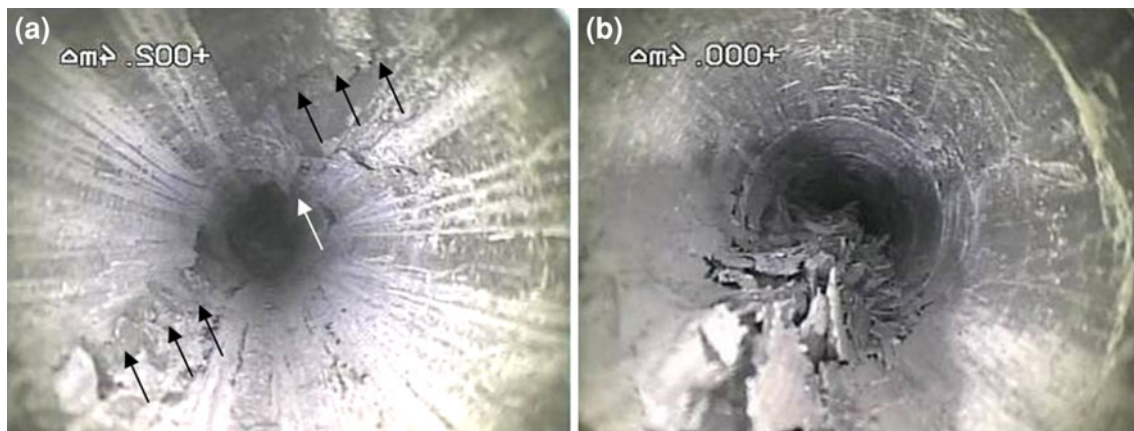
Fig. 11 Screenshots of borehole videos showing the progressive evolution of damage in a horizontal borehole following the bedding (Seeska et al., in preparation 2013). Bedding planes dip $\sim 45^\circ$ to the right. The images were flipped to allow comparison with Fig. 10. Right image taken 3 months after left image at different depth

positions. Left shearing along bedding (*black arrows*) and incipient buckling in the background (*white arrow*). Right fragment rotation in deeper regions pushes up the borehole contour to form a triangular structure; about a third to a half of the borehole circumference is affected by the failure
