## Zagreb earthquake of 22 March 2020 – preliminary report on seismologic aspects and damage to buildings

Research Paper

Zagreb earthquake, post-earthquake building inspections, masonry buildings, damage, historic core, cultural heritage

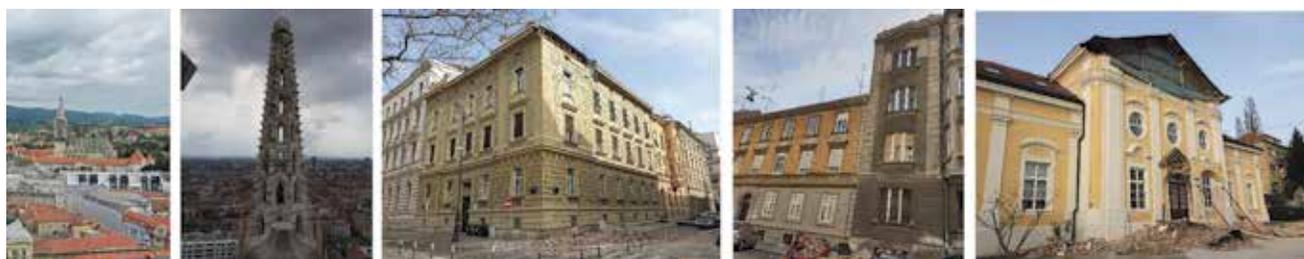
Figure 1. Earthquake effects in historic centre of the city (photos courtesy of: AIR-RMLD d.o.o. [www.air-rmld.com](http://www.air-rmld.com), Filip Foretić, Karlo Jandrić)

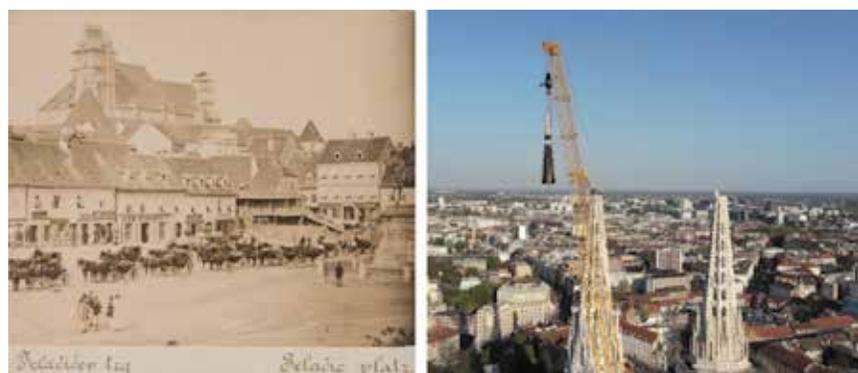
**Figure 3. Zagreb Cathedral – tower removal: a) after the 1880 earthquake** (source: Museum of the City of Zagreb), **b) after the 2020 earthquake** (source: Ministry of Defence of the Republic of Croatia)

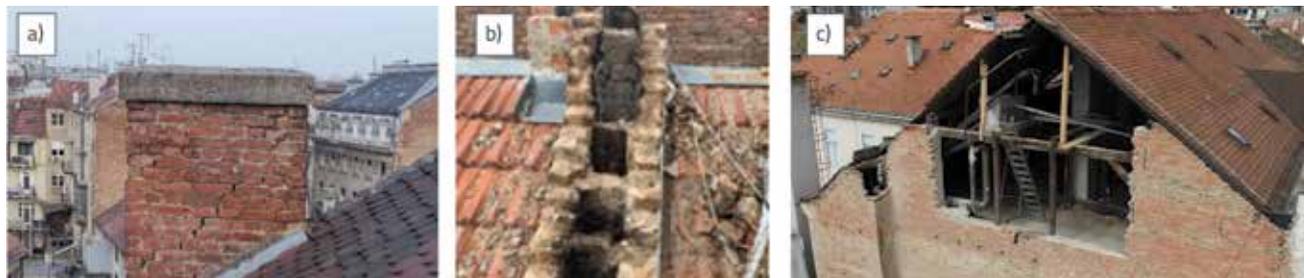
Damage most frequently suffered by old masonry buildings situated in the central part of the city involves collapse of chimneys, gable

Figure 17. Collapse of chimneys and top part of the gable walls (photo courtesy of Mario Todorčić and [39])

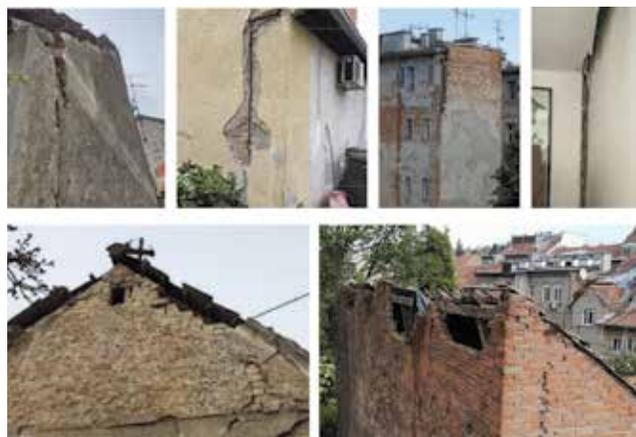
In addition to local collapse of attic gable walls, in more difficult cases the damage involved detachment of gable walls along the entire height or through several floors (Figure 19). The reason is poor connection with walls from the other direction.

Figure 19. Detachment of gable wall and typical cracks in internal part of the building (photos courtesy of Mario Todorčić and [39])

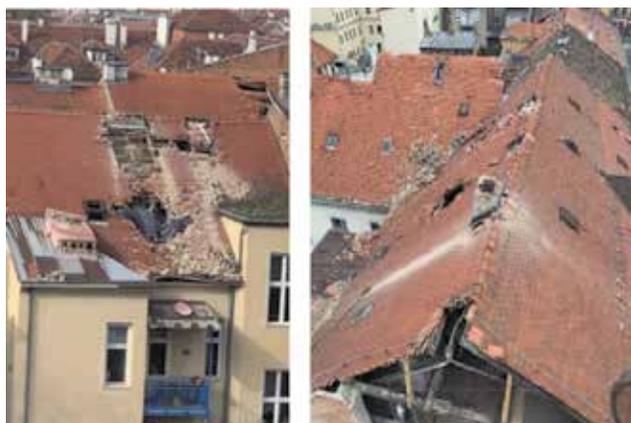
We have pointed out that the most frequent cause of damage to roof structure is the collapse of chimneys, gable walls and other unsupported elements above the roof plane. This is mostly local damage to the roof structure (Figure 20). However, it should be noted that roof structures are usually not adequately stabilised, and due to lack of maintenance and old-age they are additionally unsafe and cannot restrain chimneys and attic gable walls [38]. In some cases, involving flexible roof structures, permanent displacements of the entire roof structure were registered, which is extremely dangerous and requires full reconstruction.

Figure 20. Roof structure damage (photos courtesy of Mario Todorčić)

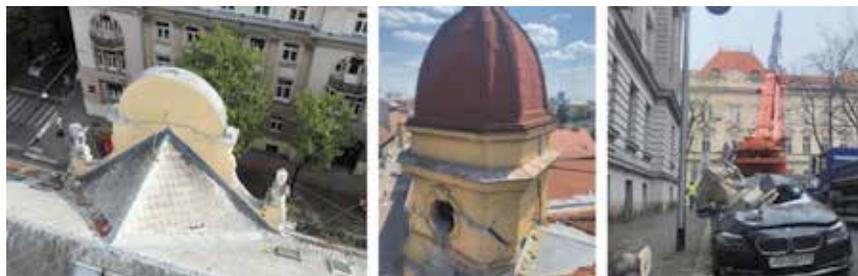
Elements of building heritage, such as roof domes, portals, cornices on facades, and decorative sculptures, have also suffered considerable damage (Figure 21). These elements represented and still represent considerable hazard in case of an earthquake event [38]. As these elements are mostly made of brick or concrete, they may inflict considerable damage when falling from large height. It is interesting to note that Andrija Mohorovičić stated already at the beginning of the twentieth century that these elements should either be properly stabilised or altogether removed precisely because they could present danger in case of an earthquake.

Figure 21. Damage of decorative elements (photos courtesy of Mario Todorčić and [39])

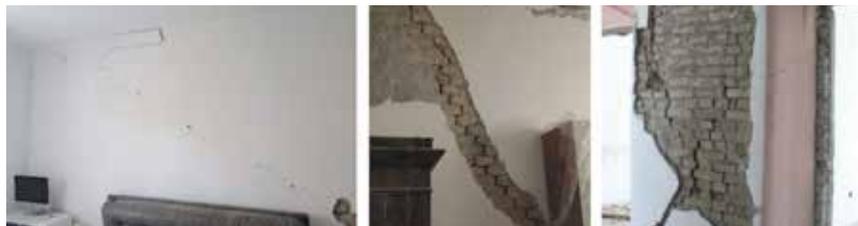
Figure 22. Diagonal cracks in load bearing walls [39]

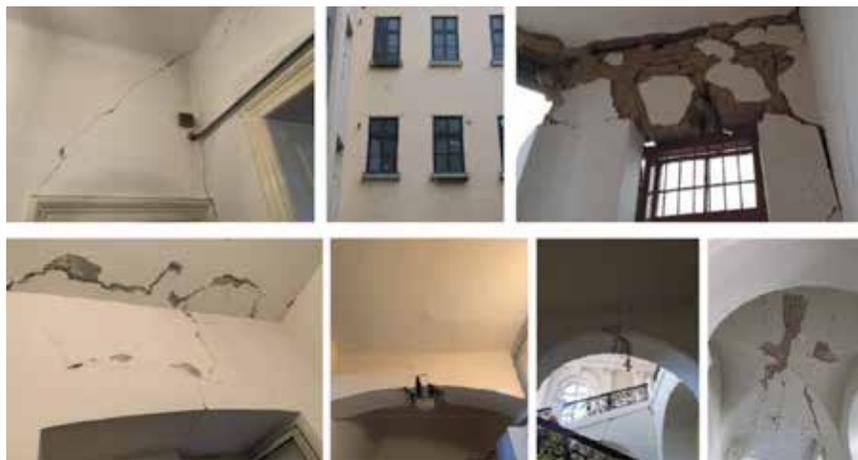
Figure 23. Lintel damage: diagonal and vertical cracks [39]

Lintel cracking is one of the most frequent forms of damage (Figure 23). It is typical for masonry and reinforced-concrete buildings. Diagonal cracks at lintels can very often be seen even in recently built buildings. If cracks are not

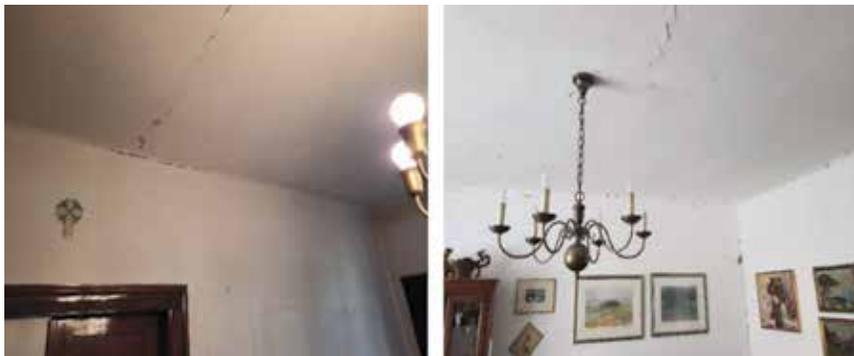
Figure 24. Cracks at ceilings [39]

Small cracks in the direction of joists most often occurred because of displacements due to bending between beams. Such cracks rarely occur due to tensile forces perpendicular to joist. Cracking is often pronounced along the connection between the wall and the floor structure, which is due to relative displacement between these elements. Generally, if the wall does not detach and lean, only the plaster is usually affected, Figure 24.

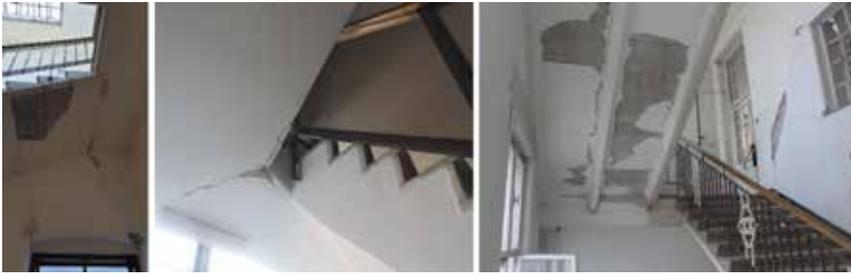
Figure 25. Cases of staircase damage [39]

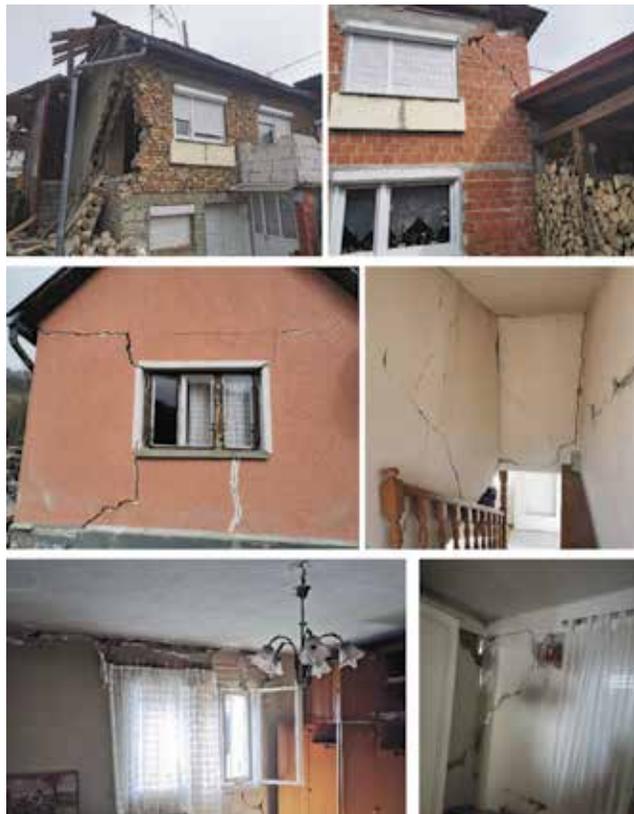
Figures 28 and 29 show frequent damage to houses near the epicentral area. As already pointed out, these are mostly masonry houses without tie beams, but various mixed systems were also encountered because old single storey houses were often subsequently raised by adding a floor.

Figure 28. Damage to houses at LB Vidovec, CD Podsljeme (photo courtesy of Luka Božić and [39])

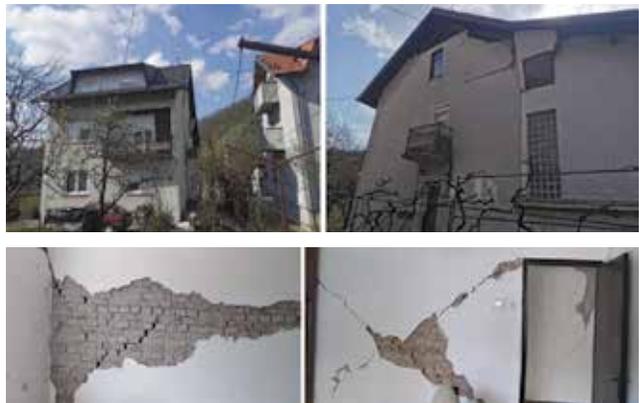
Figure 29. Damage to houses at LB Dankovec, CD Gornja Dubrava (photo courtesy of Luka Božić and [39])

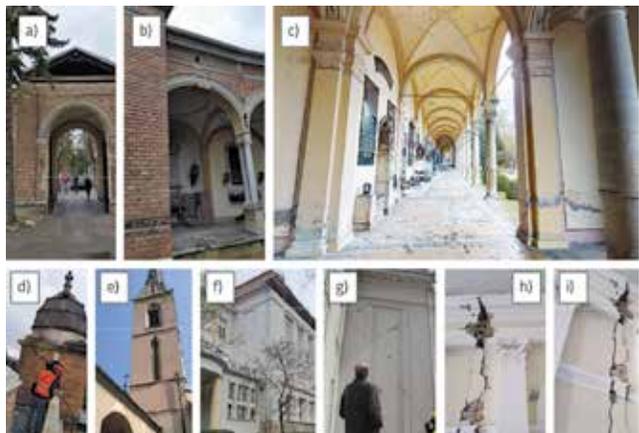
The earthquake caused damage to many significant buildings such as hospitals (for instance, Lung Disease Hospital – Jordanovac, Clinic for Women's Health and Obstetrics – Petrova, Children's Hospital – Klaićeva, and Šalata clinics), numerous schools and kindergartens, university buildings, 28 faculty buildings and three academy buildings (hardest hit were the buildings of the Faculty of Law, the Faculty of Medicine, and the Academy of Fine Arts), high school and university student dormitories, sacral buildings (such as Zagreb Cathedral and Archbishop's Palace, Basilica of the Sacred Heart of Jesus – Palmotičeva, St Catherine Church in the Upper Town, Church of the Assumption of the Blessed Virgin Mary – Remete), Croatian Parliament building, judicial buildings (Supreme Court and County Court buildings), museums (such as the Archaeological Museum, Museum for Arts and Crafts, Croatian School Museum, Croatian Science Museum, Art Pavilion), theatre buildings (such as Gavella Theatre building, Komedija Theatre building), palace and library of the Croatian Academy of Sciences and Arts, and many other notable buildings. It should be emphasized that, according to the latest processed data from inspections, two hospitals, three faculty buildings, one kindergarten, four schools, six cultural institutions

Figure 30. Earthquake damage to some notable buildings: Mirogoj Cemetery (a.-d.), Franciscan Monastery at Kaptol (e), registry office building of the Faculty of Medicine at Šalata (f.-g.), University and Faculty of Law building (h.-i.) [39]

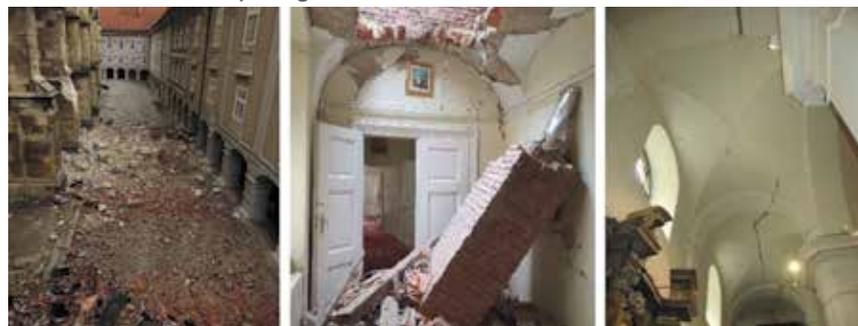
**Figure 32. Damage to the cathedral's parish house and the St Mary's Church** (source: Ministry of Culture of the Republic of Croatia and [39])

As to cultural heritage buildings, the greatest damage was inflicted on numerous centuries-old churches (cf. Figures 32-34). Out of the total of 43 churches that suffered damage in the city, 30 of them belong to the category of protected cultural monuments. The stone top of the south belltower of Zagreb Cathedral, Croatia's largest sacral building, detached from the base and fell onto and damaged the roof structure of the cathedral. After inspection, it was established that the north belltower also suffered considerable damage, which is why the potentially harmful part had to be removed as it could have fallen onto the cathedral. In addition to the belltower, the balustrade above the apse also collapsed, and great damage was inflicted on facade walls and vaults of this cathedral. Considerable damage to vaults and roofing was also incurred at the cathedral's Archbishop's Palace, where chimneys also collapsed.

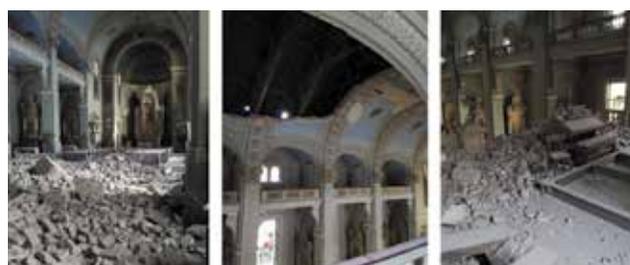
**Figure 33. Damage to Basilica of the Sacred Heart of Jesus** (photos courtesy of: Ivan Ćurić)

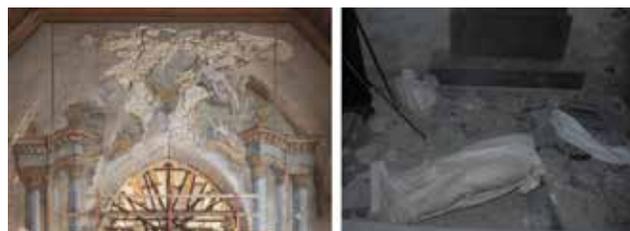
**Figure 34. Damage to Church of the Assumption of the Blessed Virgin Mary at Remete and damage to a statue in St. Catherine of Alexandria Church** (source: Ministry of Culture of the Republic of Croatia)

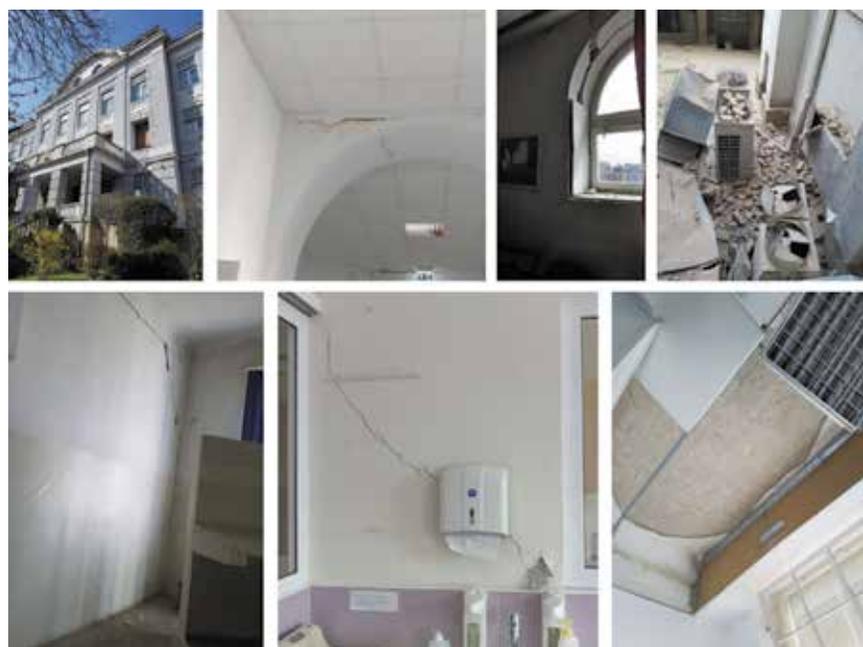
Zagreb residents will remember a long time distressing scenes of pregnant women and babies that were urgently evacuated after the earthquake from the hospital building. Rapid visual inspection of the building’s structure was conducted immediately after the earthquake. The main old building was inspected, as it is in the most critical, considering that it dates back to the early twentieth century. It is irregular in plan, and it comprises masonry walls of solid brick of old format. The building comprises the basement, the ground floor, two floors above it, and the attic. Floor structures in room areas are timber joists, while masonry vaults are used in corridors. Some chimneys collapsed in the earthquake so that the heating system had to be shut down, the gas supply turned off and he hot water supply cut-off. The inspection has revealed damage to staircases that lie along the edges of the east and west parts of the building. Over time, some improper changes and reconstructions were made, which cracked, although this cracking did not affect the overall load bearing capacity of the building. Besides these damages, cracking of the attic overhang and of the cornice was detected, which could imperil the area in front of the main entrance in case of another earthquake, and so the recommendation was given to limit the access to hospital from the front side, and to use the alternative entrance. The system of cracks spreading along the entire building was identified, but these cracks do not pose danger to the bearing capacity and serviceability of the building. Diagonal cracks were observed at

Figure 36. Damage to the Old building of Clinic for Women’s Health and Obstetrics in Petrova

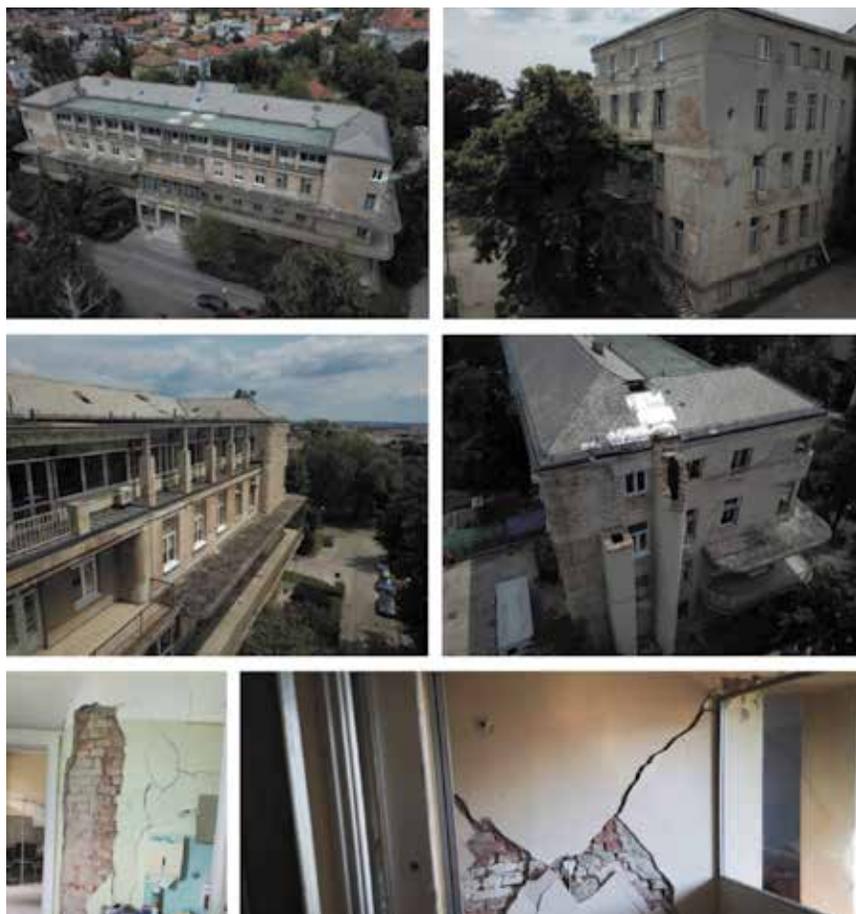
The building of Orthopaedics Clinic at Šalata was built in 1931. It is of elongated rectangular form in plan, and is composed of the central part with the main entrance, and the west and east wings that are symmetric to one another. The building measures 17 x 60 meters in plan. Basement walls are built of concrete, while walls above the ground level are built of solid brick of old format. They differ in thickness and run in longitudinal and transverse directions, interconnected with reinforced concrete floor structures. The clinic consists of the basement, the ground floor, and three floors above it. Partition walls are also built of solid brick. Even before the earthquake, the building was poorly maintained, as evidenced by brick facade walls, which were severely exposed to atmospheric influences, as much of the plaster had fallen off. Tops of both chimneys at the west side of the building collapsed as a result of the earthquake (Figure 37). One chimney separated by approximately ten centimetres from the facade wall, viewed from the roof level, and it now represents a considerable hazard for hospital staff and patients. Urgent removal or reinforcement at the RC slab levels was recommended. The inspection has revealed significant damage to many load-bearing and partition walls. The damage is especially pronounced in east wing walls, where it spreads all the way from the ground floor to the attic. Mostly affected are transverse walls where pronounced diagonal cracks, spreading across most of the walls, were observed. At the central part of the building, load-bearing walls are less damaged. Cracks observed at some locations point to shear failure of walls. Partition walls made of solid brick are generally quite damaged with pronounced diagonal cracks.

Figure 37. View of damage to building of Orthopaedics Clinic
