# Learning from Failures: Reflections on the Role of Project Design and Design Management in the Procurement of Non-Standard Buildings

**Citation:** Cardellicchio, L.; Tombesi, P. Learning from Failures: Reflections on the Role of Project Design and Design Management in the Procurement of Non-Standard Buildings. *Buildings* **2021**, *11*, 253. <https://doi.org/10.3390/buildings11060253>

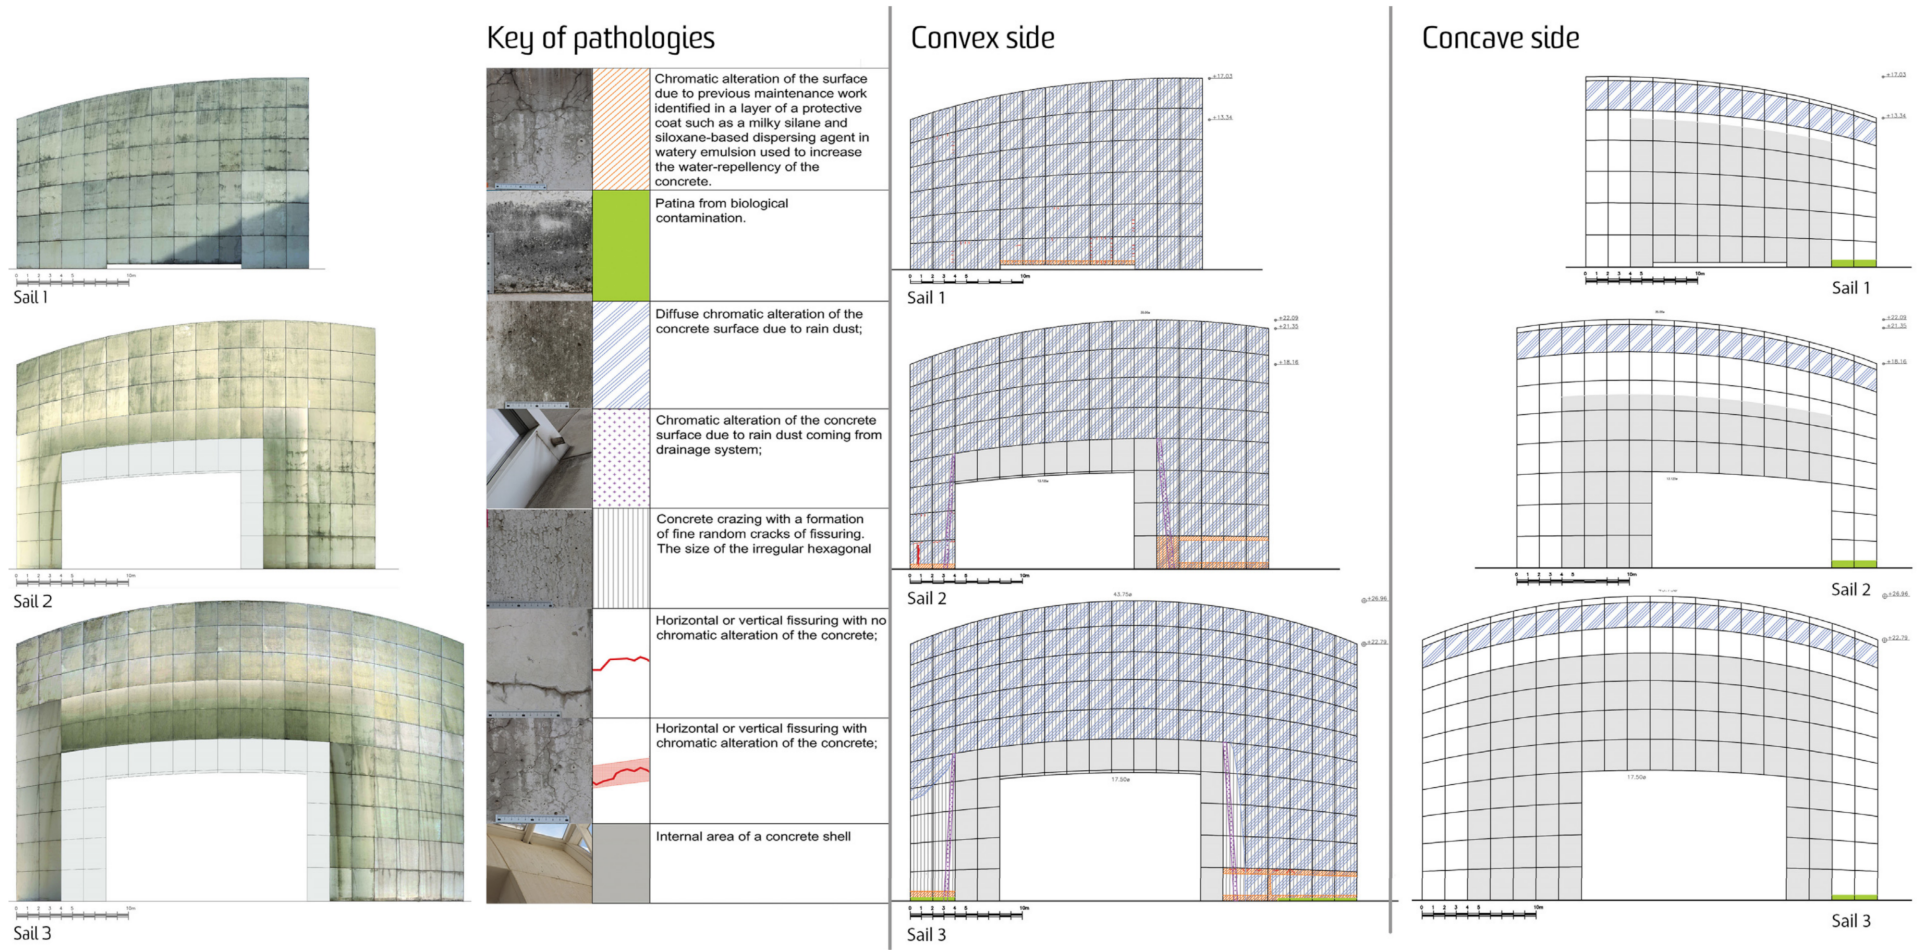
The Jubilee Church was the first building in the world [17] in which self-cleaning concrete cement paste was used, to cast blocks that were then used in the erection of three double-curved walls with a spherical geometry, the white purity of which was considered a fundamental part of the architectural concept. The concrete mix was customised by blending titania particles into the concrete mix, so as to guarantee long-lasting white colour-preserving qualities [18,19]. Now, titania is photocatalytic because it can absorb energy from light and use that energy to catalyse the degradation of organic molecules and the oxidation of some inorganic pollutants such as nitrogen oxide [20]. However, notwithstanding the use of the colour-preserving cement, accelerated decay of the appearance of the double-curved walls of the sails of the Jubilee Church was evidenced at least since 2018 by extensive black staining. Chemical tests conducted on several micro-samples from the concrete blocks [15] showed that the ageing of the material was directly linked to the geometry of the sails. Specifically, the results showed that the convex side was rougher, displayed evidence of concrete dusting, and was affected by diffuse soiling (Figure 1).

Conversely, the protected concave side still had a smooth white finish. The explanation eventually arrived at was that the abrasive action of rainfall on the convex surface enhanced the superficial roughness of the concrete, which in turn increased its bond with the dust particles. Further evidence of the relationship between material ageing and building geometry was provided by the fact that the degree of decay diminished where self-cleaning concrete panels were used to create a standard (i.e., vertical) geometry façade.

Figure 1. Jubilee Church, Rome (2003). Analysis of the concrete pathologies (Cardellicchio, 2019).

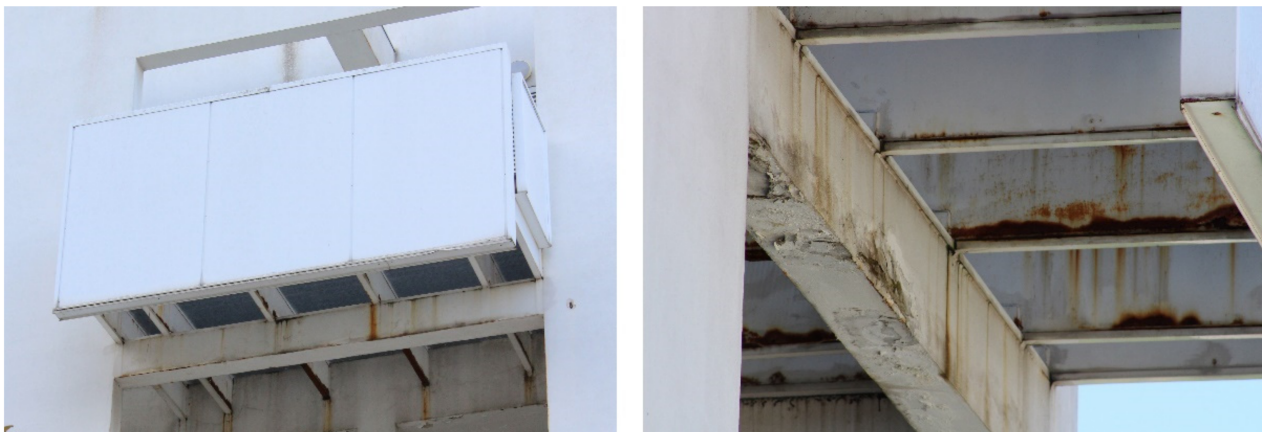
The chemical tests also showed the deleterious effects of the local environment. The self-cleaning characteristics of titania-enriched concrete are activated only if sunlight promotes the redox of pollutants and the photo-induced hydrophilicity facilitates façade cleansing [21]. Yet, in the Jubilee Church, the hydrophilic effect was constrained at least by the typical composition of the Roman pozzolanic dust present in the rain: distinguished by its volcanic origins, it cannot be oxidised by titania particles [22]. The chemical composition and abrasive effects of a locally sourced material thus rendered a solution based on nano-structured titania particles inappropriate for the specific environment, which, in addition, featured patterns of precipitation often containing desert dust from North Africa, which further inhibited the process envisioned [23]. Incidentally, the amount of precipitation and the rain–dust phenomenon affected other parts of the church’s façade by putting pressure on specific system assemblies. Such is the case with the extensive weathering stains over the opaque part of the façade or the rust over the exposed steel components, ostensibly caused by the under-sizing of the drainage systems and the lack of flashing with a dripping edge [14] (Figure 2).

**Figure 2.** Jubilee Church, Rome (2003). Rusted steel components (ph. Cardellicchio, 2018).

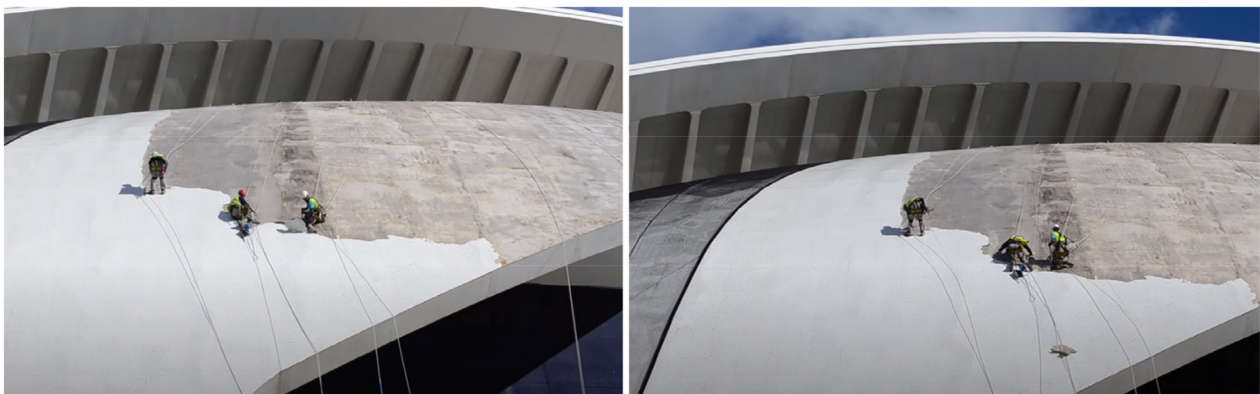
At the time of the opening of the Palau, on 8 October 2005, the *trencadís* of its shields consisted of 8000 m<sup>2</sup> of irregularly shaped tiles backed by fiberglass meshes attached to a metal plate. Roughly 8 years later, on 26 December 2013, part of the *trencadís* fell into the public hallway [29]. Immediately after the incident, the Valencian government commissioned two technical reports. One from the AIDICO Instituto Tecnológico de la Construcción (Technological Institute for Construction) on behalf of the client, the City of Arts and Sciences [27,30], and the other from the INTEMAC Instituto Técnico de Materiales y Construcciones [27], on behalf of the temporary consortium of construction companies (Unión Transitoria de Empresas) behind the project, Dragados and Acciona [31]. The reports noted that the problem of adherence between the tiles and the metal surface occurred on

60% of its area, and both eventually concluded that the failure could have been caused by a design fault connected to material selection, by an execution fault, or by a combination of the two. According to the AIDICO report, the failure of the assembly was due to the different coefficients for thermal expansion of ceramic (tiles) and steel (shields), believed to be the cause of the visible lumps and wrinkles that had appeared on the façade prior to the detachment of the material (Figure 5) [31]. In support of this hypothesis, the AIDICO report noted that the elevation worst affected by the problem was the south-facing one, naturally most exposed to thermal changes. The second of the possible causes identified in the reports related to the specific inexperience of the contractor, which allegedly manifested itself in two tasks: firstly, the preparation of the adhesive material layer, which was too thin to accommodate the tiles and was also left exposed to the weather for too long. Consequently, it was posited, the layer may have lost its adhesive properties by the time the ceramic mosaic tiles were placed on it. Secondly, the preparation of the surface of the steel support was poorly executed, as it was not sufficiently homogeneous or properly cleaned. Overall, the underperforming adhesive layer turned the tile grout into a rigid shell, which in turn reduced the typical capacity of the *trencadís* layer to move. The rigidity of the grouting explains why, over some inspections, the tile supplier, *Trencadís Innovación SL*, identified micro-fissures in the joints of the *trencadís* still in place [32]. The micro-fissures appeared to have led to water filtration, as evidenced by the extensive rust areas that appear on large areas of the steel shields, and which were visible after the removal of the whole cladding (Figure 5) [32]. In short, the difference of the thermal expansion coefficients, the rigidity of the grouting, and the infiltration of water may have all corresponded to the bulging and wrinkling, and ultimately the detachment, of the ceramic layer. An employee in charge of the maintenance of the building who was interviewed in 2015 explained that the cladding and adhesive were tested before construction on a mock-up model [33]. This is a common practice for non-standard building components; however, the mock-up gave no indication that the tiles would detach. This may be because the size and the curvature of the model were significantly smaller than those used in the original building [32].

**Figure 5.** Palau de les Arts Reina Sofia, Valencia (2005). The removal of the *trencadís*, images from video. Reprinted with permission from Tono Mañes. Copyright 2005 Tono Mañes.

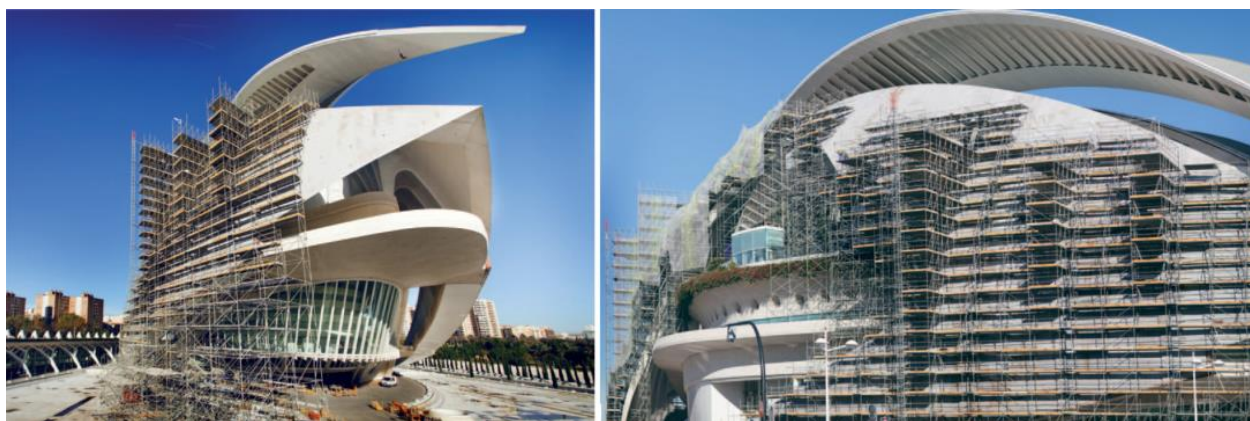
**Figure 6.** Palau de les Arts Reina Sofia, Valencia (2005). The scaffolding system used for the replacement of the trencadís. Reprinted with permission from ref. [36]. Copyright 2018 Ulma Construction.

Less than a month after the first cladding detachment, in January 2014, the work towards the identification of a suitable repairing strategy started. According to the Valencian Courts, the replacement process had to start with the cleaning and sanding of the metal shield to remove the remaining adhesive and rust [34]. To achieve a similar finish, the architect proposed three different options, all requiring the removal of the entire original layer of *trencadís* [35]. Under the first option, aluminium panels with expansion joints would be installed. Under the second option, the ceramic finish would be replaced with paint. Under the third option, the *trencadís* would be layered again, this time with adequate adhesive and labour skills in order to avoid the accelerated ageing of the assembly as had occurred

To improve the performance of the adhesive and reduce the risk of the grouting fissuring, a polyurethane-based elastic organic mineral adhesive was used [32]. The new grouting paste contained epoxy-based resins, which are more impermeable and flexible than cementitious resins. Notably, no improvement was proposed to enhance the labour conditions in terms of accessibility to the double-curved shields and the working area. A regular multidirectional scaffolding (Figure 6) system adapted to the curved geometry of the shields was employed throughout the repairing stage. Apparently, no consideration had been given historically, nor was given then, to off-site prefabrication as a strategy for creating an environment with high levels of work quality control, or not as exposed to changes in weather conditions [36]. The cladding repair was completed in October 2015. Photographs taken at the time of reopening of the Opera House in 2016 (available on social media platforms) show that wrinkles and bulges had reappeared (Figure 7).

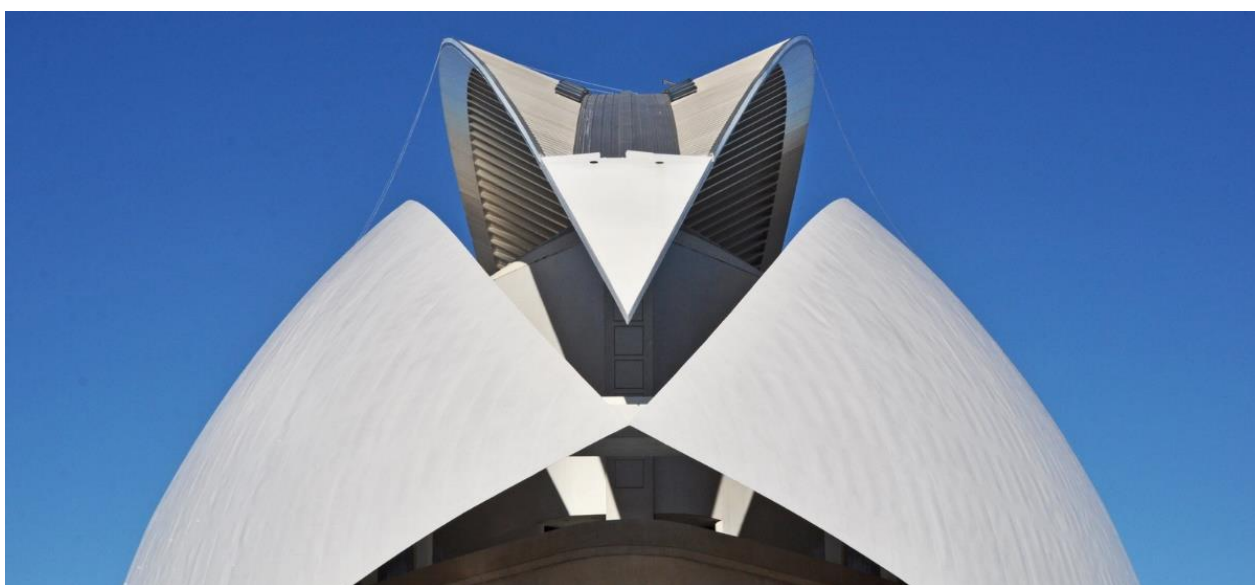
**Figure 7.** Palau de les Arts Reina Sofia, Valencia (2018). Photographer Hans Porochelt, Source: Flickr, <https://www.flickr.com/photos/porochelt/42422451695/>, Copyright License: CC Attribution-NonCommercial-NoDerivs 2.0 Generic).

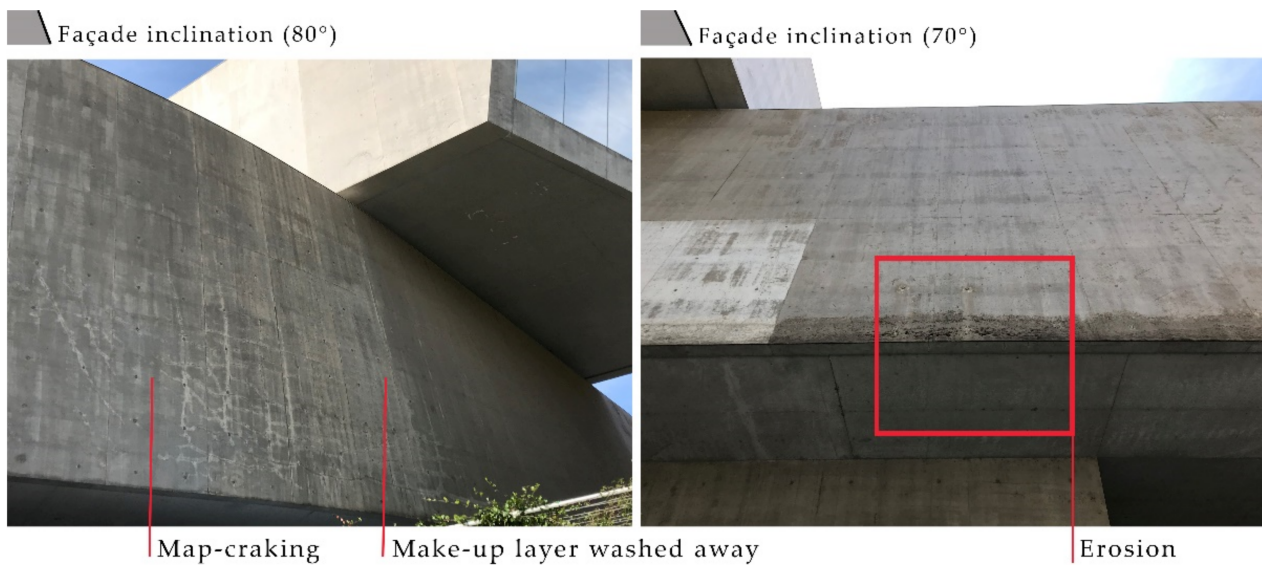
In July 2017, seven years after the opening of the museum, and given the progressive alteration of the façade in terms of colour, fissuring, and other pathologies, the Minister of Italian Culture, which owns MAXXI, commissioned a report to examine the ageing patterns of the concrete and to determine an appropriate procedure for its cleaning and restoration [45]. The mapping of the material alteration run for this study required inspections of the museum, which were carried out in October 2018. During these inspections, the façades were observed to be affected by several material anomalies, including connatural ones that concerned the exposed concrete surface (e.g., fissuring, micro-bubbles, and macro-bubbles), as well as its protective coatings (Figure 8).

**Figure 8.** MAXXI, Rome (2010). Concrete pathologies affecting the façade (ph. Cardellicchio, 2018).

Once again, the inspections revealed that the ageing pattern of the concrete was directly linked to the geometry of the volumes exposed to the weather. In fact, the inclined surface of the concrete had been affected by extensive rain wash, which had in turn contributed to the deeper erosion of the protective coating and the decay of the concrete beneath it. This was confirmed by the better conditions shown on the portions of the façade protected from the rain by the cantilevered portion of the building compared with the rest of the concrete.

Tests conducted in the subsequent restoration project revealed that the materials and procedures used for the first coatings in 2010 not only guaranteed the aesthetic appearance desired for the concrete, but also slowed down the carbonation process. Thus, the conservation plan organised in 2018 recommended that the same tasks detailed in the official documentation for the maintenance of the building, but not executed to that date, be kept and implemented [45]. The work, which relied on an aerial working platform to support the activities, was concluded in March 2020.

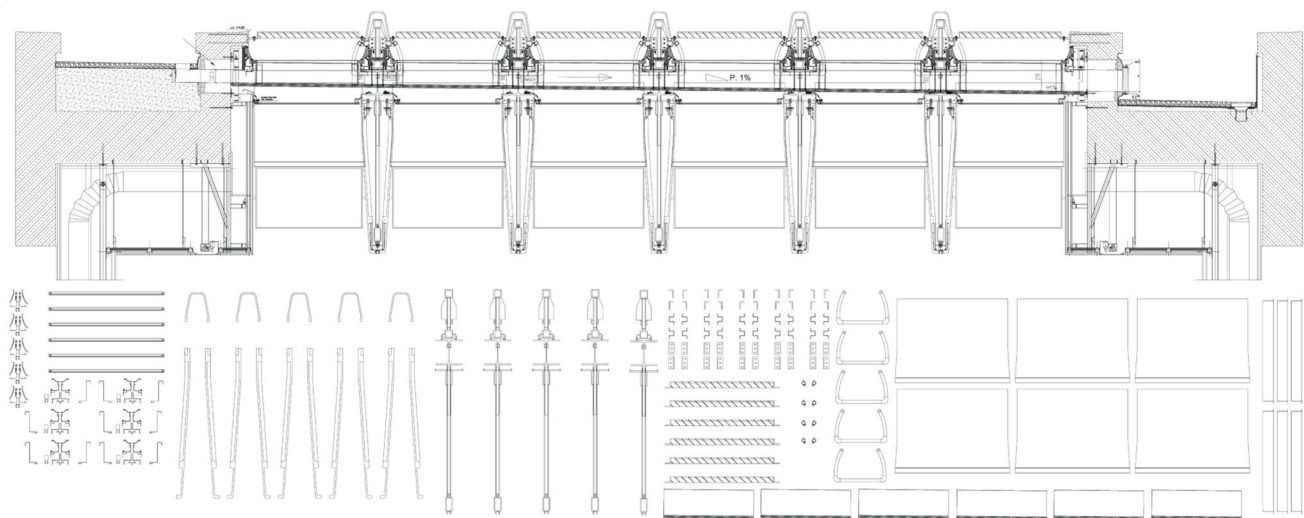
Maintenance difficulties extended to the roof of the building. In August 2015, following intense rain, the roof began to leak water into the gallery spaces below, forcing the closure of the museum [46]. Water leaking was also reported to have happened on several other occasions by members of the estate department [47]. Even in this case, the technical design of the element had considered different types of performance requirements. The first concerned the concrete-clad steel blades. The original roof section was designed to have down-stand ribs in precast concrete in order to match the finishing of the walls. However, the general contractor suggested that the ribs be made out of steel trusses later to be clad in slender glass-reinforced cement panels [48]. This modification had three major benefits: (a) the construction of the curved ribs could rely on prestressing technology; (b) the self-weight of the roof could be significantly reduced; and (c) consequently, the depth of the primary cross beams could also be reduced, from 2200 to 900 mm. The glazing panels between the blades are there to allow natural light in, while the system of louvres just below can be used to adjust the light to the illumination levels demanded by the exhibitions. The blades also feature a bottom rail that works as a support for hanging artwork and exhibition panels in the middle of the galleries. This is complemented by a system of linear lamps that provide artificial light to the galleries. The roof is topped with a layer of steel plank grating functioning as a walkable support to assist its maintenance. Underneath the grating, an automatic washing system is installed to clean the glazing panels (Figure 9).

**Figure 9.** MAXXI, Rome (2010). Top: roof cross-section taken on one of the gutters (courtesy: MAXXI). Bottom: the same section decomposed in the elements assembled onsite (auth. Cardellicchio, 2020).

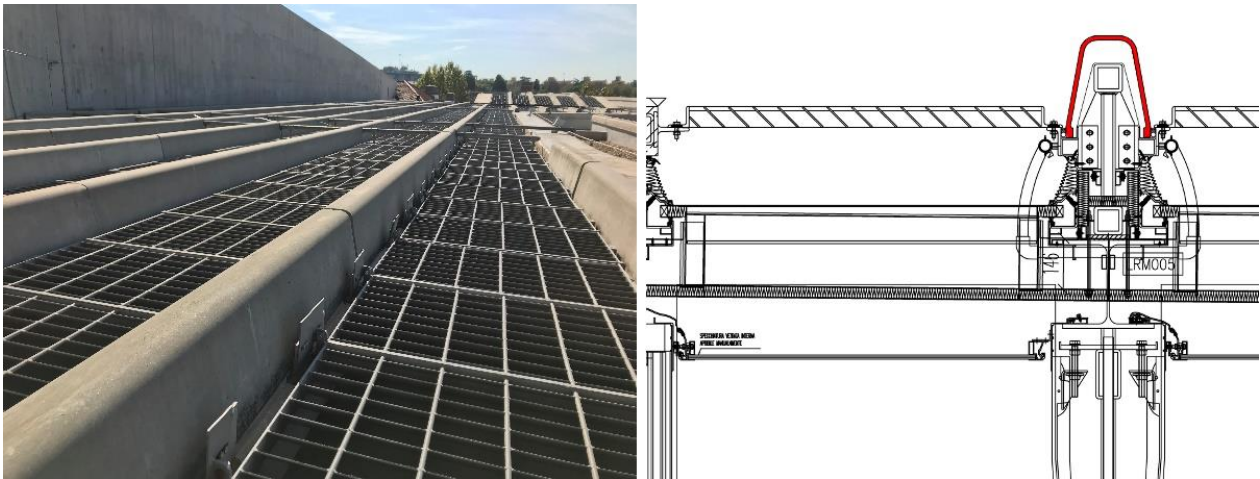
In the absence of official reports, the authors undertook analyses of their own, by comparing and considering construction details, photographs of the building site, and information gathered from site inspections or from interviews with individuals in charge of the maintenance of the roof. The results of this work suggest multiple possible reasons for the underperformance of the element. The first relates to the effectiveness of the construction detail. The galleries of the museum have a span of approximately 12 m, surmounted by six glazing panels with an individual width of 1.2 m. Each panel sits on the roof-raftering blade, which is also the load-bearing structure of the louvre systems. As these blades were designed to be visible on the roof of the building, the top end of the metal rafter was raised from the glass alignment. Such a design choice multiplied the number of sealant connections in the cross-sections. A regular glass roofing system resting on top of the rafters would have needed seven sealant connectors to ensure the water tightness of the six glazing panels; the solution adopted for the roof of the MAXXI required 12. The number of connections between the structure and glazing naturally extended the length of the elements to maintain and inspect, reaching of a ratio of almost one linear metre of sealant per square metre of space. For example, the roof of Gallery Number 2, with an area of 1648 m<sup>2</sup>, achieved water tightness through the installation of 1588 linear metres of sealant connectors. Ironically, the ad hoc increase in the number of sealant joints was based on the architectural determination of a roof system acting as the visible fifth elevation of the building [49]. Originally, this horizontal elevation should have been visible from pavilions surrounding the main block of the museum [50]. However, these were eventually removed from the project because of cost escalations [51]. As a result, the roof is not visible from any point in the building. Importantly, the architectural ambitions, eventually frustrated by the economics of construction, rendered maintenance more challenging. In fact, the desire to make the blades visible from above led to the decision to top the sealant junctions with glass-fibered reinforced concrete caps (Figure 10). This makes it difficult to inspect the integrity of the sealant connectors even in the presence (or particularly because of the presence) of the over-head walking platform: in the event of water leaks, both the concrete capping and the over-head walkable platform grating must be removed to inspect even a small section of the connector.

**Figure 10.** MAXXI, Rome (2010). The glass-fibered reinforced concrete caps shown in a picture taken on the roof (ph. Cardellicchio, 2018) and on the construction detail (courtesy: MAXXI).

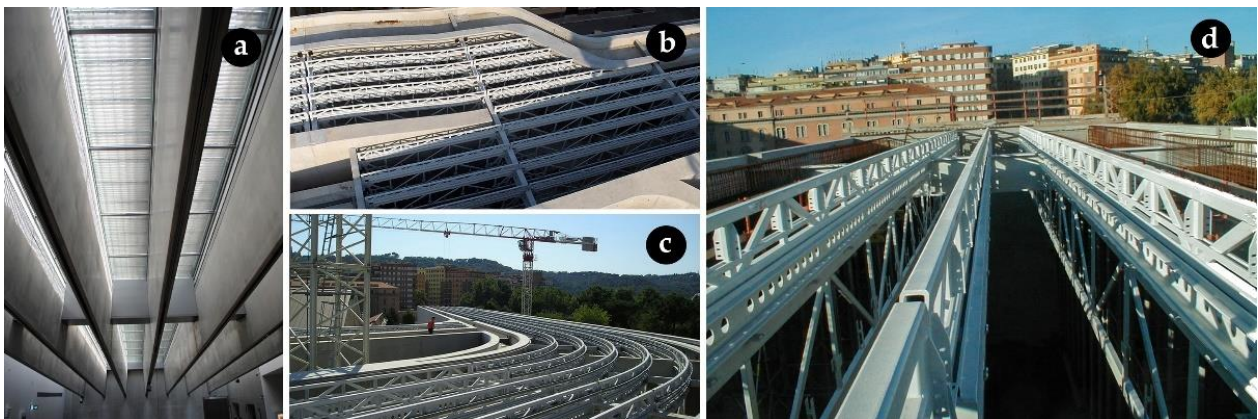
A second possible reason for the under-par waterproofing performance relates to the way in which the roof was constructed. The cross-section of each gallery shows that each linear metre of the roof is composed of 189 different components (Figure 9), which photographs of the building site reveal as being bolted together completely on-site, without any off-site pre-assembly (Figure 11). The water-tightness of each linear metre of the roof relies on 14 different sealant connections constructed directly on the roof. This raises natural questions about the level of quality control in placing water-proofing materials in such working areas conditioned by curved geometries, accessibility, or weather conditions compared with the prefabrication of large portions of the roof in dedicated workshops.

**Figure 11.** MAXXI, Rome (2010). (a) The roof from the inside (ph. Cardellicchio, 2018). (b–d) Construction pictures of the roof showing the metal blades (courtesy: MAXXI).

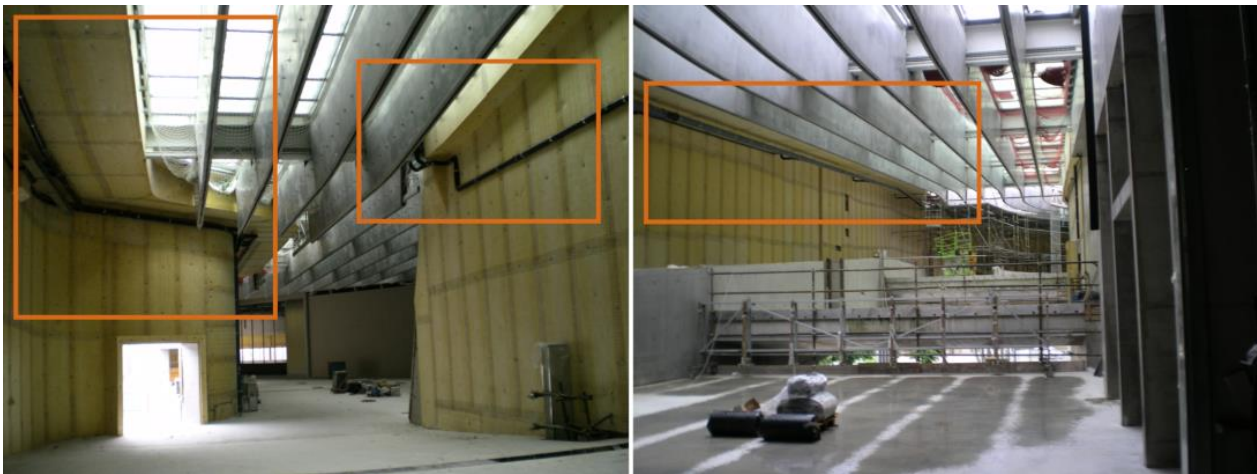
A third possible reason relates to the drainage system, organised so that a single gutter, 22 cm deep and 12.5 cm wide, serves 80 m<sup>2</sup> of roof. The gutters, running perpendicular to the blades, drain the water towards one of the edges of the building, near one of the two external concrete walls. From there, the water is collected in a drainpipe that runs horizontally along the whole length of each gallery and parallel to the concrete walls (Figure 12). In line with the idea that no drainage components should be visible outside the building in order to preserve the continuity of the concrete on the façade, the drainage system ended up being contained inside the building, encapsulated in a non-inspectable service cavity installed between the concrete walls and the internal plasterboard finishing. As confirmed by the estate-and-maintenance department of the museum, this made the

identification of potential water discharge failures eventually leading to its stagnation on the roof particularly difficult [47].

**Figure 12.** MAXXI, Rome (2010). Construction pictures highlighting the drainage system running inside of the museum (ph. Cardellicchio, 2009).

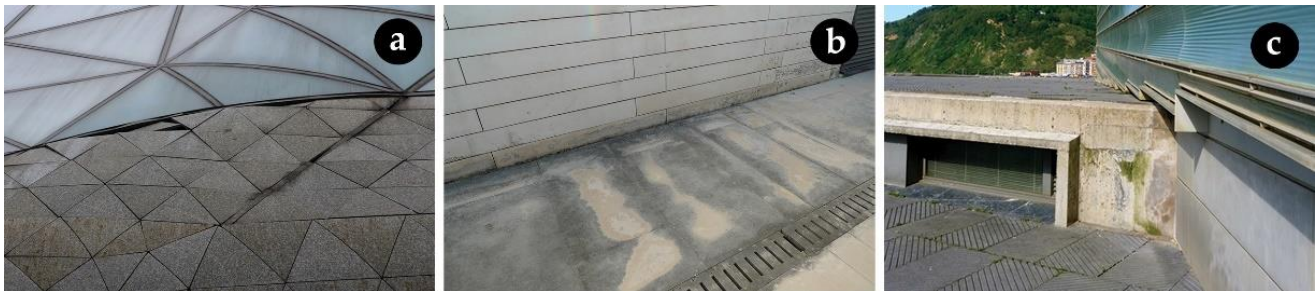
**Figure 13.** Iconic projects with premature patterns of defects. (a) Guangzhou Opera House (2002–2010) (ph. Cardellicchio, 2017); (b) rectory of the of Nova Universidade in Lisbon (1997–1999) (ph. Tombesi, 2014); (c) concert and convention centre Kursaal in San Sebastian (1996–1999) (ph. Tombesi, 2013).
