Seismic Retrofit of Existing Structures Based on Digital Surveying, Non-Destructive Testing and Nonlinear Structural Analysis: The Case of Gjirokastra Castle in Albania

Abstract: The present paper showcases the work carried out as part of the seismic retrofit of the Ottoman fortress of Gjirokastra, a UNESCO World Heritage site located in Albania. The need for strengthening and retrofitting the structure stems from the fact that it is situated in a region of high seismicity and showed signs of structural distress at the time of investigation. The hill on which the castle is built also has stability issues. The seismic retrofit focused on a damaged stone masonry tower of the fortress and was designed following a comprehensive methodology for the inspection, diagnosis and geotechnical and structural analyses. Through the use of non-destructive tests, the existing soil conditions, the material properties and composition and the dynamic behaviour of the tower were assessed. Nonlinear finite element analysis was used to establish the cause of the existing damage and to determine the most effective strengthening solutions. The findings of the investigation revealed potential causes of th

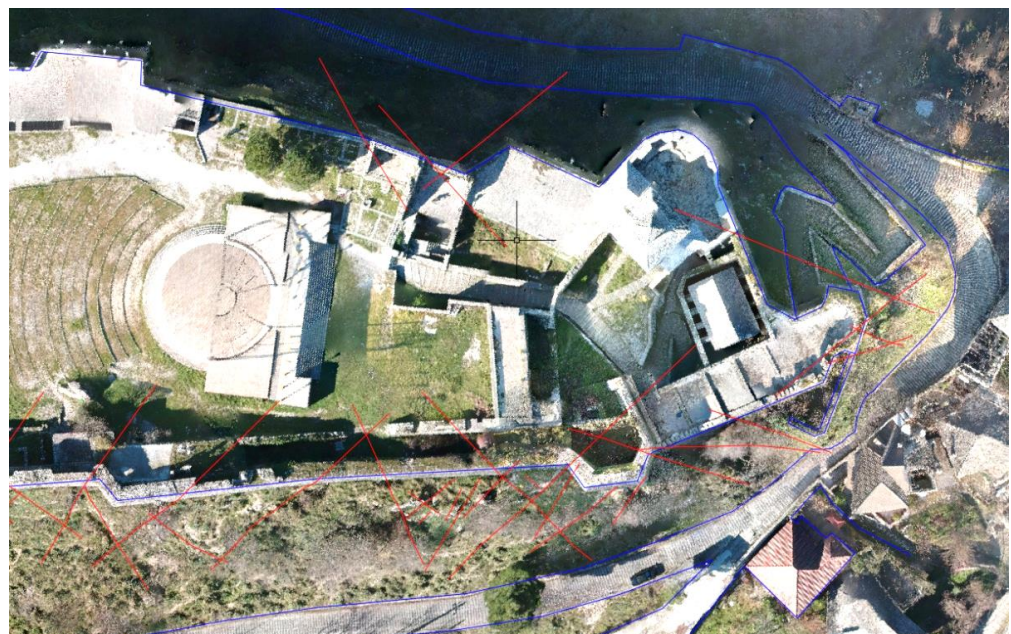
There are no faults or folds of interest that have been mapped but widespread joints in the geological units can be observed. Some differences between the southern and northern part of the conglomeratic unit are seen (Figure 4). In the southern part, two main families are developed, with subvertical dips and an orthogonal shape with north and west dip directions. In the north section, a third joint family was measured and the dip changes range from east to south.

Figure 4. Detailed image of main joints in the conglomeratic around the tower located at the north-eastern end of the fortress (in red). Blue lines mark the outline of the fortress and the roads below. (Photo credit: GEA, based on photo by Rand Eppich).

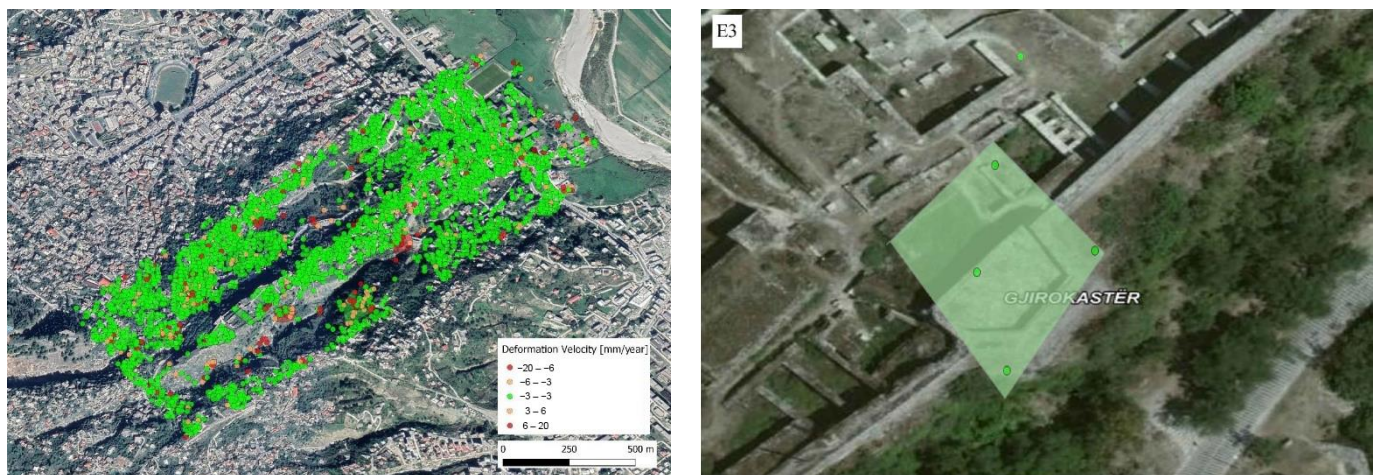
The study consisted of a historical analysis of the satellite images of the Gjirokastra castle area. To this aim, two independent Sentinel-1 datasets were processed—in one, 180 images acquired in descending geometry and covering the period between November 2014 and January 2020; in the second one, 140 images acquired in ascending geometry and covering the period between November 2015 and March 2020. The use of both datasets allows one to decompose the measured displacements in the west–east direction and vertical displacements in those areas with intersection. This information enables an easier interpretation of the results compared with the usual single geometry DInSAR results. The results of the DInSAR deformation measurement of the Gjirokastra castle and surrounding area indicated that there have been no significant displacements inside the castle in the last 5 years. More specifically, no displacement was observed at the location of the tower (Figure 5).

Figure 5. Deformation velocity map of the area of interest (mm/year) (left) and around the studied tower (right).

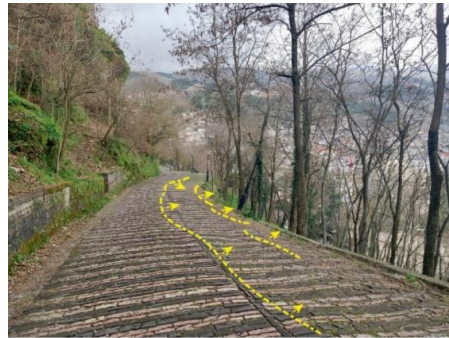
Figure 6. Scarps along the road on the northwest part of the castle. The retaining wall, as well as the lamppost, are rotated and have sunk with respect to the road. In yellow, dotted lines marking shape and direction of deformation on perimetral road below the castle.

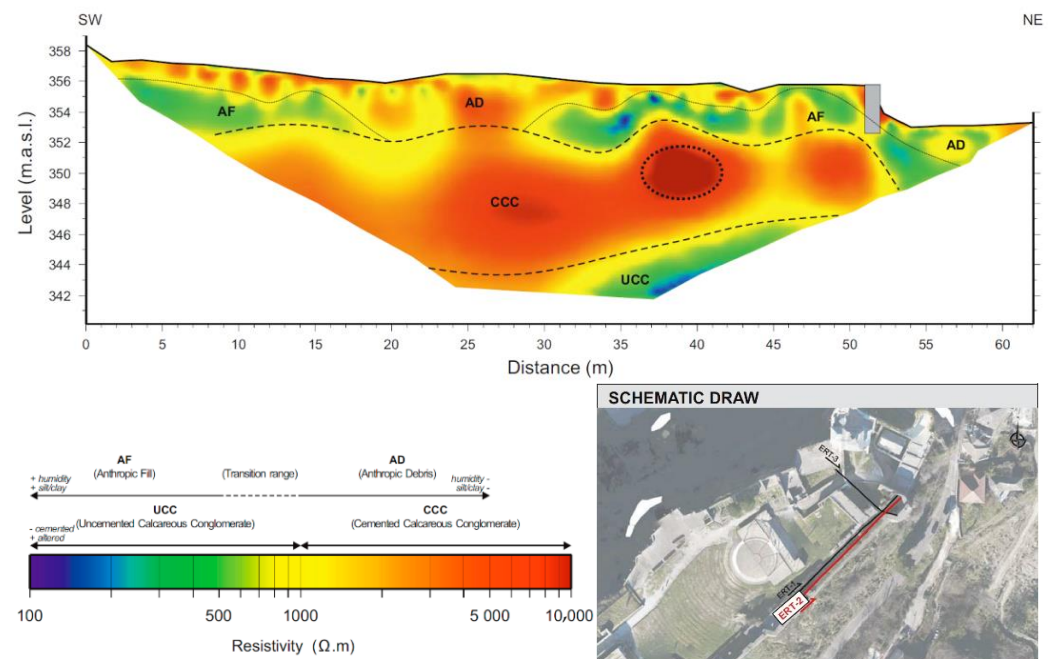
ERT was used to obtain information on the geometry of the different soil layers present around the tower, to detect anomalous zones (e.g., cavities) that correspond to instabilities detected in this area of the castle. For ERT data acquisition, a double-injection curve was used with a 256 ms semi-period and readings of potential differences (and, therefore, apparent resistivity) every 2 ms, with an injection curve delay of 250 ms. An average apparent resistivity was obtained at every measurement point from 130 different values, which provided high-quality data readings. The result obtained from the ERT tomography helped to identify the location of a geoelectrical anomaly that corresponds to a cavity under the wall located next to the investigated tower (Figure 9).

Figure 9. Geoelectrical model obtained for ERT-2. The presence of a geoelectrical anomaly that corresponds to a cavity under the wall located next to the tower is clearly observed. (Photo credit of schematic draw: GEA, based on photo by Rand Eppich).

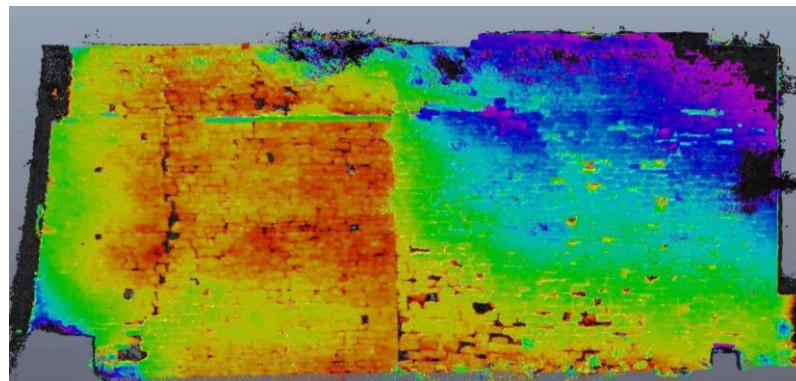
Deformation analysis of the external surfaces of the main masonry walls of the tower was carried out by postprocessing the laser-scanner-generated point clouds and relative out-of-plane displacements were plotted on selected masonry walls (Figure 10). The results were used to obtain a better understanding of the out-of-plane displacements in the tower. This input was crucial to understand the effects of past cracking, the relative position between different sections of walls and for interpreting the modal shapes obtained from the dynamic identification.

While some of the relative displacements were more clearly associated with cracking phenomena, others could be related to plumbing from different construction phases or differential masonry degradation and washed-out joints.

Figure 10. Out-of-plane deformations of the northern elevation of the tower obtained through processing the LiDAR point cloud. The spectrum colour scale indicates the distance of each point to a reference plane, having red colours indicate areas farther away from the plane and purple areas being the closer ones.

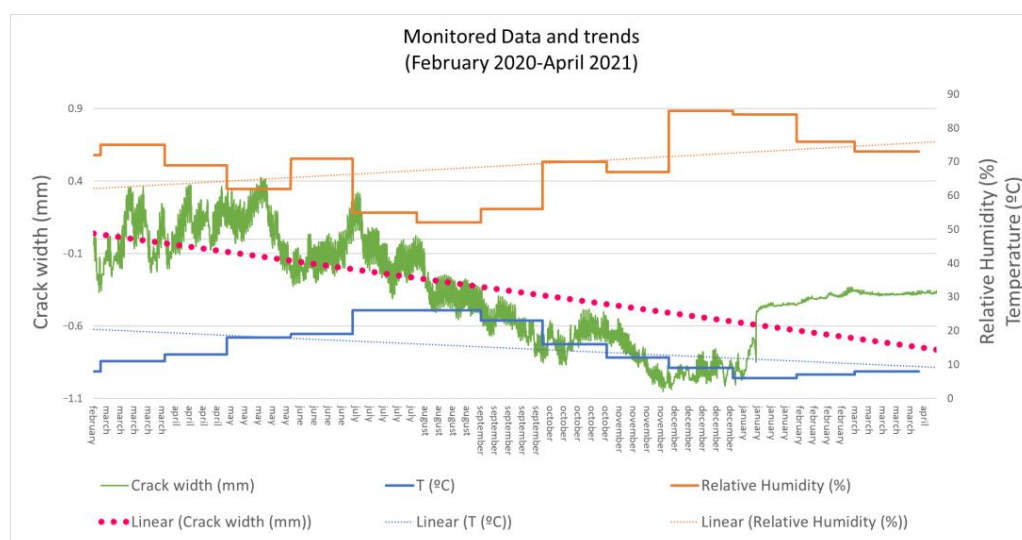
Digital monitoring of the main crack that runs vertically along the tower (seen propagating vertically on the left in Figure 10) was carried out for an approximate duration of 13 months. Average temperatures fluctuated between 8 °C and 26 °C and relative humidity (RH) between 52% and 85% during the period of study, while crack-width variation fluctuated between -1.051 mm and $+0.425$ mm (Figure 11). The temperature and relative humidity values presented along with the crack-width variation are monthly averages for the city of Gjirokastra. Negative and positive values of crack-width variation indicate closing and opening of cracks, respectively.

Figure 11. Graph showing variation in monitored parameters from February 2020 to April 2021. Positive values indicate that the crack has closed since the beginning of the monitoring, and negative values indicate that the crack has opened.

A sudden change in the crack width was detected between 8:00 and 9:00 a.m. of local time in Gjirokastra on 12 January 2021. This coincided with a seismic event registered by several seismological institutions, such as the National Observatory of Athens and the European Mediterranean-Seismological Centre. The movement was evidence of the tower and/or conglomerate being vulnerable to seismic events and, therefore, signalled a need for intervention to avoid further propagation of damage or potential collapse in the case of seismic events with higher magnitudes.

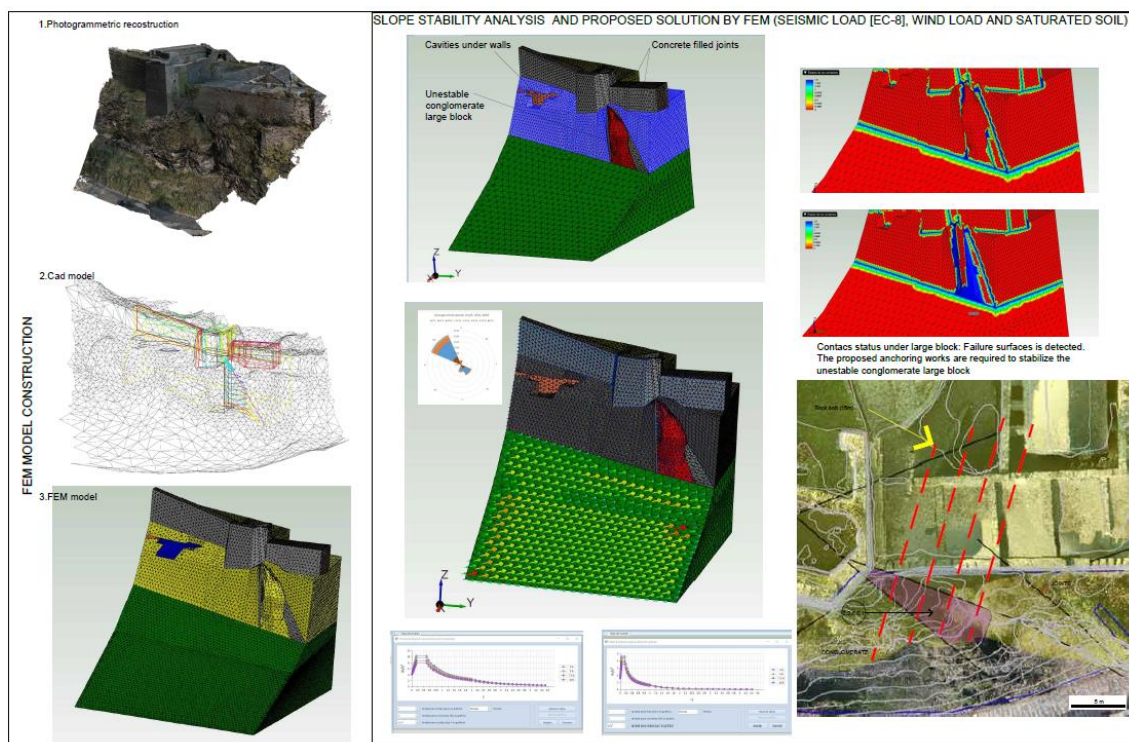
Figure 18. Example of FEM analysis carried out to evaluate and design an engineering solution to stabilize unstable rock blocks. (Photo credit: GEA, aerial photo by Rand Eppich).

The cliff stability analysis revealed that there is a high risk of rock toppling and the potential for rock fall due to the roots of the trees growing in open joints and rotational and/or translational landslides (Figure 18). In the southwestern end of the tower, an open fracture under the wall continued below the castle. In the north-eastern end of the tower, a big fracture under the masonry was observed.

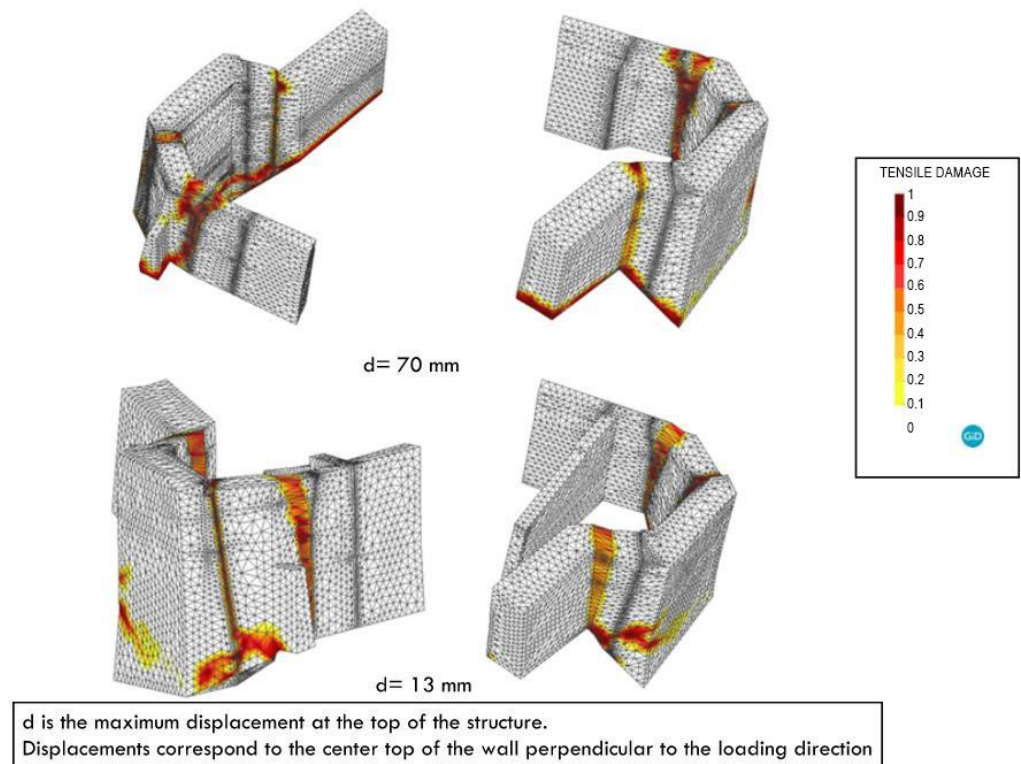
Two scenarios for differential soil settlements were considered by applying incremental vertical (Figure 23 bottom) and diagonal displacements over a portion of the base of the eastern walls of the tower that is separated from the rest of the structure by two existing rock joints. Displacements were imposed at the base of the easternmost wall. In both loading scenarios, the cracking pattern was similar to that observed in the real structure. Based on the above analyses, it can be concluded that a large part of the existing damage is due to a differential soil settlement at the base of the eastern walls.

Figure 23. (top) Tensile damage in the pushover analysis carried out in the east–west direction (deformation $\times 50$); (bottom) tensile damage after imposed vertical movement (deformation $\times 50$).

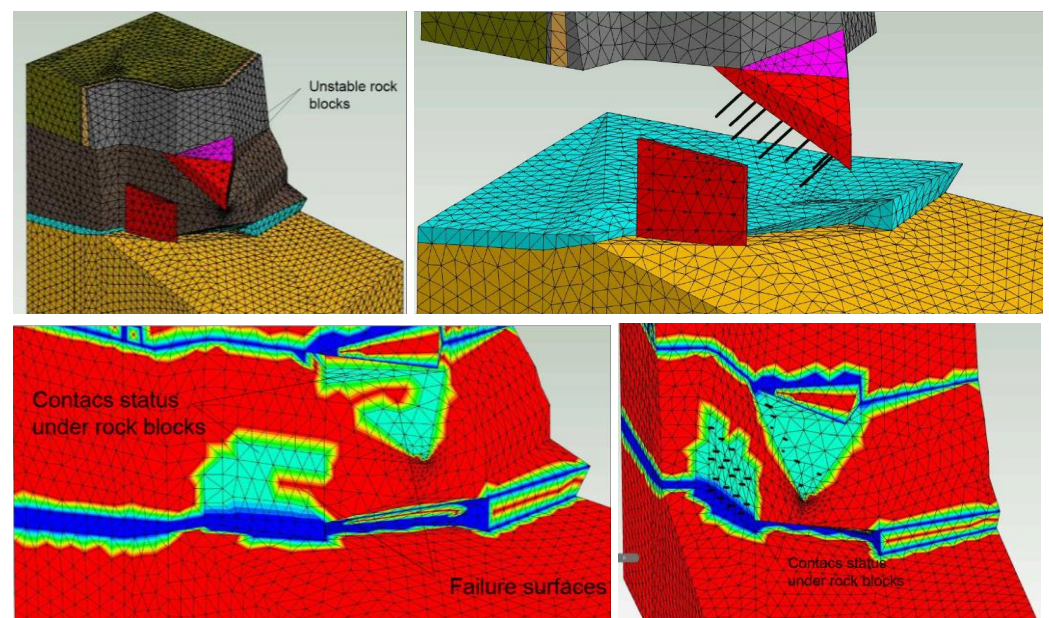
Figure 26. Design of geological intervention at the rock blocks at the southern end of the castle, similar to the ones carried out at the location below the tower: **(top)** location of unstable rocks, where different colours indicate different material properties, such as masonry, soil and rocks **(left)**, and proposed anchors **(right)**; **(bottom)** comparison of contact status under the rock blocks before and after the introduction of anchors at the southern end of the castle. Red areas within the annotated contact surfaces indicate the presence of failure areas.

The main interventions proposed were drilling and pinning the rock to solid substrate and injecting mortar or concrete into the fissures, joints and cavities below the castle to fill the voids. Netting was also designed and recommended to secure to the rock to prevent rock from falling on the road below. Although the netting is visually obtrusive, its long-term impact on the aesthetical appearance of the site will be minimized with the formation of a patina and vegetation growth. The removal of several large rock blocks, which pose life-threatening risks, will not impact the Outstanding Universal Value (OUV).

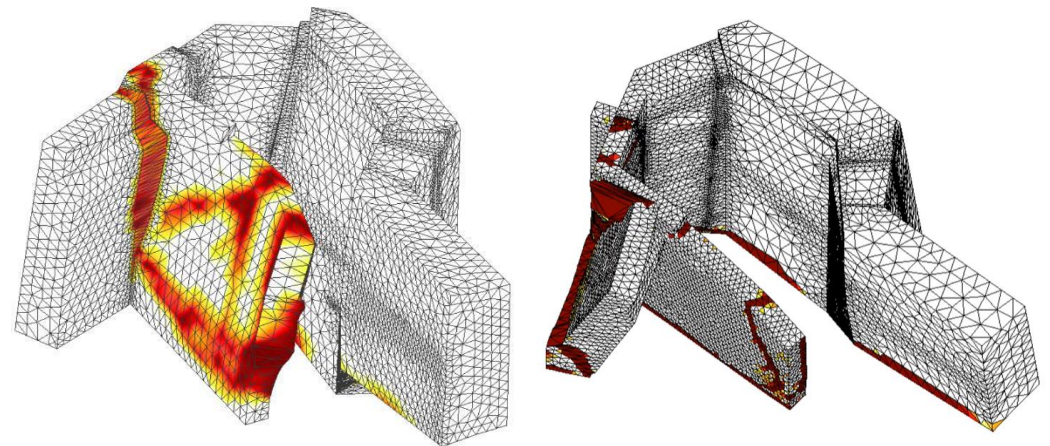
Figure 28. Comparison of tensile damage distribution and deformations for the pushover analyses in EW2 direction considering: (left) damaged model with rear wall and (right) retrofitted model with lower-bound injections and small buttresses type A. (deformation $\times 40$).

In general, the maximum horizontal acceleration, deformation capacity and ductility were found to increase in the retrofitted condition for all directions of analysis. The increase in the maximum horizontal acceleration ranged between 45% and 100%, depending on the loading direction.
