SEISMIC ASSESSMENT OF A MASONRY CHURCH AND RETROFITTING PROPOSITIONS

Case study of the Kapela Sveti Nikola in Petrinja

Master thesis

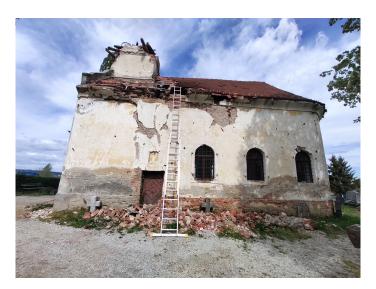
The most obvious damage was the failure of the bell tower, where the spire and the top part of the masonry tower completely fell of (see figure 5). It fell on the timber roof which was largely destructed. The vaults show some huge cracks, due partly to the seismic forces and partly because the bell tower fell on them. We can also see many cracks in all the walls, with the plaster coming off in some places.

Figure 5: Condition of the church after the earthquake

The part of the roof that was destructed has now been temporarily repaired with a metal sheet covering. The bell tower has also been covered. This is to avoid further damage on the inside due to the rain. There are also some temporary braces on the inside to give the vaults and walls additional support.

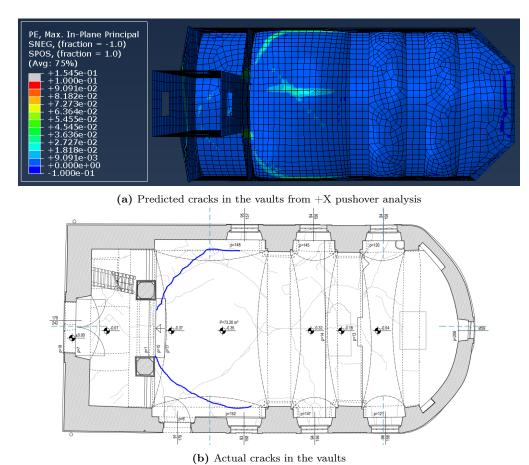
The damage predicted by the numerical analysis corresponds partially to the observed damage on the church. The horizontal crack in the front facade predicted by the analysis is also visible in reality. The analysis also predicts cracks in the large vault near the bell tower, which is confirmed by the current state of the church, although it is hard to know which of these cracks were caused directly by the seismic action and which ones were caused by the fall of the bell tower on the vault. Similarities can even be seen in the shape of the cracks, as the curved cracks on the sides of the vault are also visible in reality (see figure 25).

Figure 25: Comparison of the cracks in the vault (similar crack shapes highlighted in blue)

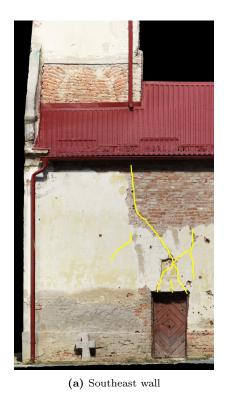
The vertical cracks in the side walls are also visible on the church on both sides (figure 29). In the southeast wall, the crack seems to go through the side door. The predicted vertical cracks in the front facade also appeared in reality.

Figure 29: Cracks at the connection between the bell tower and the rest of the church

The goal of the intervention is therefore to connect these two parts of the church together, so that the whole church behaves as a monolithic ensemble. This can be achieved by the addition of longitudinal steel ties inside the southeast and northwest walls, above the windows (see figure 48). The procedure consists of inserting ties into holes drilled in the walls parallel to the wall surface, and anchoring them at both ends with simple devices like bars or plates [14]. These ties would connect both parts together thanks to their tensile strength and could transfer part of the horizontal forces (caused by the mass of the bell tower) to the rest of the church and therefore increase its total strength. It could also avoid some potential pounding between the bell tower and the rest of the church.

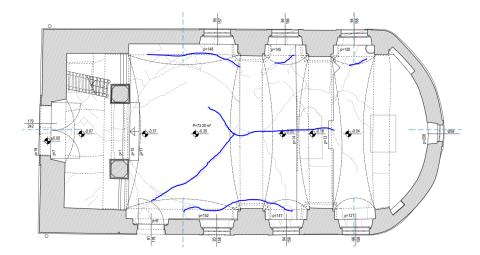
This predicted out-of-plane mechanism appears to be consistent with what happened in reality, because this northwest wall suffered some permanent deformation and is still slightly leaning outwards. The vertical cracks in the wall itself are also visible above some of the windows, on both the northwest and the southeast wall. Some cracks predicted in the vaults are also visible in reality (see figure 33).

Figure 33: Cracks on the vaults that correspond to the predicted damage in the +Y direction

Concerning the problems brought forward by the +Y pushover analysis, the cracking of the vaults would be avoided if the OOP overturning of the northwest and southeast walls was restricted. A solution could be to introduce steel ties between these walls to withstand the thrust of the vaults and restrict the movement of the supports of the vaults. The best location to place them is probably at the center of the two central arches, where the thrust is the most important (see figure 51). Concerning the height, they could be introduced either under or over the arches. Placing the tie under the arch has the advantage of directly taking up the thrust of the arch, but it would be visible from inside the church and could be considered obtrusive. With a placement over the arch, the tie would not be visible but it would create a bending moment in the walls and a different failure mechanism could be possible [2] (see figure 52). A structural analysis would be necessary to determine which placement is more suitable. As already discussed for the ties in the other direction (section 6.1), this method provides a good compatibility, is removable and the durability should not be too much of a concern as most of the ties would be controllable.

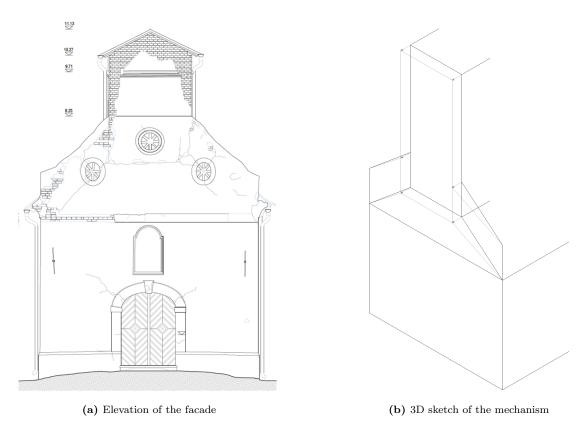
A very clear crack pattern can be seen in the upper part of this facade (figure 40(a)) with horizontal, vertical and diagonal cracks. While some of these cracks are predicted by the pushover analysis in the +X direction (section 4.4.2), they could also indicate an out-of-plane mechanism as shown in figure 40(b), which did not appear in the numerical analysis. Therefore, it is also interesting to investigate this mechanism with hand calculations.

Figure 40: Southwest facade mechanism

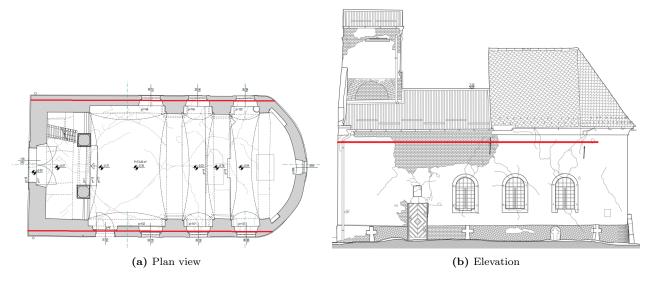
Figure 48: Introduction of the steel ties

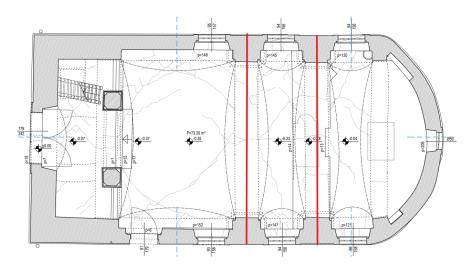
Figure 51: Introduction of the transverse steel ties
