Engineering Failure Analysis

Photogrammetry-aided numerical seismic assessment of historical structures composed of adobe, stone and brick masonry. Application to the San Juan Bautista Church built on the Inca temple of Huaytará, Peru

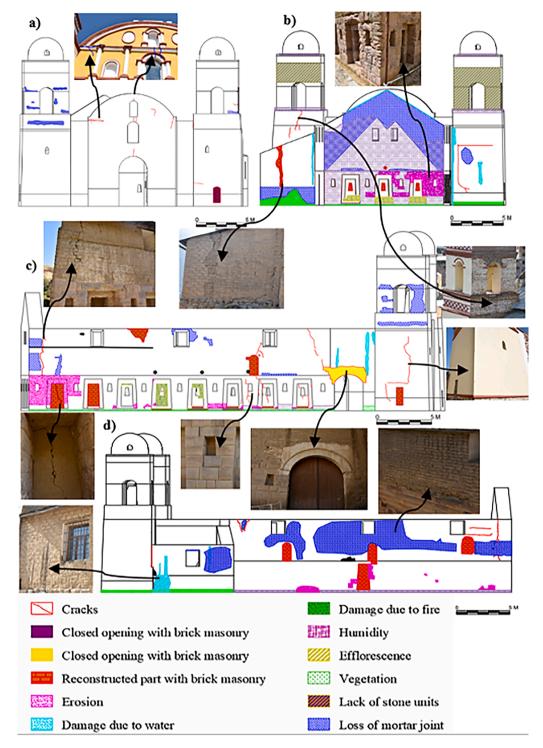
After centuries and almost no conservation, the structure's damage is evident nowadays. The Inca walls evidence stone separations, the presence of vegetation in between the blocks, especially in the lower courses, and section loss due to erosion and previous fires. The adobe walls of the nave (north and south) present cracks and loss of integrity due to humidity. The north tower shows important cracks in its interior, especially near the corridor. Both towers also exhibit horizontal cracks in the boundary zone between stone and adobe masonry. There is damage due to rainwater erosion at the edge between the south wall and the south tower. At the top of the towers made of brick masonry, there are problems of efflorescence and loss of mortar section, and moisture damage at the base of the columns and the dome. Fig. 8 shows a graphic summary of the damage reported during the field visit.

Fig. 8. Damage survey: a) East, b) west, c) north, and d) south façades.

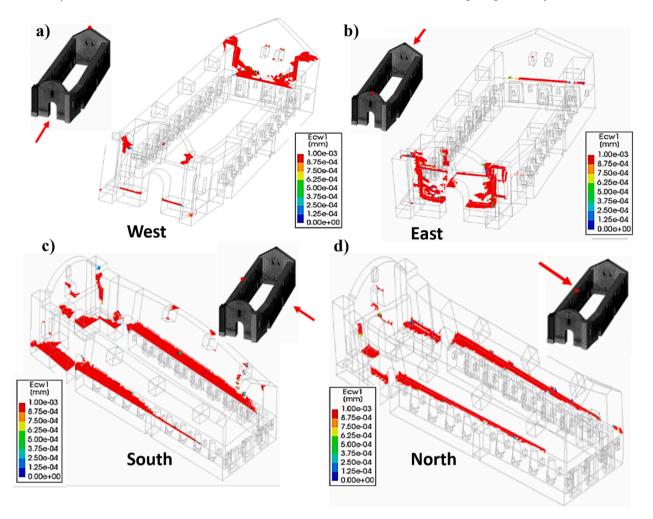
Among the four considered loading cases for the analyses of main nave, the lowest base shear corresponds to loading towards the South direction, with damage affecting mainly the western façade, see Fig. 20c. For loading towards the west (Fig. 20a), vertical cracks appear at the adobe walls along the connections of the façade with the transversal walls at the same location where cracks appear today in the structure (see Section 3.3), and horizontal cracks at the interface with the Inca stone masonry. Cracking also occurs at the base of the gable in the eastern façade, but to a lesser extent than the western one. Damage at the eastern façade is more prominent for loading towards the East (Fig. 20b). The adobe walls present substantial vertical cracking at the connections with the transverse walls and above the door and window openings. Horizontal cracks appear at two locations, i.e. at the interface with the stone masonry at the base and at the height where the width of the façade decreases.

The damage in the structure for loading towards the South-North direction are similar to each other (Fig. 20c-d), affecting mainly the southern and eastern walls. In these cases, horizontal cracking occurs at the interface between the adobe walls and the Inca stone masonry, overturning the former. For loading towards the south, cracks appear at the intersection between orthogonal walls, which are visible today. Some cracking is also present at the eastern façade above the openings. The smaller thickness of the southern wall results in the earliest initiation of its out-of-plane failure when loading towards the south. This justifies the lowest acceleration capacity among the four studied cases.

Fig. 20. Distribution of the crack width for the four pushover analyses of the main nave: (a) West direction, (b) East direction, (c) South direction, and (d) North direction.

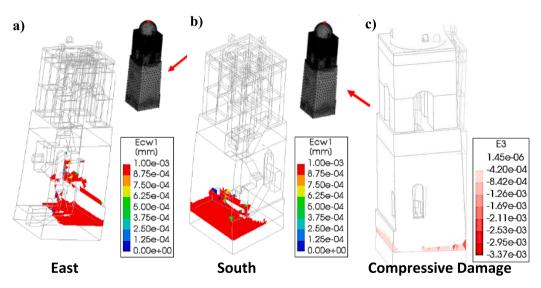
The towers behaved as a cantilever and developed a flexural overturning mechanism characterised by important cracking at the interface between stone and adobe masonry (see Figures Fig. 23 and Fig. 24) for all analysed cases. The northern tower's northern wall also presents important vertical cracking in the interior at the location of the internal staircase, which was also observed during the insitu inspection (see Section 3.3). Similar damage does not appear in the southern tower due to the limited width of the staircase compared to that of the northern tower. Compressive damage was also observed at the base of the adobe walls, which started appearing close to the peak base shear and interior corridor of the north tower, see Figures Fig. 23c and Fig. 24c.

Fig. 23. Failure mechanism for the north tower: a) Crack width for the east direction, b) crack width for the east direction, and c) compression damage in the interior corridor of the north tower, showing considerable deformation at the base of the adobe structure.

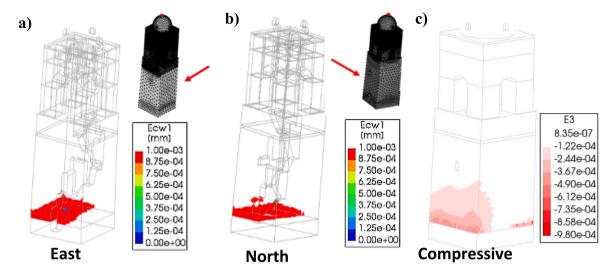
Fig. 24. Failure mechanism for the Southern tower: a) crack width for the east direction, b) crack width for the north direction, and c) compression damage in the interior corridor of the south tower, showing deformation at the base of the adobe structure.

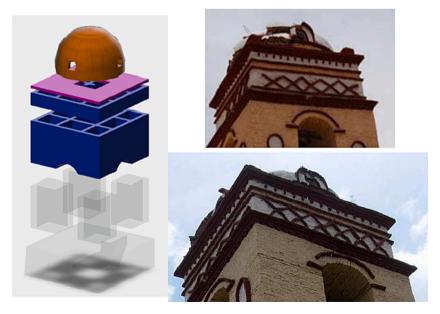
During the 2007 Pisco earthquake, which occurred 150 km away from Huaytara the San Juan Bautista church experienced localised damage in the North tower, resulting in the collapse of the dome, as depicted in Fig. 5e. Specifically, the top part of the north tower collapsed, and cracks appeared at the connection with the neighbouring walls of the nave. Additionally, there is no record of PGA in the area. The pushover analysis with a loading pattern proportional to the mass distribution could not represent this type of failure. There are two potential reasons for this. First, the interaction of the towers with the adjacent nave influences their dynamic response, which

Fig. 26. Platform constructed as basement of the dome and collapsed dome of the North tower.
