Appendix B

Experiments on materials on DVD

B.1 Introduction

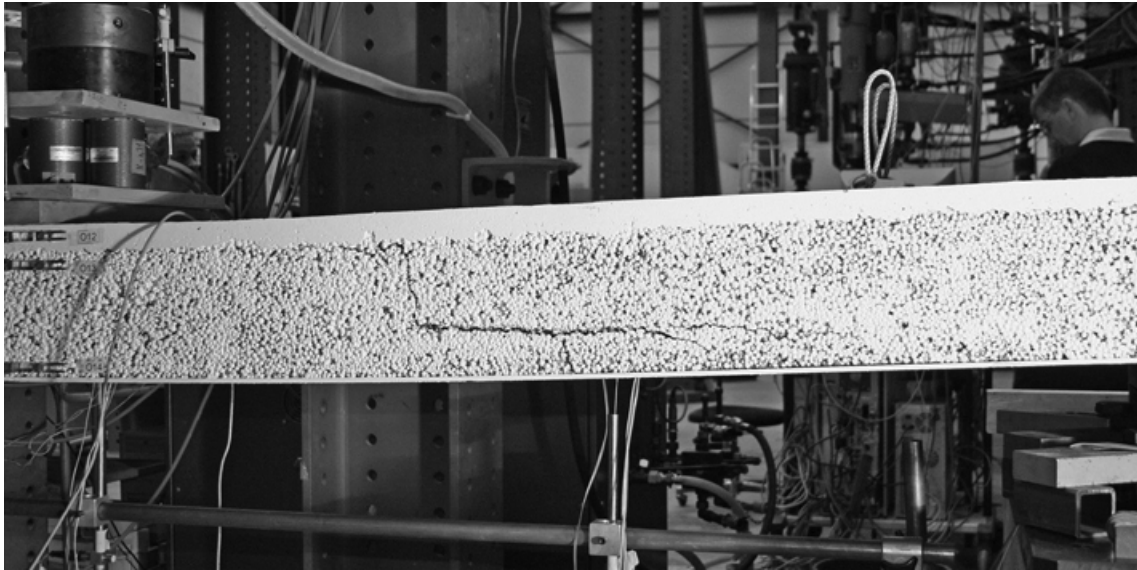
(a) Crack development on southern side at 4.0 kN (post-peak)

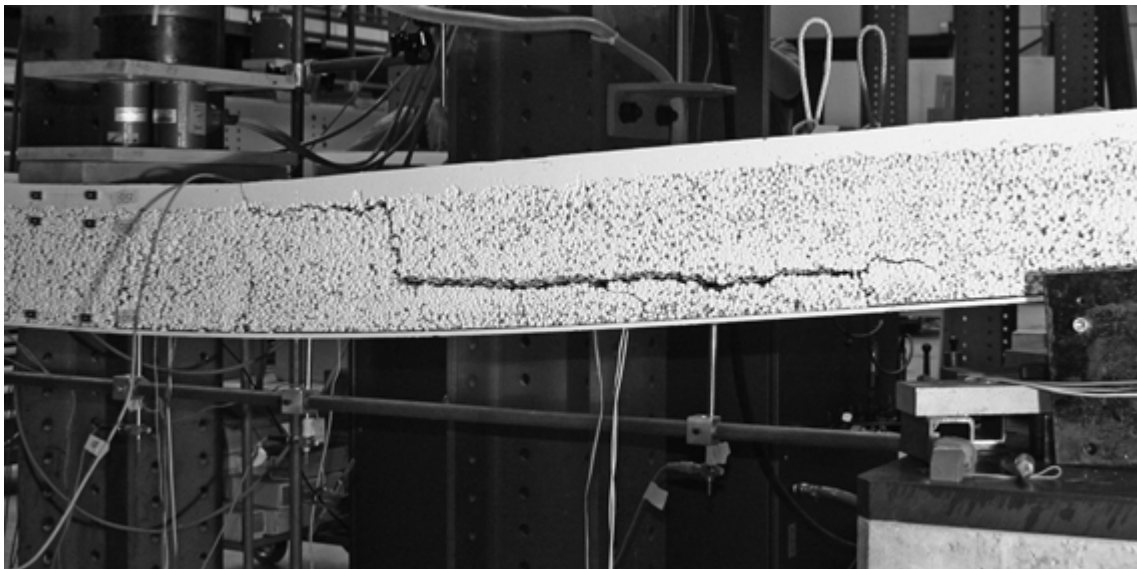
(b) Crack development on southern side at 5.0 kN (post-peak)

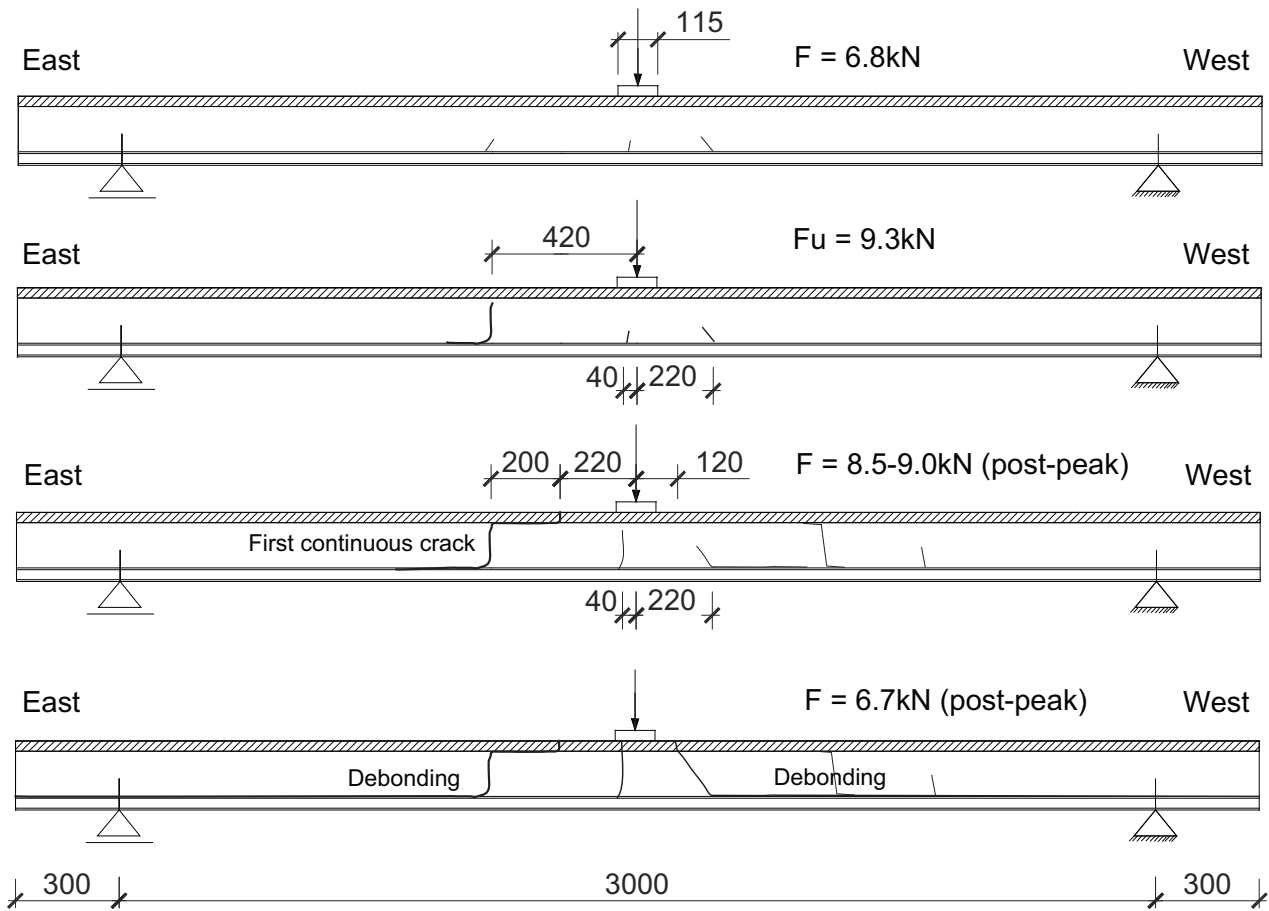
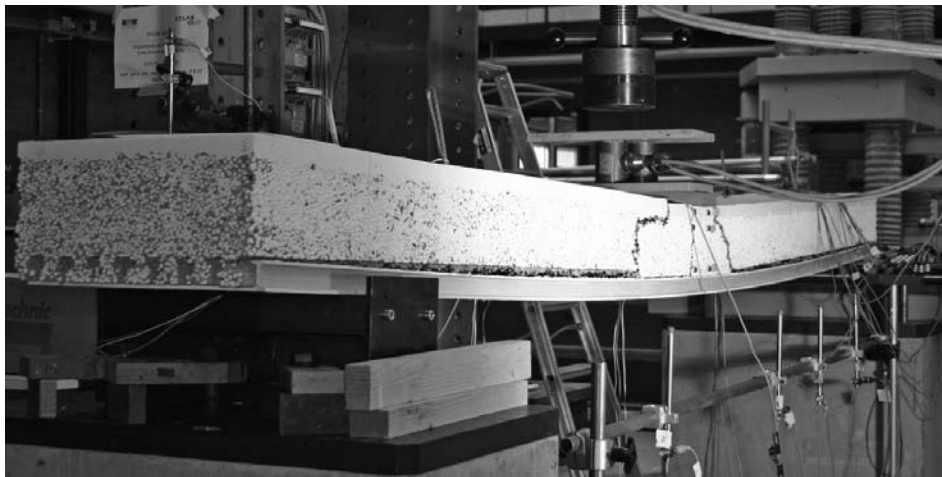
Figure C.19: 900-1: a) Failure process and b) unloaded failed beam after experiment - north.

(a) View from north - failure process

(b) View from north - unloaded failed beam after experiment

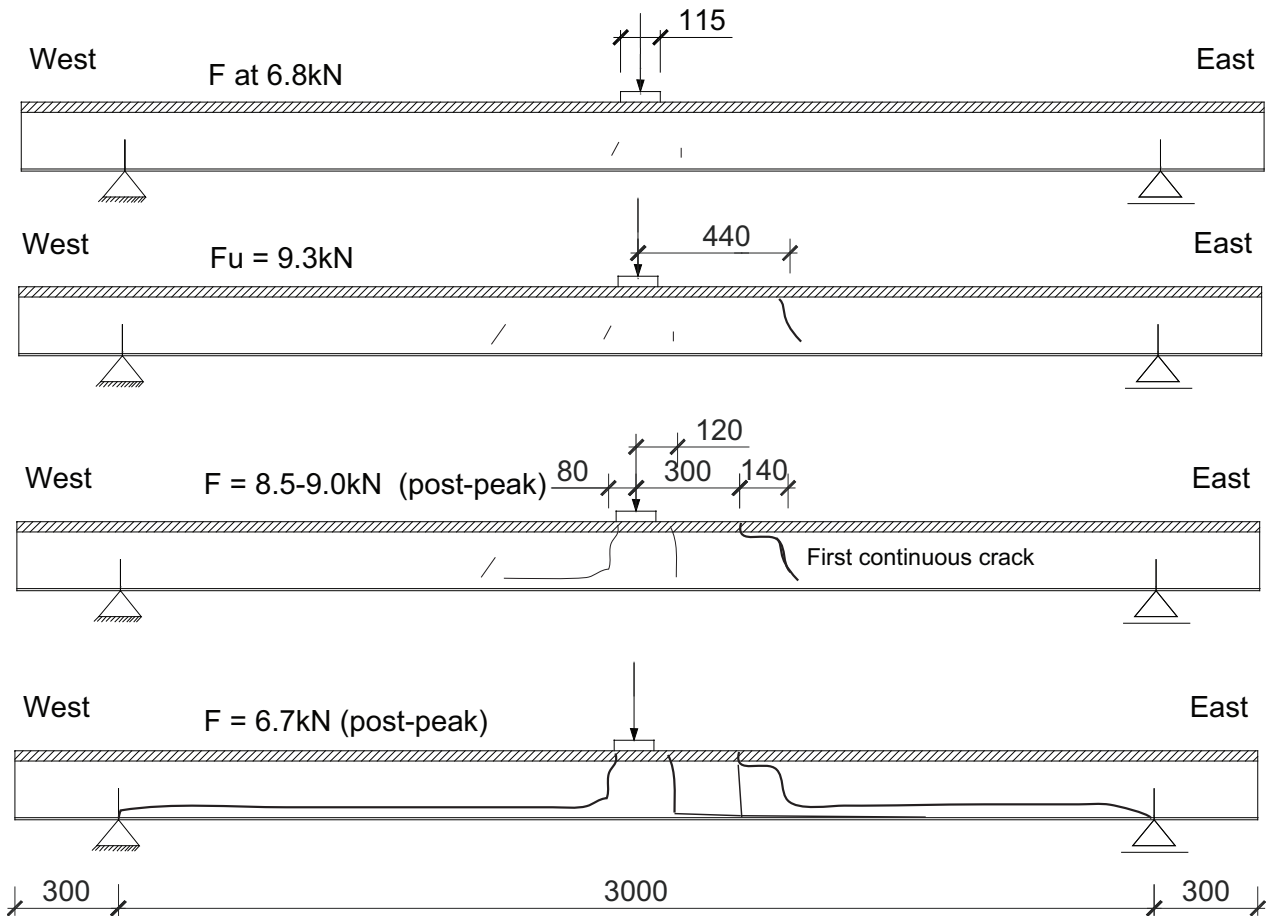
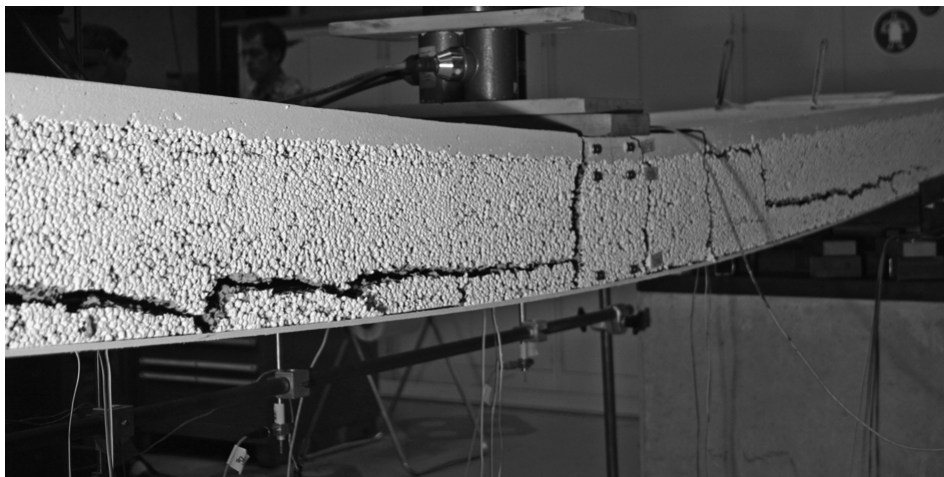
Figure C.20: 900-1: a) Failure process and b) unloaded failed beam after experiment - south.

(a) View from south - failure process

(b) View from south - unloaded failed beam after experiment

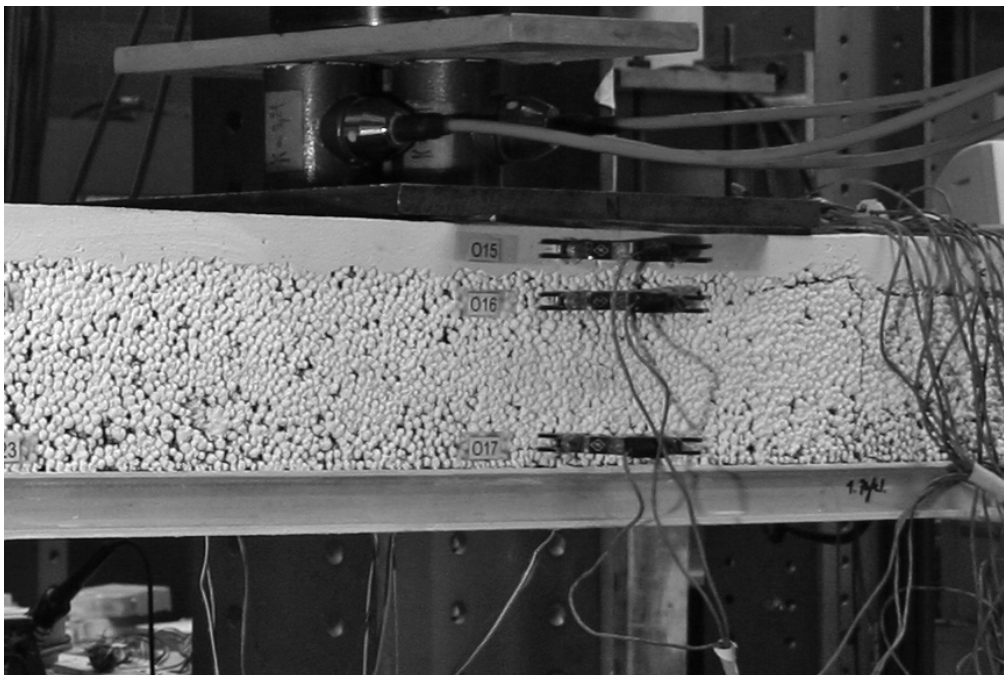
Figure C.30: 900-2: Continuous crack next to loading plate during unloading of second load cycle (post-peak).

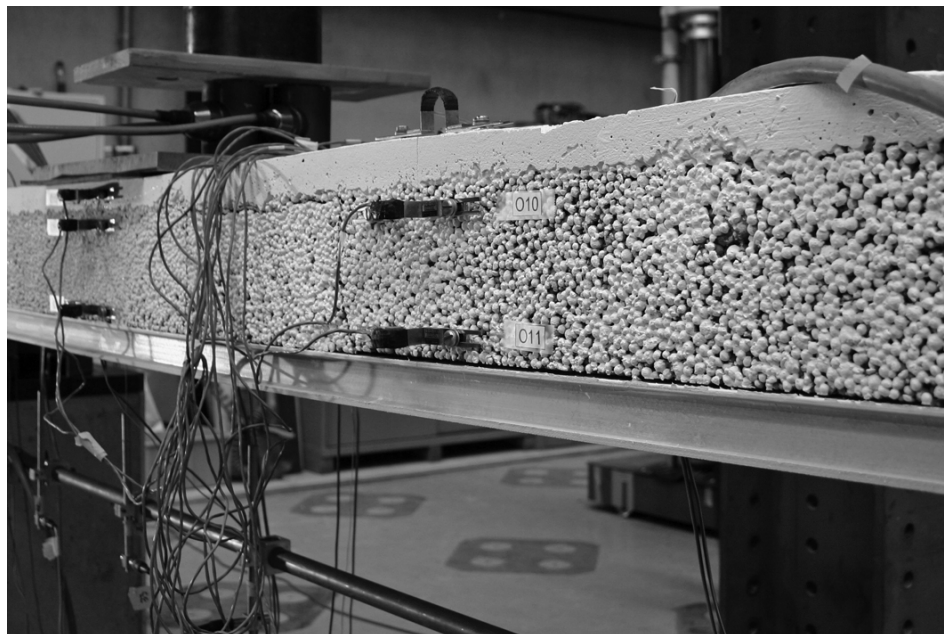
(a) Crack development after second load cycle; at ~ 8.5 kN

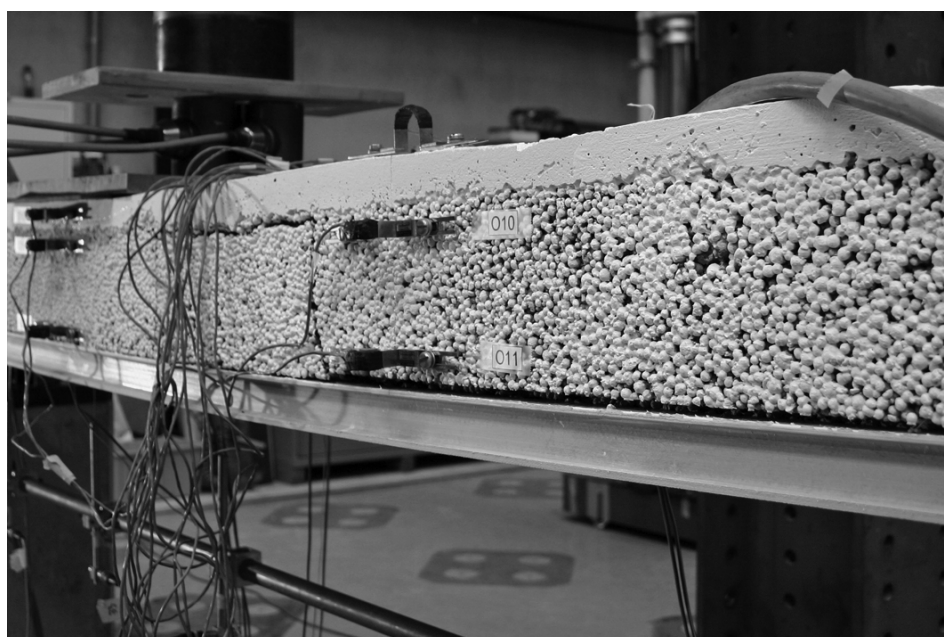
(b) Crack development after second load cycle; at ~ 5.5 kN

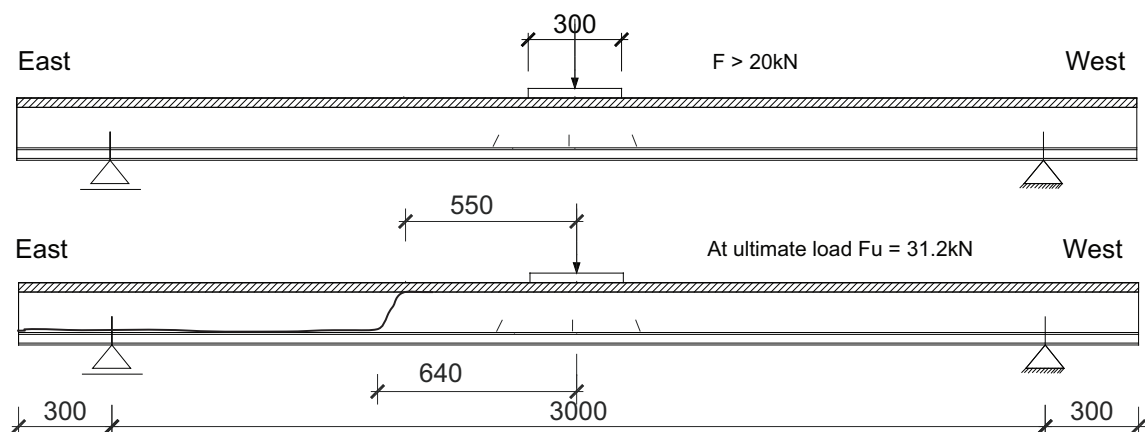
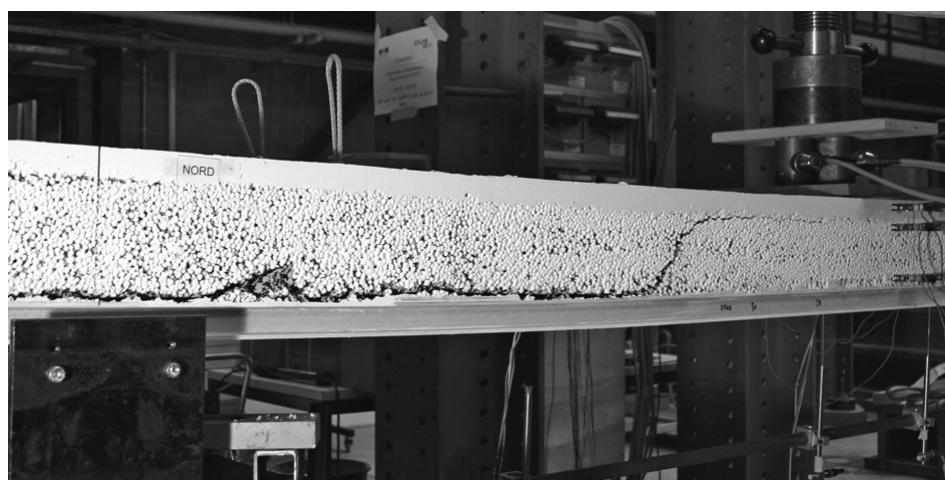
Figure C.47: 900E-1: a) Failure process and b) still loaded failed beam after experiment - north.

The failure process of beam 900E-1 is illustrated in Figures C.46, C.47 and C.48. The first noise occurred at a load of 15 kN. From 20 kN onwards, some small cracks could be observed in the tension zone of the LC layer next to the loading plate. The beam failed at the ultimate load of $F_u = 31.2$ kN and the corresponding deflection was 8.7 mm. The failure was an immediate and brittle shear failure of the lightweight concrete. The diagonal crack occurred at approximately 60 cm from the mid-span. The crack at the FRP-LC interface developed horizontally along the top of the T-webs up to the beam end (Figure C.46-a). The cracks propagated through the lightweight aggregates and the FRP-LC interface with the epoxy resin remained undamaged, (Figure C.46-b). After failure, the load decreased immediately to the final value of 3 kN, where the experiment was stopped. The failed and still loaded specimen is shown in Figures C.49 and C.50.

(a) View from north - failure process

(b) View from north

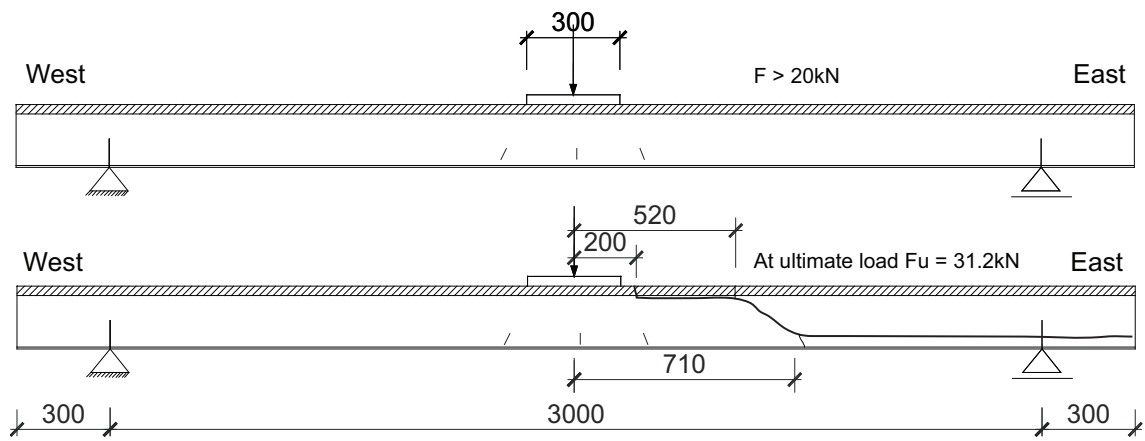
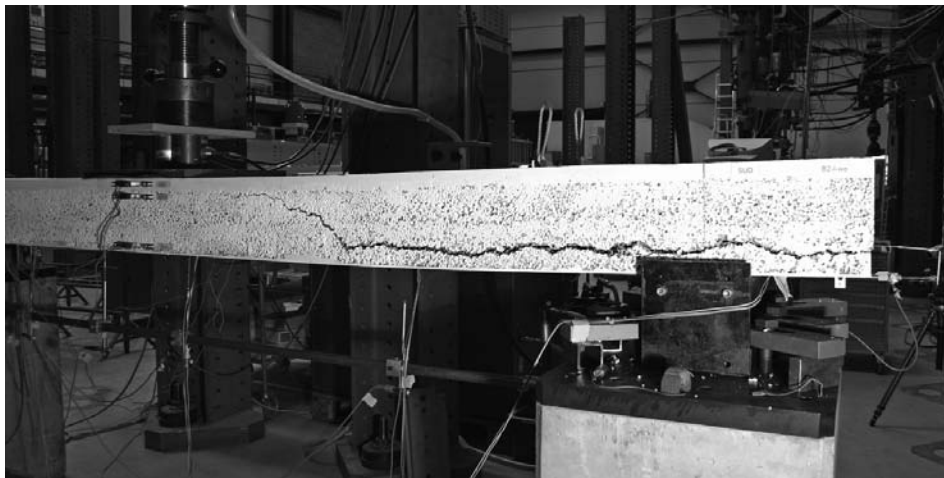
Figure C.48: 900E-1: a) Failure process and b) still loaded failed beam after experiment - south.

(a) View from south - failure process

(b) View from south

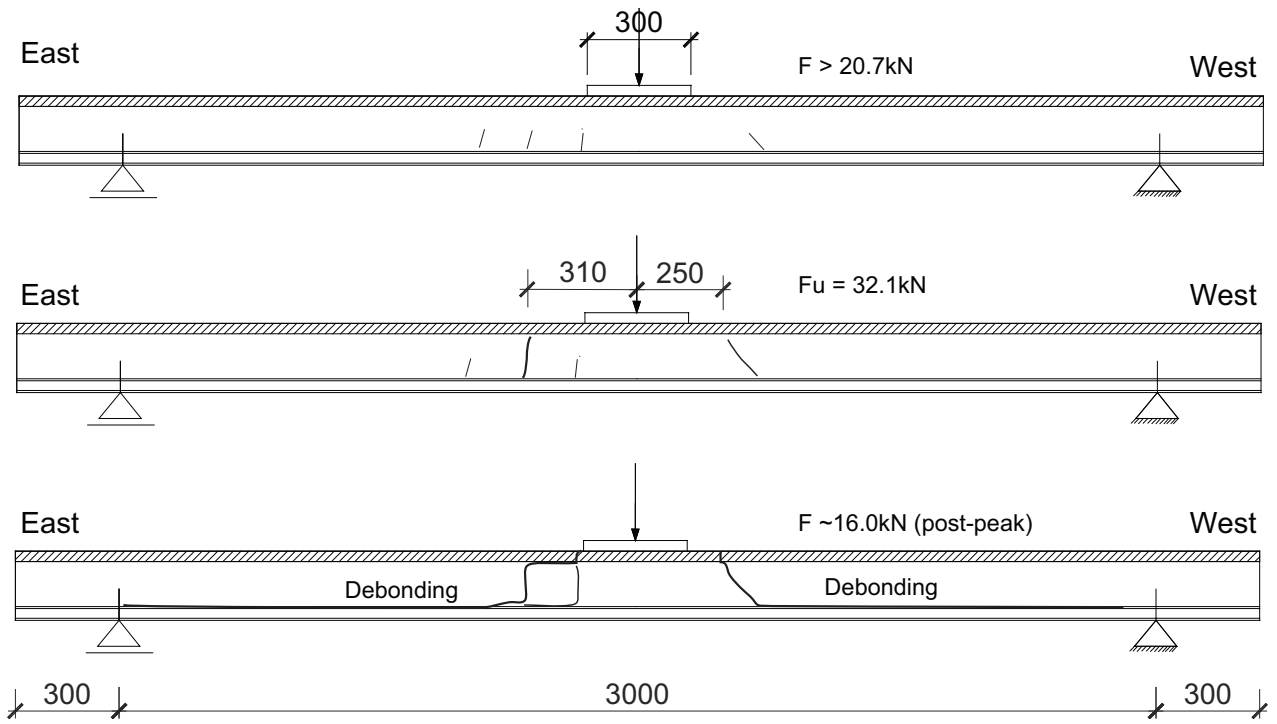
Figure C.73: 1300-1: a) Failure process and b) still loaded failed beam after experiment - north.

(a) View from north - failure process

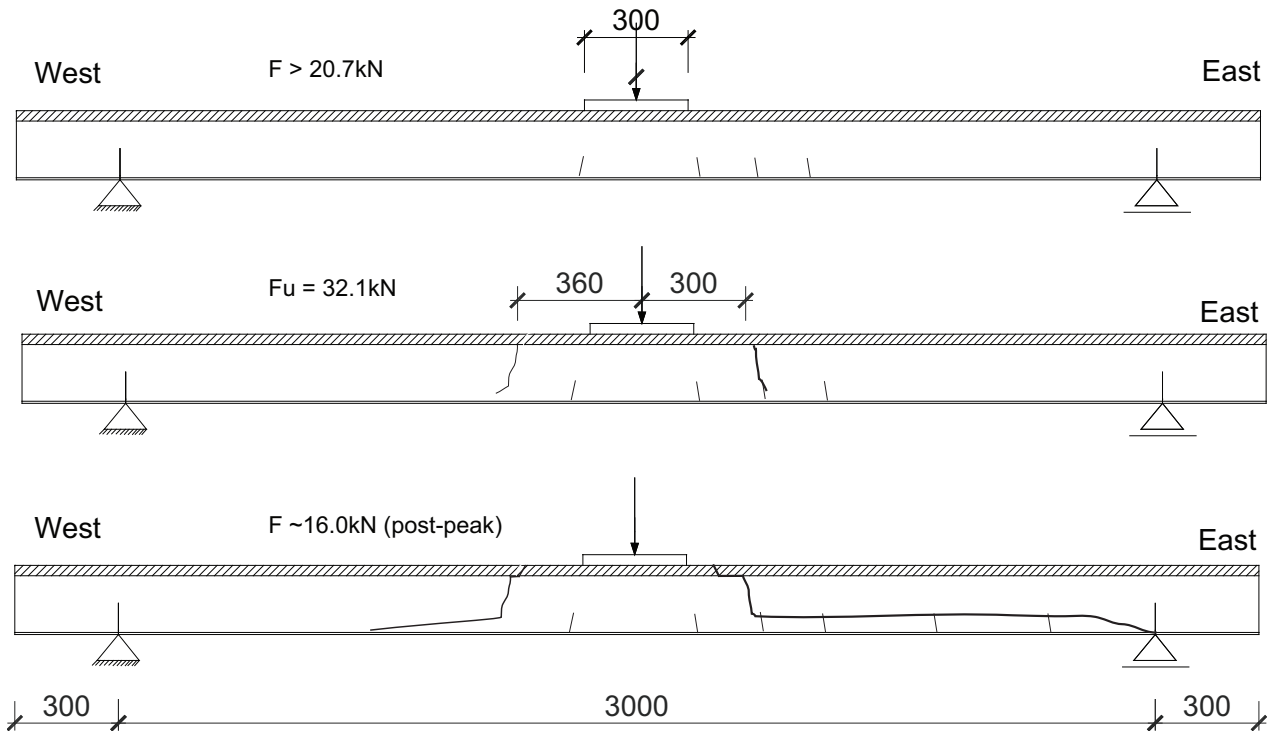
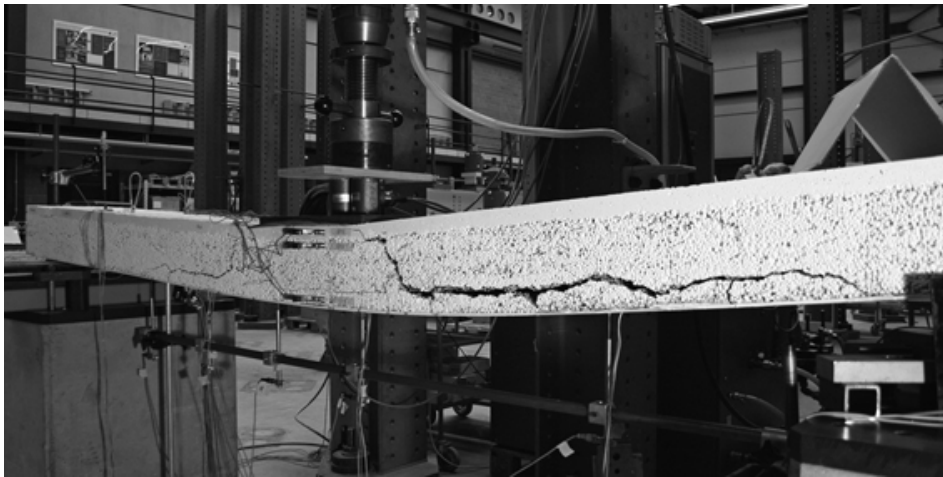
Figure C.74: 1300-1: a) Failure process and b) still loaded failed beam after experiment - south.

(a) View from south - failure process

(b) View from south

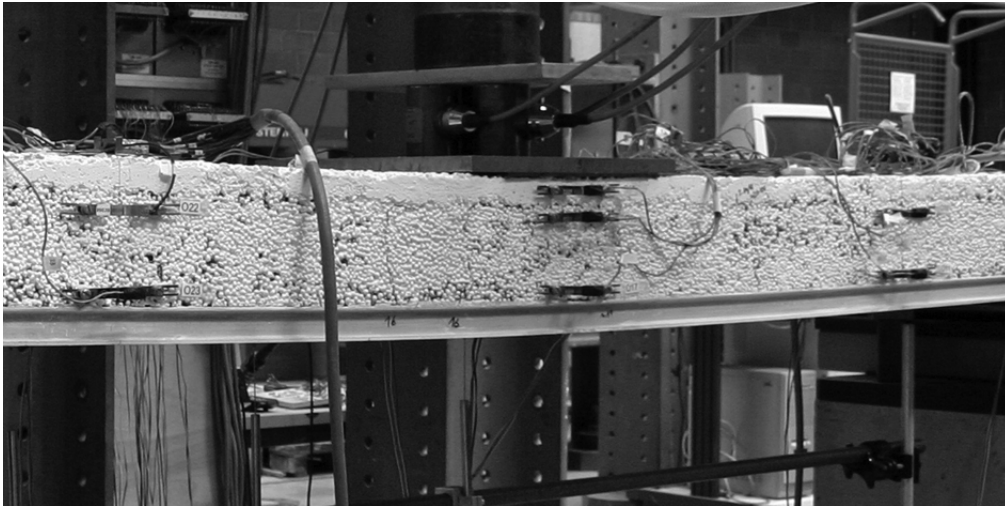
(a) Vertical cracks next to loading plate at ~ 21.0 kN, second load cycle

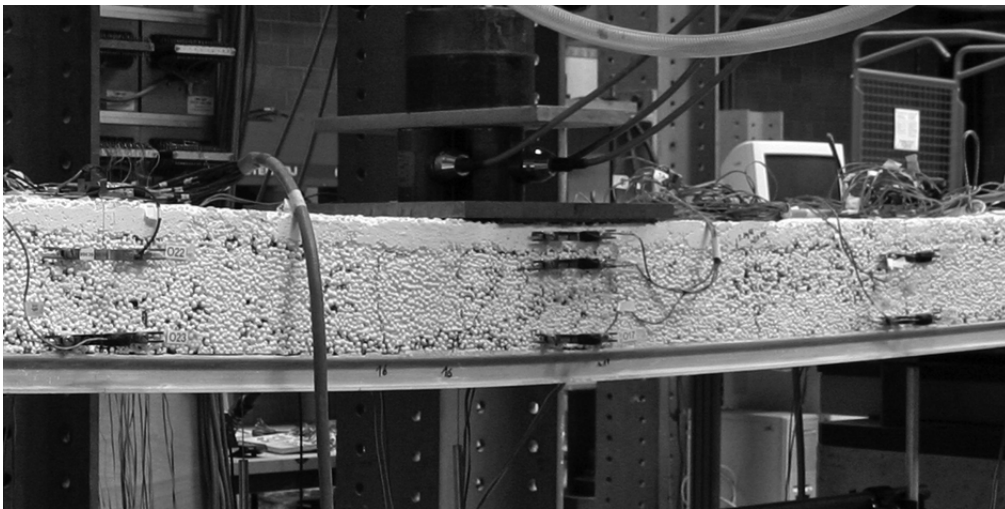
(b) Vertical cracks and debonding at ultimate load at $F_u = 23.3$ kN

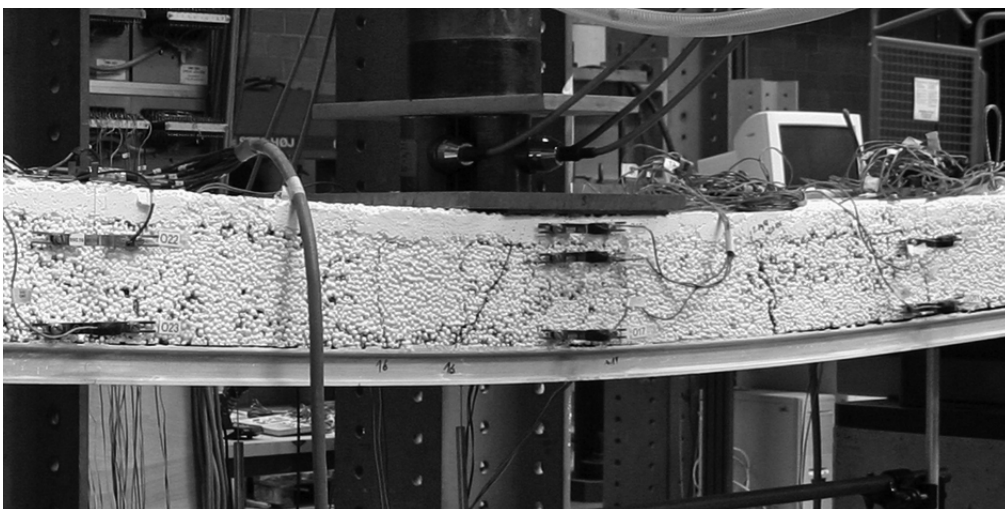
(c) Vertical cracks and debonding at ~ 10 kN (post-peak)

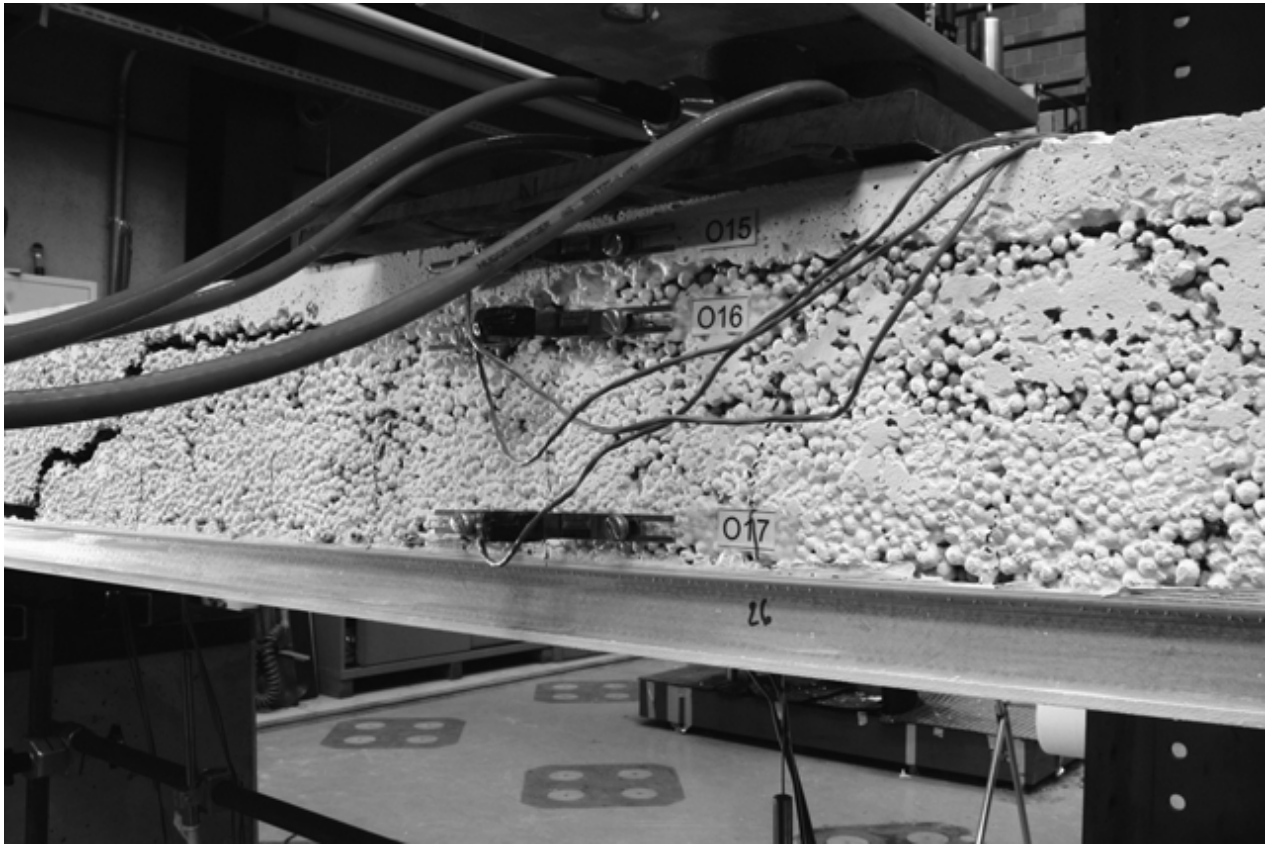
(a) View from north - mid-span - small cracks below loading plate

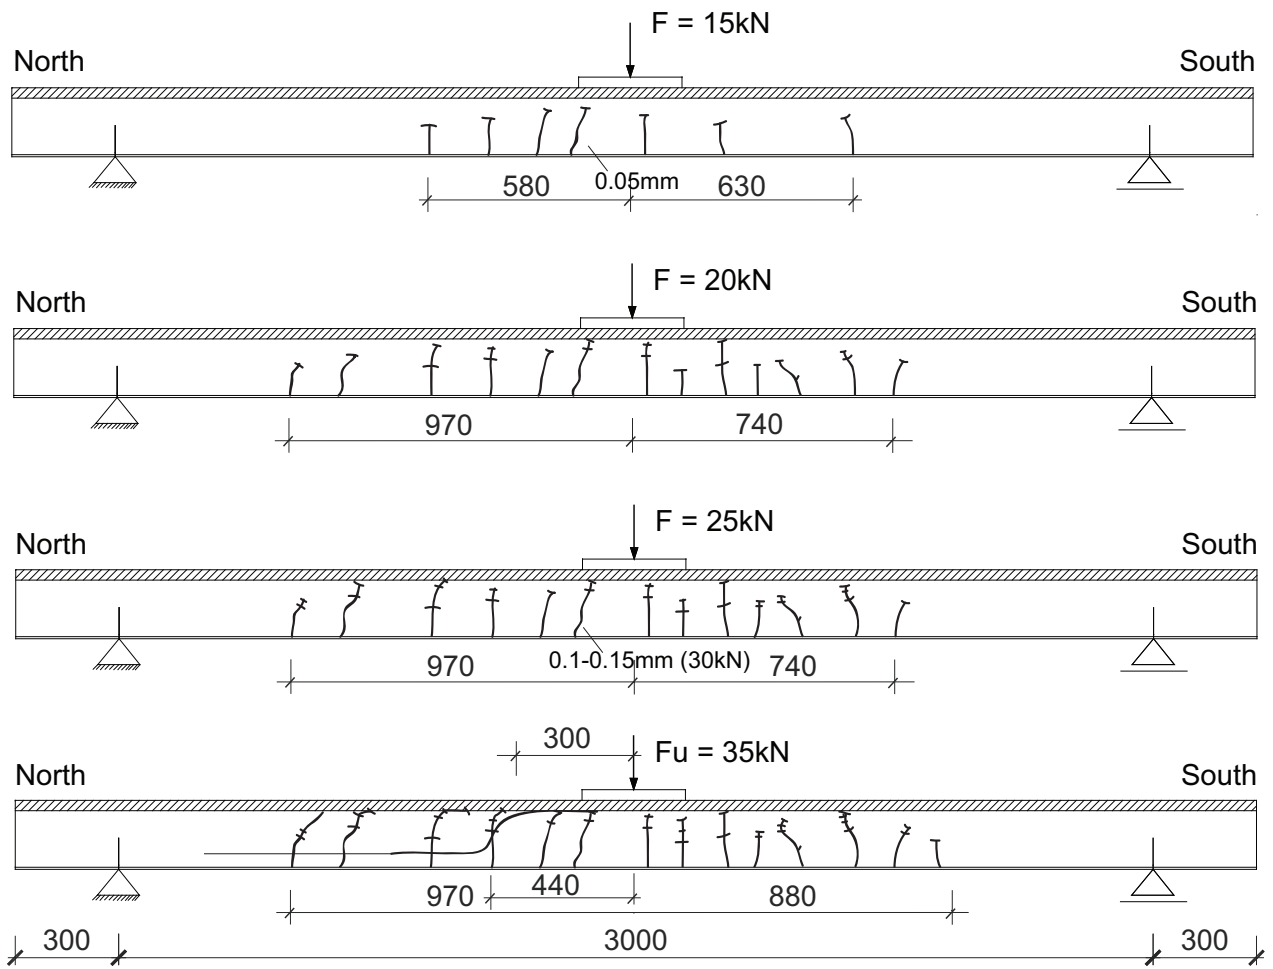
Figure C.123: 1000: Failure process.

At a load of 35 kN the jack was stopped in order to observe the crack development properly, but immediately the beam failed and one vertical crack turned and propagated horizontally in the northern beam part, approximately 40 cm from the mid-span. The load dropped to 23 kN. The beam was however able to slightly regain its stiffness. At the same time the LC started to be pushed out of the GFRP profile. While the load increased to 27 kN the main crack propagated towards the support. Subsequently the load dropped again and the main crack developed along the top of the T-upstands to the end of the beam. Figure C.127 illustrates the pushing out and shear failure of the LC along the top of the T-upstands. The southern end of the beam remained almost undamaged.

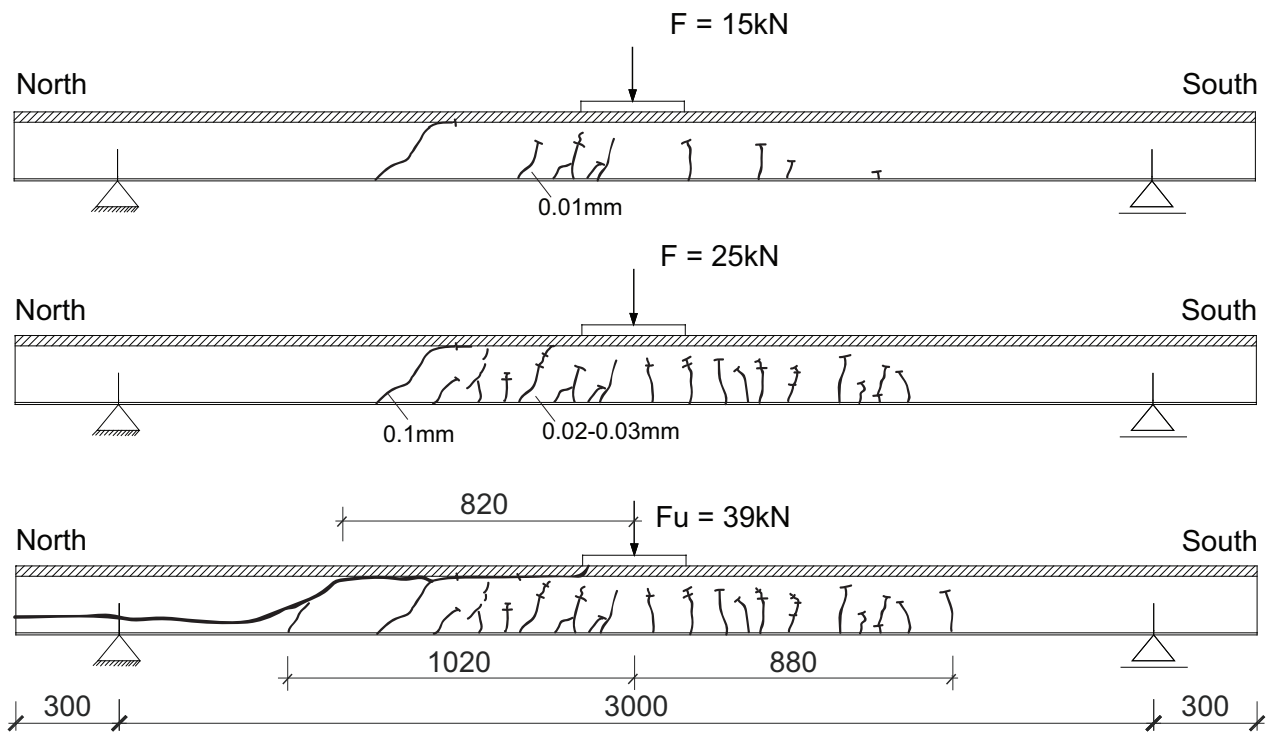
Figure C.139: 1000E: Failure process.

At a load of 39.2 kN the most inclined crack on the northern side suddenly propagated through the depth of the beam, along the LC-NC interface to the loading plate in one direction and along the top of the FRP T-upstands, just above the FRP-LC interface, to the support and up to the beam end in the other direction.

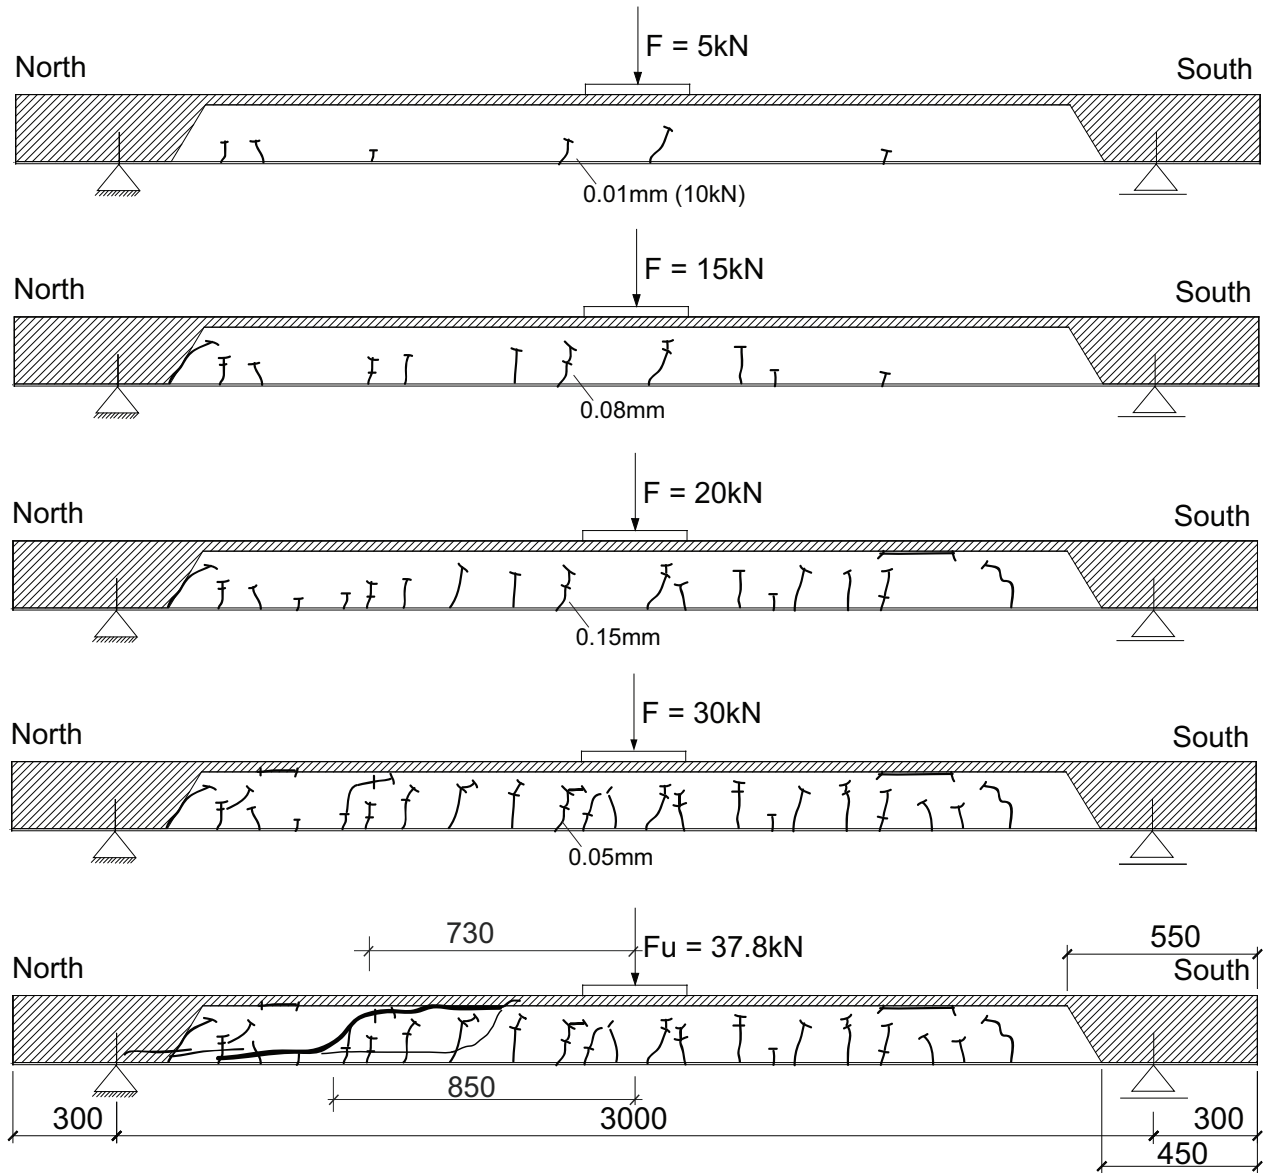
Figure C.152: 1000A: Failure process.

At a load of 32 kN three loud noises occurred. However, no obvious change could be noticed. At 37.8 kN the beam failed when a crack suddenly propagated through the depth of the LC on the northern side. This crack was slightly inclined and developed further along the LC-NC interface and along the top of the FRP T-upstands, just above the FRP-LC interface, up to the anchor block. The load dropped to a value of 19.9 kN, where a short stabilization could be noticed followed by a load cracking and second drop in the load. At the same time, omega-shaped extensometer O6 detached from the concrete surface. The experiment was then stopped. The anchor blocks remained undamaged, and no slippage at the beam ends was measured.

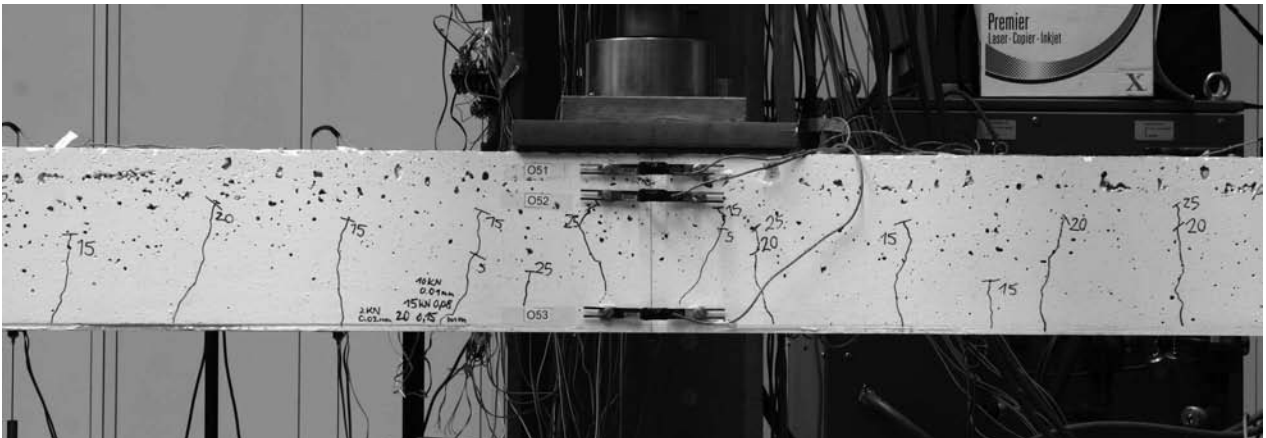
(a) Vertical cracks at 25.0 kN - first load cycle

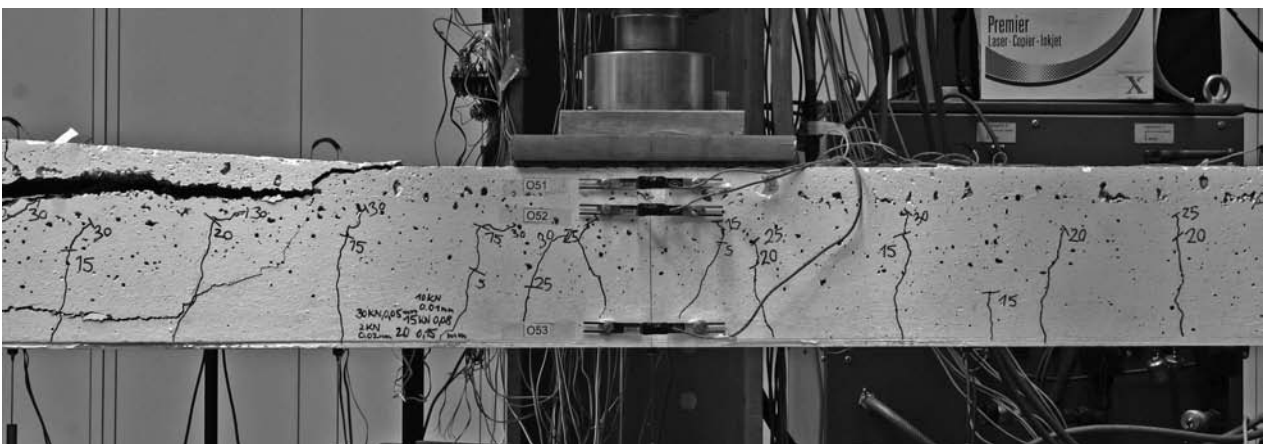
(c) Crack pattern of failed beam

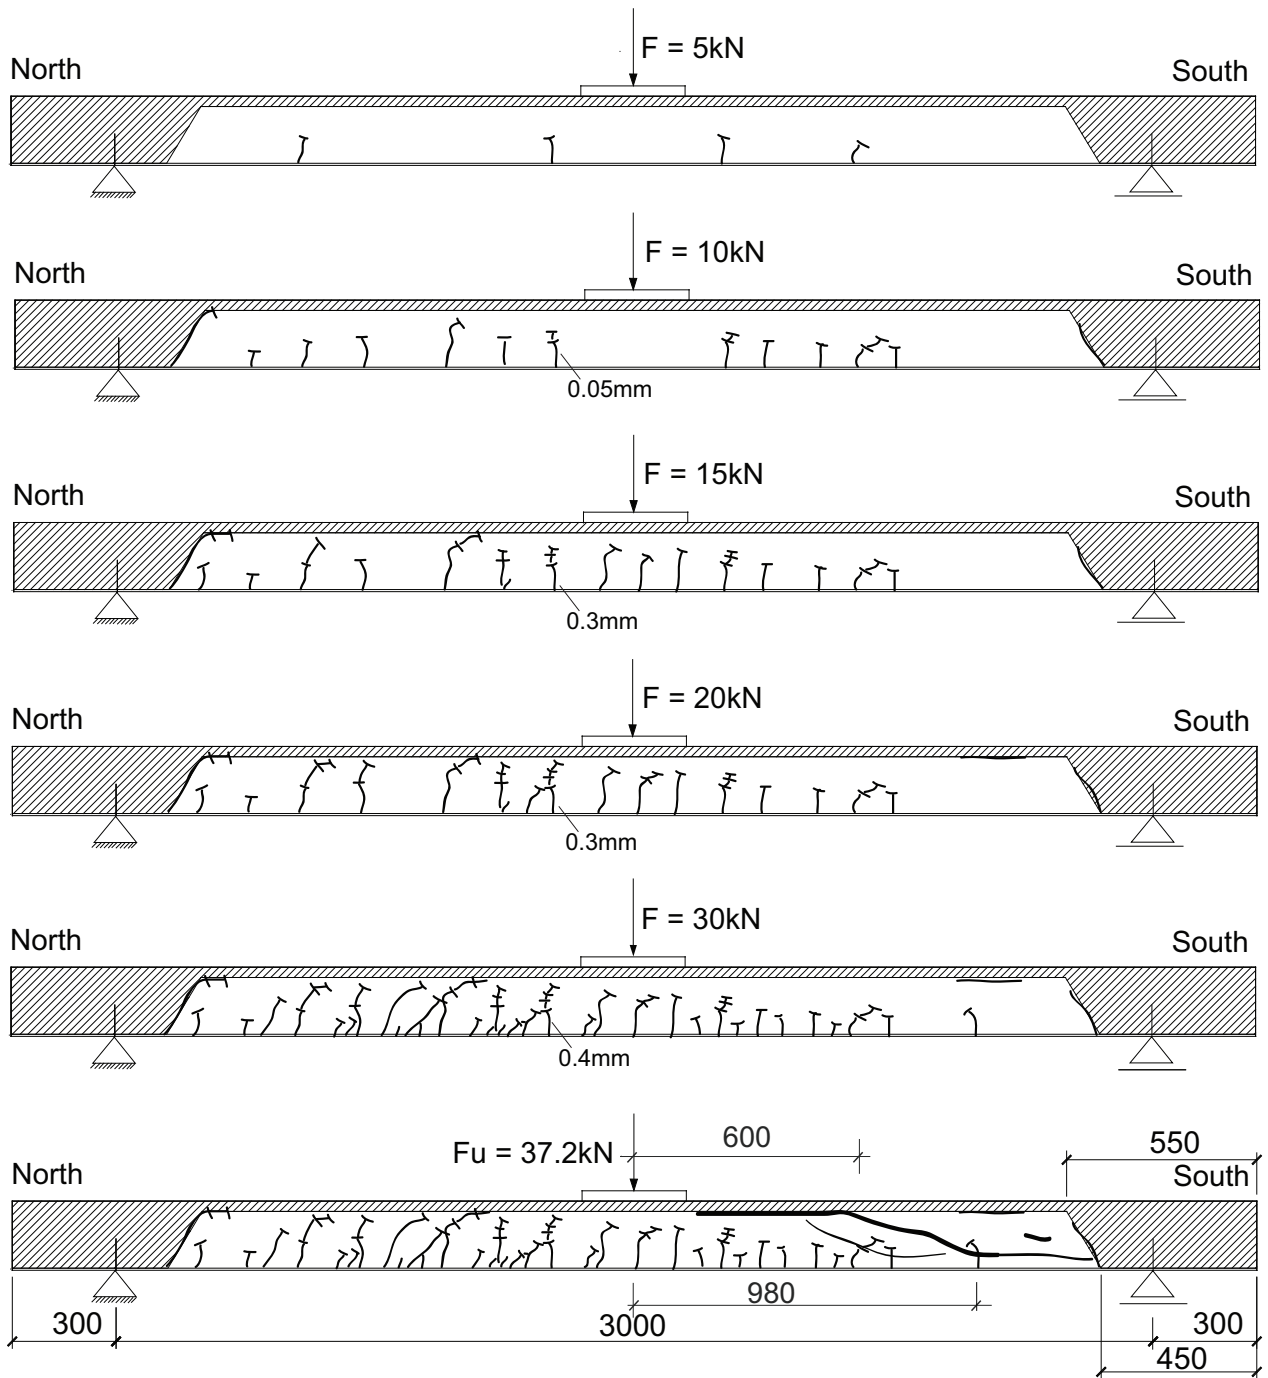
Figure C.166: 1000EA: Failure process.

At a load of 34 kN loud cracks occurred in the southern part of the beam. At 37.2 kN the beam failed when a crack suddenly propagated through the depth of the LC on the southern side. This crack was inclined and developed further along the LC-NC interface on one side and along the top of the FRP T-upstands on the other side, just above the FRP-LC interface, up to the anchor block. The load dropped to a value of 17 kN and the experiment was stopped. The anchor blocks remained undamaged, and no slippage at the beam ends was measured.

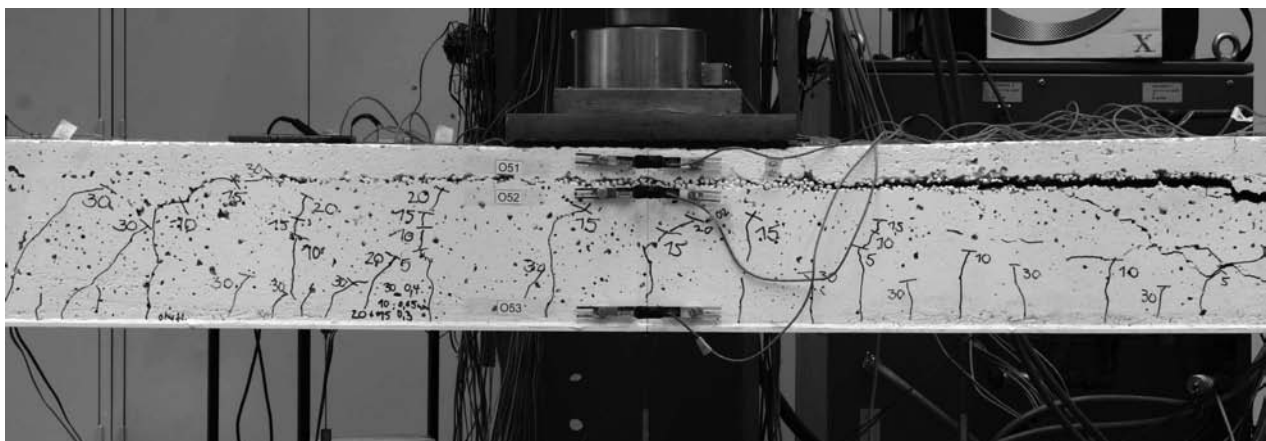
(c) Crack pattern at ultimate load

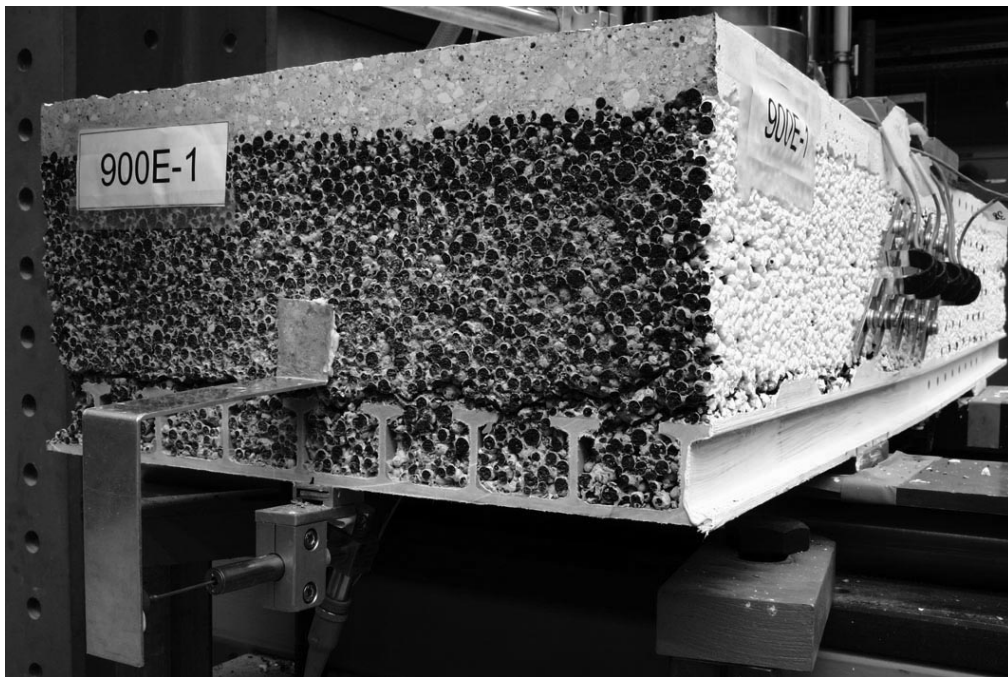
(b) Sheared LC-NC unity at north end, after experiment

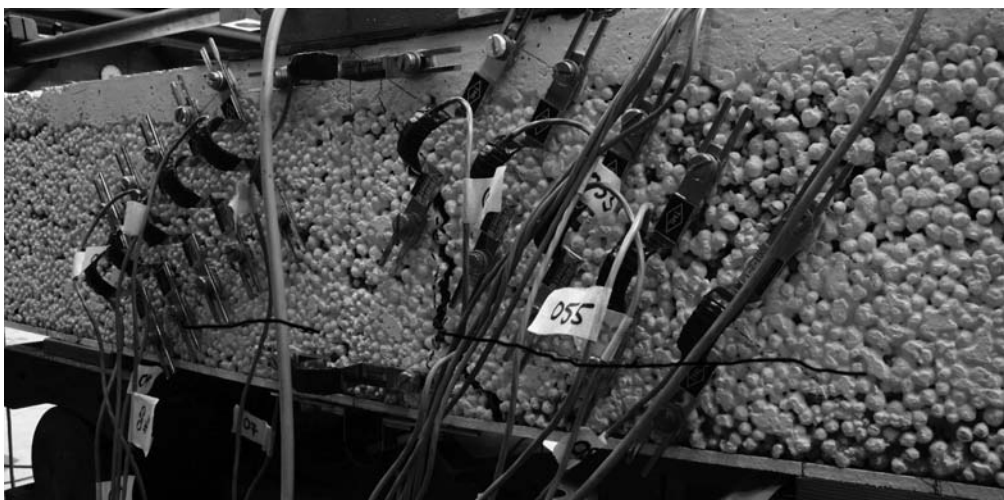
(d) Horizontal cracks on eastern part of specimen at 80 kN
