Appendix B

Experiments on materials on DVD

B.1 Introduction

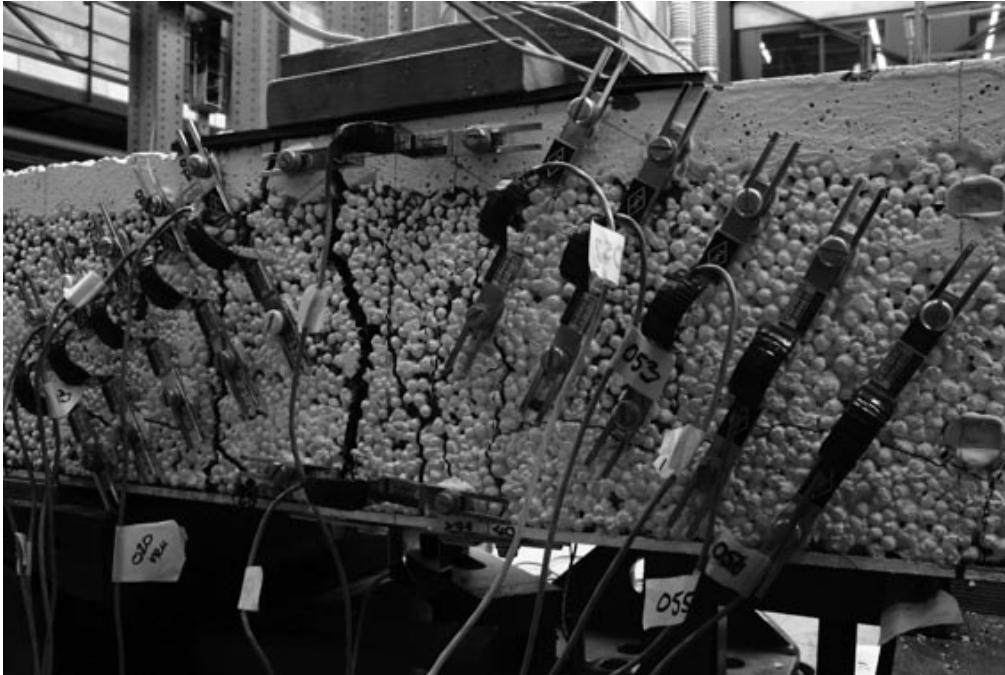
(a) Eastern part of specimen

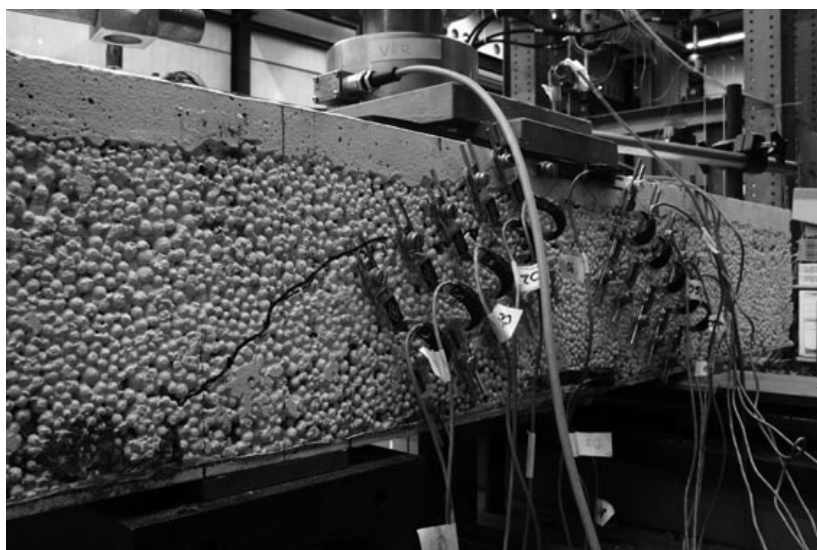
(b) At approximately 140 kN (post-peak) - crack development above O23 and O24

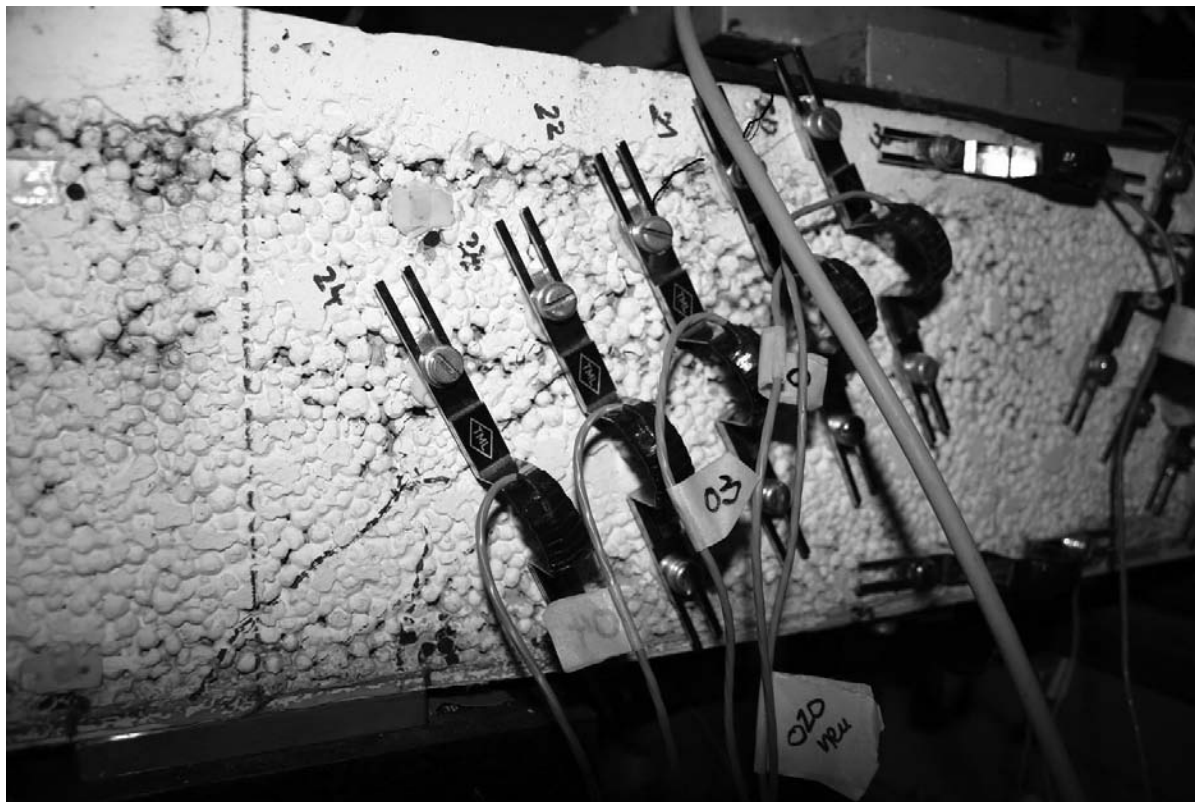
(a) At approximately 165 kN - crack development above O20, O21 and O23

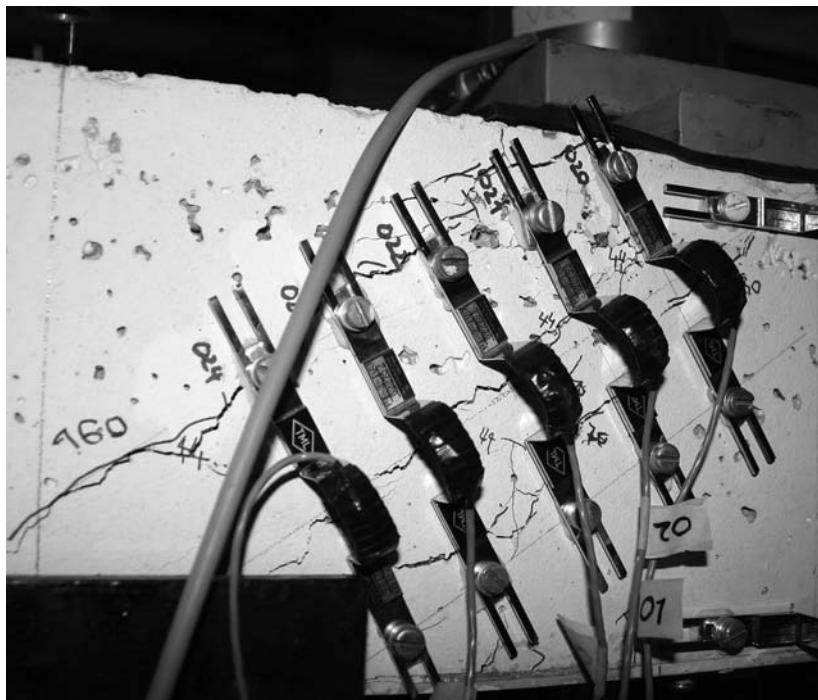
(b) Crack development in east part of specimen after ultimate load (post-peak)
