Behaviour of concrete elements subjected to cyclic bending

Autor: Jan Osterwalder

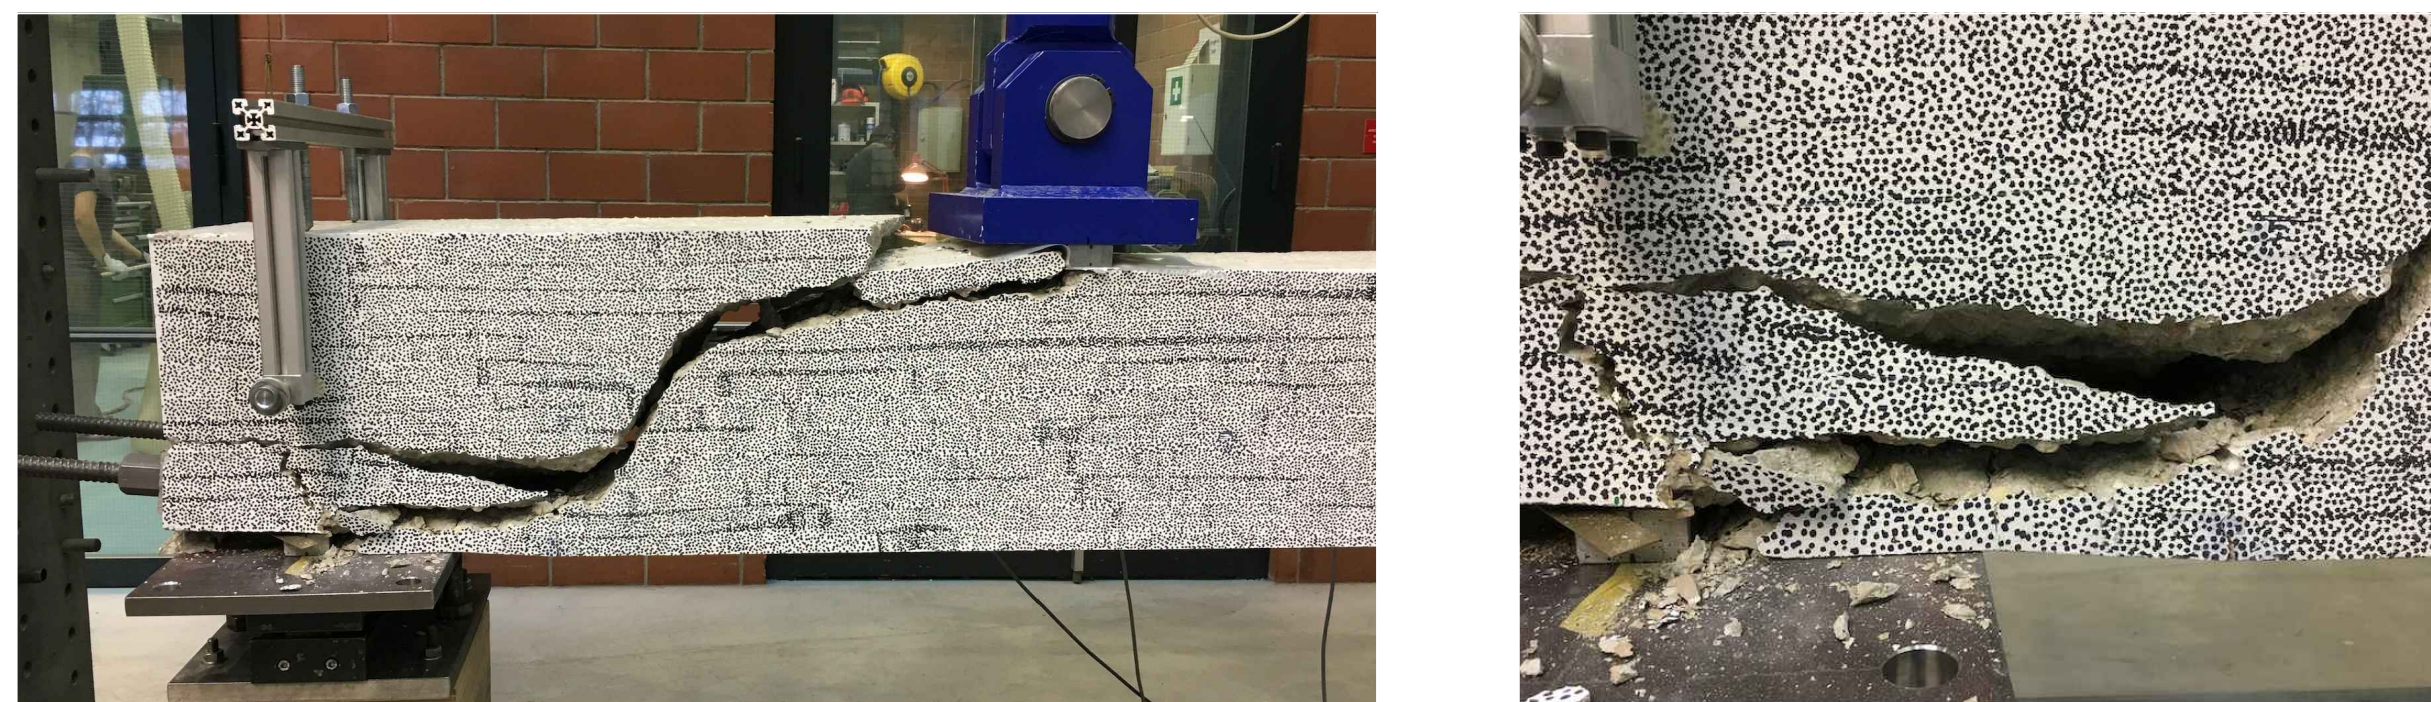
The three samples are tested at three different load levels (Level 1: 24 kN, Level 2: 50 kN, Level 3: 80 kN) to investigate the behaviour during each of the critical phases - crack development phase, crack opening phase as well as creation of the Critical Shear Crack (CSC). All of the samples failed in shear. However samples 1 and 2 failed during the static loading which was performed after at least 50 cycles had been completed successfully. The failure load was 92 and 94 kN respectively. The last sample failed during the 22nd cycle at a load of 78 kN.

Figure 3: Post failure of sample SC75 showing very clearly the shear crack that led to the failure of the sample. On the right side a close up of the lower part of the fracture showing the influence of the dowel action on the failure mechanism.

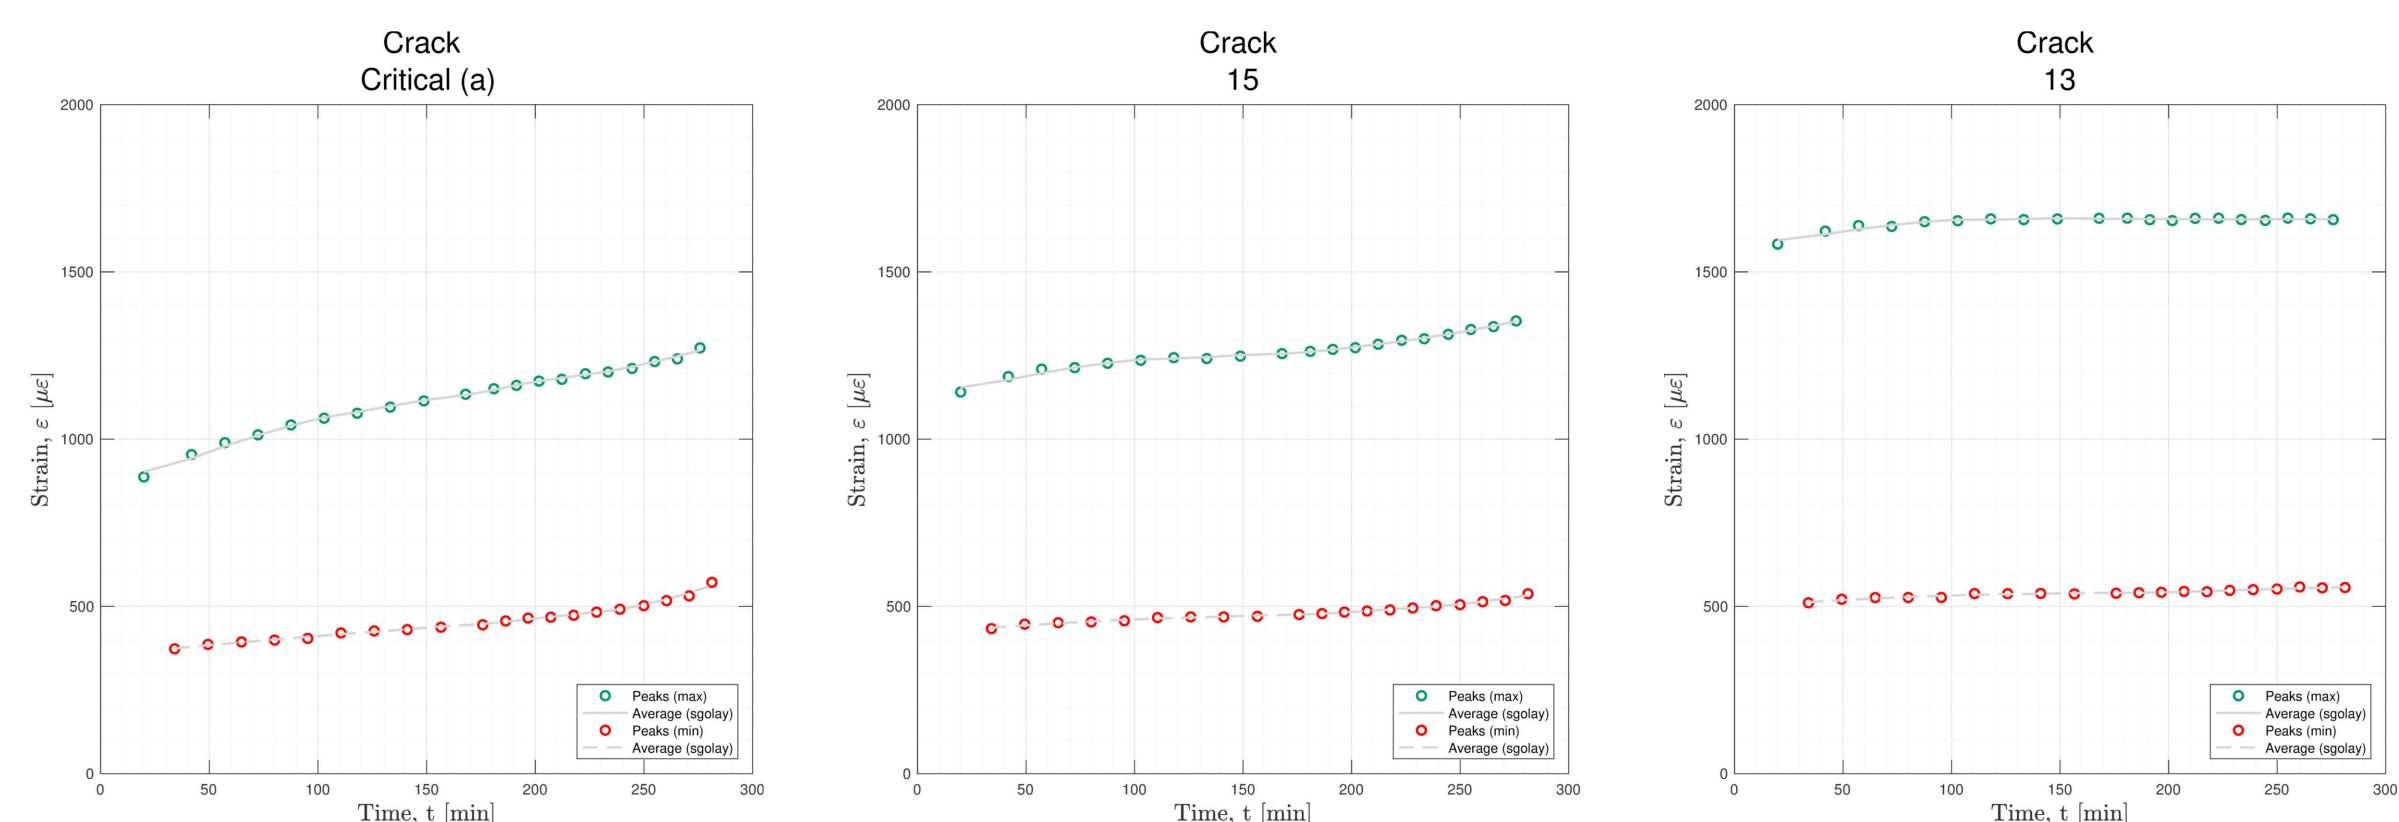
For selected cracks, detail analysis of the crack development as well as the strain development are performed. In the case of the sample tested at 80 kN, figure 5 shows clearly the difference between the critical shear crack (on the left) and one where the strain remains constant during the cycles (on the right).

Figure 5: Strain development of three selected cracks for sample SC77 showing the difference in the behaviour of the various cracks.

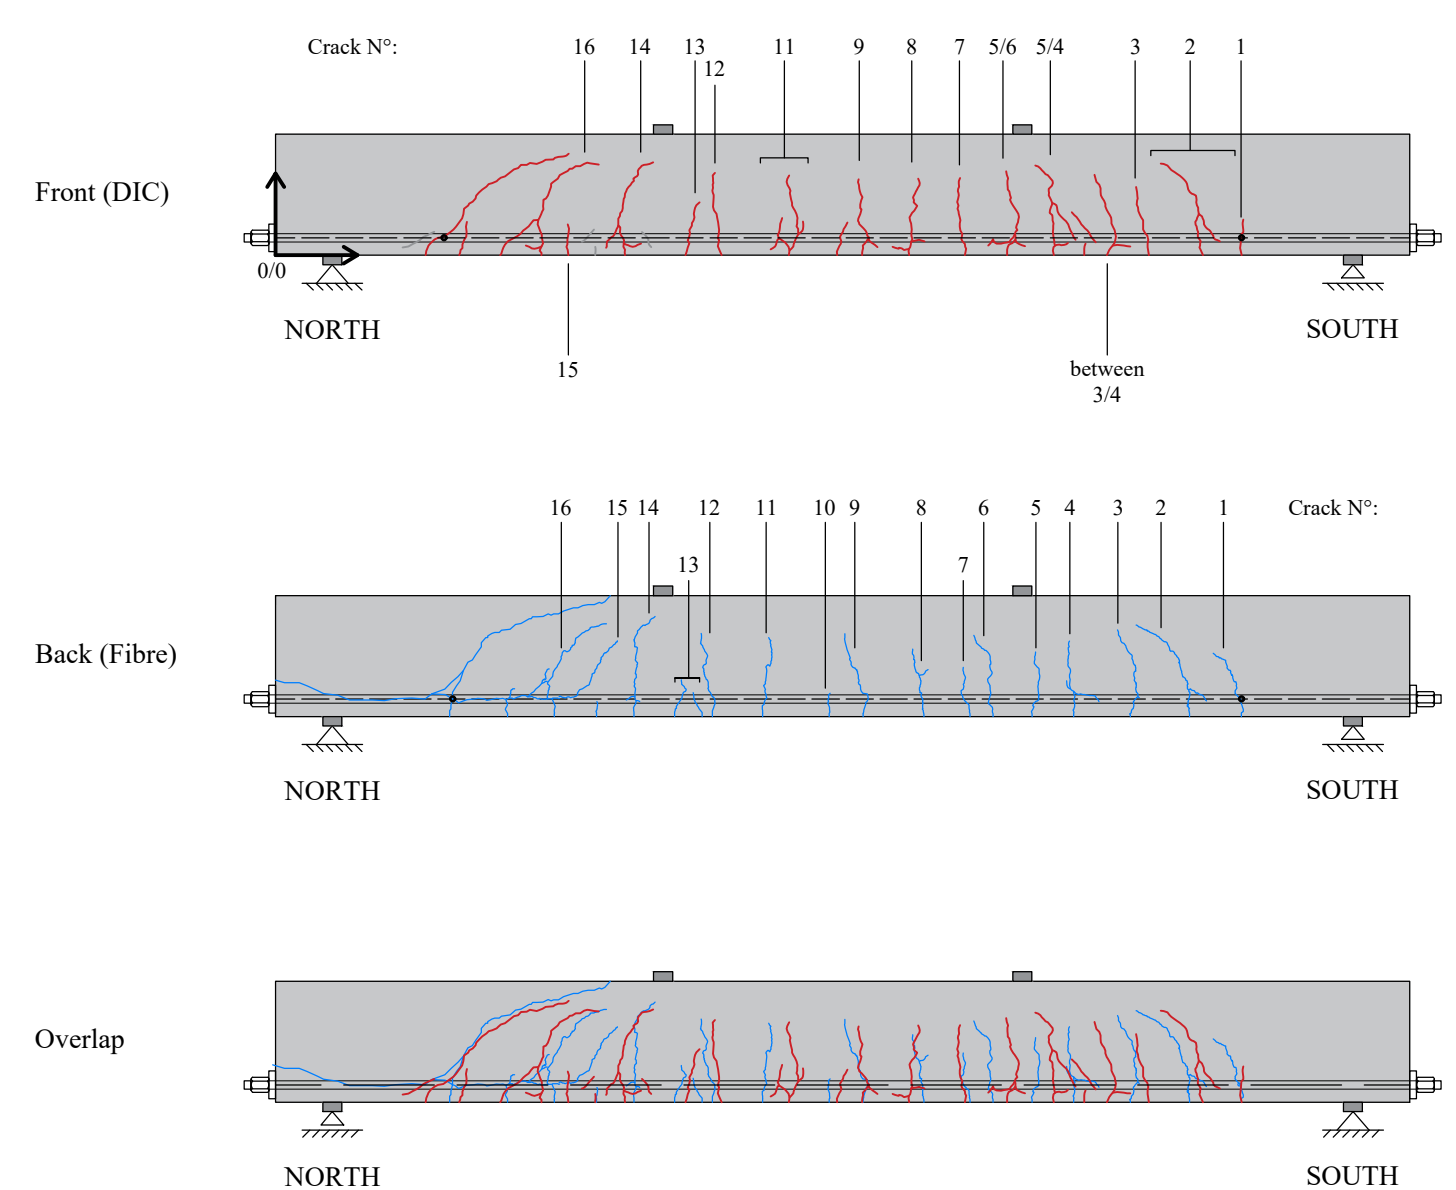
Figure 2: Crack pattern on the front (top) and back (centre) of sample SC76 as well as the superposition of both (bottom) to allow quick visual comparison.

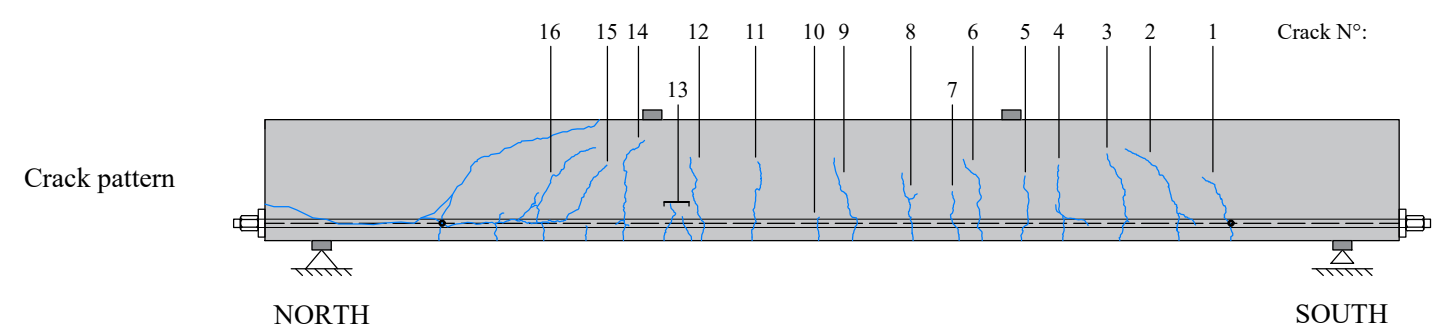
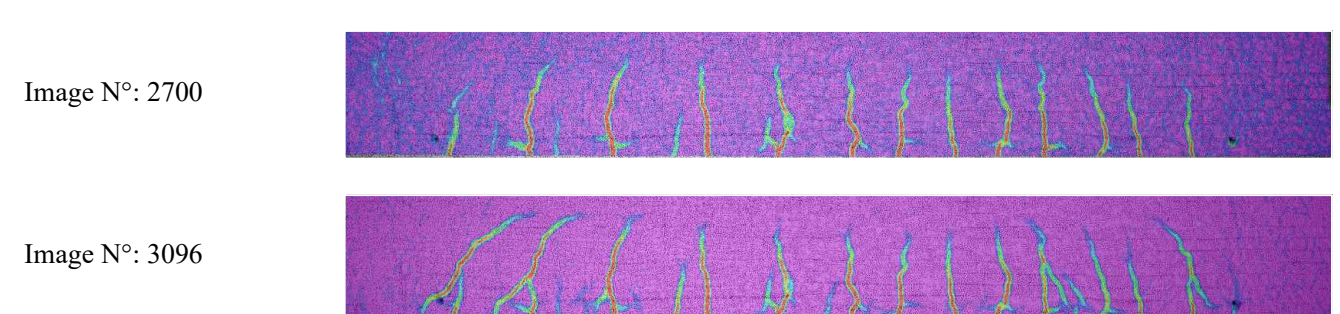
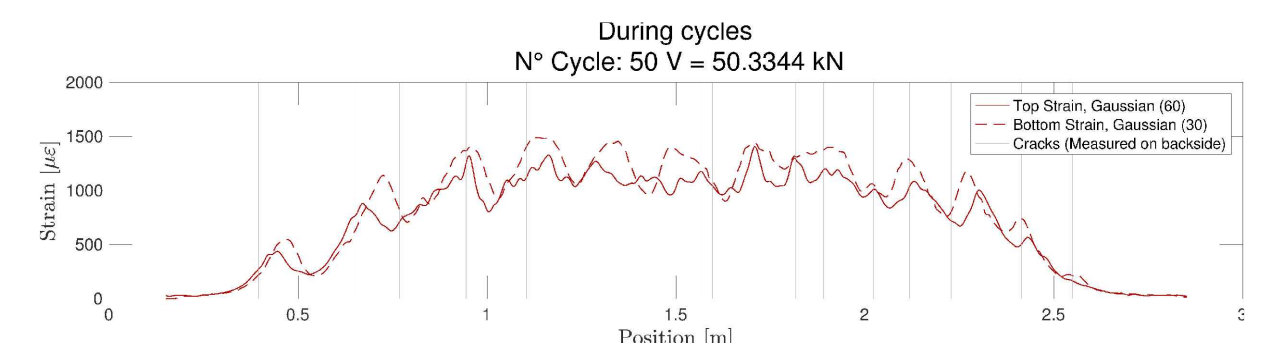
For further analysis of the data, it is critical to know the exact location of the cracks. As the cracks were traced both on the front as well as the back surface of the sample (see figure 2), their intersection with the rebar is known for both sides. However, the cracks can cross the sample at an oblique angle and the crack position on the surface does not correspond with the crack position at the rebar. Figure 3 shows the process used to determine the exact crack location - Comparing the crack pattern (Figure 3, top) with the DIC images (Figure 3, centre) as well as the fiber strain of the top and bottom of the rebar (Figure 3, bottom).

Figure 4: Determination of the exact crack location both from DIC images (centre) and fiber measurements (bottom).

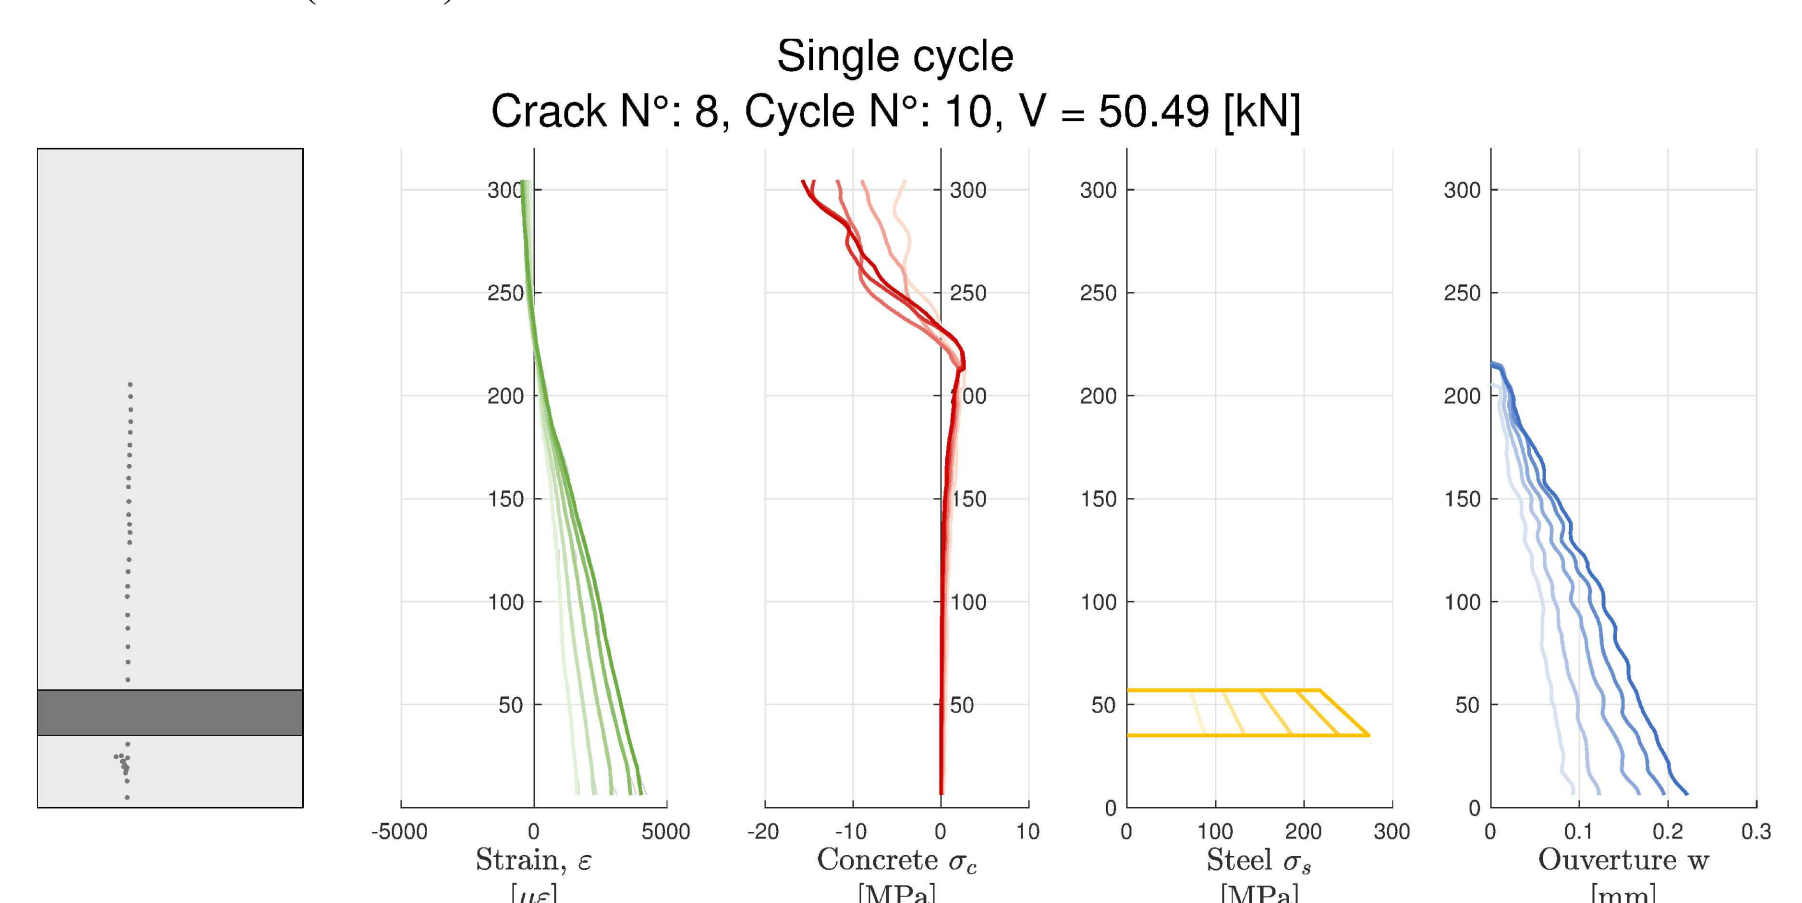
By combining the measurements from all three data acquisition tools, specific flexion cracks are selected for which the data is the most suitable and vertical profiles are created (see figure 6) showing the development of strain (green), stresses (red and yellow) as well as crack opening (blue) during one chosen unloading cycle. The results obtained show good agreement with existing models.

Figure 6: Vertical profile describing the behaviour of the sample at the location of crack N° 8 by combining all of the different data acquisition methods. The shades indicate the difference in load (dark = max load, light = min load).
