CODE 372

ENERGY RENOVATION OF THE BUILT HERITAGE HOUSING BASED ON THE LIVING BUILDING CHALLENGE CERTIFICATION. CASE STUDY IN BRESCA (SPAIN)

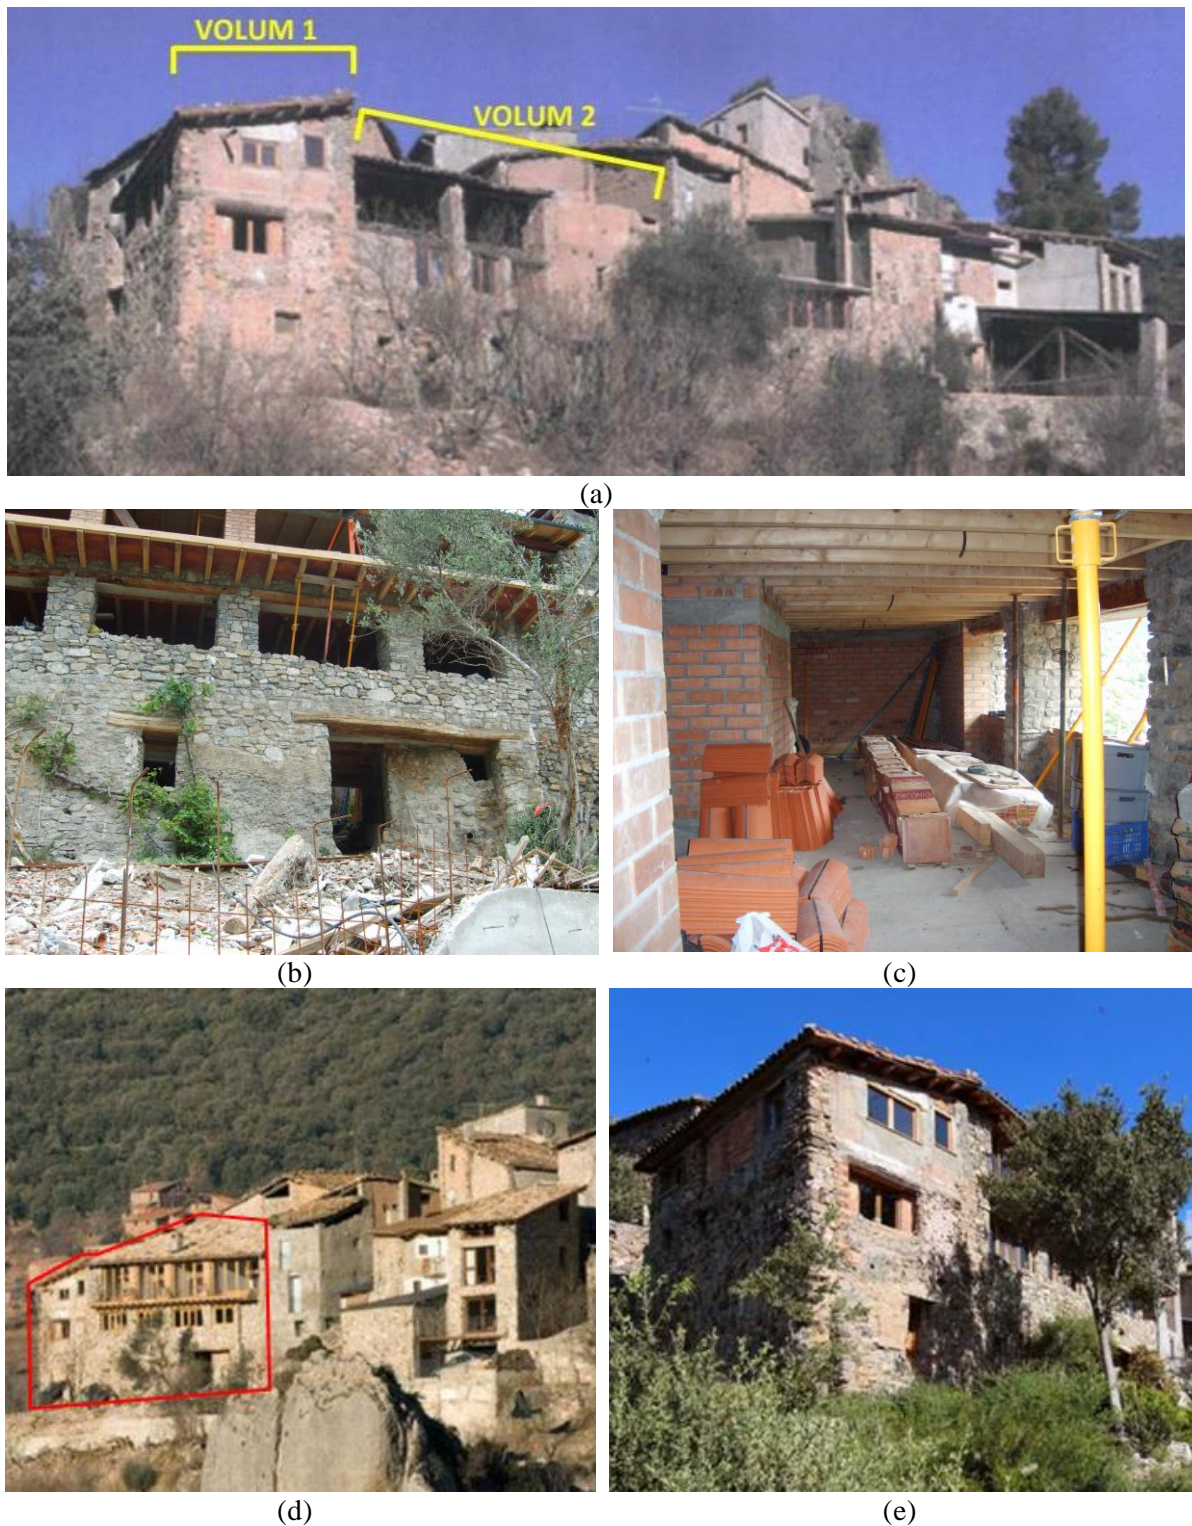
The initial construction date is unknown, but the house, composed by two main volumes with three stories each, underwent a first basic renovation in 2007. Figure 1a shows the house prior to this basic renovation, which was conducted mainly on volume 2. The construction work consisted of renovating the floors and adding a building envelope to finish the building and make it inhabitable.

Pictures in Figure 1b and 1c, taken during this first renovation process in 2007, show the type of construction of this building. It is possible to intuit that the improvement of the airtightness as well as the insulation of the building envelope were not part of the scope of this basic renovation.

Figure 1: Images during the first renovation conducted in 2007 (a, b and c) and the current status (d and e).

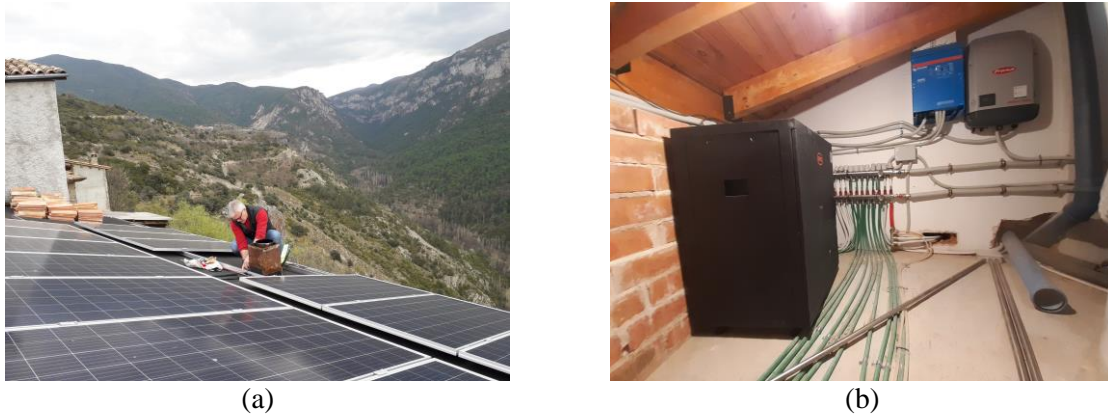
The main on-site production strategy consists of a photovoltaic installation on the roof of a total installed power of 4,95 kWp, in combination with a 5,12 kWh capacity battery storage system. The system allows to self-consume 52% of the total produced energy on-site, while the overproduction is injected into the grid. Figure 4a shows the installation of the 15 PV panels with 330 Wp each on the roof and Figure 4b shows the inverter with 5 kW [9], the charger-inverter regulator [10] and the battery block with 5,12 kWh of capacity, but with the space available to upgrade to 10,24 kWh [11].

Figure 4: Sample of images to illustrate the on-site production strategy implemented in the project.
