Seismic Vulnerability of Cultural Heritage Buildings in Switzerland

THÈSE N° 4167 (2008)

À LA FACULTE ENVIRONNEMENT NATUREL, ARCHITECTURAL ET CONSTRUIT
LABORATOIRE D'INFORMATIQUE ET DE MÉCANIQUE APPLIQUÉES À LA CONSTRUCTION
PROGRAMME DOCTORAL EN STRUCTURES

ÉCOLE POLYTECHNIQUE FÉDÉRALE DE LAUSANNE

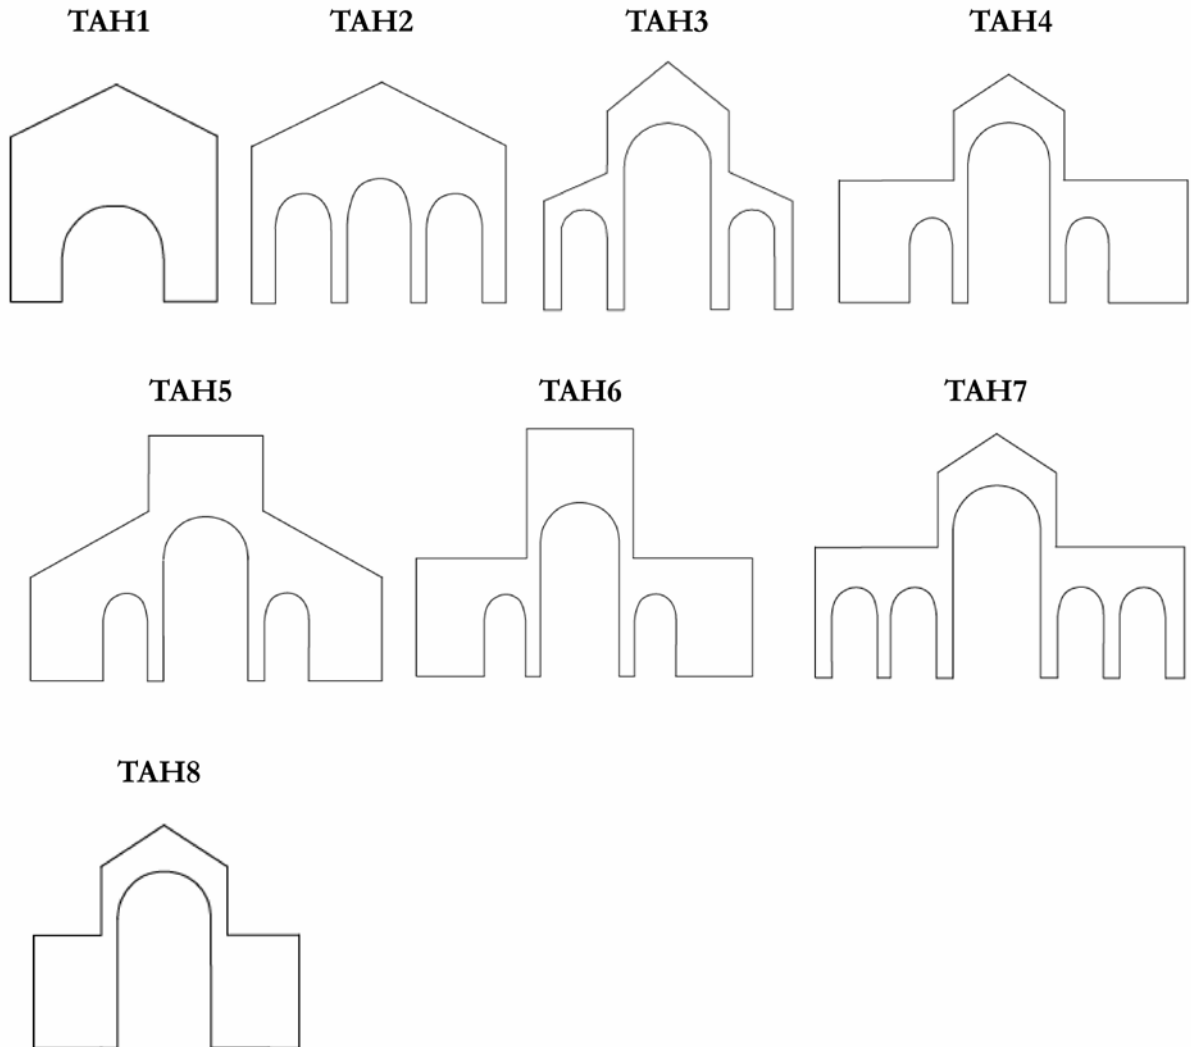
is found in cathedrals, churches and chapels. Most chancel arches in basilicas have the TAH3 or TAH 4 shape. Chancel arch of smaller churches have a TAH1 or TAH2 shape.

Figure 3.12 : Standard units for chancel arches.

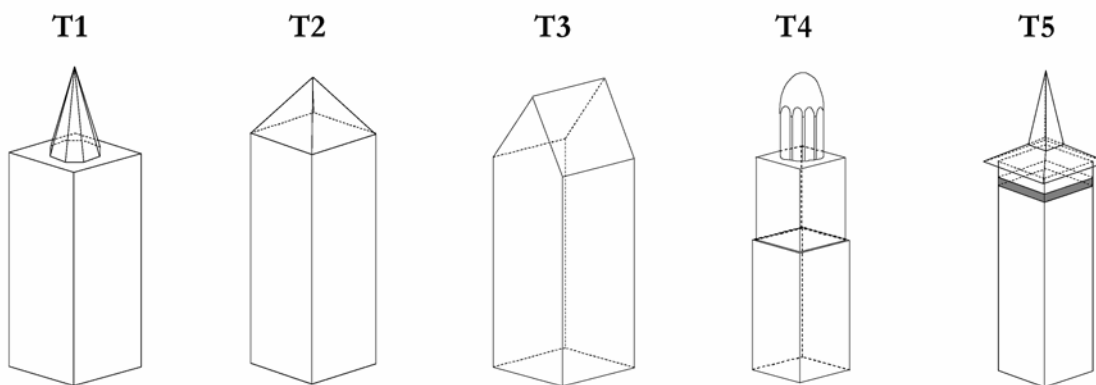
Figure 3.18 : Standard units of bell-towers.

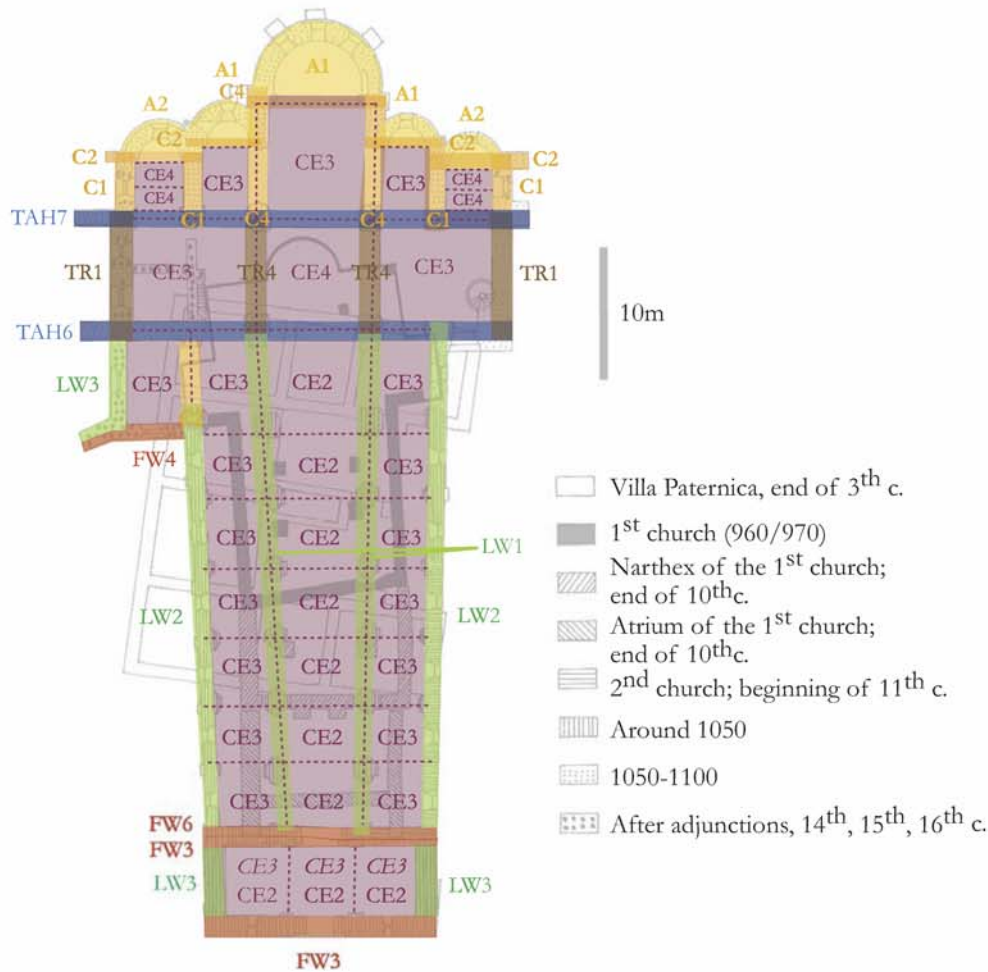
Figure 3.21 :Application of the method on the Abbey of Payerne.

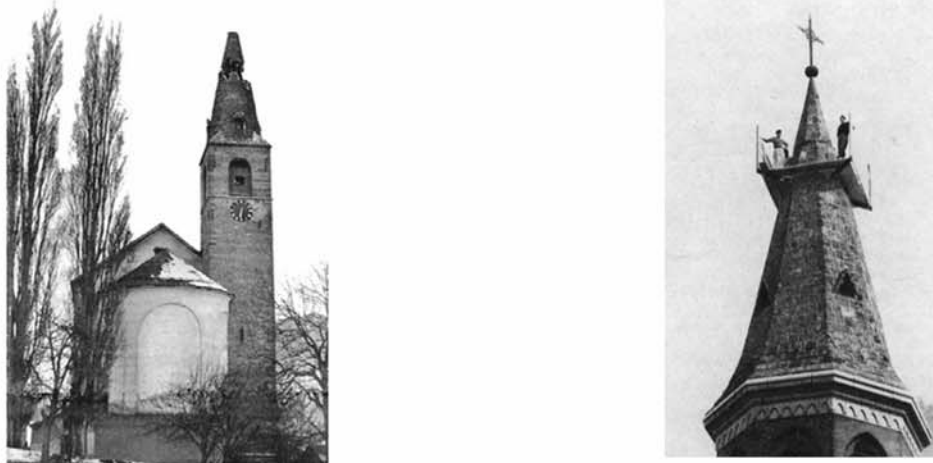
According to this list of damage, the most damaged part was the spire of the bell tower (Sembrancher, Ardon, Sion, Grône, Chalais, Chippis, Sierre and Montana). For every case the damage consisted of the sliding of the spire's upper part; the volume of this part was different for each tower. In both following pictures, the spire of the church in Chalais (left) was hollowed whereas only the top of the bell tower of the church in Chippis dislocated and slightly slid aside.

Figure 4.13 : Damage to the bell-tower of the churches in Chalais and in Chippis [AR 05] and [Chippis BP].

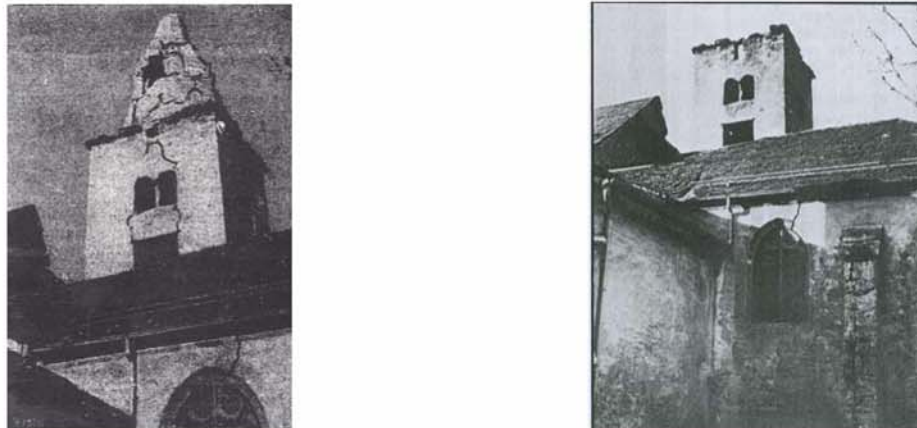
The case of Our-Lady-of-the-Moor in Sierre was probably one of the worst ones; the whole spire was split (Figure 4.14). Moreover the rest of the church was also highly cracked.

Figure 4.14 : State of Our-Lady-of-the-Moor in Sierre after the main shock of the 1946 earthquake. Source: Le Nouvelliste, 30.01.1946.

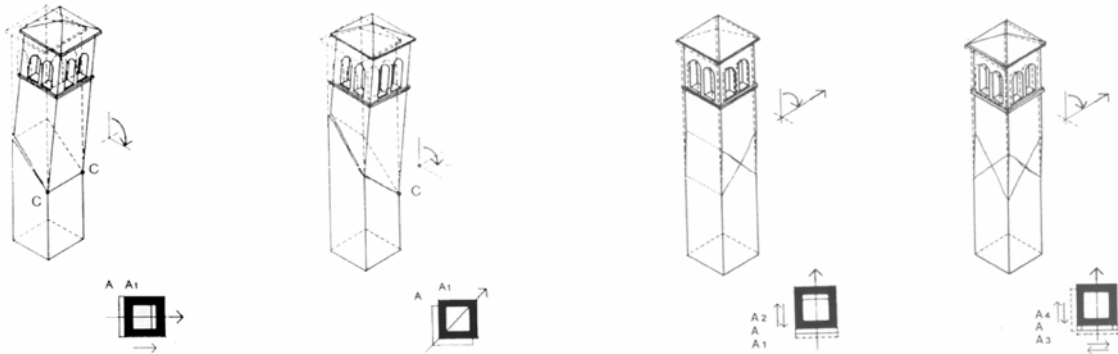
1. Rotation of the upper part of the bell tower around a horizontal axis (flexion).
2. Cyclical movement of the upper part of the tower along one direction or two directions (usually horizontal) (flexion).

Figure 4.33 : Most frequent damage mechanisms observed on bell-towers by [Do 94] after the Tolmezzo earthquake.

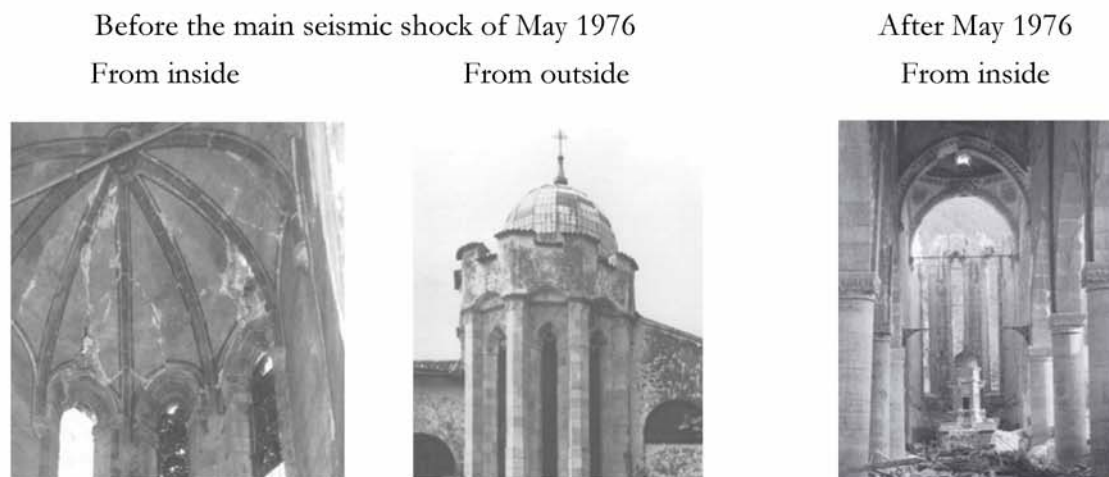
Observations showed that the impact of pre-existing damage or cracks is very important and may be the most relevant one compared to the other factors that might affect the seismic vulnerability of cultural heritage buildings under seismic actions. This fact is illustrated by the following pictures of the Duomo di Gemona: it showed large cracks in the webs of the apses vaults before the main seismic shock and the ceiling fell down during the earthquake (Figure 4.45).

Figure 4.45 : Views from in- and outside of the apse of the Duomo di Gemona, before and after the main seismic shock of 1976 [Do 94].

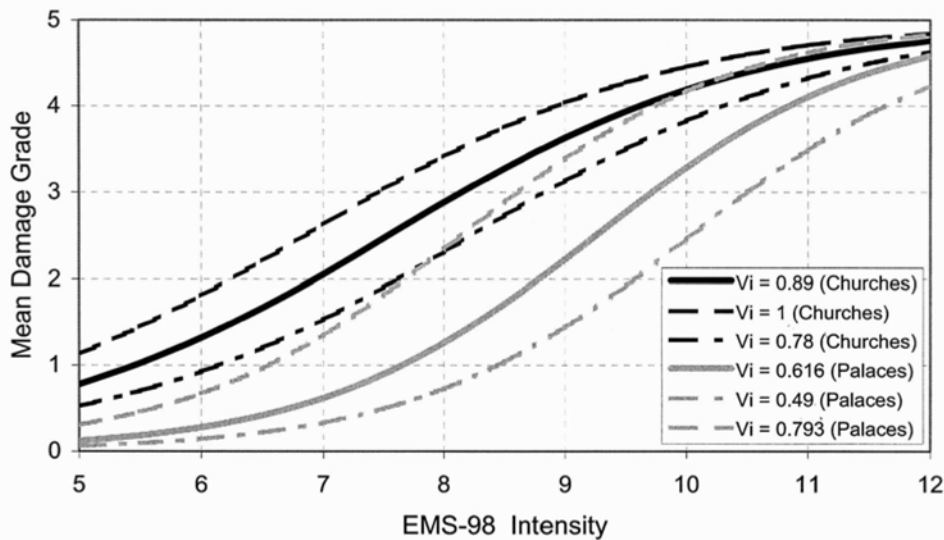
Where: μ_D mean damage grade
 V_I vulnerability index
 I EMS-98 intensity
 κ parameter related to the typology

Figure 5.1 : Mean Damage Grade in function of EMS-98 Intensity; taken from [La4 04].

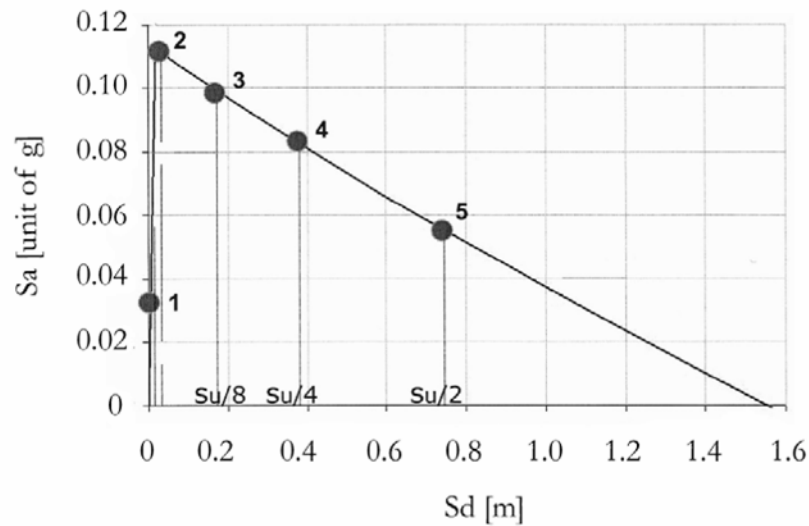
Figure 5.3 : Capacity curve with the damage limit states [La4 04]

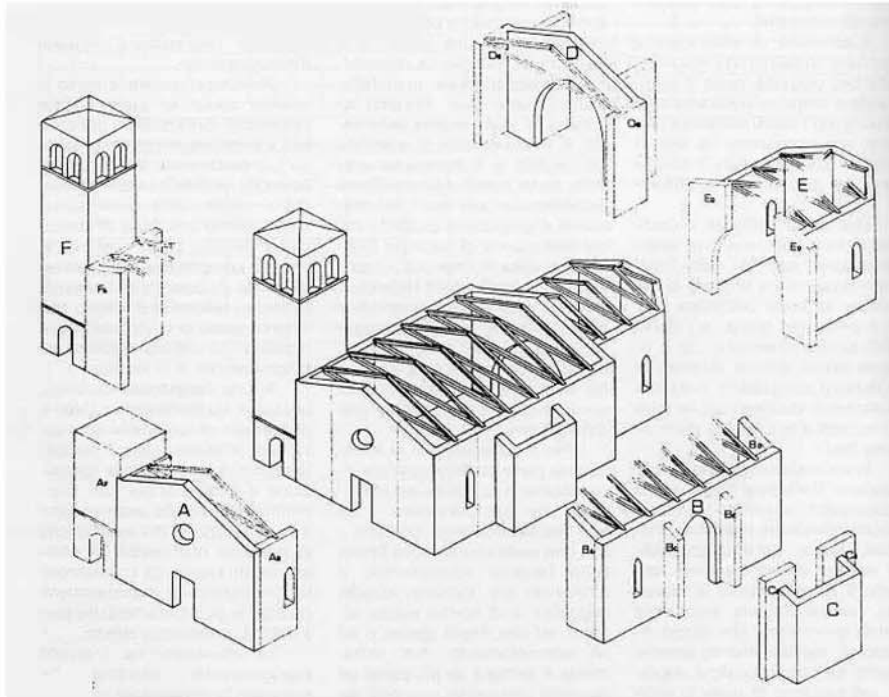
The macro-element approach was developed by Doglioni et al. [Do 94], after they surveyed the damage on churches after the 1976 Friuli earthquake. The next figure shows the identified macro-elements.

Figure 5.4 : Macro-elements that were identified by Doglioni et al. [Do 94].

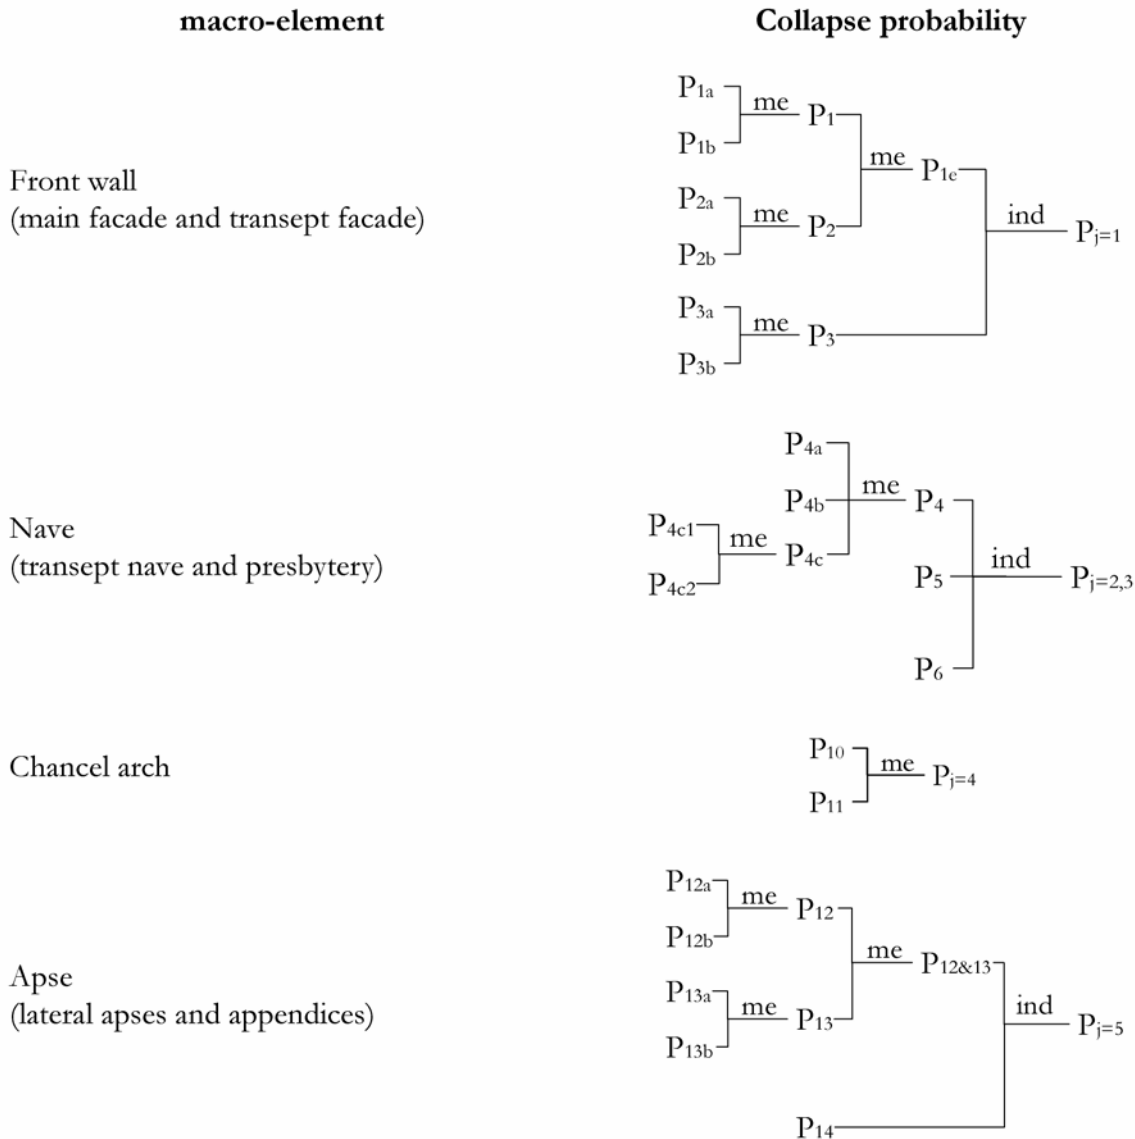
The following diagram shows a few examples of combinations that give an evaluation of the collapse probability P_j of each considered macro-element.

Note: me and ind mean: mutually exclusive and independent mechanisms respectively.

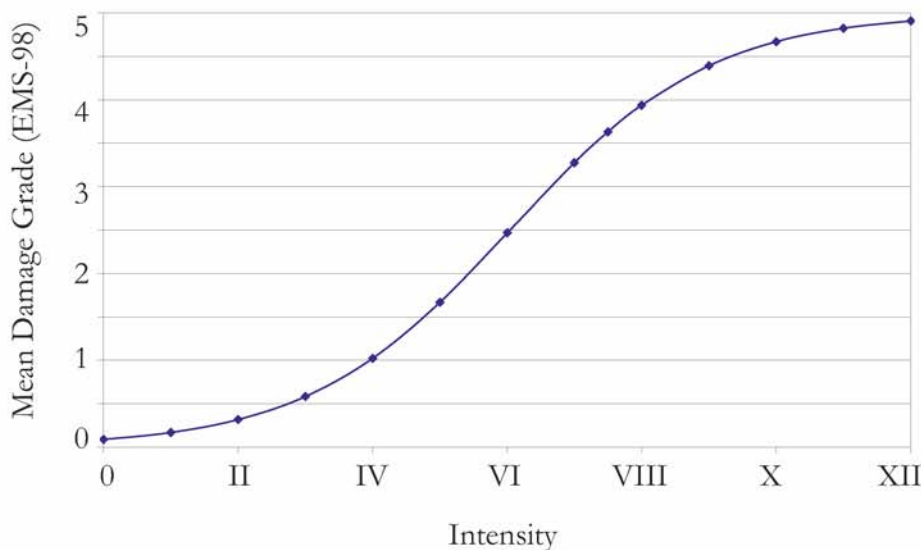
Figure 5.25 : Vulnerability curves of the collegiate church of Valère.

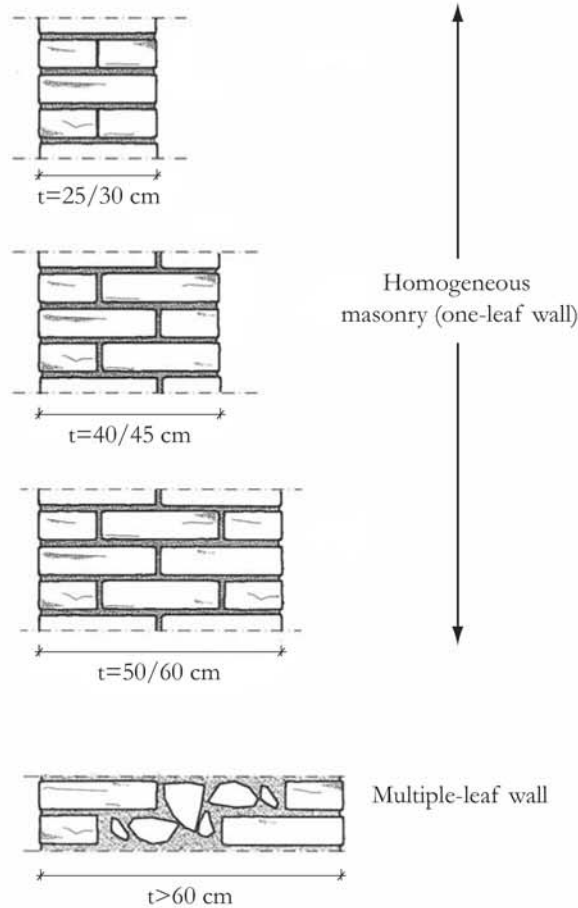
Figure 6.8 : Types of cross-sections as a function of the thickness [BP 06].

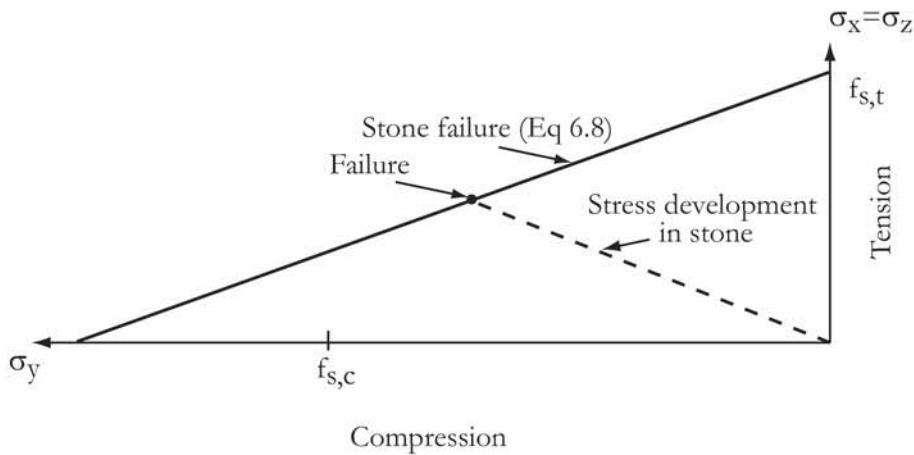
Eq 6.9 can be represented by the following diagram showing the failure curve of stone:

Figure 6.17 : Criterion of natural stone masonry after Berndt and Schöne [BS 91].

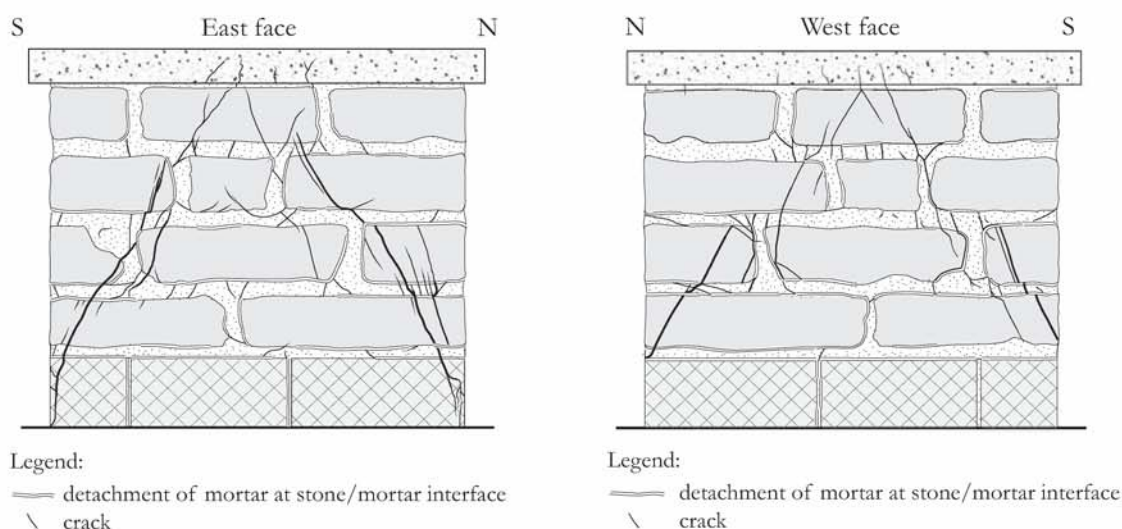
A second stage of three complete cycles at 9‰ relative displacement is performed to prevent mistakes due to the opening of the footing crack at the previous stage. One cycle later, still with a drift of 9‰, cracks along the failure surface widen and new cracks also appear.

Figure 7.9 : Crack pattern on both faces at a drift of 10‰.

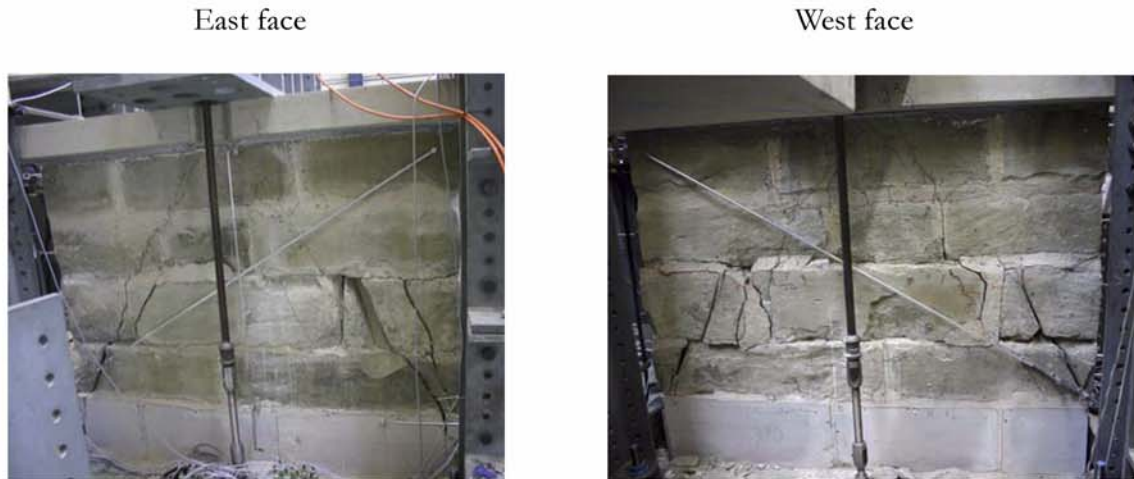
Figure 7.10 : Crack patterns on the east and west faces at the end of the 9‰ cycles.

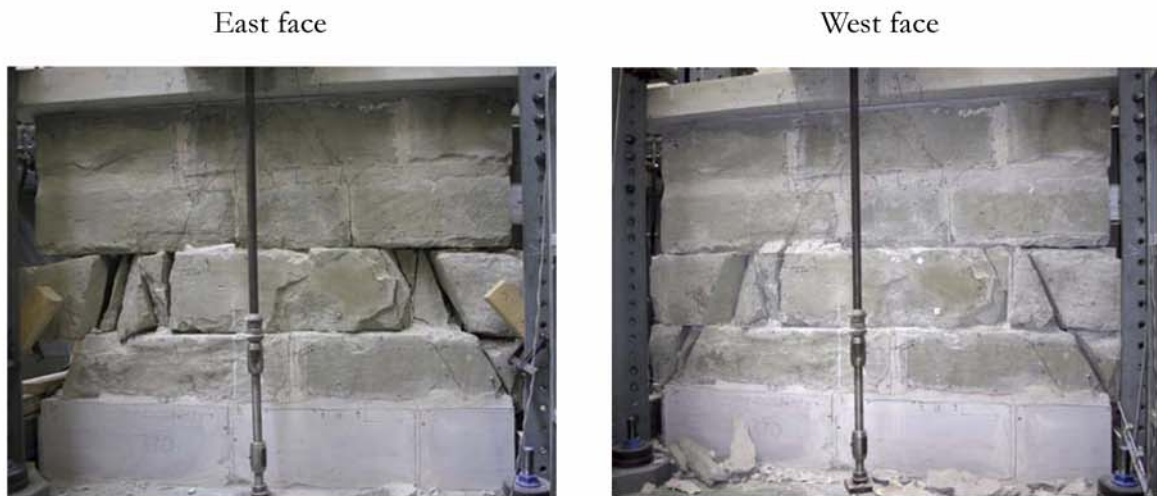
Figure 7.11 : Crack patterns on the east and west faces at the end of the 11‰ cycles.

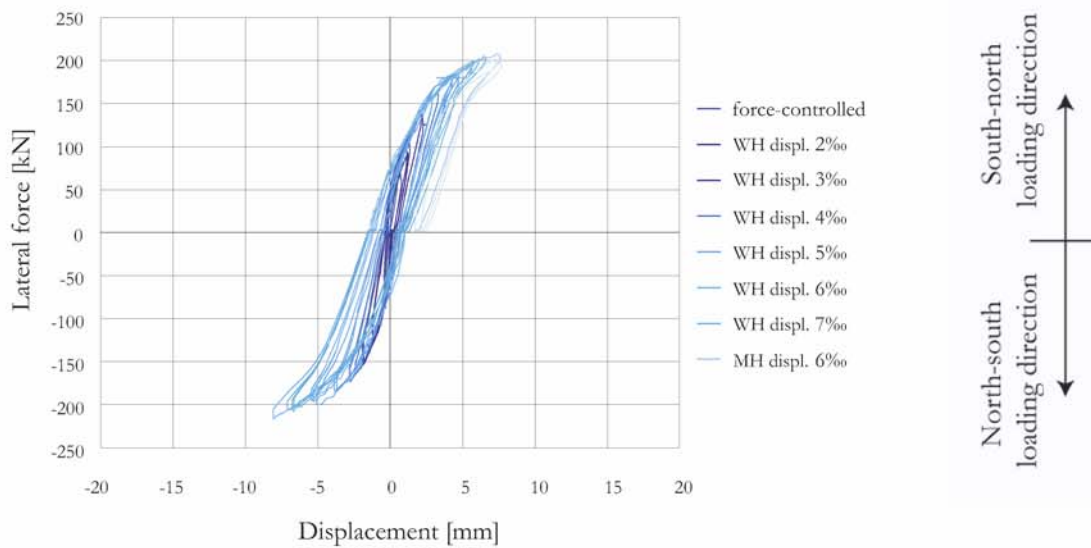
Nevertheless, both graphs display phases in the shear behaviour of the sample¹. The first phase, which spans the start of the test to the point just before failure, is almost linear, at least at the beginning. The residual deformation is small and little energy is released. Nevertheless, after reaching a lateral force of 165 kN, the curve is no longer straight when lateral force decreases, contrary to what happened during the previous cycles. In fact, this phenomenon is due to the closing of cracks.

Figure 7.14 : Hysteresis loops from the beginning to 6‰ relative drift.

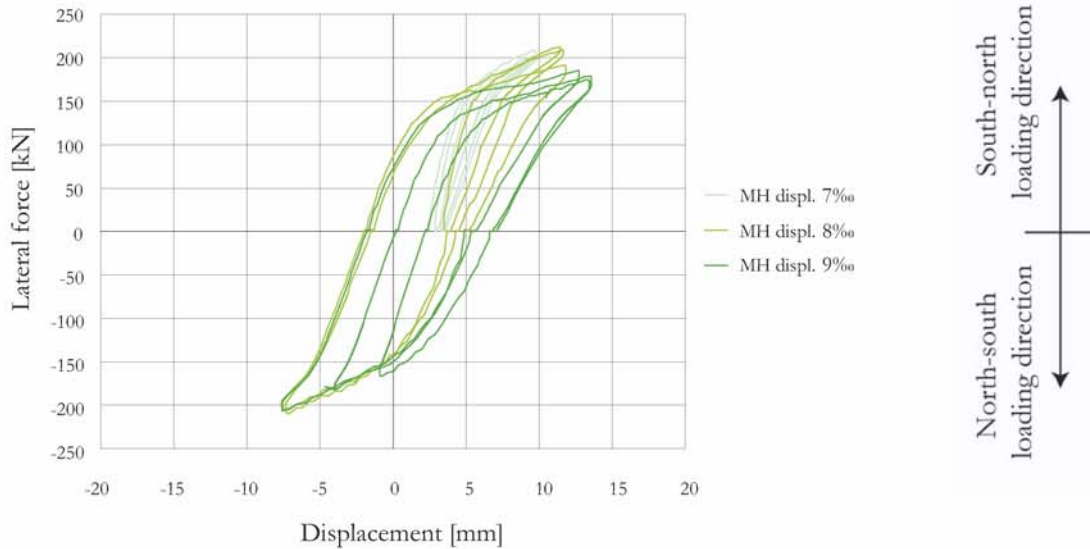
is more energy released in this phase than during the first phase. The phenomenon of cracks-closing is still recognizable for high lateral loads.

Figure 7.15 : Hysteresis loops from 7‰ to 9‰ relative drift.

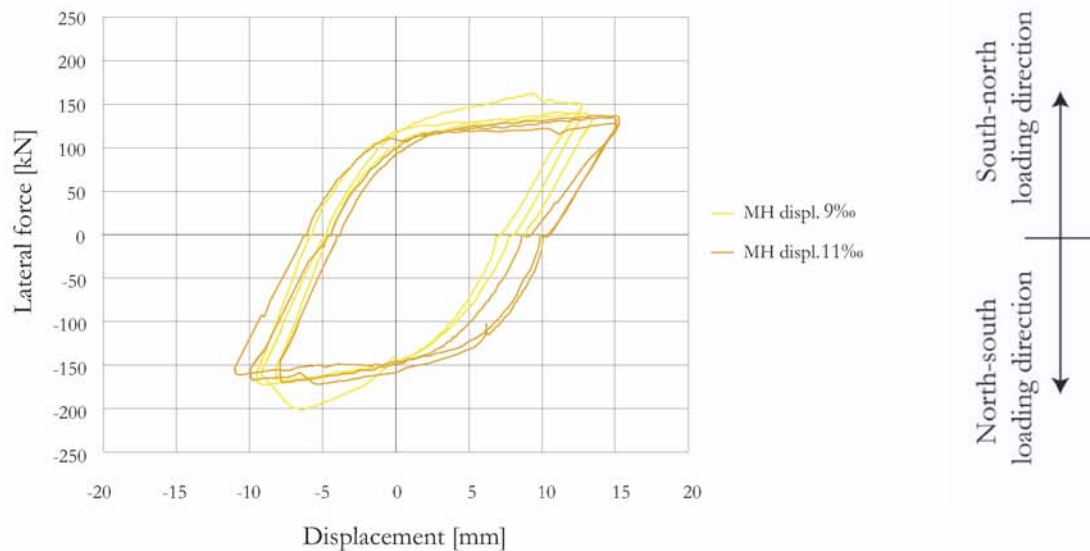
Figure 7.16 : Hysteresis loops from 9‰ to 11‰ relative drift.

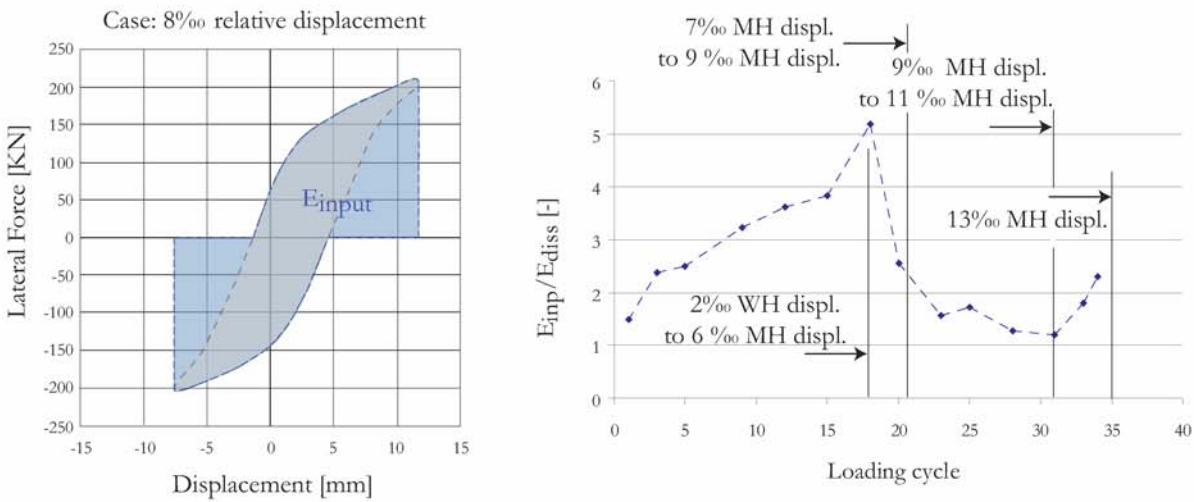
Figure 7.20 : Input and dissipated energy for one loading cycle.

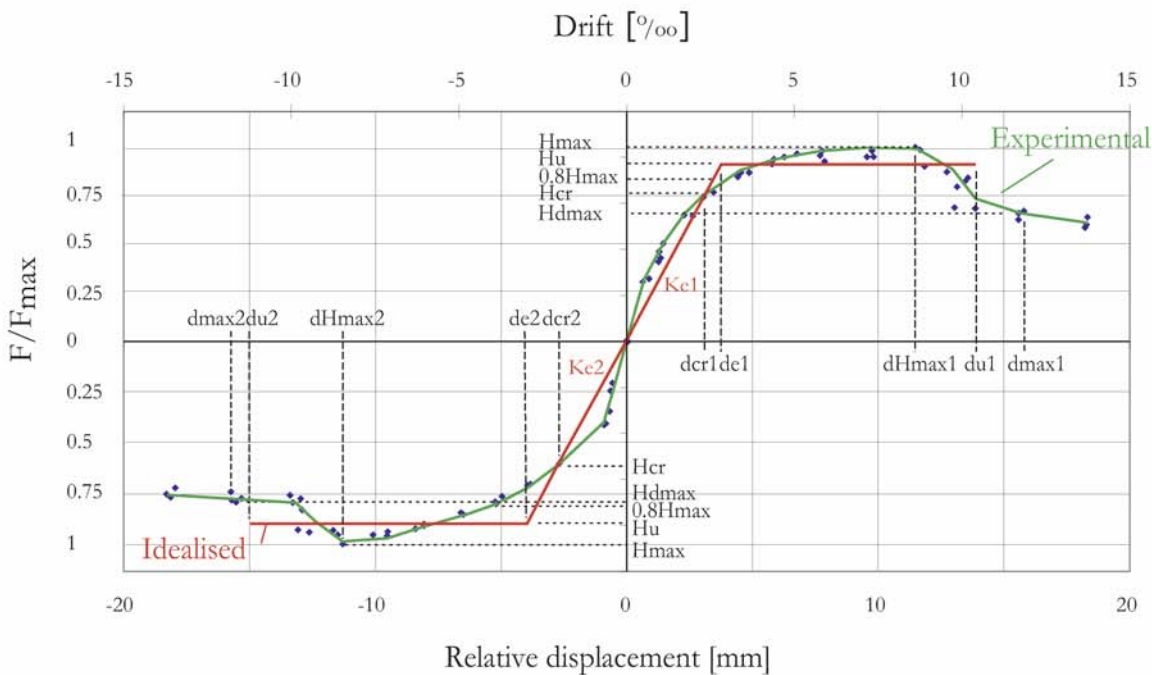
Figure 7.22 : Experimental and idealised envelop curves of the lateral-displacement vs lateral resistance hysteresis loops.

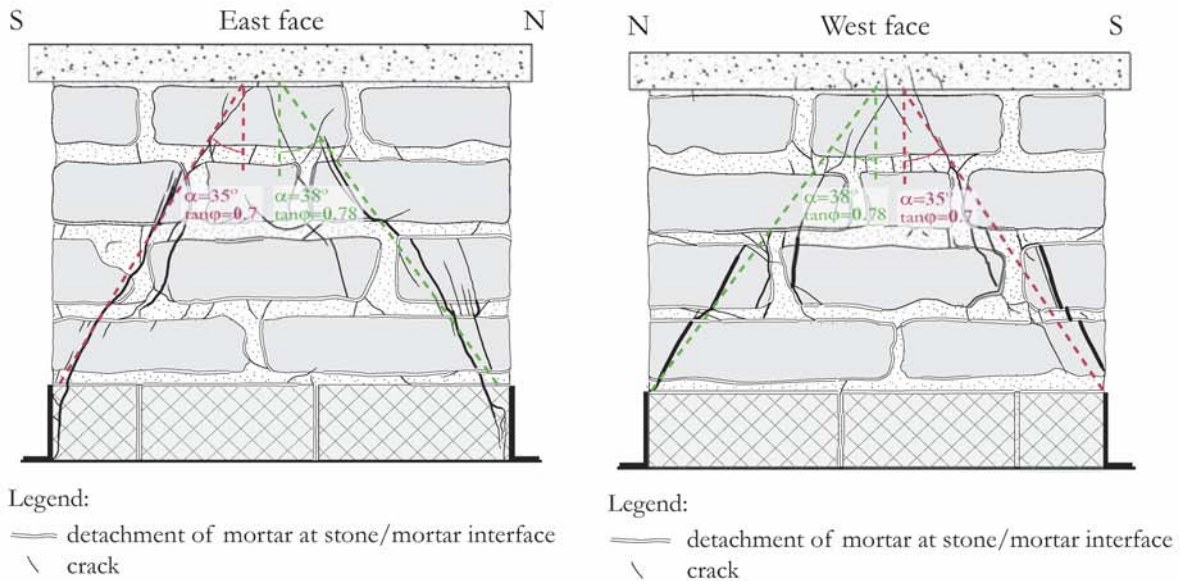
Figure 7.23 : Measured angles of internal friction.

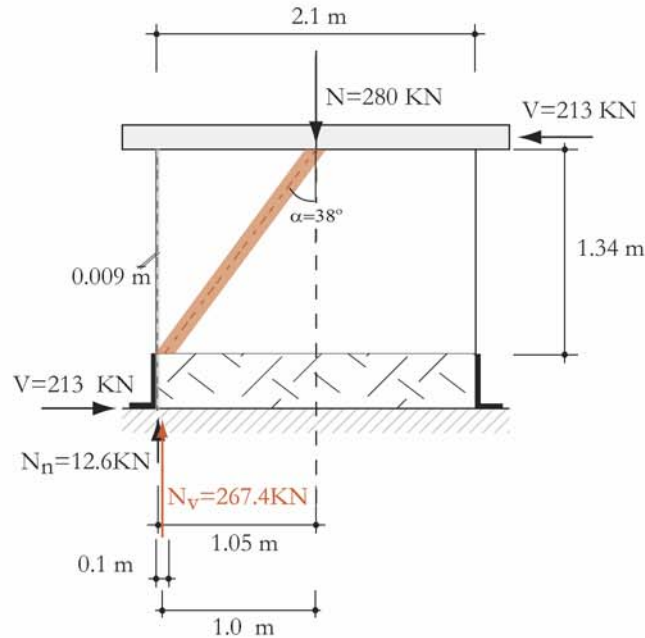
Figure 7.25 : Maximal shear load according to the Ganz's model, for different boundary conditions.

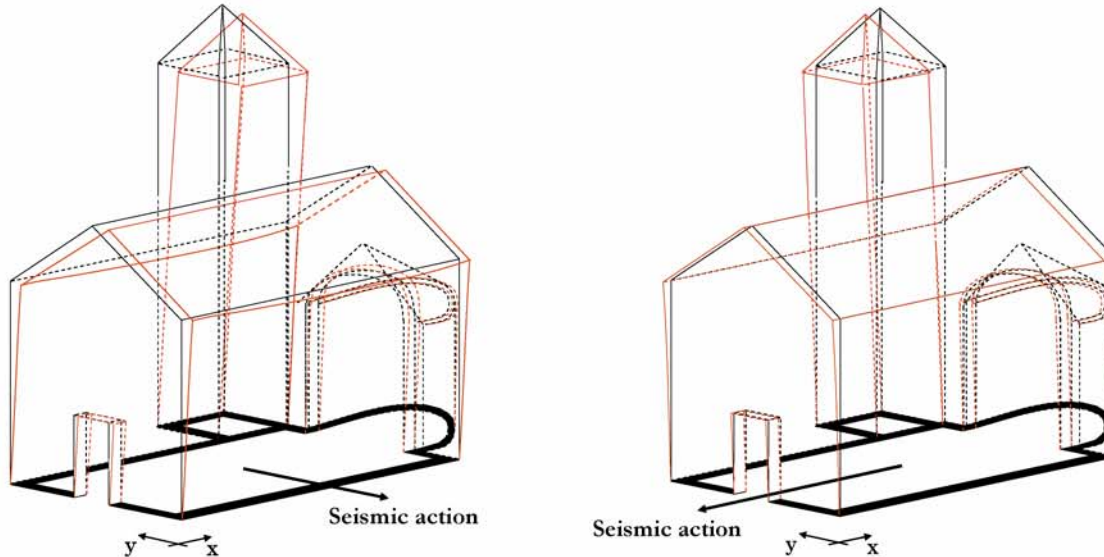
Figure 8.1 : Seismic response in both directions of a simple church with a bell-tower.

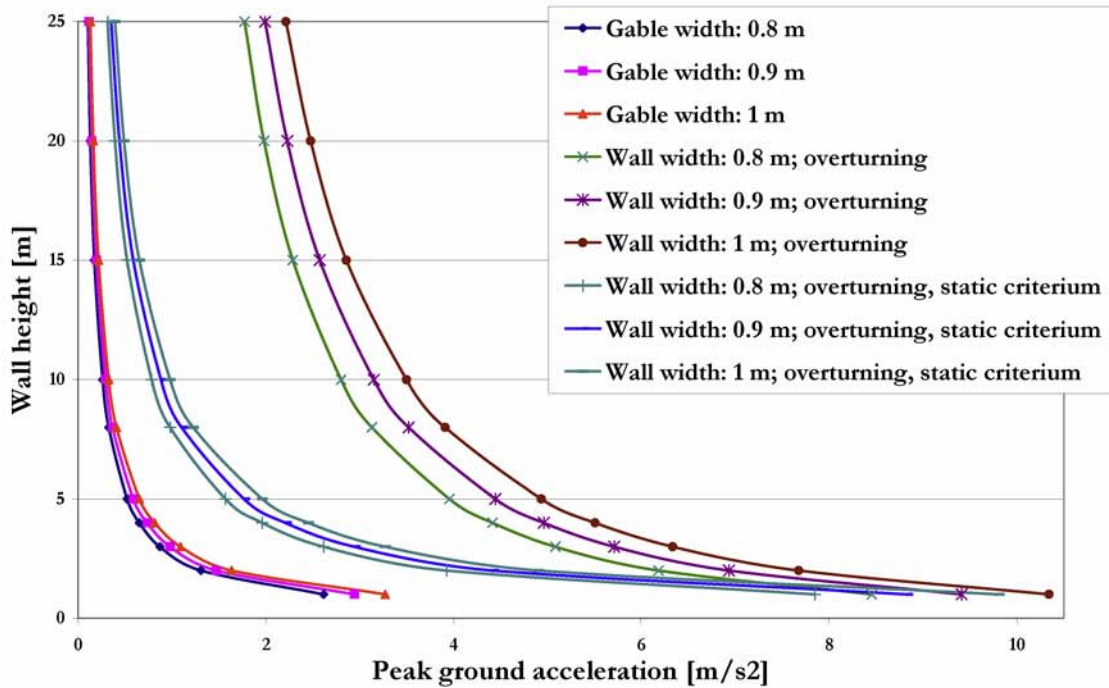
Figure 8.18 : Peak ground acceleration that leads to collapse (overturning) of simple walls or gables.

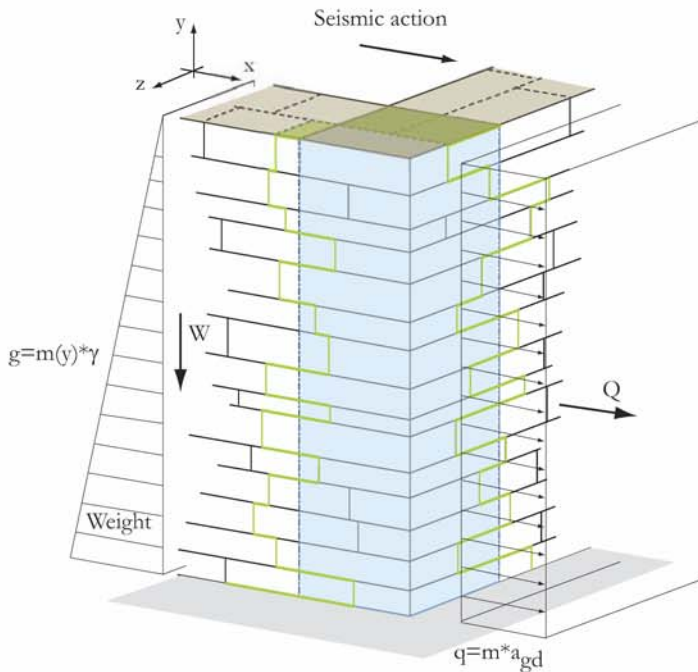
The case shown on Figure 8.21 under increasing out-of-plane acceleration can have two issues: either the wall gets separated on its side or on the perpendicular wall one. Of course, it depends on the masonry type as well as quality (especially in case of heterogeneous masonry) and on the size of the friction surfaces. For instance, corners of squared stone masonry resists better than an angle with pebbles masonry and a damaged (erosion of mortar for example) masonry also counteract the out-of-plane action to a less extent than a masonry in a good state of maintenance.

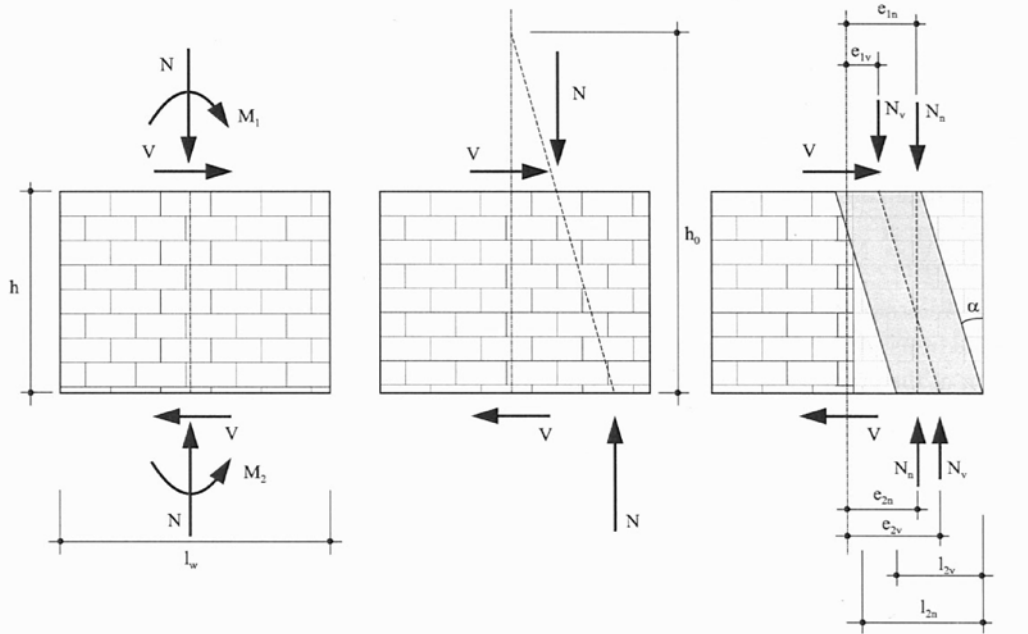
Figure 8.24 : Internal forces and the related stress fields of a wall, according to Ganz; figure taken from [La 02].

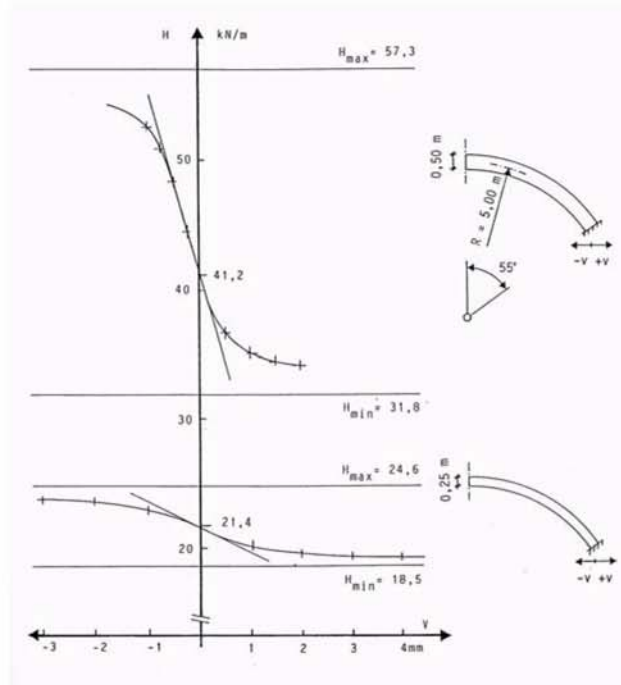
Figure 8.29 : Change of the horizontal force (H) as a function of the bearing horizontal displacement [Ba 91].

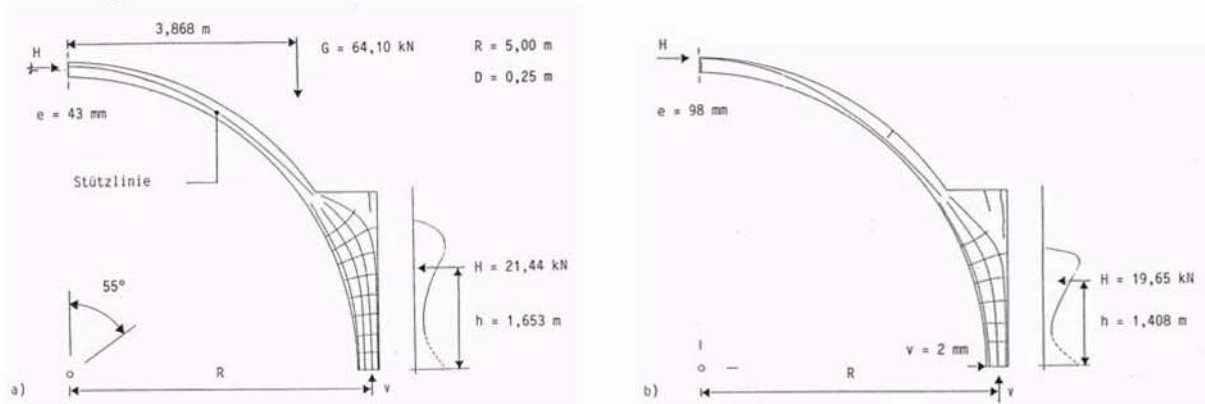
Figure 8.30 : Flow of forces within an arch with a fill under the self-weight and the bearing displacement [Ba 91].

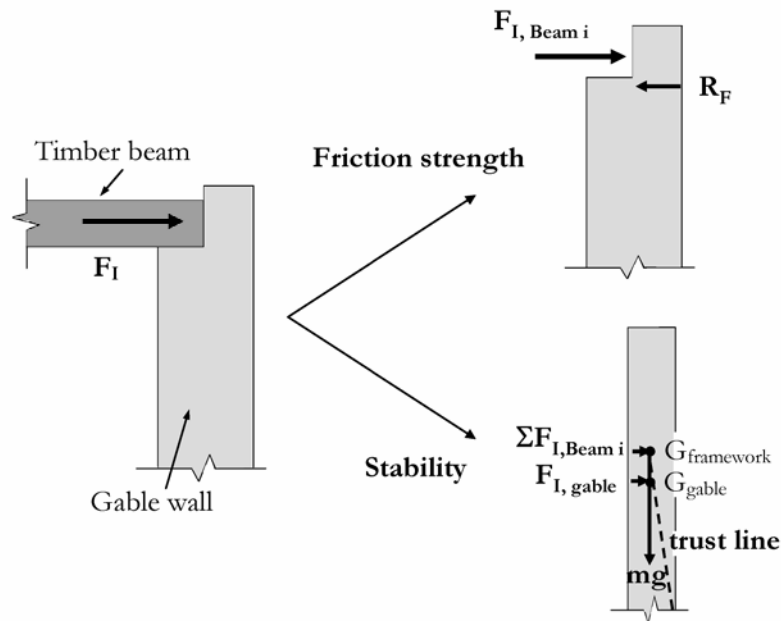
Figure 8.42 : Impact of the seismic response of the timber framework on the gable wall (one-leaf walls).

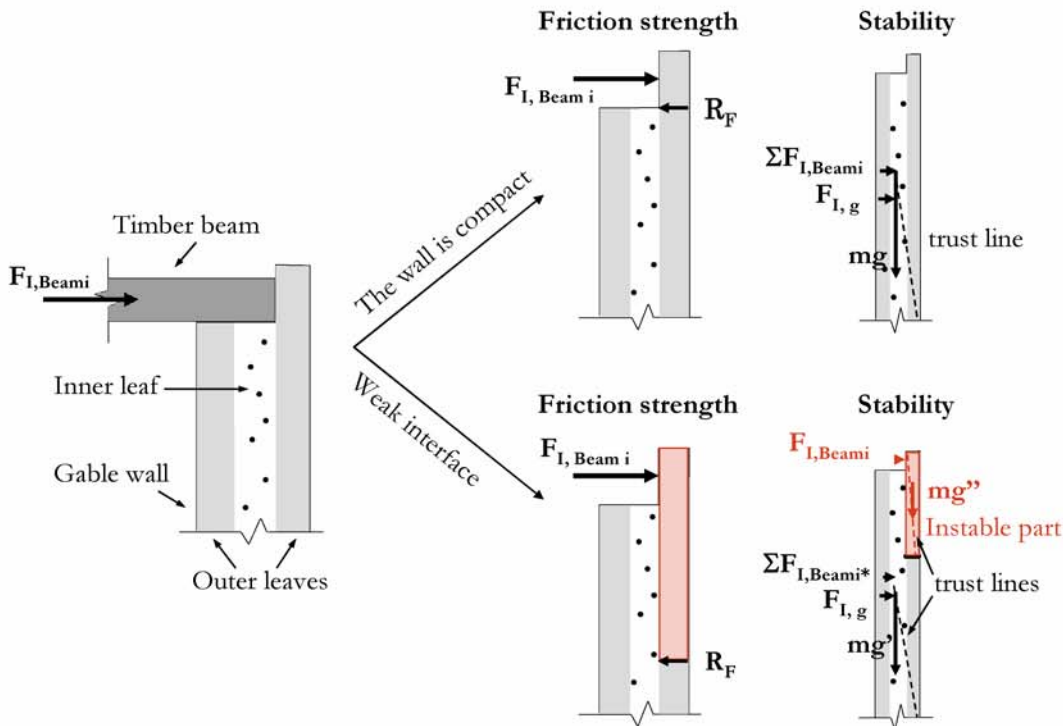
Figure 8.43 : Impact of the seismic response of the timber framework on the gable wall (multiple-leaf walls).

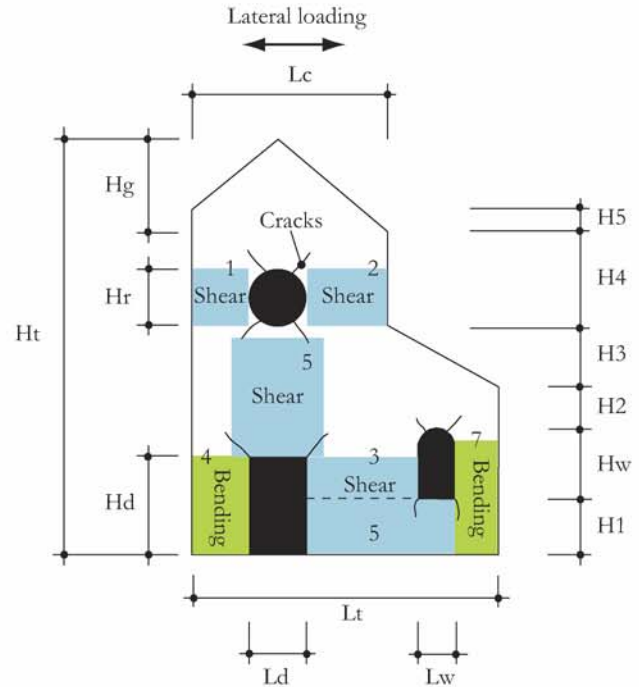
Figure 8.48 : Effects (cracks) and forces within masonry under lateral loading.

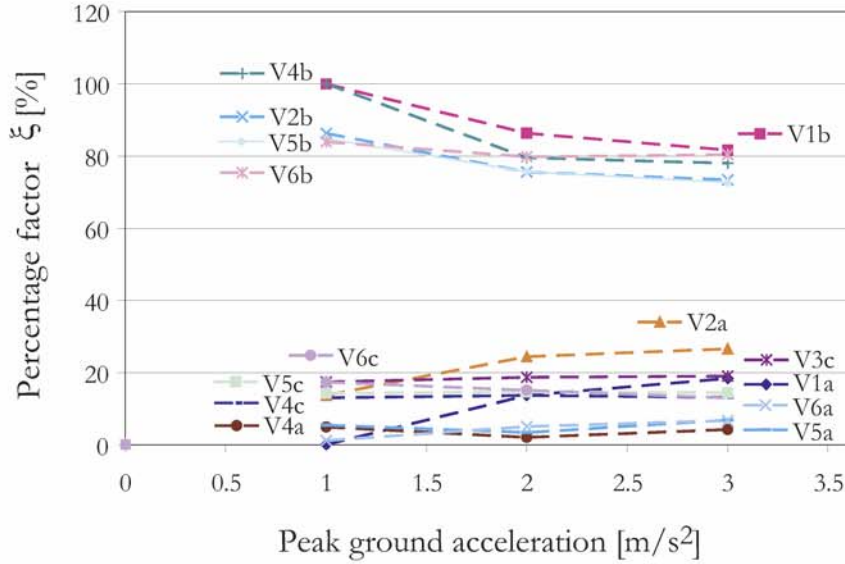
Figure 8.50 : Percentage of V force that transfer through the different parts of FW7 front wall.

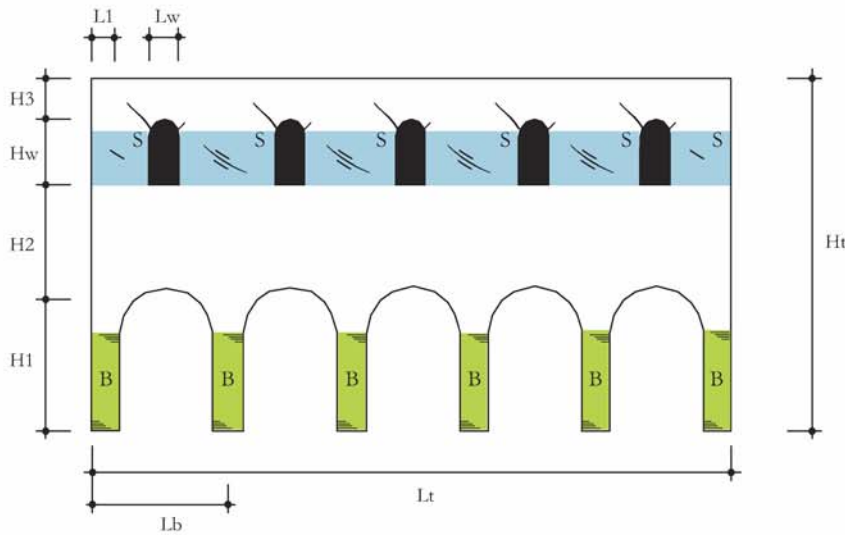
Figure 8.61 : Impact of the transfer of the inertia forces to the ground on the LW1 unit.

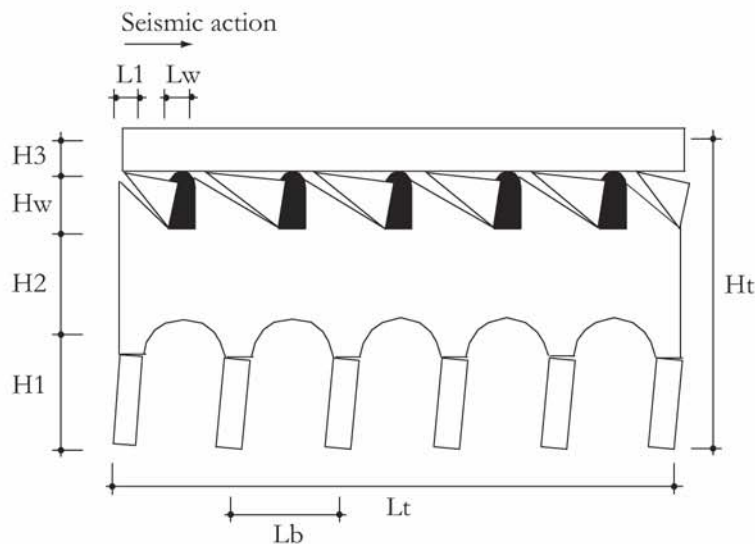
Figure 8.68 : In-plane possible collapse mechanism for LW1 lateral wall.
