Seismic Vulnerability of Cultural Heritage Buildings in Switzerland

THÈSE N° 4167 (2008)

À LA FACULTE ENVIRONNEMENT NATUREL, ARCHITECTURAL ET CONSTRUIT
LABORATOIRE D'INFORMATIQUE ET DE MÉCANIQUE APPLIQUÉES À LA CONSTRUCTION
PROGRAMME DOCTORAL EN STRUCTURES

ÉCOLE POLYTECHNIQUE FÉDÉRALE DE LAUSANNE

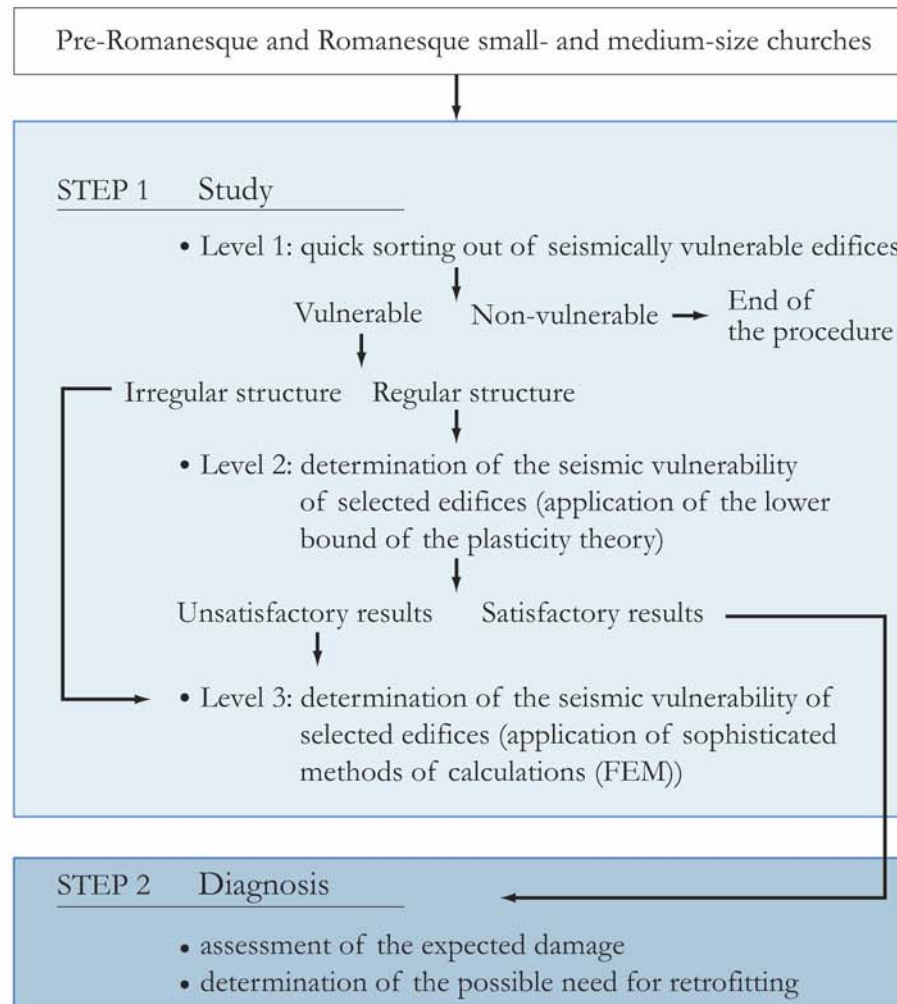
Figure 9.2 : Diagram of the method.

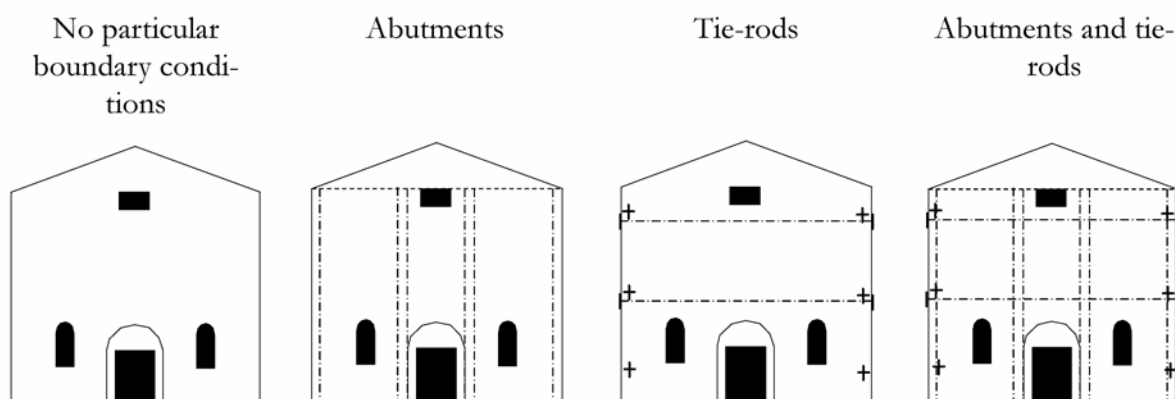
Figure 9.7 : Examples of boundary conditions.

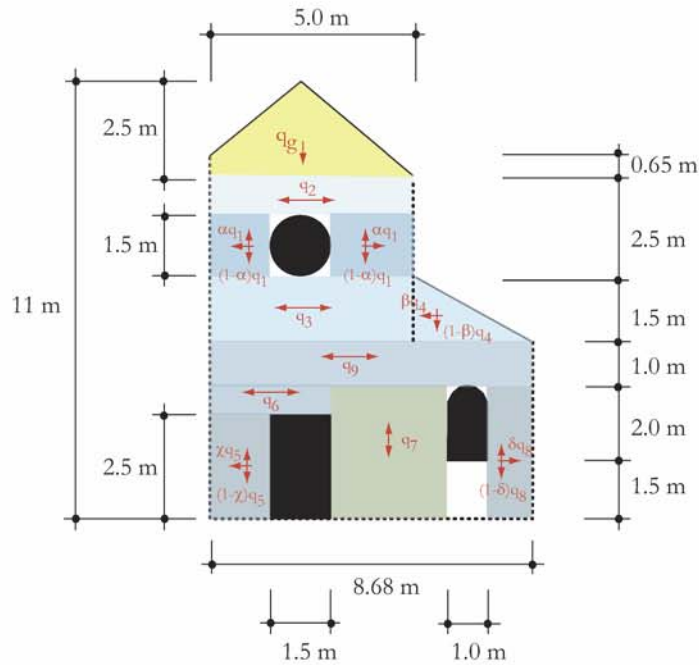
Figure 10.9 : Chosen transfer of forces within the FW7 front wall of the case study.

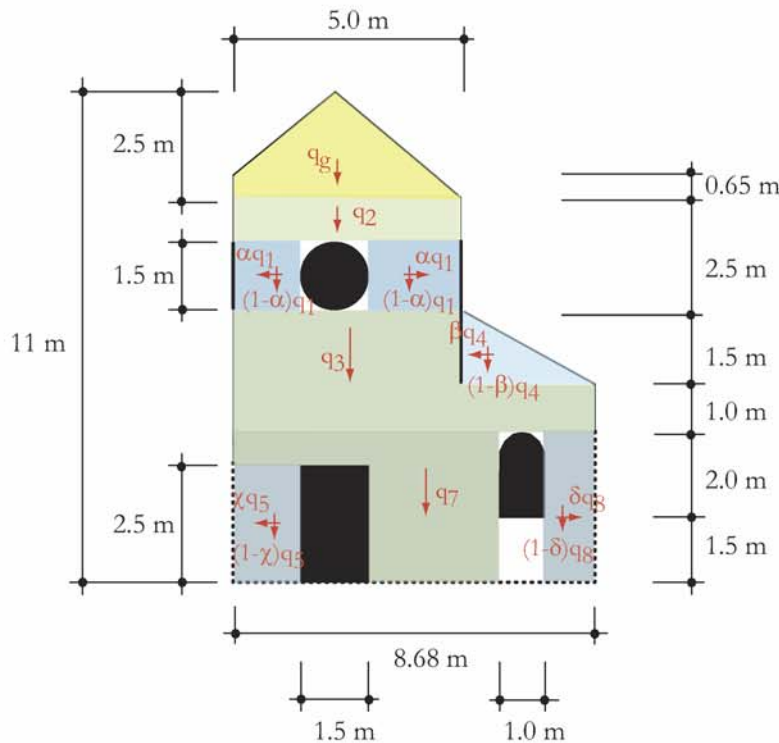
Figure 10.10 : Transfer of forces within the FW7 front wall of the case study after a out-of-plane acceleration of 1.15 m/s^2 .

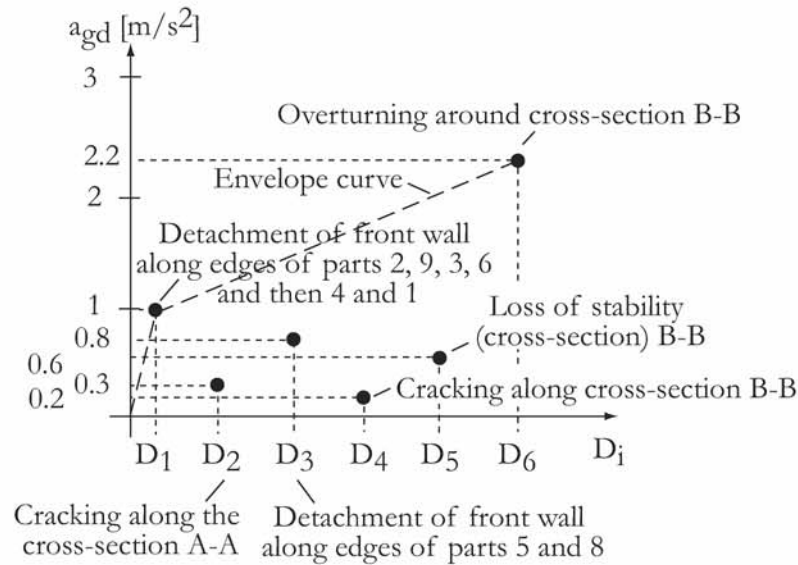
Figure 10.11 : Out-of-plane vulnerability curve of the front wall.

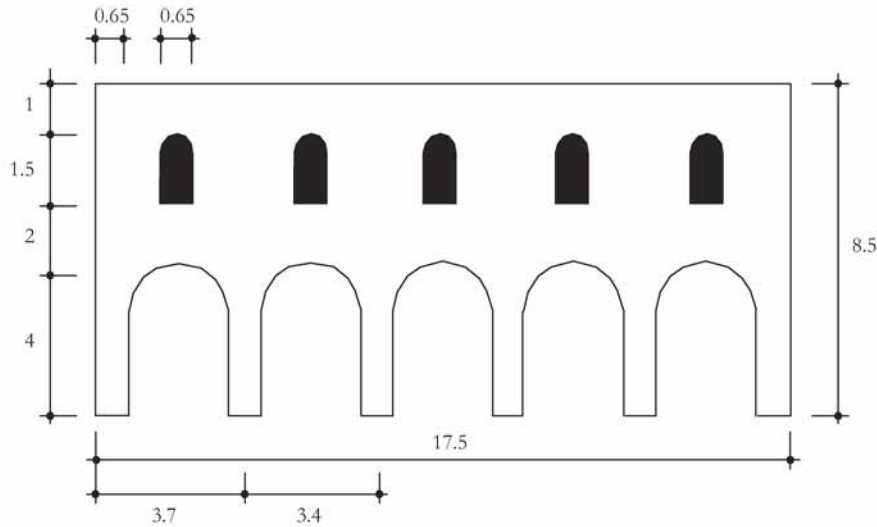
Figure 10.12 : Plan of the main nave lateral walls.

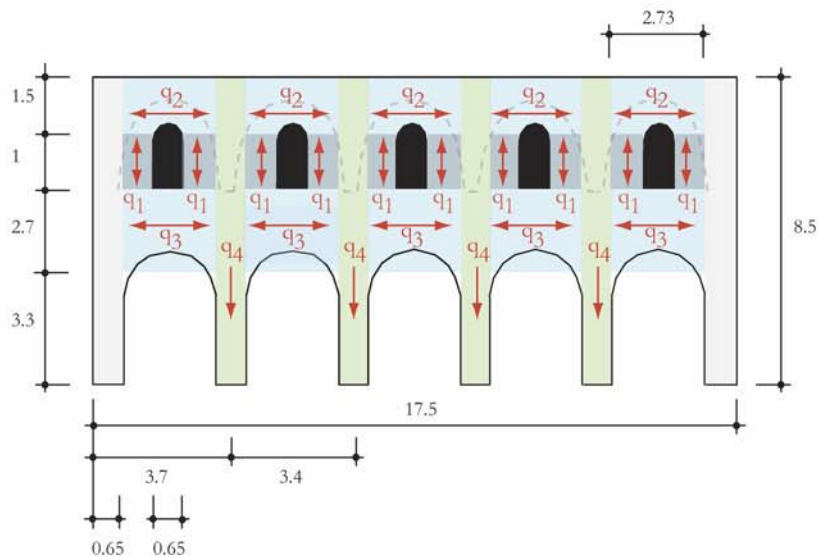
Figure 10.21 : Resulting transfer of forces after a very small out-of-plane acceleration ($a_{gd} < 0.01 \text{m/s}^2$).

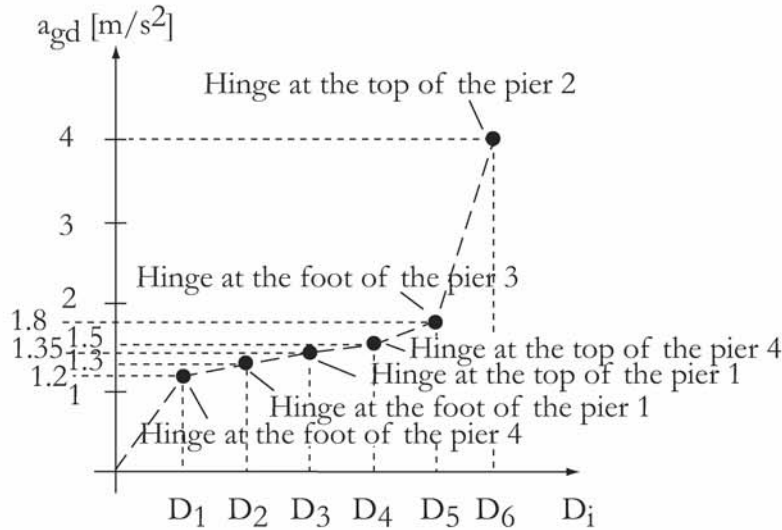
Figure 10.25 : Vulnerability curve for the in-plane seismic response of the TAH 3 chancel arch.

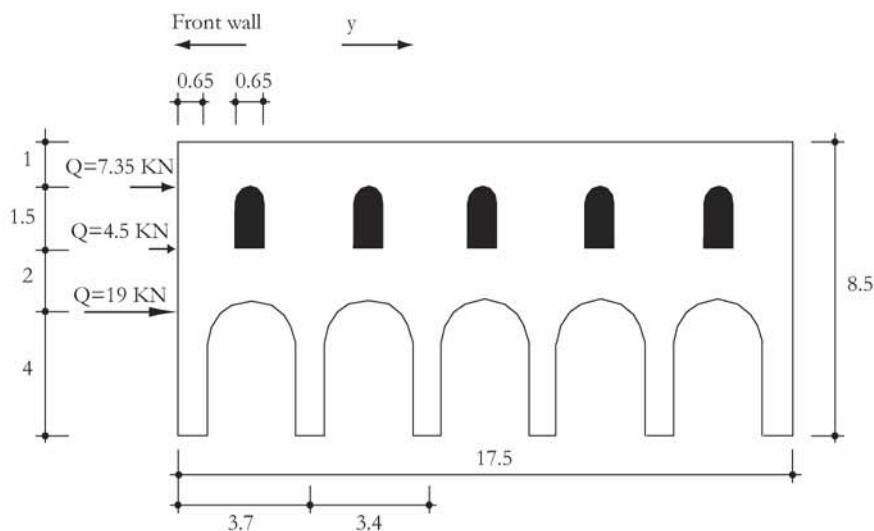
Figure 10.26 : The lateral wall LW1 supports the reaction forces of the front wall when it is loaded by seismic load in the y direction.

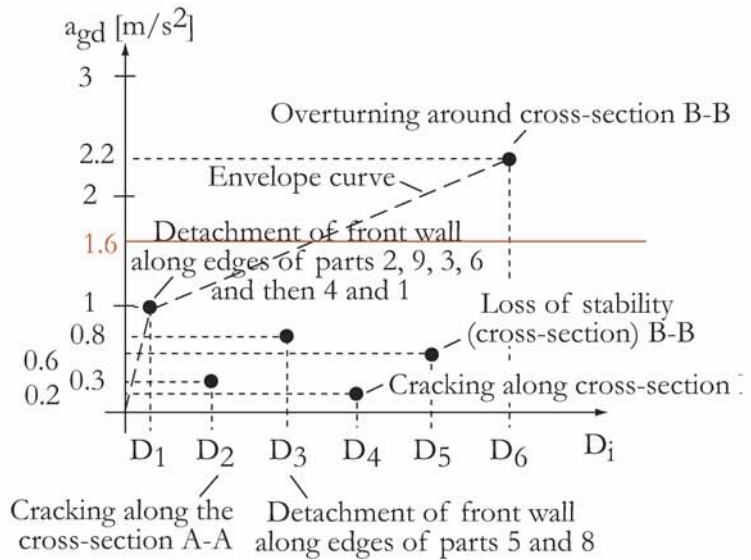
Figure 10.28 : Comparison of the vulnerability curve (out-of-plane) of the front wall with the seismic demand.

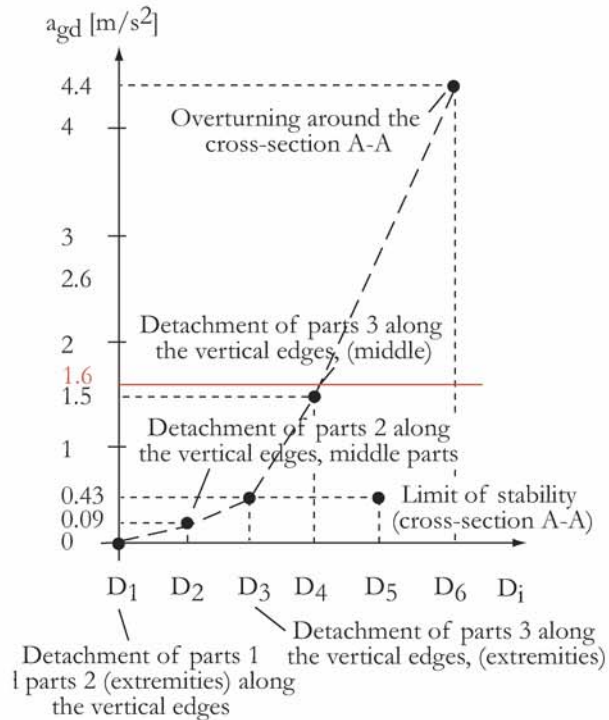
Figure 10.30 : Comparison of the vulnerability curve (out-of-plane) of the LW1 lateral wall with the seismic demand.

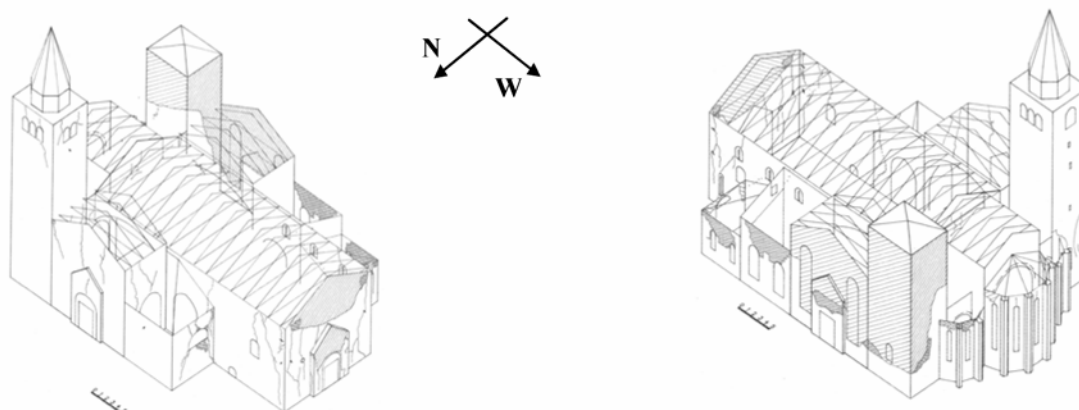
Figure 16.27 : Observed damage on the duomo di Venzone after the 1976 seismic event.

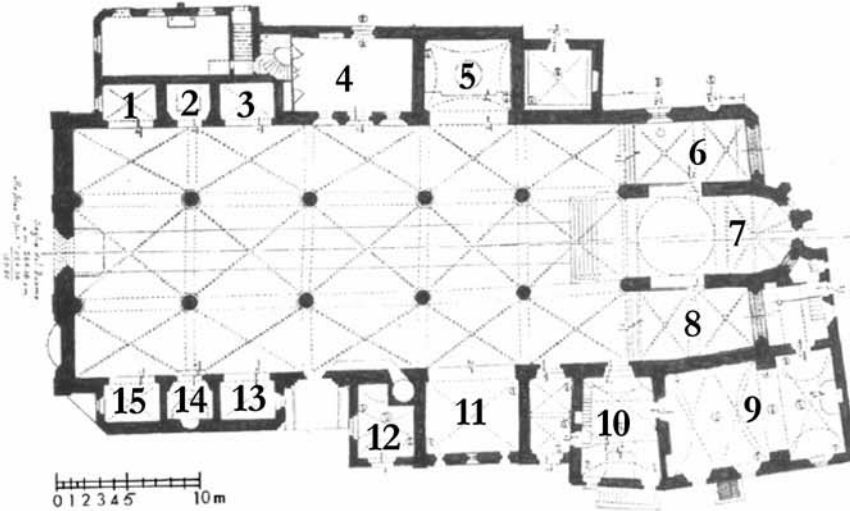
Figure 16.32 : Plan of the Duomo di Gemona.

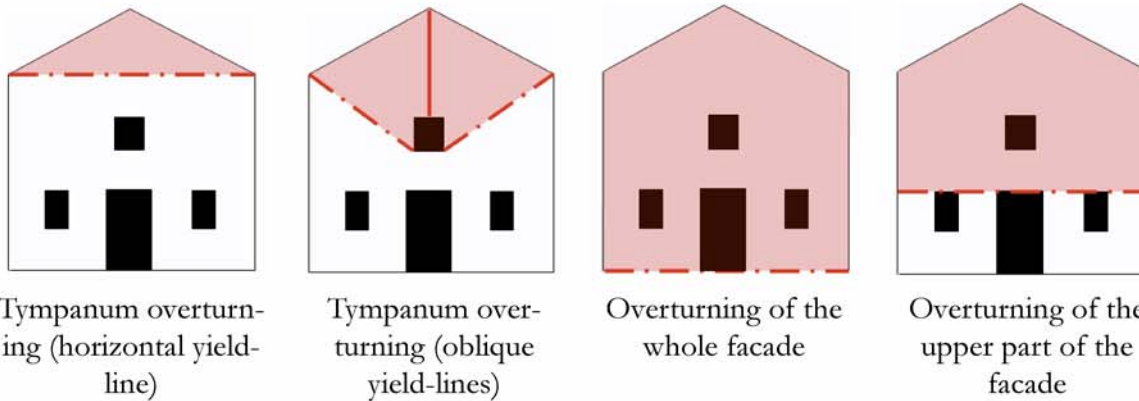
Note: the overturning part is hatched and the yield lines are indicated by dotted outlines; the plain lines correspond to cracks.

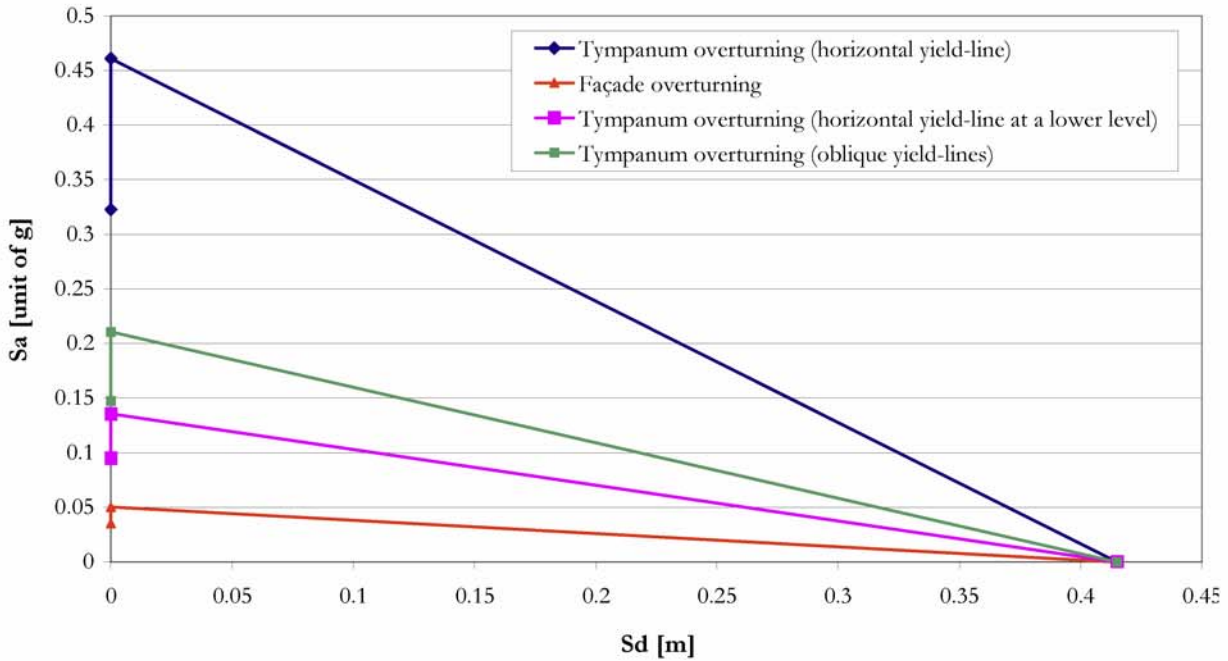
Graph 7 : Capacity curves of the out-of-plane behaviour of the main façade; collegiate of Valère.

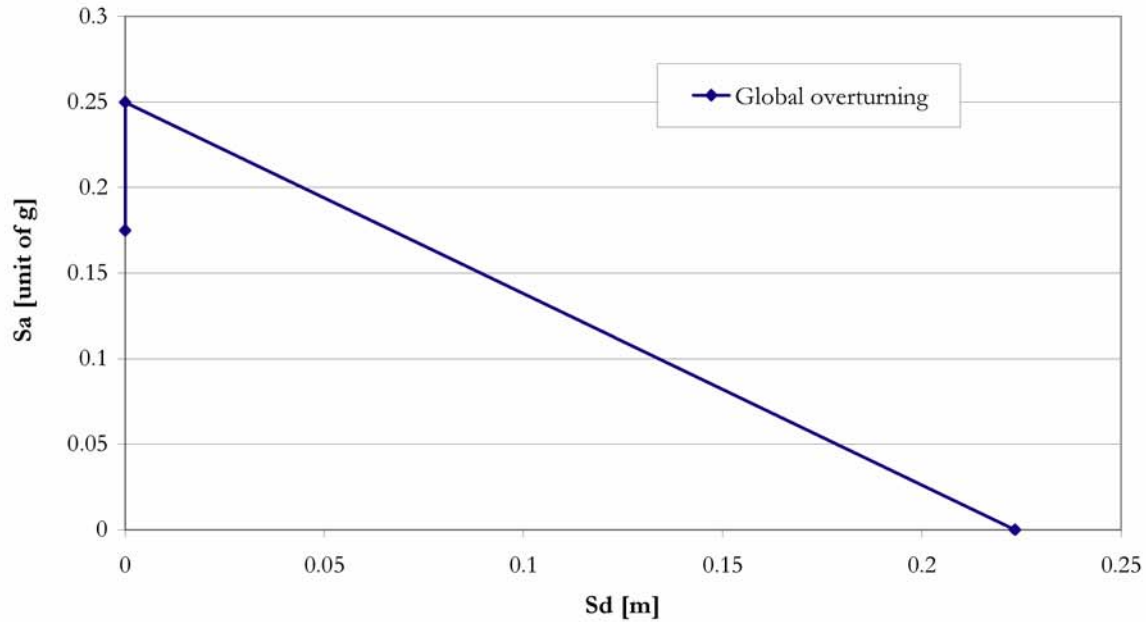
Graph 12 : Capacity curve of the in-plane overturning of the transversal structure of the collegiate of Valère.

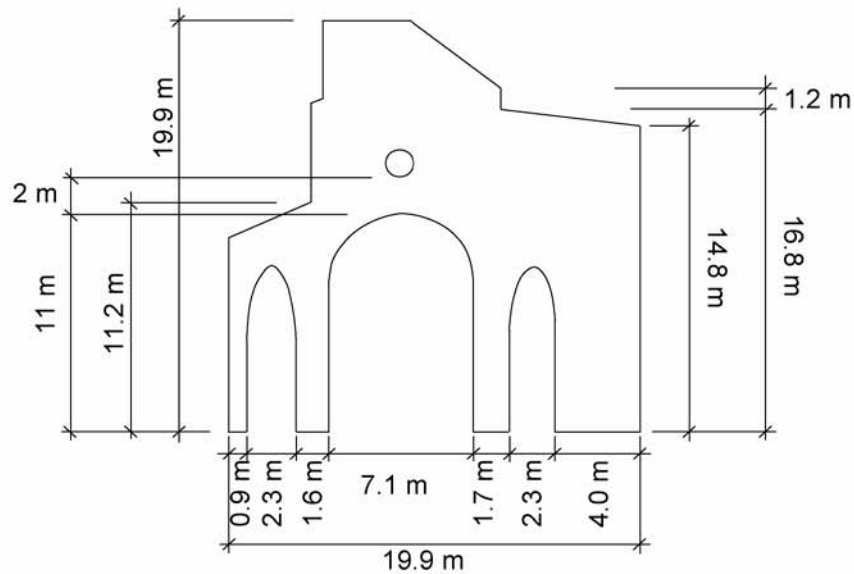
Figure 16.57 : Plan of the chancel arch

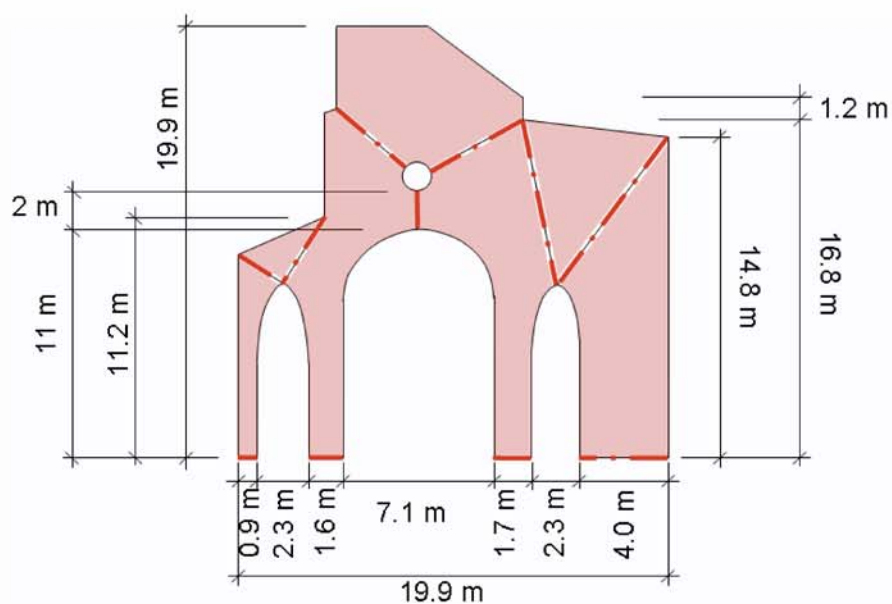
Figure 16.58 : Collapse mechanism of the chancel arch.

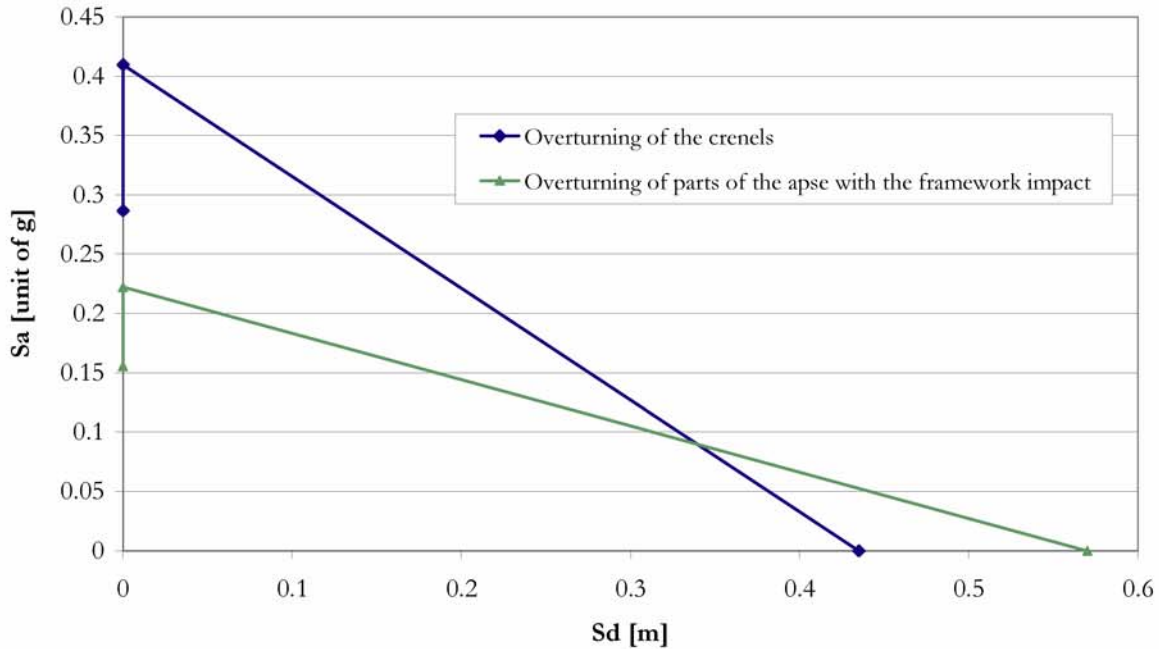
Graph 14 : Capacity curves of the overturning of the crenels and of horizontal strips belonging to the apse; collegiate of Valère.
