# Quasi-Static Monotonic and Cyclic Tests on Composite Spandrels

Katrin Beyer,<sup>a), c)</sup> M.EERI, and Alessandro Dazio,<sup>b), c)</sup> M.EERI

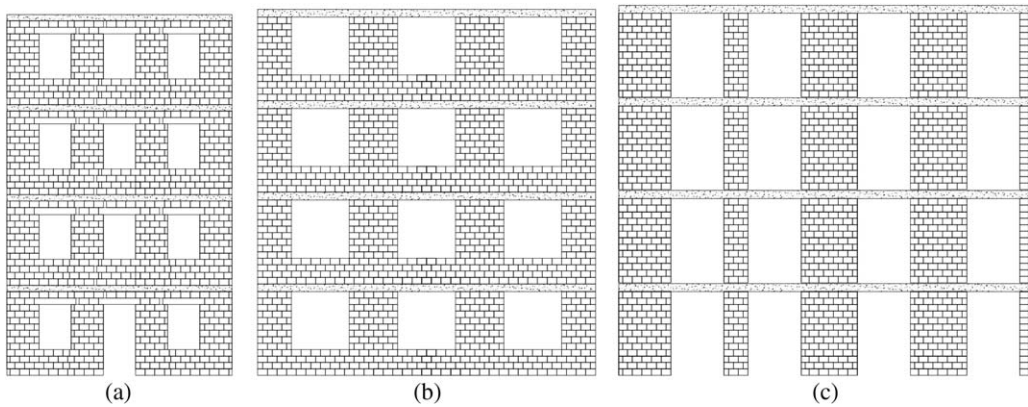
**Figure 1.** Facades of masonry buildings with RC slabs and different spandrel types: Spandrels consisting (a) of masonry spandrel, RC slab and lintel, (b) of masonry spandrel and RC slab, and (c) of an RC slab only.

Facades of buildings with RC slabs feature three different types of spandrels. The first type of spandrel consists of a masonry spandrel, a strip of the RC slab and an RC or reinforced masonry lintel (Figure 1a). This type of spandrel is typically found in older buildings with RC slabs. Larger window openings are indicative of newer construction. Often, the lintel disappears altogether and the window frame with the roller shutter casing reach up to the RC slab (Figure 1b). In very recent buildings, even the masonry spandrel above the slab sometimes disappears and the window unit reaches over the entire story height (Figure 1c). In these cases, the coupling of the masonry piers results from the RC slab only. A similar coupling mechanism can be found in the inner walls where the coupling action due to the RC slab is sometimes reinforced by a door lintel. In view of the large variety of spandrel elements in modern URM buildings, it is impossible to conduct large-scale tests on all types of spandrels. The tests will serve only for the validation of numerical models. For this reason it was decided to concentrate on spandrel elements which comprise a masonry spandrel and a strip of a RC slab. Once the numerical model will be validated, a much larger range of spandrel configurations will be analyzed and then tested. The following sections present the test units, the test setup and the most important test results.

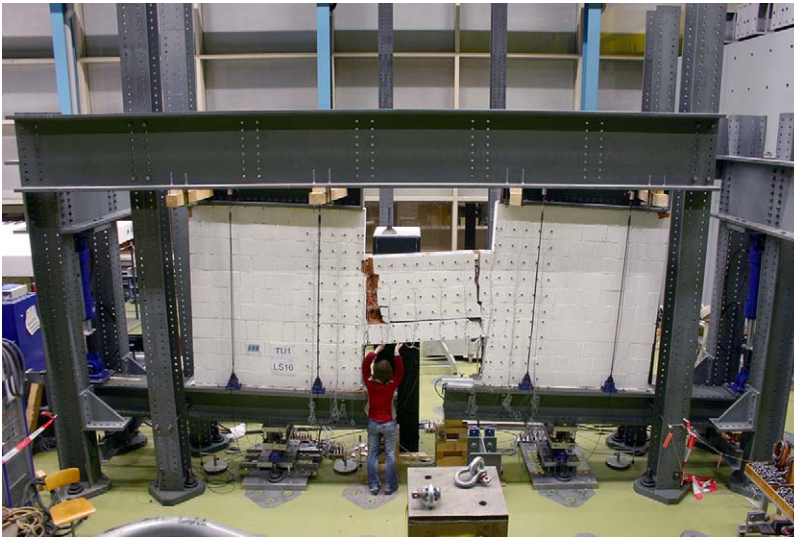
**Figure 6.** Photo of the test setup: View from the east.

In the test setup, the test unit stood on two stiff beams (“lever beams”) that were supported on hinges at the center line of the piers and connected to servo-hydraulic actuators at their ends (Figures 5 and 6). During testing, the two servo-hydraulic actuators were moved

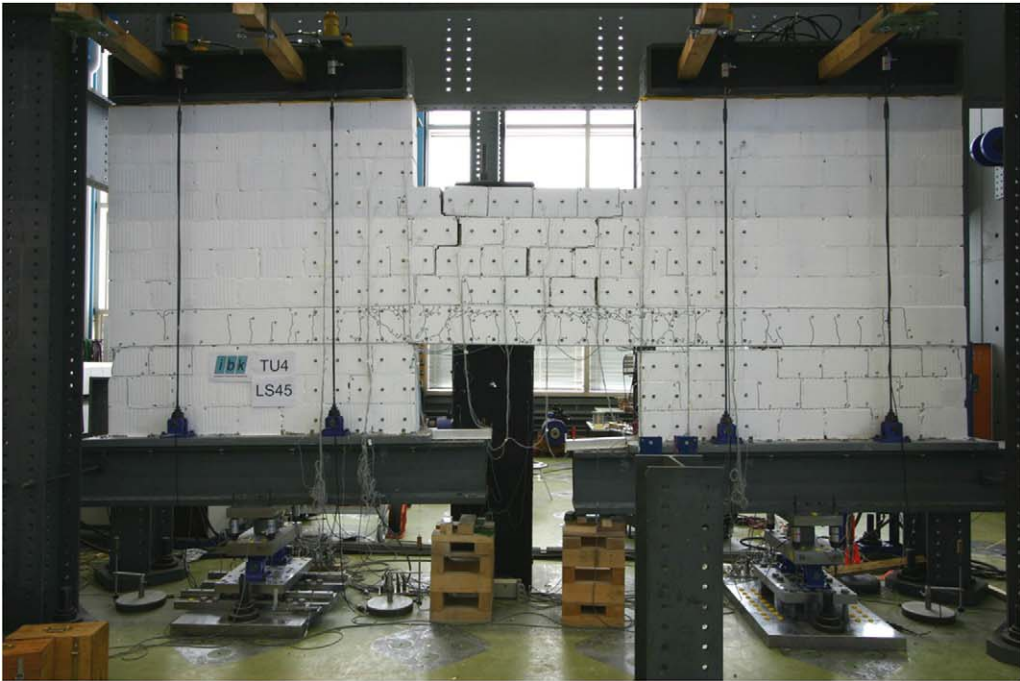
**Figure 14.** TU4: Crack pattern at (a) LS 45 ( $\theta_{nom} = +0.8\%$ ) and (b) LS 50 (failure of TU4 at  $\theta = +3.0$ ).

The RC beam of TU4 was considerably stiffer and stronger than that of TU3 and forced a gap to open up between the bottom of the RC beam and the pier, which reduced the deformation demand on the RC beam itself (Figure 10b). For loading in the positive direction (drift toward the North) the gap opened in the South pier and only a negative plastic hinge formed in the RC beam at the location of the North end of the spandrel. No positive hinge formed in the RC beam. For loading in the negative direction (drift toward the South), the behavior was mirrored (Figure 14a). At the end of the cycles with a rotation of  $\theta_{nom} = \pm 2.0\%$ , the axial

stress in the piers was increased from 0.4 MPa to 0.6 MPa. Consequently, the gap between the pier and RC beam did not open up as much and the RC beam had to deform more. This increased deformation demand on the RC beam led to the yielding of the positive plastic hinge, producing shear failure of the RC beam in the second cycle (Figure 14b).
