Quasi-Static Cyclic Tests on Masonry Spandrels

Katrin Beyer,^{a,c)} M.EERI, and Alessandro Dazio,^{b,c)} M.EERI

This paper presents the results of an experimental campaign on masonry spandrels. Within this campaign, four masonry spandrels were subjected to quasi-static cyclic loading. Two different spandrel configurations were tested. The first configuration comprised a masonry spandrel with a timber lintel, and the second configuration, a masonry spandrel on a shallow masonry arch. For each configuration, two specimens were tested. The first was tested with a constant axial load in the spandrel, while for the second specimen, the axial load in the spandrel depended on the axial elongation of the spandrel. This paper summarizes the properties of the four test units, the test setup, and the most important results from the experiments, documenting the failure mechanisms that developed and the force-deformation hysteresis of the spandrel elements. The paper also presents a mechanical model for estimating the peak strength of masonry spandrels. [DOI: 10.1193/1.4000063]

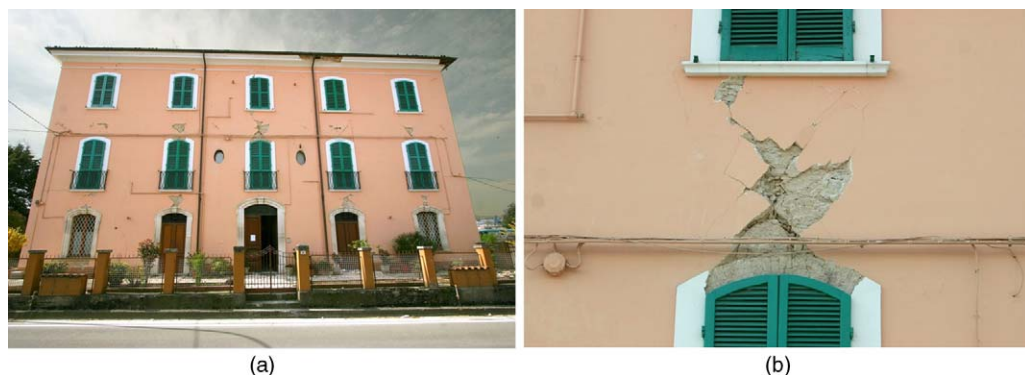
Figure 1. Shear failure of spandrels with shallow masonry arches in an old URM building after the L'Aquila earthquake on 6 April 2009: (a) Entire building and (b) detail of a spandrel.

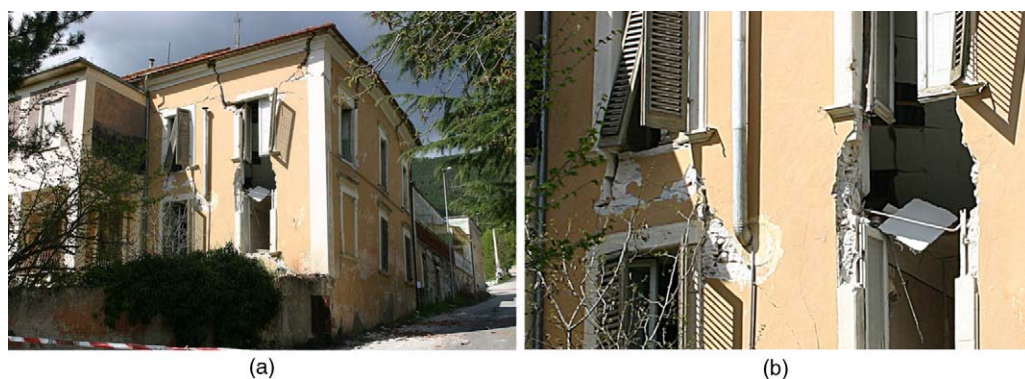
Figure 2. Flexural failure of spandrels in an old URM building after the L'Aquila earthquake on 6 April 2009: (a) Entire building and (b) detail of a spandrel.

Failure of all four spandrels occurred for significantly greater drift demands than those that are typically associated with the shear and flexural failure of piers. The current European seismic design code proposes for shear and flexural failure of the piers ultimate drift limits of 0.4% and $0.8\% H_0/D$, respectively, where H_0/D is the shear ratio (CEN 2005). The spandrel tests were continued beyond these limits. However, it is recommended to regard these results with caution when transferring them to real applications. This is for two reasons: (i) Possible damage to the piers during real earthquakes might modify the boundary conditions imposed on the spandrel while in the tests the piers remained over the entire range of rotations virtually undamaged; (ii) out-of-plane accelerations might lead to out-of-plane failure of the masonry spandrels once the in-plane loading has disjuncted the masonry spandrel (see Figure 2).

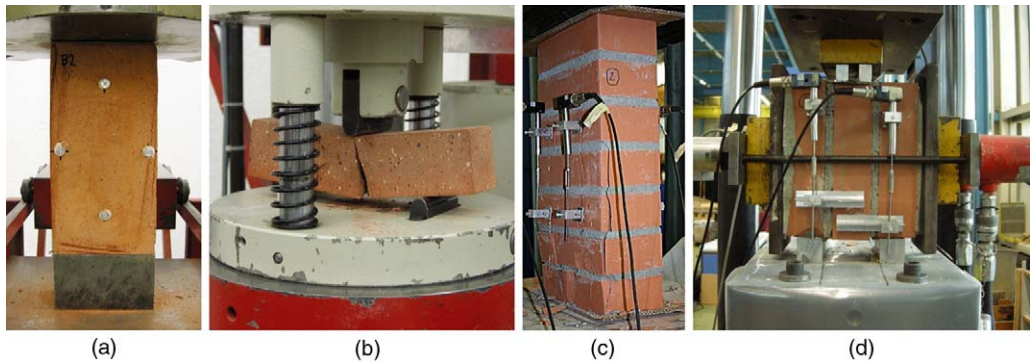
Figure 3. Material tests: (a) Compression test with Demec measurement points on an entire brick; (b) 3-point bending test on a brick prism; (c) compression test on a masonry prism; and (d) triplet shear test.

160×40×40 mm and a free span of 100 mm (Figure 3b), that is, the same test, which is typically used for mortar samples (CEN 2006a).

In addition to tests on the constituent brick and mortar, compression tests on masonry prisms were carried out (Figure 3c). The properties of the interface between mortar and brick were characterized by means of triplet tests (Figure 3d) according to EN 1052-3 (CEN 2007). TUA and TUB as well as TUC and TUD were constructed pairwise at the same time. For each construction phase only one set of six prisms for compression tests and twelve triplets was constructed and tested. From the compression tests on the masonry prisms the E-modulus E_{cM} , the compressive strength f_{cM} and the strain at peak strength ϵ_{cM} of the masonry were determined. The results of the compression tests are summarized in Table 3. The first two columns indicate the mortar strength values for f_{tm} and f_{cm} that were obtained from mortar samples during the construction of the masonry prisms. Mohr-Coulomb relationships describing the peak and residual shear strength of the joints are summarized in Table 4.

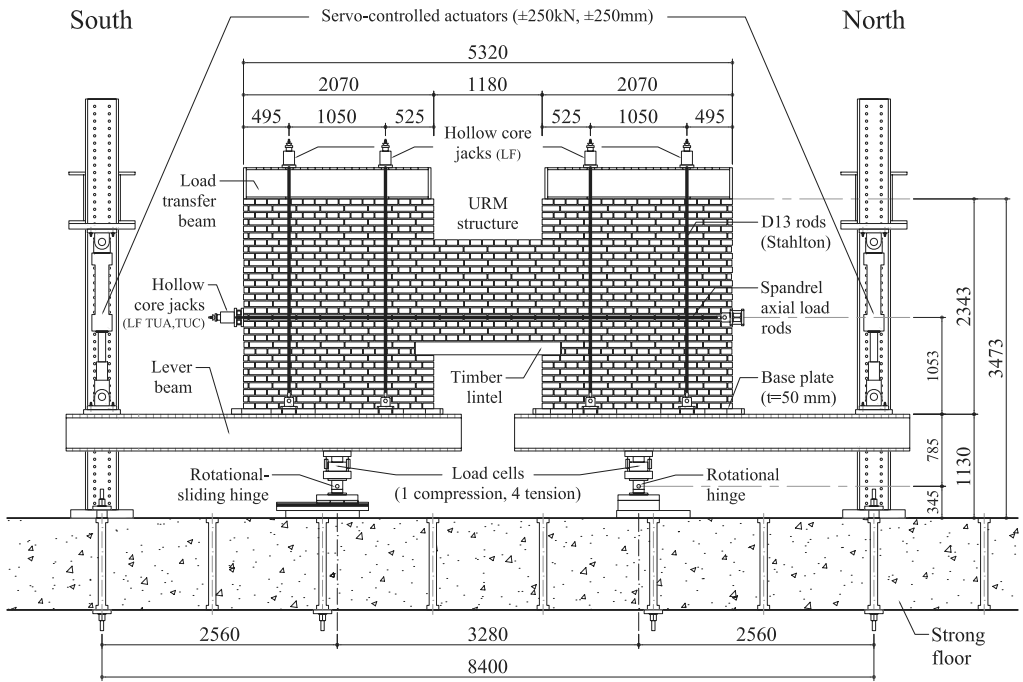
Figure 4. Drawing of the test setup for the masonry spandrel with timber lintel. View from the east without side restraint. All dimensions are in [mm]. (LF = Hollow core jacks connected to load follower, which keeps the oil pressure constant.)

In the test stand, the test unit stood on two stiff steel beams (“lever beams”) that were supported on hinges at the centre line of the piers and connected to servo-hydraulic actuators at their ends (Figures 4 and 5). During testing the two servo-hydraulic actuators were moved with the same velocity in opposite directions. As a result, the two horizontal lever beams rotated and the piers right and left to the spandrel were subjected to the same drifts, which caused the demand on the spandrel. The support of the South lever beam allowed next to a rotation also a sliding movement along the longitudinal axis of the beam. Hence, the test stand did not restrain the axial elongation of the spandrel. To apply an axial load to the spandrel, two horizontal rods introduced an axial force into the spandrel, which was either constant throughout the test (TUA and TUC) or dependent on the axial elongation of the spandrel (TUB and TUD). The position of the rods reflects the typical height of steel rods in real buildings. The two piers were post-tensioned by four vertical

Gattesco et al. (2008) and Graziotti et al. (2009) used a test setup for testing masonry spandrels (setup A), which differed from the test setup shown in Figure 4 (setup B). In their

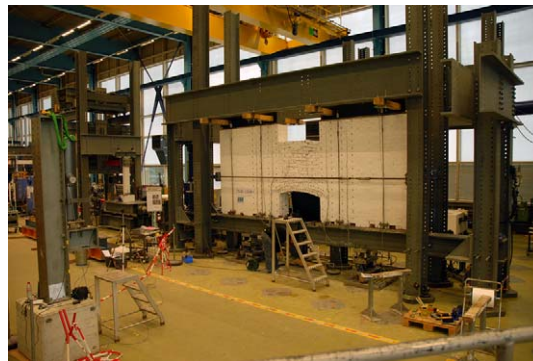
Figure 5. Photo of the test setup. View from the northeast.

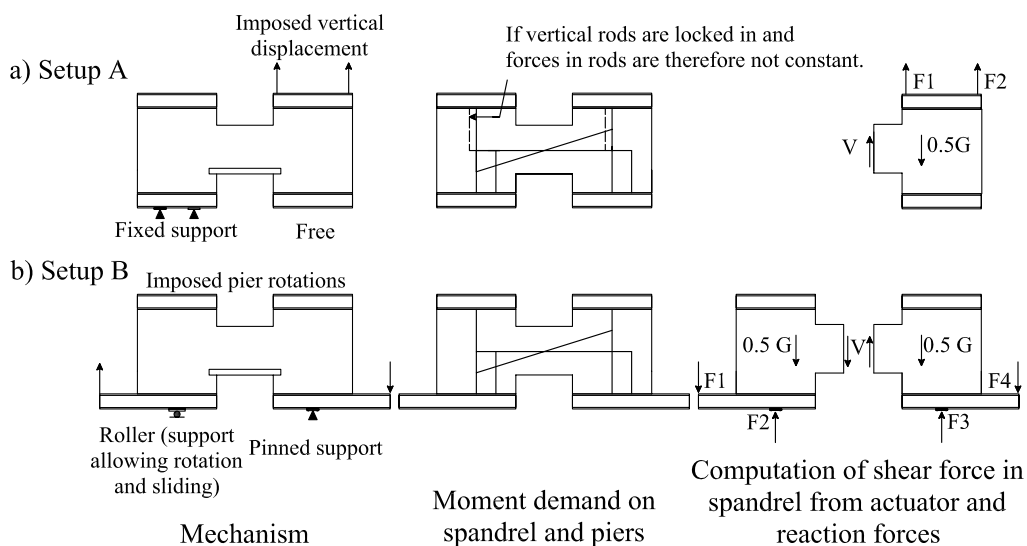
Figure 6. Comparison of two different test setups for spandrel tests: (a) Setup A was used by [Gattesco et al. \(2008\)](#) and [Graziotti et al. \(2009\)](#), while (b) Setup B was adopted in the study presented here.

test setup one pier was fixed on the ground while the other was moved vertically up and down (Figure 6a). Figure 6 shows the moment demand on the piers and spandrel for the two different test setups. Both test setups impose on the spandrel element a linear moment profile, which corresponds to the moment demand on spandrel elements obtained from numerical studies of URM buildings. However, for neither of the two test setups, the moment demand in the piers reflects the moment demand on piers in URM buildings. For this reason, excessive damage to the piers should be avoided by applying a sufficiently large vertical prestress to the piers. A first comparison of the results obtained for test unit M1r by [Gattesco et al. \(2008\)](#) and TUC, which had similar spandrel dimensions as well as similar axial stress levels in the spandrel, revealed that the two test setups yielded similar results in terms of the force-deformation hysteresis of the spandrel as well as the failure mechanism.

None of the two test setups allows measuring the shear force in the spandrel directly. Figure 6 shows schematically how the shear force in the spandrel can be computed from the measured actuator and reaction forces as well as the weight of the test unit. Test setup B has the advantage that the spandrel shear force can be computed from the left and the right end of the test unit, which allows double checking the measured quantities and determining the weight of the test unit from force measurements rather than volume and density estimates. In addition, the authors considered test setup B advantageous, since a possible sudden loss in pressure in the actuators, would not have caused significant damage to the test unit since the weight of the test unit was supported on the hinges underneath the lever beams. Throughout all tests, the test setup B worked very reliably.

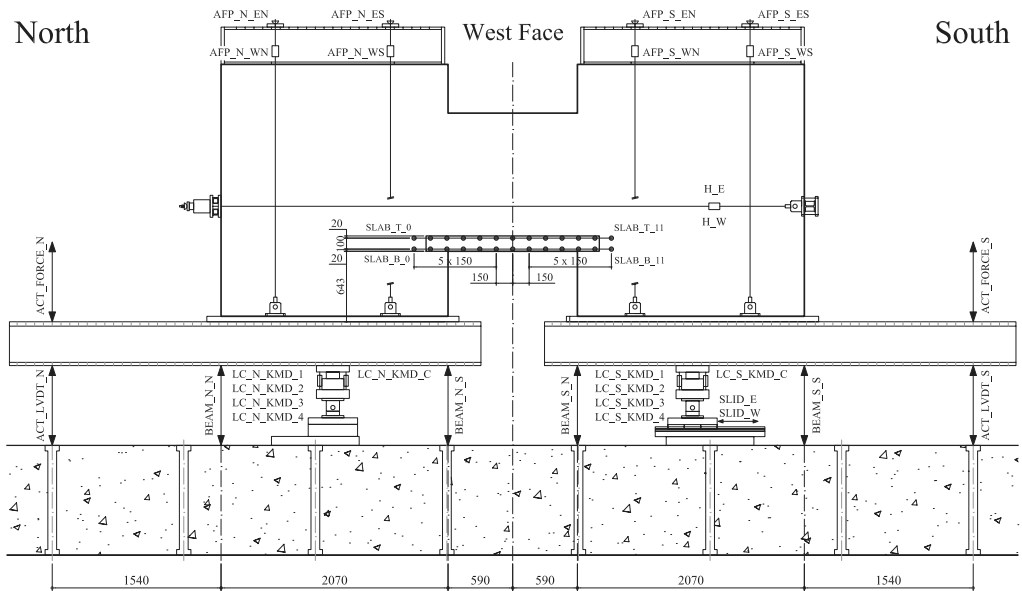
Figure 7. Layout of the hard-wired instruments for masonry spandrels with timber lintel.

Different global and local quantities were measured during testing by means of hard-wired instruments. These included (Figure 7): (i) The actuator forces and the reaction forces at the supports of the beams, (ii) global deformation quantities, i.e., the rotation of the lever beams and the sliding movement of the South lever beam and (iii) the forces in the vertical and horizontal rods generating the axial load in the piers and spandrel, respectively. For TUA and TUB also the local deformation of the timber lintel was measured by means of linear variable differential transformer (LVDT) chains running along the top and bottom edges of the lintel's West face. From the measurements of the actuator forces and the forces at the supports the spandrel shear force was computed. The rotation of the piers was measured by the LVDTs mounted underneath the lever beams. For each lever beam the rotation was computed as:

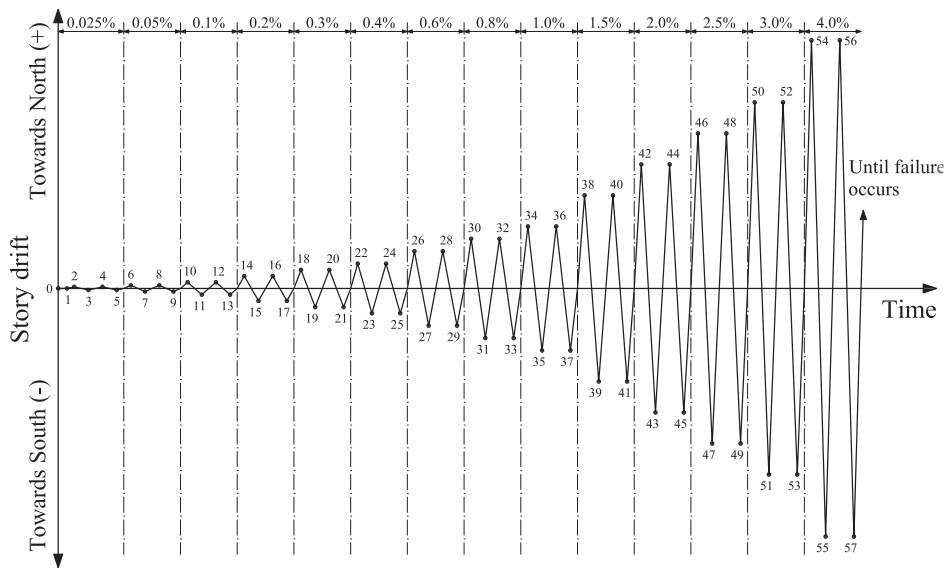
Figure 9. Loading history for quasi-static cyclic spandrel tests.

Quasi-static cyclic tests were performed and for each amplitude level two cycles were applied. The considered amplitudes of the half-cycles corresponded to the following nominal drift levels θ_{nom} : 0.025%, 0.05%, 0.1%, 0.2%, 0.3%, 0.4%, 0.6%, 0.8%, 1.0%, 1.5%, 2.0%, 2.5%, 3.0%. The nominal drift refers to the target drift of a load step. Since the loading was stopped manually, the actual drift at the end of a load step could differ slightly from the target drift. A schematic figure of this loading scheme is shown in Figure 9. A load step corresponds to the peak of one half-cycle of the loading history. The numbering of the drift-controlled load steps commences with LS 2. LS 0 refers to the state before any rotations or forces were applied. Afterwards, the axial load was applied to the piers (LS 1a) and the rods restraining the axial elongation of the spandrel were post-tensioned (LS 1b). At each load step the loading was stopped, cracks were marked and photos taken.

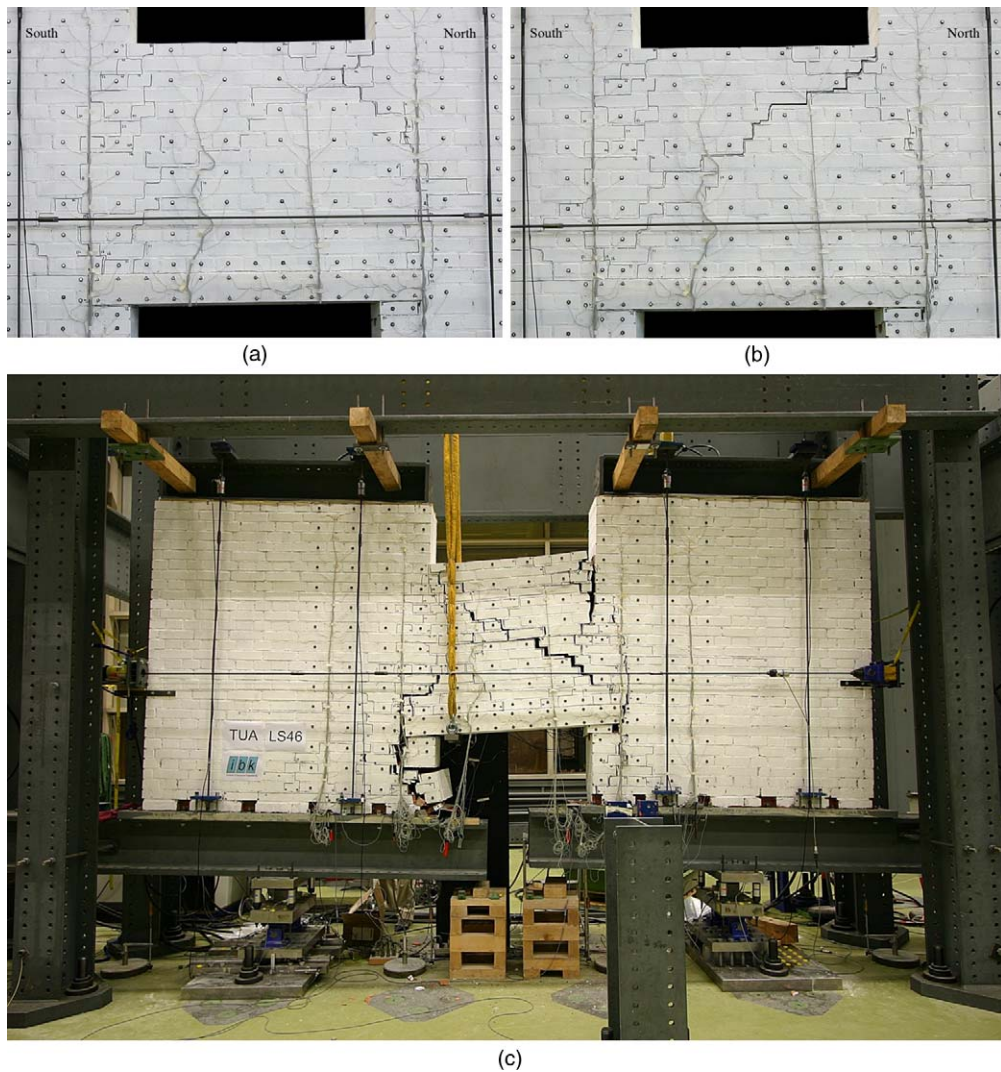
Figure 10. TUA: Crack pattern at (a) LS 22 ($\theta_{nom} = +0.4\%$); (b) LS 23 ($\theta_{nom} = -0.4\%$); and at (c) LS 46 (failure of TUA at $\theta = +3.0\%$).

Figure 10 shows the crack pattern for pier drifts of 0.4% and at failure for a drift of 3.0%. At $\theta_{nom} = \pm 0.4\%$, for the positive direction of loading (Figure 10a), the spandrel had

developed a flexural mechanism with vertical cracks at both ends of the spandrel, which reached around the timber lintel. For the negative direction of loading (Figure 10b), most of the deformations were absorbed by a large stair-stepped shear crack, which crossed the entire spandrel. As loading continued, such a diagonal crack developed also for the positive direction of loading. The final crack pattern of the spandrel corresponded to a mixed flexure-shear failure with vertical cracks at the end of the spandrel and shear cracks in the spandrel. The final failure of the test unit occurred for a drift of 3.0% and was associated

with the failure of the supports of the timber lintel in the piers (Figure 10c); they rotated inwards due to the horizontal shear stresses caused by the pull-out forces of the timber lintel.

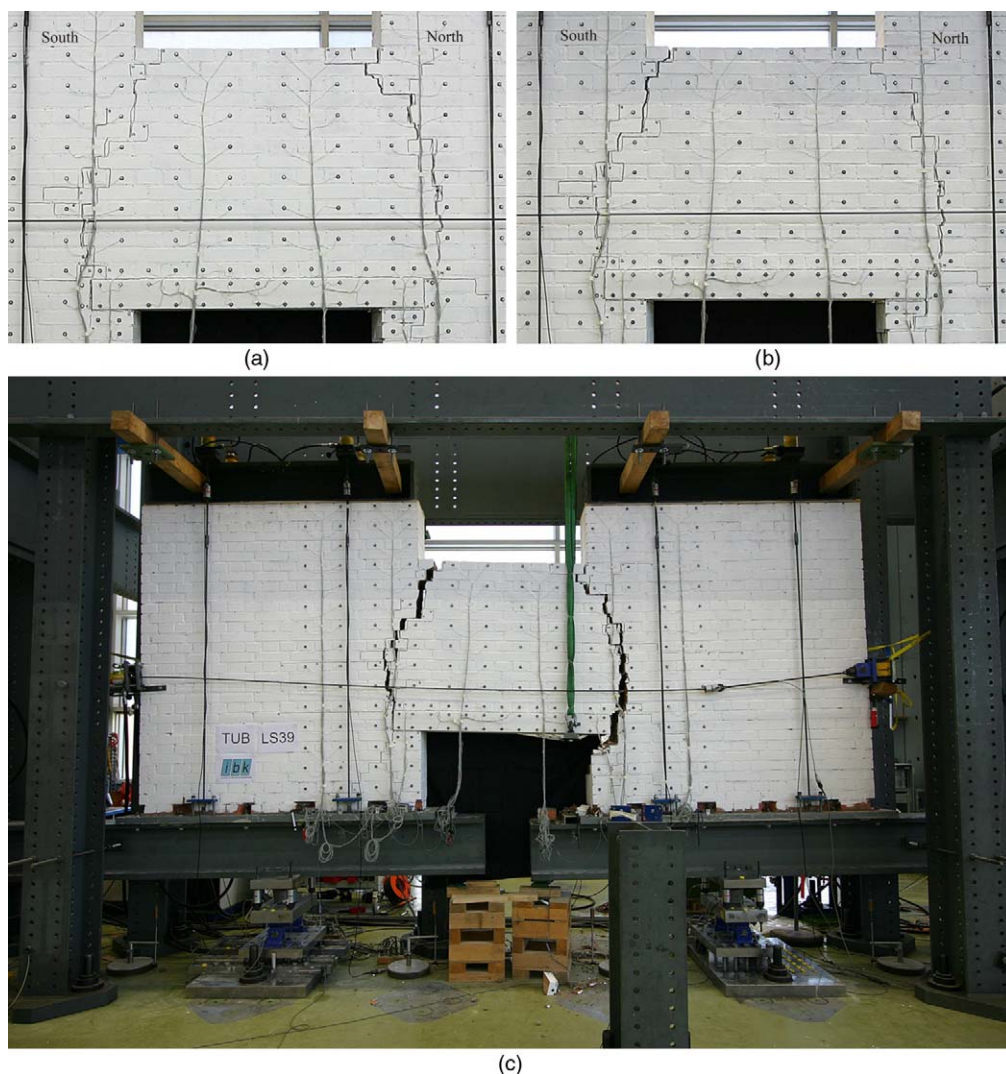
Figure 11. TUB: Crack pattern at (a) LS 22 ($\theta_{nom} = +0.4\%$, a), LS 23 ($\theta_{nom} = -0.4\%$, b) and LS 39 (failure of TUB at $\theta_{nom} = -1.5\%$, c).

TUB was the first test unit to be tested for which the axial load in the spandrel depended on the axial elongation of the spandrel. In order to straighten the two horizontal rods, the horizontal rods were pre-tensioned to 2.5 kN each at the beginning of the test and then locked-in. The axial stress in the piers, which was applied by the vertical rods, was 0.33 MPa (Table 1). Similar to TUA, the first cracks that developed were flexural cracks at both ends of the spandrel reaching around the ends of the timber lintel. The cracks were rather vertical and passed through several bricks indicating a flexural failure of the spandrel. As a result of the cracking the force in the horizontal rods increased. Figure 11a and b show the cracking state of TUB at a pier drift of 0.4%. At this point of the loading history the crack pattern of the spandrel was basically complete. In the following, small stair-stepped cracks developed below the support of the timber lintels. In particular the North support of the lintel deteriorated significantly during the cycles with $\theta_{nom} = 1.0\%$. Most likely due to pull-out forces of the lintel, the bricks supporting the lintel detached from other bricks or broke in two. The test unit failed just before reaching for the first time $\theta_{nom} = -1.5\%$ (Figure 11c). Almost simultaneously the North support of the lintel failed and the West horizontal rod fractured. It was not possible to discern which of the two failure mechanisms occurred first. After failure, the spandrel still carried its own weight; the crane support at the right end of the spandrel was not activated (Figure 11c).

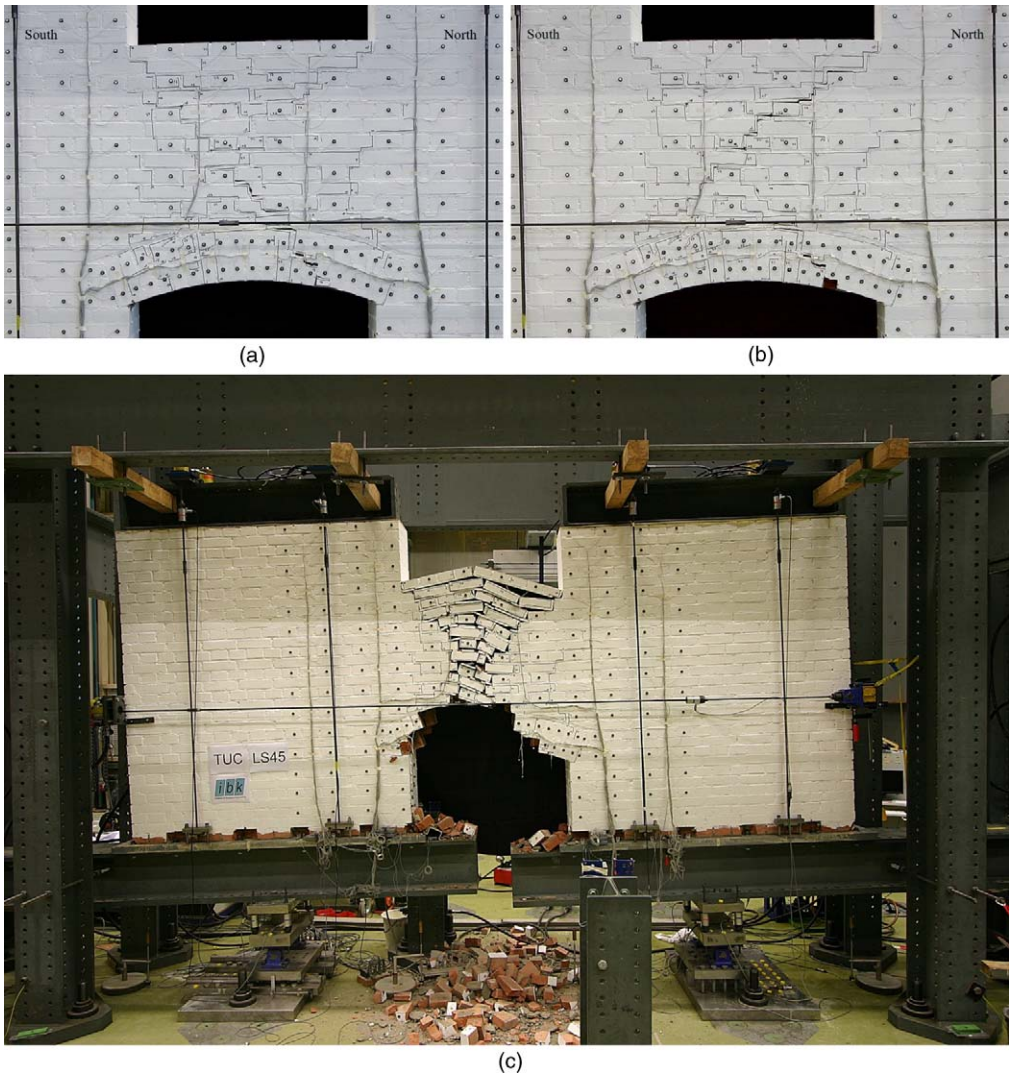
Figure 12. TUC: Crack pattern at (a) LS 22 ($\theta_{nom} = +0.4\%$); (b) LS 23 ($\theta_{nom} = -0.4\%$); and at (c) LS 45 (failure of TUC at $\theta = -3.5\%$).

TUC featured a shallow masonry arch instead of the timber lintel. Similar to TUA the axial force in the spandrel was kept constant throughout the test but it was doubled to create a failure mode, which was different to that of TUA. To avoid the opening of a gap at the base of the piers, the axial stress in the piers was increased from 0.33 MPa to 0.43 MPa (Table 1). TUC reached its peak shear capacity during the cycles with a nominal rotation of $\theta_{nom} = 0.2\%$. During these cycles the spandrel failed in shear forming the characteristic X-pattern, which was also observed in real buildings (see Figure 1). Figures 12a and 12b show the crack pattern of TUC for the positive and negative direction of loading, respectively, at a nominal drift of $\theta_{nom} = \pm 0.4\%$. For both directions of loading the diagonal shear cracks were the widest cracks, hence indicating a shear failure of the spandrel. Two hinges had formed in the arch, which were located at approximately 1/3 and 2/3 of the span. While the South hinge seemed to be mainly a flexural hinge, the North hinge showed already at $\theta_{nom} = \pm 0.4\%$ a significant sliding movement. This was most likely caused by the diagonal crack reaching into the spandrel from the spandrel's South top corner. Unlike the other diagonal crack, it did not point to the corner of the spandrel but ended within this North plastic hinge of the arch. As loading continued the damage to the arch increased with each cycle. The final failure occurred at a drift of $\theta = -3.5\%$ due to collapse of the arch (Figure 12c).

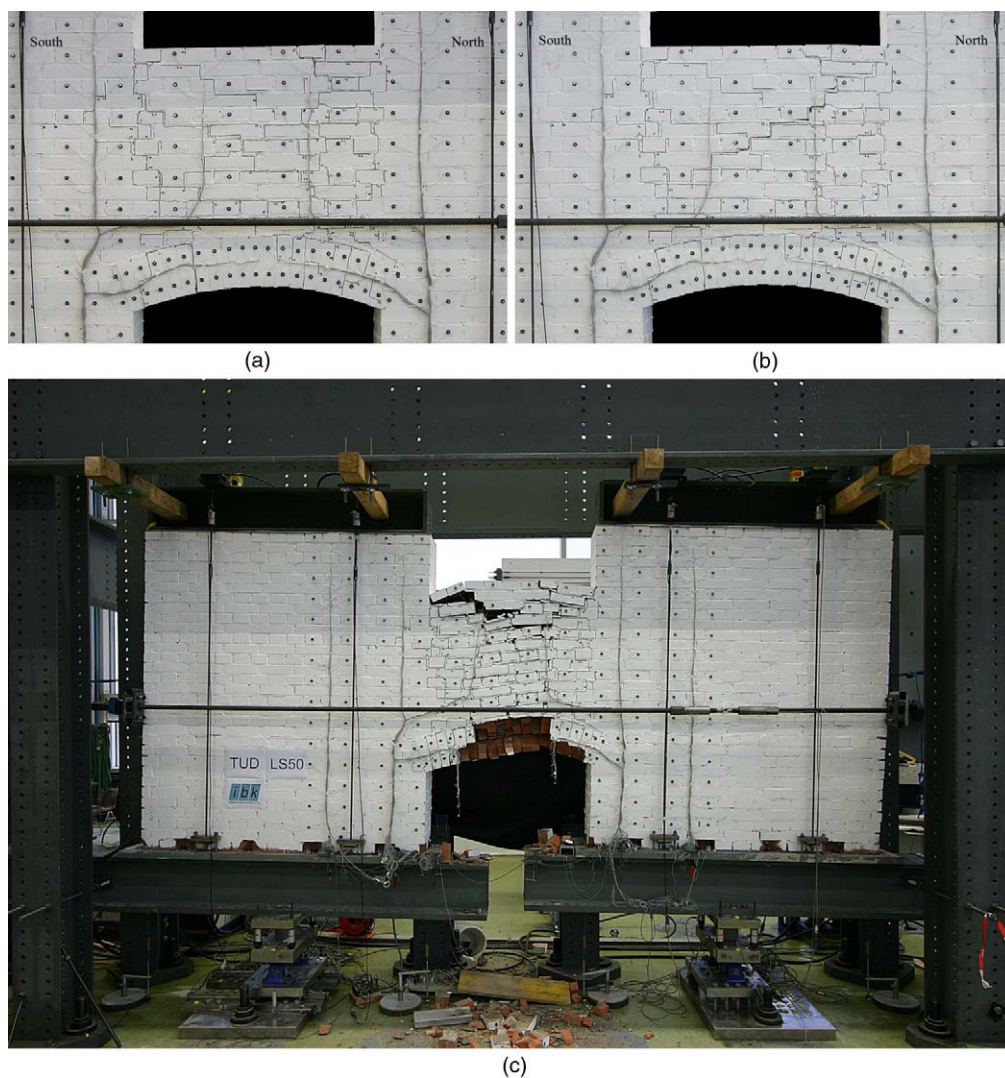
Figure 13. TUD: Crack pattern at LS 22 ($\theta_{nom} = +0.4\%$, a), LS 23 ($\theta_{nom} = -0.4\%$, b) and at LS 45 (failure of TUD at $\theta = +2.5\%$, c).

time the loading direction was reversed some lower parts of the bricks fell down. At the end of the test the front row of the central part of the arch collapsed (Figure 13c).

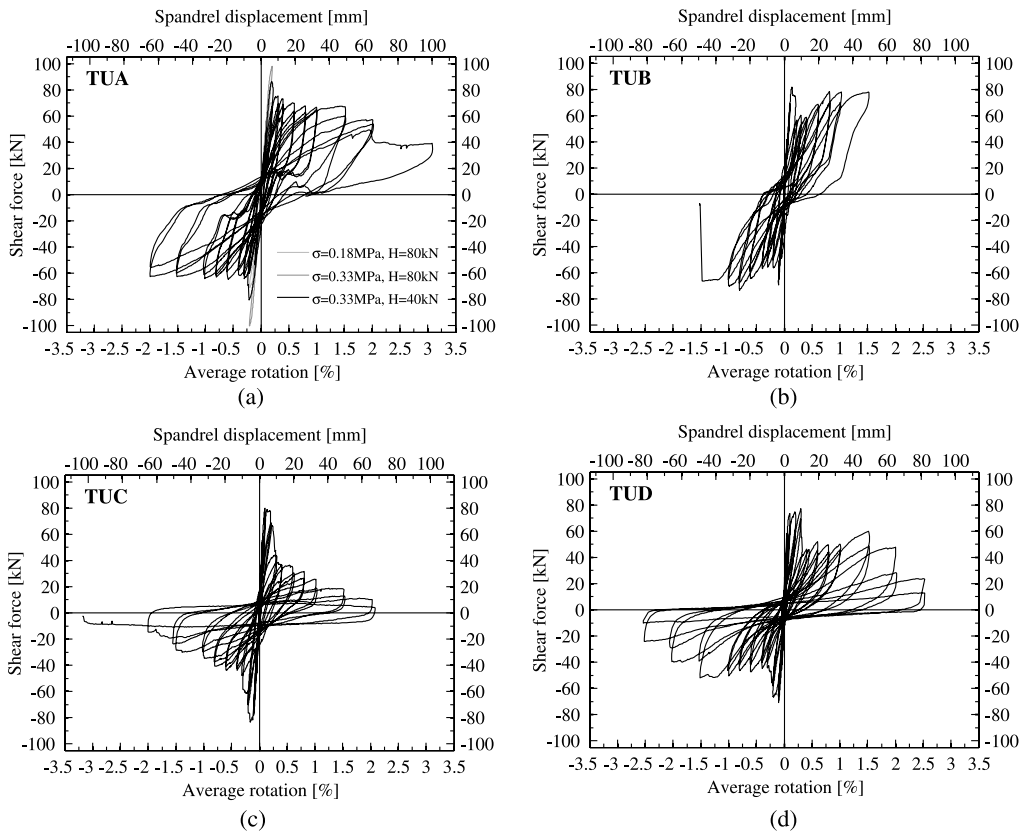
Figure 14. Spandrel shear force-deformation hysteresis for the test units TUA to TUD.

Figures 14 and 15 show the hysteresis curves for the shear force and the axial force in the spandrels, respectively. All masonry spandrels reached their peak resistance at about the same rotation demand. Until the peak resistance was reached, the spandrel remained largely

Differences in the spandrel shear force-rotation hysteresis (Figure 14) are also noticeable between masonry spandrels with timber lintels (TUA and TUB) and masonry spandrels with shallow arches (TUC and TUD). For the latter the loss in strength was significantly larger than for the spandrels with timber lintels since the timber lintel contributed substantially to the integrity of the spandrel at large rotation demands. When the spandrel was damaged the timber lintel served as a support for loose parts of the spandrel. The masonry arch on the contrary was prone to damage and eventually collapsed for both test units TUC and TUD.

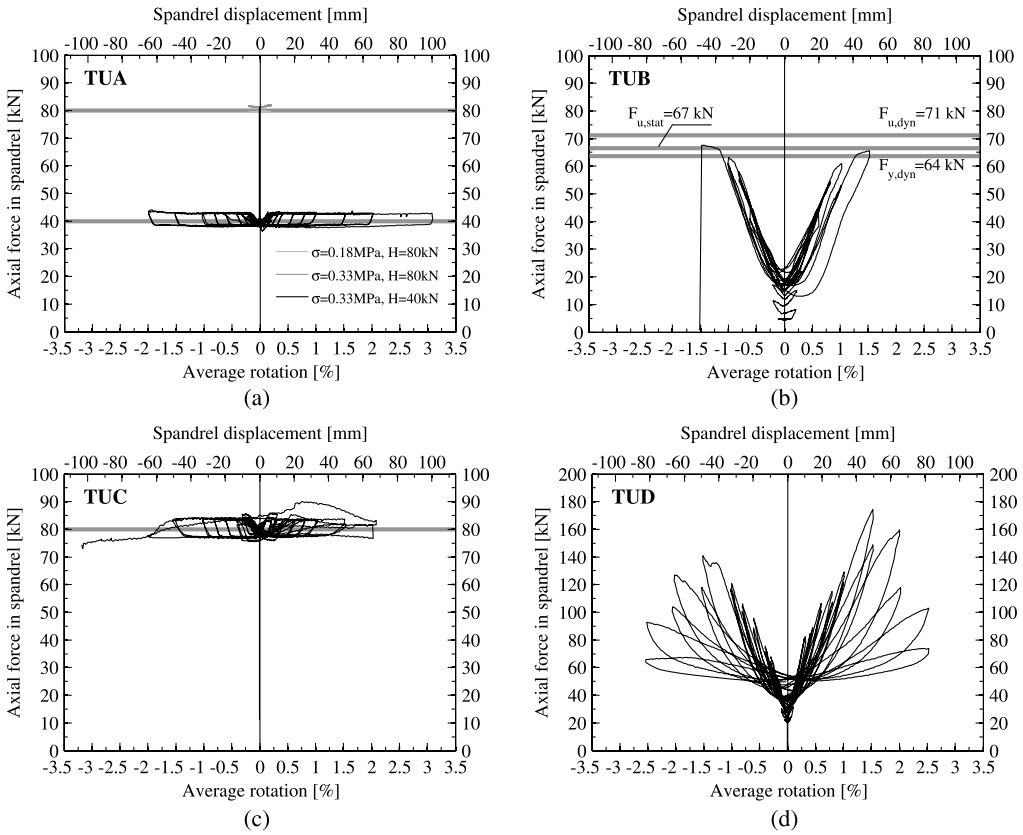
Figure 15. Hysteresis curves of the axial load in the spandrels of TUA to TUD. Note that for (d) TUD, the curve is plotted at a different scale.

Figures 15b and d. As long as the spandrel remained uncracked, the force in the horizontal rods did not change and was virtually equal to the initial post-tensioning force, which was applied to straighten the horizontal bars. The initial post-tensioning forces were 5 kN and 20 kN for TUB and TUD, respectively (Figure 15b and 15d). As soon as the spandrel cracked, the force in the horizontal bars increased considerably. The increase was nearly proportional to the rotation applied to the spandrel. It is noteworthy that the axial force in the spandrel at zero rotation tended to increase over the duration of the test suggesting a permanent elongation of the spandrel. The thick grey lines in Figure 15b indicate the yield and tensile strength of the two threaded D10 mm rods, which were used to apply the horizontal force to TUB. For the cycles of $\theta_{nom} = \pm 1.5\%$ the yielding of the horizontal bars is clearly visible. At the end of the test, one of the horizontal bars fractured and the horizontal force dropped to zero.

The bars used for applying an axial force to the spandrel of TUD were so strong that they remained elastic throughout the test. The increase in axial force with rotation was almost linear up to a rotation of $\theta_{nom} = \pm 1.0\%$ (Figure 15d). For larger rotations, the
