# Updating existing railway bridges based on monitoring data

E. Brühwiler, M. Rocha & M.A. Treacy  
*École Polytechnique Fédérale de Lausanne (EPFL), Switzerland*

**ABSTRACT:** Due to ever increasing traffic demands the fatigue safety and service life of the bridges of a railway line in Brazil need to be examined. Conventional assessment methods using load models and approaches as suggested in codes lead to conservative results resulting in significant strengthening interventions. Due to the important direct and indirect costs of the intervention, more detailed examination methods based on data as obtained from monitoring is suggested. This paper reports on an ongoing study to examine the fatigue safety of one standard bridge type, i.e. riveted steel truss structure. First results show that all bridge members are safe under the various limit states. The level of stress ranges found in the truss members due to fatigue loading are low such that only two members experience fatigue damage. The bridge structure has thus significant reserves in capacity which makes a future increase in axle loads feasible.

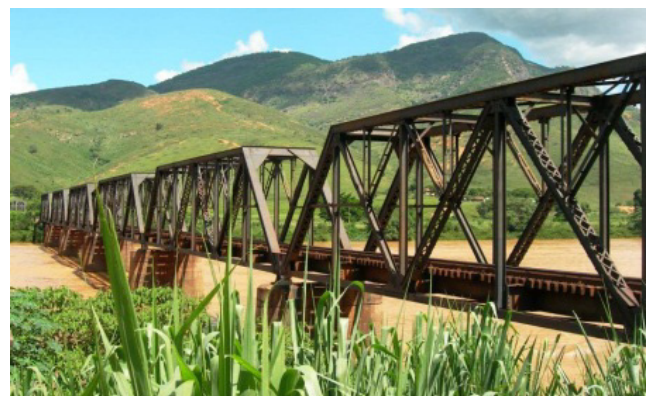
The steel truss under investigation (Fig. 1) has a single span of 41 m and is in service since 1940. It carries a single railway track which is trafficked by mineral ore trains.

Figure 1. Viaduct composed of single span standard steel trusses.

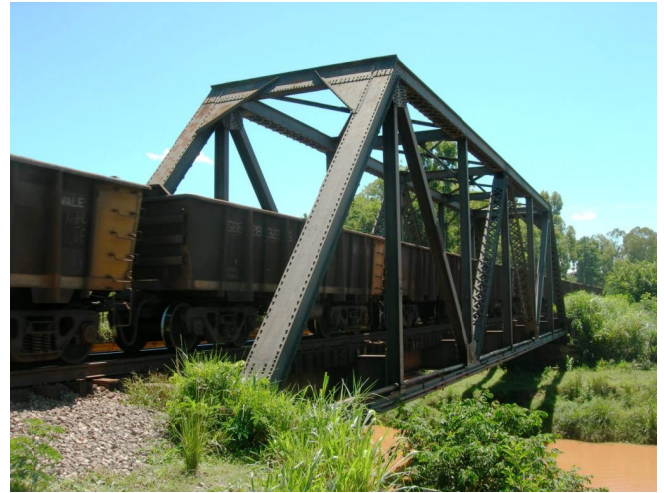
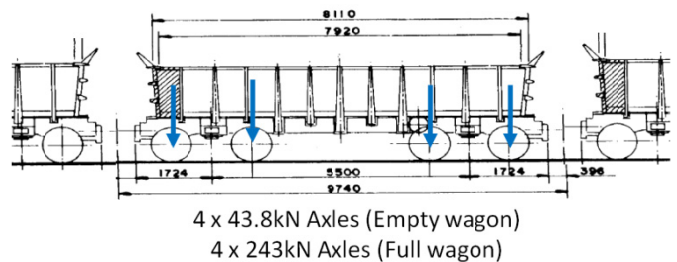
The worst case load effects are generated in the structure during the passage of fully loaded ore trains. A number of different wagons types were observed on the railways and a comparison of the mass distribution of the various cargo wagons was carried out. It was found that the GDE type wagon has the greatest load effect. The weight is 175 kN and payload is 795 kN giving a total load of 970 kN spread onto four axles. The bridge fatigue effects were analysed assuming this worst case GDE wagons with axle arrangement and loading as shown in Figure 3.

Figure 3. Standard ore wagon loading and geometry (mm).

A series of dynamic wheel loads measured on the tracks during the passage of a long ore train at a velocity of 32 Km/h revealed an average axle load of 228 kN which is slightly less than that given in the previous figure and therefore conservative. This was performed by instrumenting a section of rail before the bridge with strain gauges (Fig. 4) and calibrating the measured strain readings against axles of known weight to enable recording of all train axles.

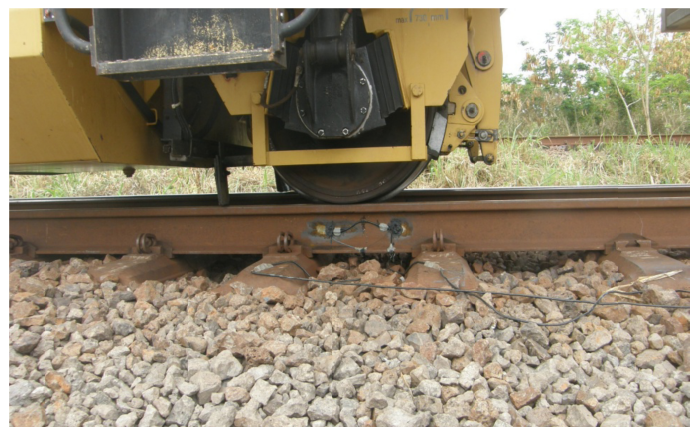
Figure 4. Instrumentation for measurement of axle loads on track.

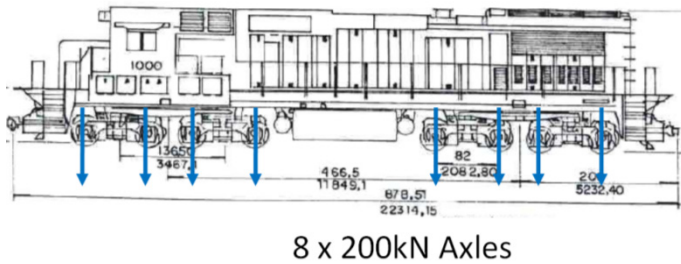
The locomotive selected for this study is the DASH 9M model shown in Figure 5 with a total mass of 160 tonnes. There are generally two loco-

Figure 5. Locomotive loading and geometry (mm).

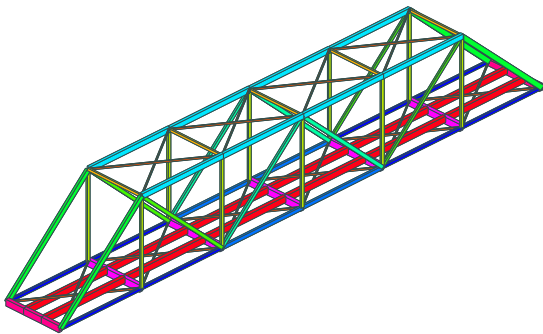
A linear elastic model of the structure was created using the Oasys GSA structural analysis software package as shown in figure 6.

Figure 6. Three-dimensional view of structural model.

The bridge is supported on the four outermost corners with no longitudinal rotational restraint at either end i.e. a simply supported pin-roller detail. One end of the bridge is fixed in displacement in the vertical, transverse and longitudinal directions while the other end features only vertical and transverse restraint to model the sliding bearing.

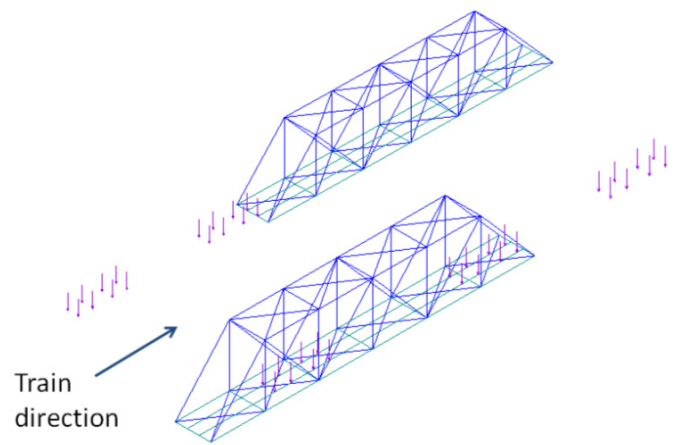
The GSA software was programmed to simulate the crossing of a full 200 wagon ore train over the bridge and calculating the static stresses generated in the bridge as the wheel loads are moved along the deck. Figure 7 illustrates the vehicle load step application process. An increment spacing of 1 m was chosen for the calculation of wheel load stresses. The results were then compiled into worst case envelopes for each member.

Figure 7. Train load step application process.

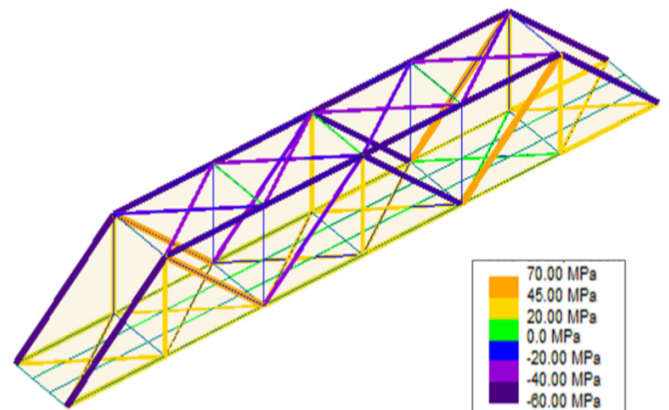
Figure 8 graphically illustrates the axial stresses in the bridge under the combined effect of permanent actions and the static load of full ore trains. The results indicate that the tensile diagonal members to be most highly stressed elements of the structure.

Figure 8. Envelope of axial stress in bar members due to full ore train loads and bridge self-weight.

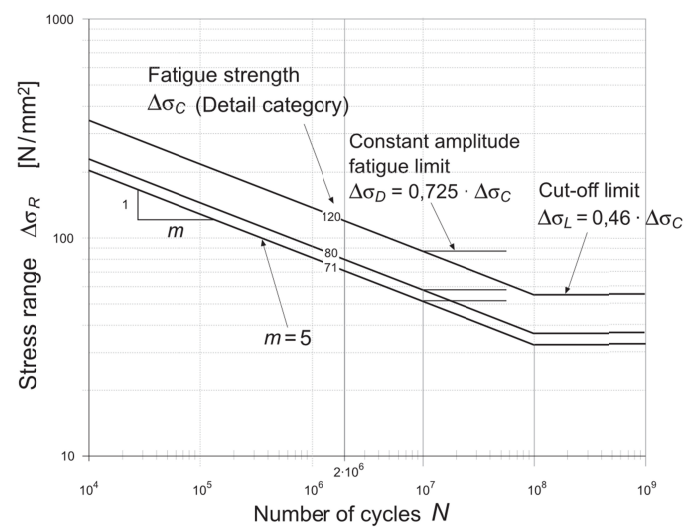
The truss and deck members were analyzed with the S-N curve occurring to the fatigue category 80 and 71 respectively as shown in the Figure 10. These curves take account of secondary stress effects in members and assume that the connections are modeled as pinned for the analyses.

Figure 10. S-N curve used in study (SIA 269/3, 2011).

The stress ranges ( $\Delta\sigma_i$ ) during train passage were analysed by means of the Rainflow counting method (Stephens et al. 2001). Stress ranges greater than 58 and 51.5 MPa (fatigue resistance limit under constant amplitude) on the S-N curves are considered to reduce fatigue life of truss and deck members respectively. The frequencies of full ore wagon trains (with 200 wagons) are a total of approximately 8740 trains per year (considering 24 trains per day, 7 days of train operation per week and 52 weeks of train operation per year). This data was considered for fatigue analyses for the past 70 years and also for 50 years into the future, ignoring in a first step future increase in train loads. Truss and deck members which show stress cycles exceeding the fatigue limit and therefore experiencing fatigue damage are given in Table 2. Further work is required to determine the future trends in traffic volume.

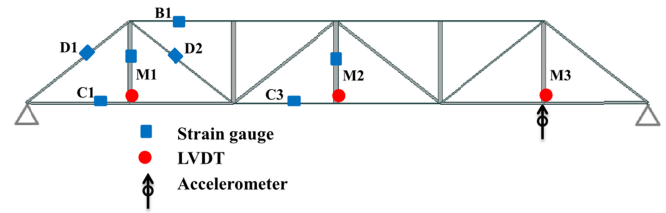
A monitoring system was implemented to verify the structural analysis results. The monitoring locations are highlighted in Figure 11. The system includes accelerometers, strain gauges and LVDT's.

Figure 11. Locations of various sensors on bridge.

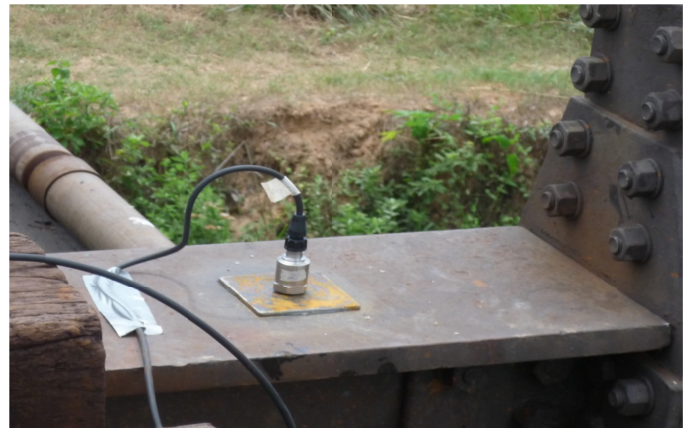
In order to verify the dynamic response of the structure a series of accelerometers are located on the structure as shown in Figure 12.

Figure 12. Accelerometer for investigation of dynamic effects.

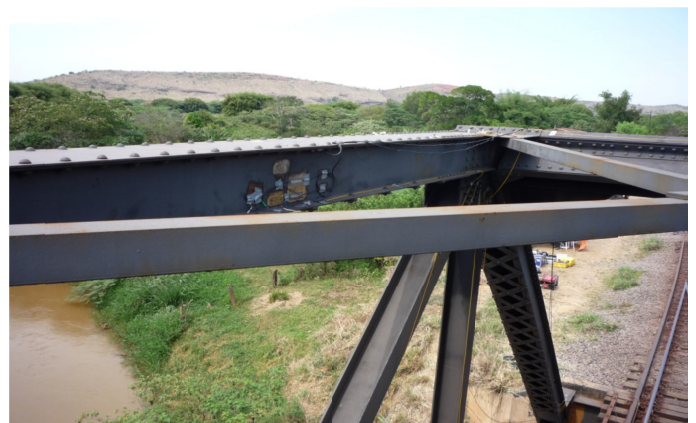
The principal results from the monitoring system are the strains in the members which are directly applicable for fatigue and ULS assessment. Clusters of strain gauges are positioned at critical point in the structure as shown in Figure 13.

Figure 13. Strain gauges on top chord of truss.
