Fatigue safety examination of a 150-year old riveted railway bridge

E. Brühwiler

BridgIng Consulting Engineers, Lausanne, Switzerland

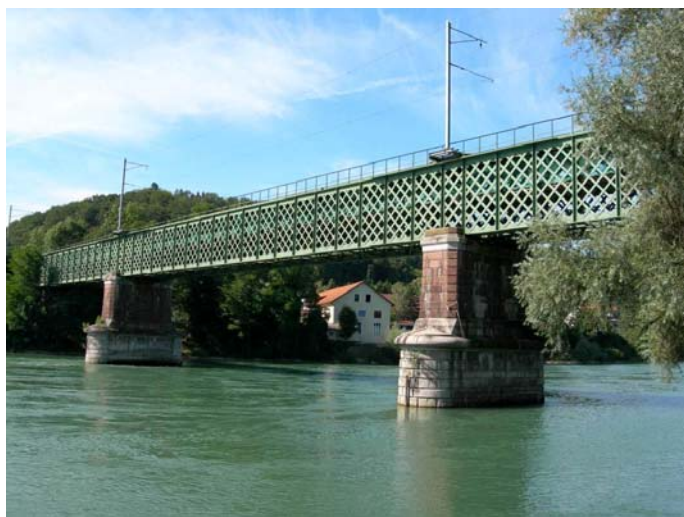
The investigated bridge (Fig. 1) crosses the Rhine river in northern Switzerland to carry a one lane railway line between Koblenz (Switzerland) and Waldshut (Germany). It was built in 1859 and comprises riveted wrought iron members. The straight lattice-truss structure is one of the last examples of a construction type that was typical for the railroad construction boom in Europe during the third quarter of the 19th Century.

Figure 1. Railway bridge over the Rhine between Koblenz (Switzerland) and Waldshut (Germany).

The wrought iron structure was designed as a continuous girder over three spans of 37.5m, 55m and 37.5m with a total length of 130m supported by abutments and piers in natural stone masonry. The bridge girder carries a single track by an open deck carriageway, i.e. the timber sleepers are directly

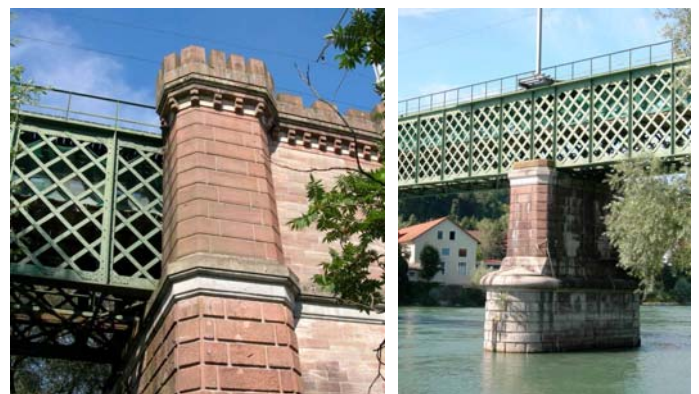
Figure 2. Details showing the interrelation between the wrought iron lattice girder and natural stone pier and abutment.

Aesthetics: the bridge convinces aesthetically, first of all, by the transparency of the lattice girder structure and its interrelation with the massive river piers and abutments in natural stone masonry (Fig. 2). The wrought iron structure is characterized by the riveted construction. It looks filigree and bold despite of the strong appearance as a continuous beam of constant height. The massive river piers and abutments contribute significantly to the impression of stability.

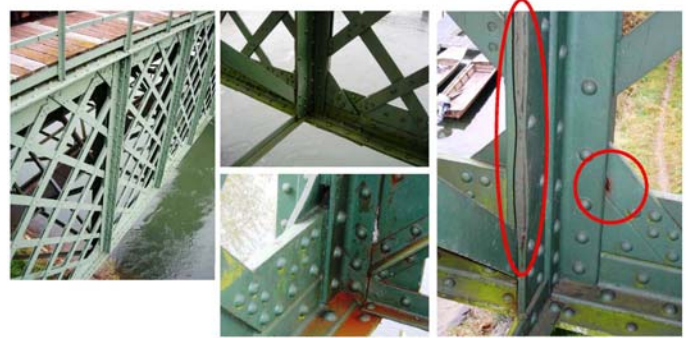
The corrosion protection coating has proved itself of value, and since the last renewal in 1991 only some isolated spots show some peeling of the surface layer (Fig. 4).

Figure 4. Condition of the corrosion protection coating.

2 Corrosion protection coating: Two options were investigated. The first option consists in repairing the relatively few zones with active corrosion of the existing corrosion protection coating and to apply an additional surface layer. This soft intervention is obviously only feasible because the corrosion protection is still in fair condition (Fig. 4). The second option consists in a full replacement of the existing corrosion protection coating. Both options differ regarding the duration of the effectiveness of the corrosion protection as well as the costs.

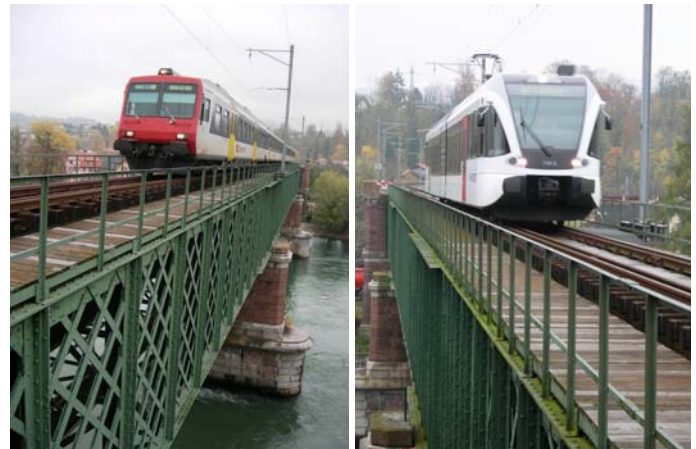
The estimated total number of 1.20 million trains during the past service life of more than 150 years is rather low, compared to bridges on main lines (totaling typically 5 to 7 million trains for the same service life). Actually, with the introduction of the suburban traffic in 1999, the train frequency increased significantly with currently 74 trains per day (Fig. 6).

Figure 6. Top: passenger train in 1961, bottom: today's passenger trains crossing the bridge.

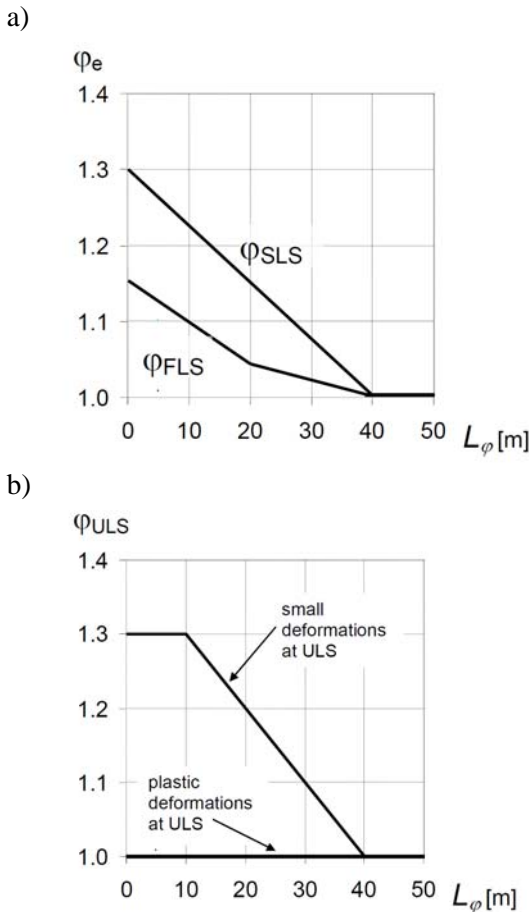
Under service conditions, the structure behaves elastically. The corresponding dynamic amplification factors φ_{FLS} for fatigue limit state and φ_{SLS} for serviceability limit state are fixed according to acceptable probability of occurrence as rare or frequent values respectively (Fig. 8a).

Figure 8. Dynamic amplification factors : a) at SLS and FLS for elastic structural behaviour, and b) at ULS depending on the structural failure behaviour; L_φ : determinant element length.

The dynamic amplification factor to be considered for the structural safety verification depends on the deformation capacity of the structure at ultimate limit state. At ULS, structural elements provide significant plastic deformation due to yielding of the steel. In this case, deformation induced by dynamic forces may also be dissipated by the structural element. (Ludescher, 2004) and (Herwig, 2008) showed by means of dynamic structural models how the external work due to dynamic action effects (i.e. impact-like events, excitation by surface irregularities) is dissipated in common structural elements without fracture of the element. A dynamic amplification

factor of $\varphi_{ULS} = 1.0$ is considered in case of ductile failure behaviour and the conditions for application of plasticity methods are fulfilled. In case of failure behaviour with small deformation capacity a dynamic amplification factor decreasing with increasing live load (or determinant length of the structural element) is considered according to Fig. 8b.
