## Shake-table test on a four-storey structure with reinforced concrete and unreinforced masonry walls

**Abstract.** With the introduction of higher seismic design forces in the Swiss loading standard of 2003 most unreinforced masonry (URM) buildings failed to satisfy the seismic design check. For this reason, in new construction projects, a number of URM walls are nowadays replaced by reinforced concrete (RC) walls. The lateral bracing system of the resulting structure consists therefore of URM walls and some RC walls which are coupled by RC slabs and masonry spandrels. Within the scope of a FP7-Series project a four-storey RC-URM wall structure is tested on the shake-table at the TREES laboratory of the EUCENTRE in Pavia (Italy). The test is conducted at half-scale and is part of a larger research initiative on mixed RC-URM wall systems initiated at EPFL. The key objective of the test is to gain insights into the dynamic behaviour of RC-URM wall structures and to provide input for the definition of a performance-based design approach of such mixed structural system. This paper presents details on the structural system, the instrumentation and the selected ground motion and discu

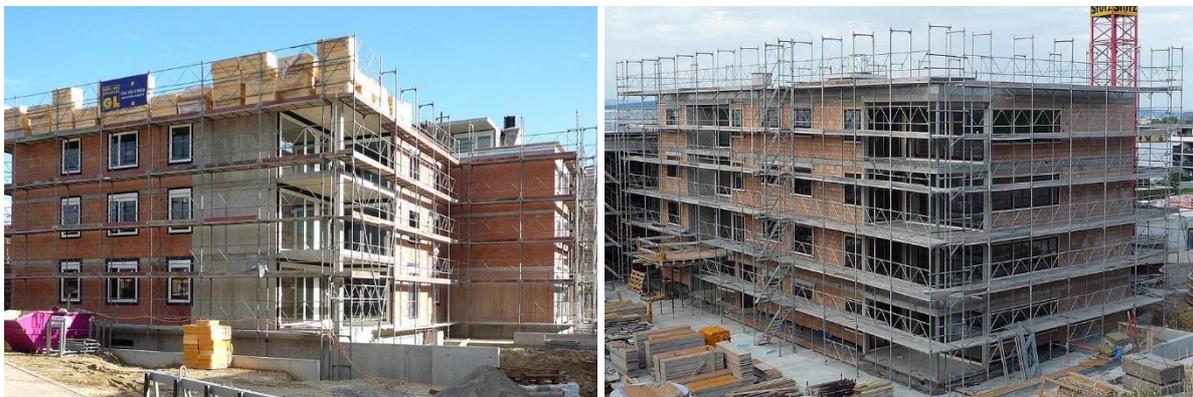
**Figure 1.** 3- and 6-storey residential buildings with RC wall and URM walls (Photos: Thomas Wenk).

In many countries, existing URM structures are reinforced by adding RC walls or by replacing selected URM walls by RC walls. In Switzerland, new residential buildings are often directly constructed as mixed RC-URM wall structures (Figure 1) with RC slabs. Although such structures are very common in design and retrofit practice their seismic behaviour is, at present, not well understood and they have never been tested before under seismic loading.

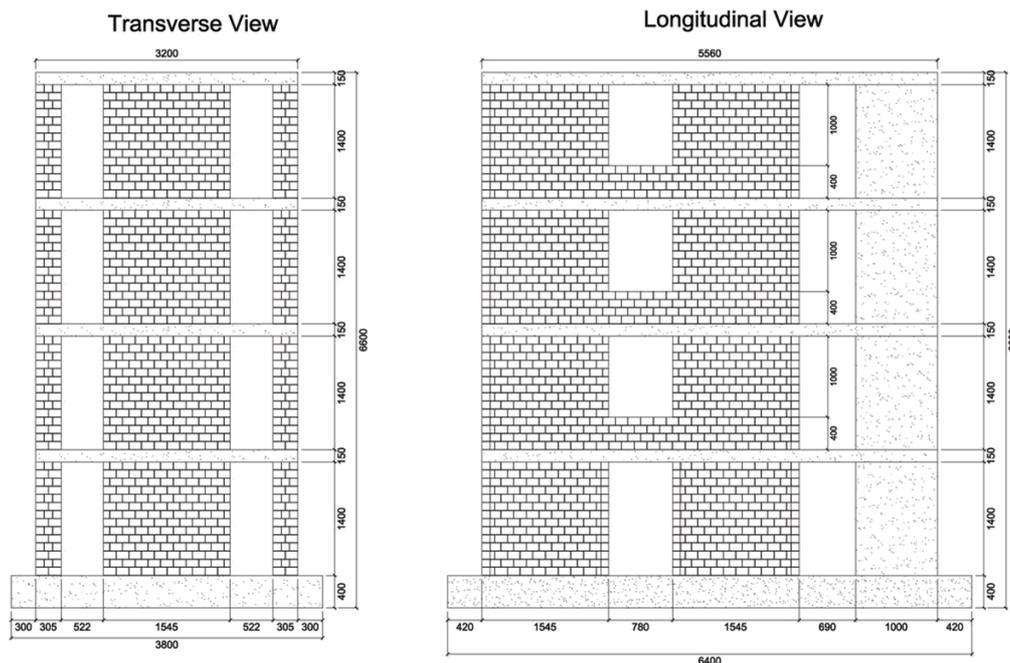
**Figure 2.** Transverse (North) and longitudinal (West) views of the test unit, dimensions are in mm.

The test unit was a four-storey structure built at half-scale representing a modern residential building where most walls are constructed as URM walls and some as RC walls and where the two systems are coupled by RC slabs. The test specimen, shown in Figure 2, was composed by two RC walls and six URM walls; four of which were loaded in-plane and two out-of-plane.

URM walls were built using half-scale clay brick units (width 9.5 cm, length 15 cm, height 9.5 cm) produced by the Swiss brick manufacturer “Morandi Frère SA” and using a standard mortar M15. The masonry unit that were used to build the URM piers were selected after a large experimental campaign performed before the shake-table test intended to investigate the effect of scaling on the properties of the masonry. In fact while it could be shown that concrete elements, when scaled properly, show similar behaviour at reduced scale, this is often not the case for masonry elements. The experimental campaign included material tests as well as quasi-static cyclic tests on half- and full-scale masonry piers to compare their behaviour (Petry and Beyer, 2013a,b). The tests could show that a very satisfactory correspondence between half- and full-scale masonry was obtained in terms of force and deformation capacity. RC walls (thickness 10 cm) were built with a concrete of class C28/35 and the reinforcement consisted of a double layer of longitudinal steel bars of class B450C. The RC slabs (thickness 15 cm) presented a double layer of steel net reinforcement; both concrete and steel of the same class of the RC walls.

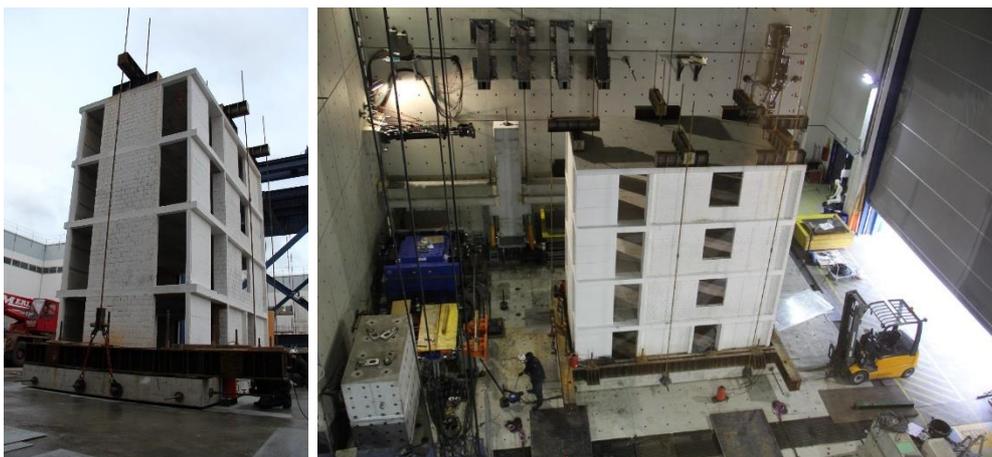
**Figure 3.** Test specimen during transportation.

The test unit was built outside the laboratory and was then lifted and pulled inside using hydraulic jacks and a slider system. For the transportation phase a prestress system was installed in order to assure the integrity of the structure during the transportation (Figure 3).

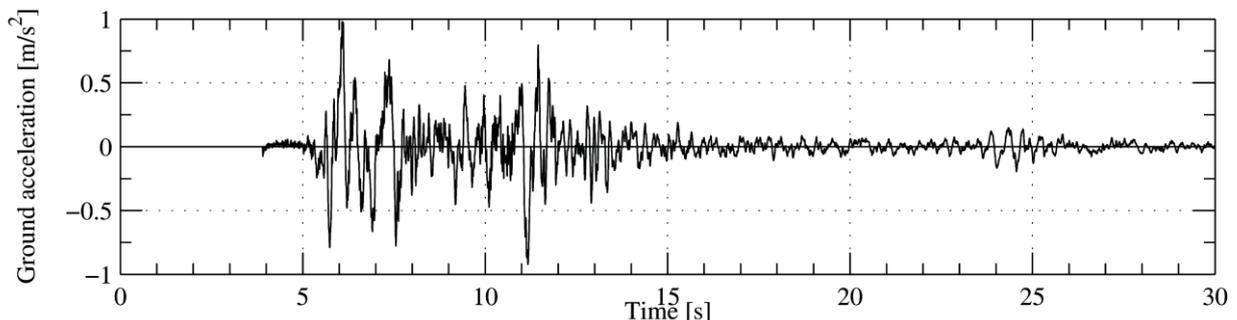
Figure 4. Input signal for shake-table test for a PGA of  $1 \text{ m/s}^2$ .

The source ground motion input selected for the shake-table test was the record of the Montenegro 1979 earthquake (Herceg-Novi station). The accelerogram was applied in the longitudinal direction of the structure and to account that the test specimen was built at half-scale the record was scaled in time reducing the duration by a factor of  $\sqrt{2}$ . The record was then scaled to match different levels of peak ground acceleration (PGA) that were used as input signal for the shake-table test (ranging from 0.05 g to 0.9 g). Figure 4 shows the acceleration history for the record scaled to a maximum PGA of  $1 \text{ m/s}^2$ .

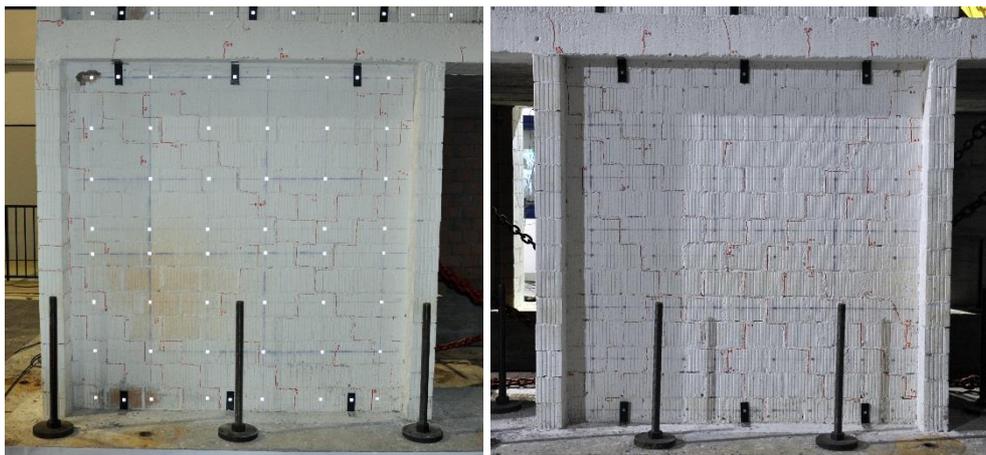
**Figure 5.** Crack propagation on the URM piers of the first storey after test number 6.

The structure started showing a more severe level of damage after test number 6. At this point URM piers at all the storeys were showing diagonal cracks. At the first storey the pre-existing cracks started widening up to a crack width of 0.8 mm, nevertheless in the majority of cases crack widths were still less than 0.2 mm (Figure 5).

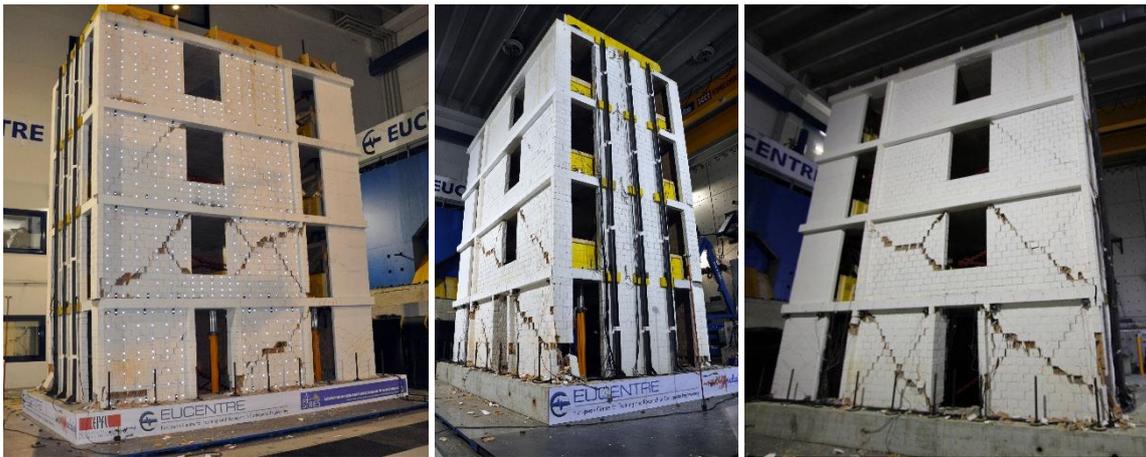
**Figure 6.** Different views of the structure after test number 9.

The final test at 0.9 g brought the structure rather close to its collapse limit state as the four in-plane loaded URM piers of the first and second storey lost their axial load bearing capacity. The axial load was finally carried by the URM piers in the out-of-plane direction and by the two RC walls. Immediately after the test it was necessary to install steel props to support the first storey slab to prevent the collapse of the structure (Figure 6).

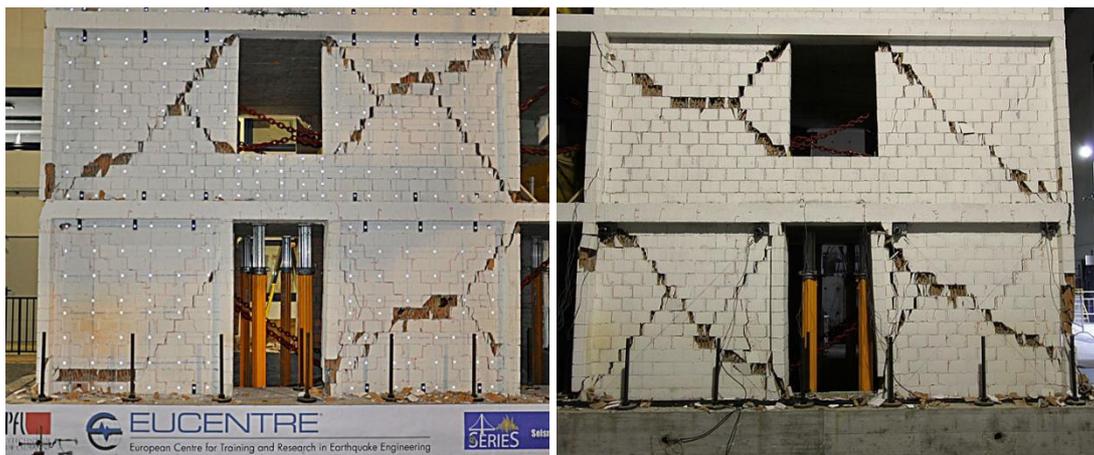
**Figure 7.** URM piers of the first and second storey after test number 9.

An interesting feature showed by the specimen was that the two lower storeys experienced the same level of damage (Figure 7), differently from what is expectable for a URM structure where the damage is mainly concentrated at the first storey. This showed how the addition of RC walls to the URM structure influenced the seismic behaviour as similar levels of drift were attained for the two lower storeys.

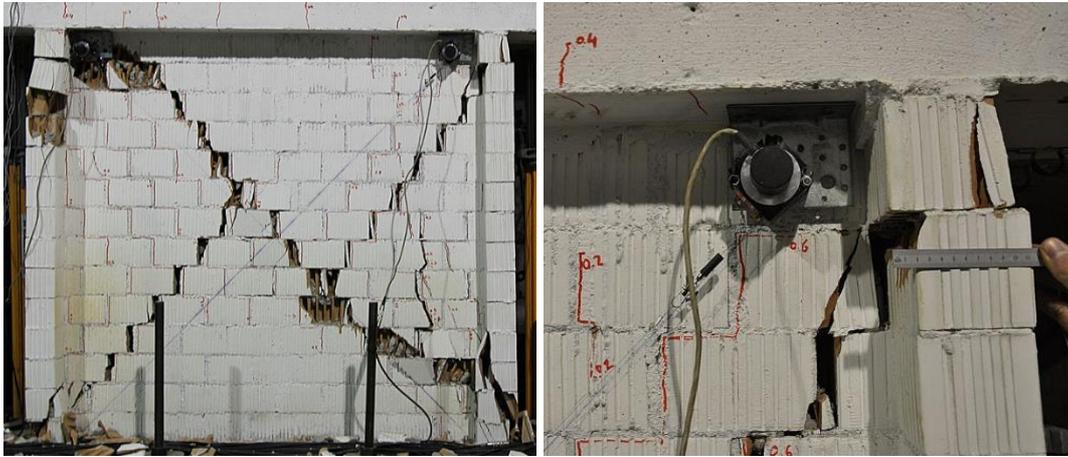
**Figure 8.** Residual deformations of one URM piers after test number 9.

The failure mechanism of the URM piers was characterized by the crushing of the compressed diagonal at the corners and at the mid height where the two diagonals intersected. Large residual deformations were observed which were associated with the sliding down of the top part of the piers

along the diagonal cracks (Figure 8). Differently from the URM piers the spandrels at all storeys remained uncracked.

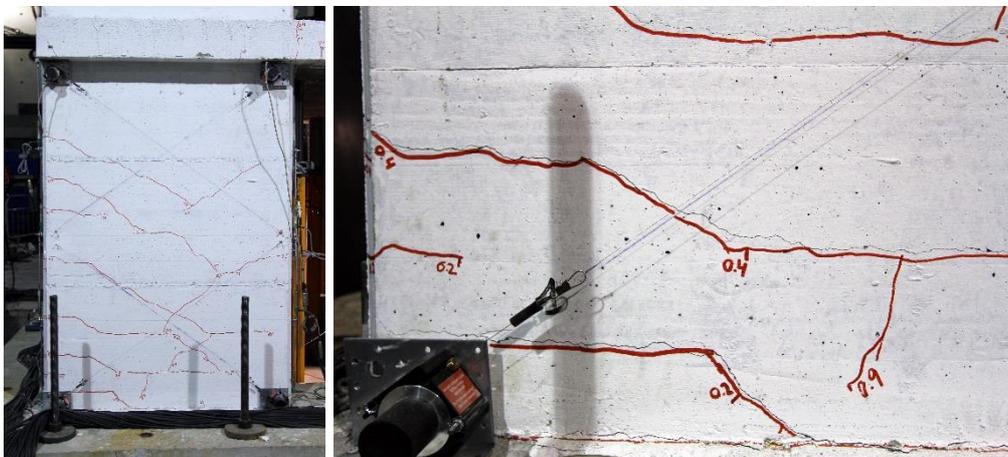
**Figure 9.** Cracking pattern of the RC wall of the East façade after test number 9.

RC walls had a different behaviour depending on the loading direction, when the structure was pushed toward North the walls were in tension and therefore the South side of the walls developed horizontal flexural cracks along all the height. The latter showed a residual width of approximately 1 mm indicating that the longitudinal reinforcement had yielded (Figure 9). When the structure was instead pushed in the South direction the RC walls were in compression and remained largely uncracked; the few cracks which developed had a residual width close to zero indicating that in this direction the longitudinal reinforcement did not yield.

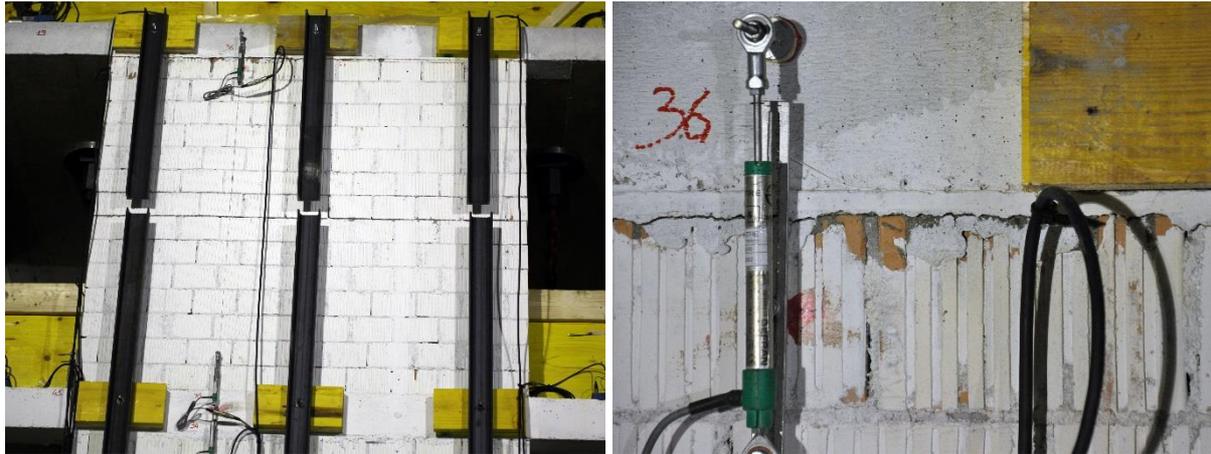
**Figure 10.** Out-of-plane failure of URM wall: horizontal cracks at mid height and on top of the wall.

During the last test, for the first time, a clear out-of-plane movement of one of the URM piers in the transverse direction was observed. The fourth storey panel of the North face of the building showed a large deformation during the shaking and touched the steel beams which had been installed to prevent a possible out-of-plane collapse. After the test clear cracks over the entire pier length were observed at midheight and at the top and bottom of the panel (Figure 10). As expected the boundary conditions provided by the RC slab and lateral walls influenced the seismic behaviour of the out-of-plane wall since the transverse wall of the opposite façade did not show any type of out-of-plane deformation and no cracks in the horizontal joints after the test. For the future numerical investigations of the boundary conditions of out-of-plane loaded URM walls are planned.
