## Soft load testing and associated deck slab monitoring of Morges A1 highway bridge, Switzerland

MCS Test Report number 23.13.03

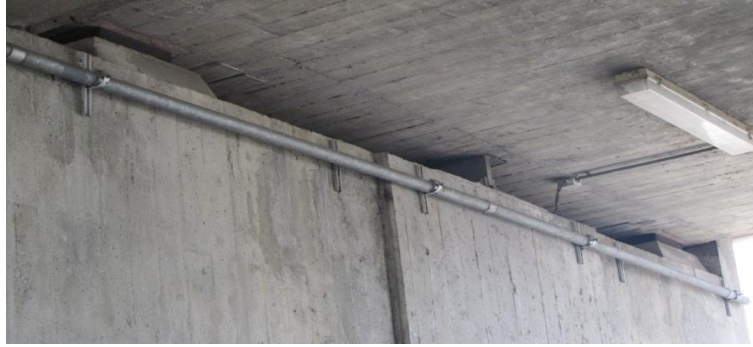
Figure 4. End Support showing additional lateral fixities in centre (Geneva end).

In later works in 1986, additional restraints were added at both ends to prevent transverse movement which can be seen in the middle of the Figure 4.

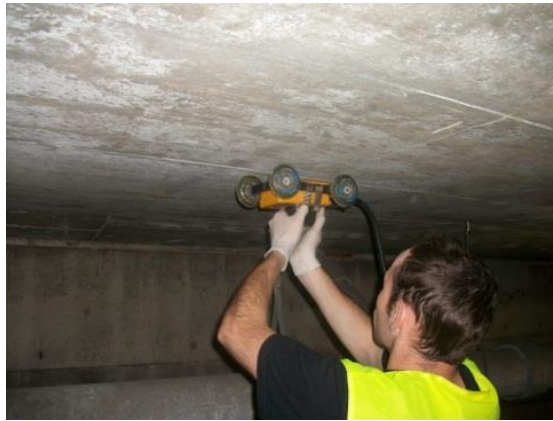
Figure 7. Locating rebars using a GPR system.

The installation of strain gauges on rebar required the local removal of cover concrete in the region of the proposed sensors. In order to limit damage to the concrete structure to an absolute minimum, GPR (ground-penetrating radar) techniques were used to locate the reinforcement bars to be instrumented (Fig. 7).

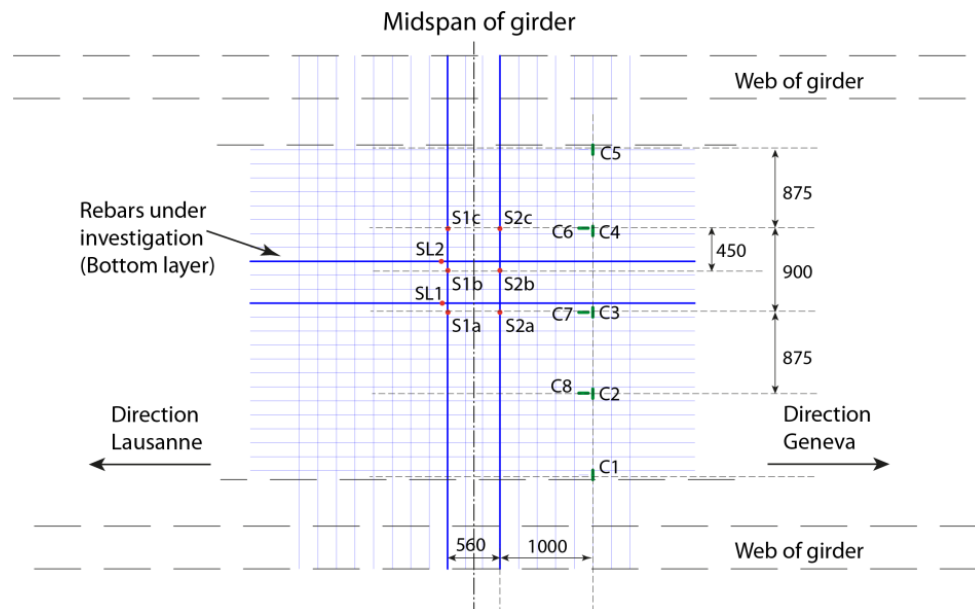
Figure 10. Location of Smart Section strain gauges on underside of deck slab.

The exact positioning of the strain gauges on the reinforcement and concrete structure on the underside of the deck slab are illustrated in Figure 10. Only the four rebars of interest are shown for clarity but a detailed reinforcement drawing of the cross-section is contained in Appendix C.

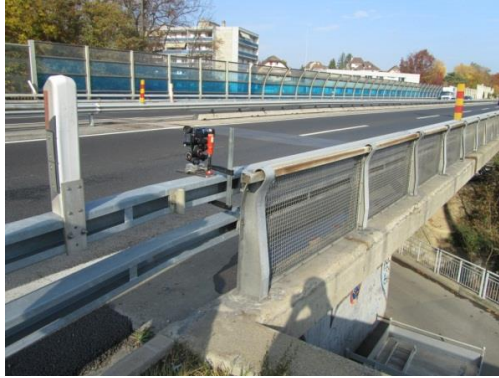
Figure 13. Location of video camera.

The test series involved the vehicle performing loops along the A1 highway between Crissier and Morges West. For the higher speed tests the vehicle exited at Bussigny instead of Morges West in order to have a longer stretch of road to reach the required velocity. All of the tests were filmed with digital camera located before the Geneva end of the bridge as shown in Figure 13(a). A video file of the tests has also been compiled.

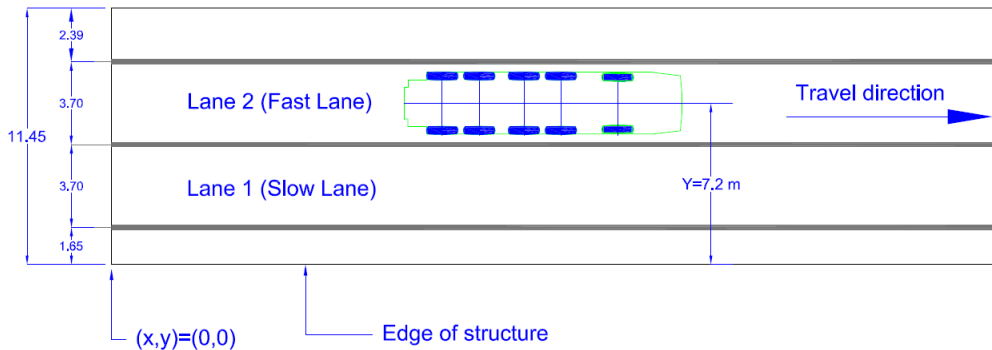
Figure 14. Arrangement of lanes and vehicle positioning notation.

The lateral position ‘Y’ of the vehicle, required for later numerical simulations, is referenced from the south-west corner of the bridge which is chosen as the origin as shown in Figure 14.

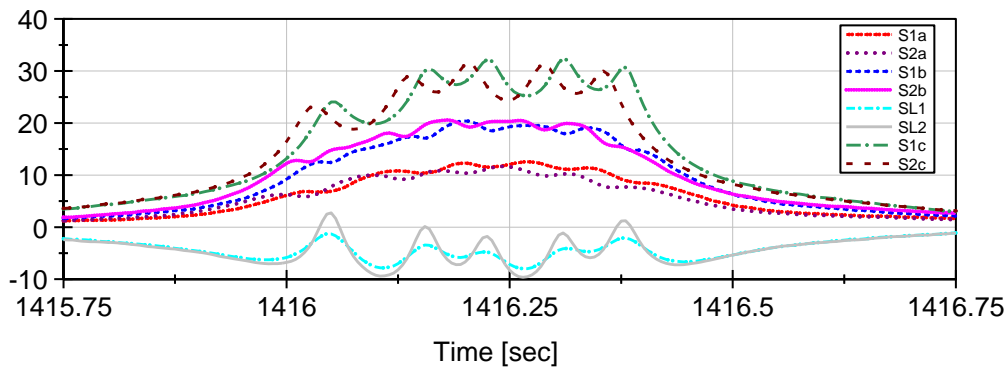
Figure 16. Strain on rebars during Test 3.

Confidence in the system was assured by comparing the behaviour of sensors at the same lateral position on different bars. i.e. S1a/S2a, S1b/S2b, S1c/S2c and SL1/SL2. Figure 16 shows the results from the strain gauges on the rebars during test 3. The signature of each of the crane's five axles can be clearly seen in each sensor with a slight time lag between the corresponding sensors on the two bars to account for the time taken for the vehicle to pass from one to the other. I.e. the vehicle passed over rebar 2 first therefore reading S2a is offset slightly to the left hand side of reading S1a.

The maximum recorded strain was  $74 \mu\epsilon$  on gauge S1c in which is equivalent to 15.2 Mpa with a Young's Modulus value of  $210 \text{ kN/mm}^2$  for this steel. This strain is far below any fatigue limit for steel reinforcement bars of this type and would therefore not cause any fatigue problems for the steel reinforcement at this location. Furthermore the section is compressed from the transversal prestressing of approximately 670 kN/m (assuming 10% loss in prestress since construction).

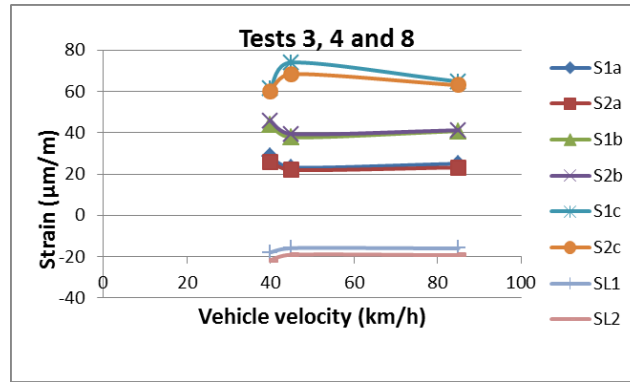
Figure 19. Strain in reinforcement bars with vehicle in centre of slow lane.

While this number of tests is not extensive enough to have very detailed information on the dynamic amplification of vehicle loads due to higher velocities, it can be used as an indicator. Figure 19 shows little dynamic amplification of the measured strains for this particular rebar detail when the vehicle velocity is increased by a factor of two. In this case the vehicle was travelling in the slow lane.

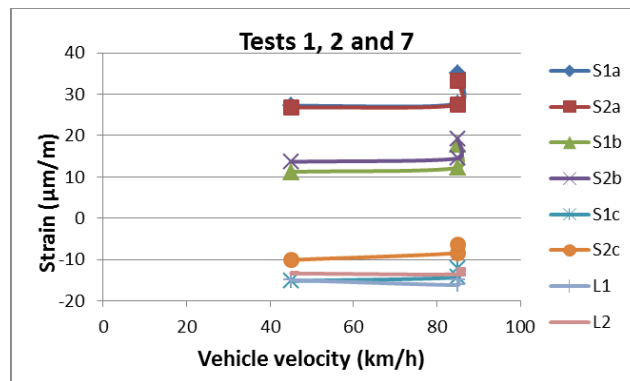
Figure 20. Strain in reinforcement bars with vehicle in centre of fast lane.

In Figure 20 for the fast lane, two of the tests provide the same measured result with almost double the velocity. Test 1 showed a higher result but this could be associated with the lateral position. I.e. the crane was not exactly on the centre of the lane as required.

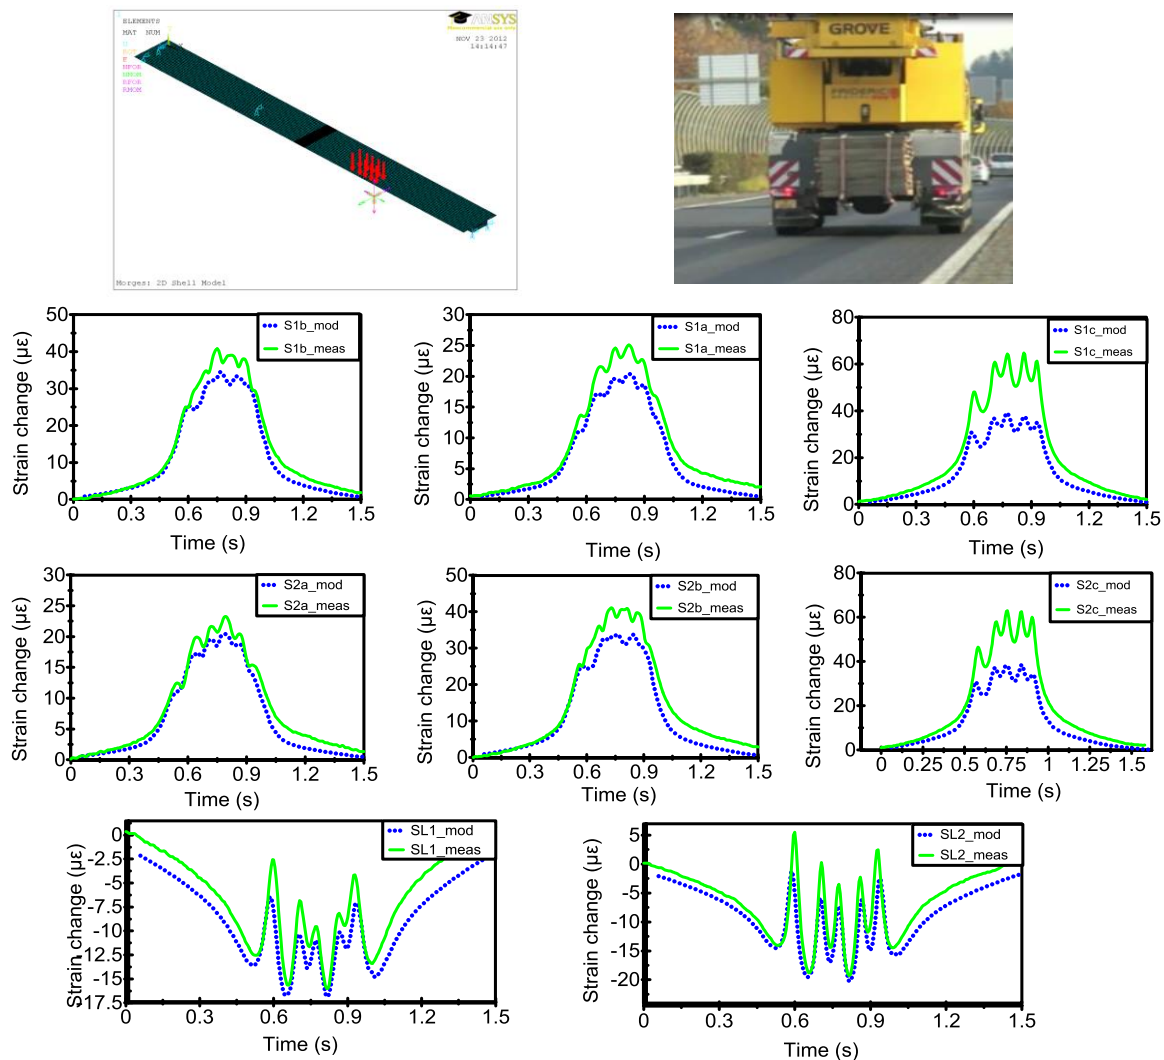
Figure 23. Comparison of ANSYS simulated (mod) and measured (meas) strain influence lines for rebars for Test 3.

An example of the results for test 3 is presented in Figure 23. All of the sensor locations show a very similar overall signal shape between the measured and simulated result. The longitudinal results for sensors L1 and L2 show a strong goodness of fit providing confidence in the model globally. The transverse sensor results are reasonably close except for sensors S1c/S2c which may result from inaccuracy in the assumption of wheel load spread to the neutral axis for the model. This will be investigated in further research. No allowance for dynamic amplification was applied in the structural model but the closeness in results confirms that dynamic amplification is low for extremely heavy vehicles as also demonstrated in [5].

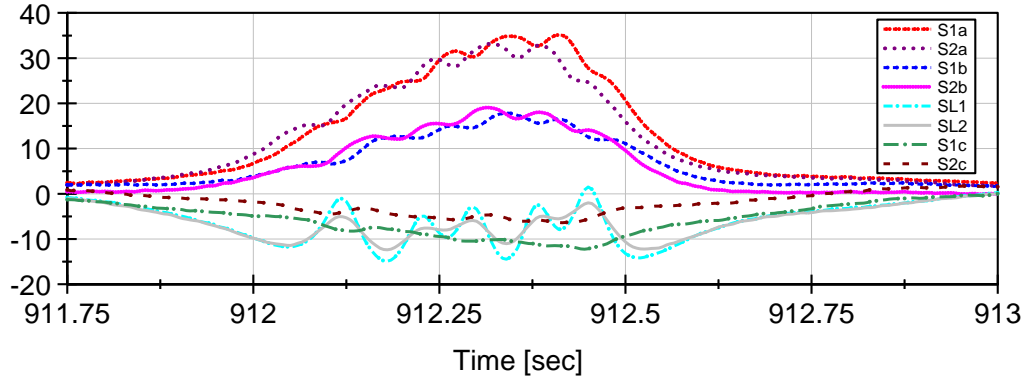
Figure B.1. Strain on rebars during Test 1.

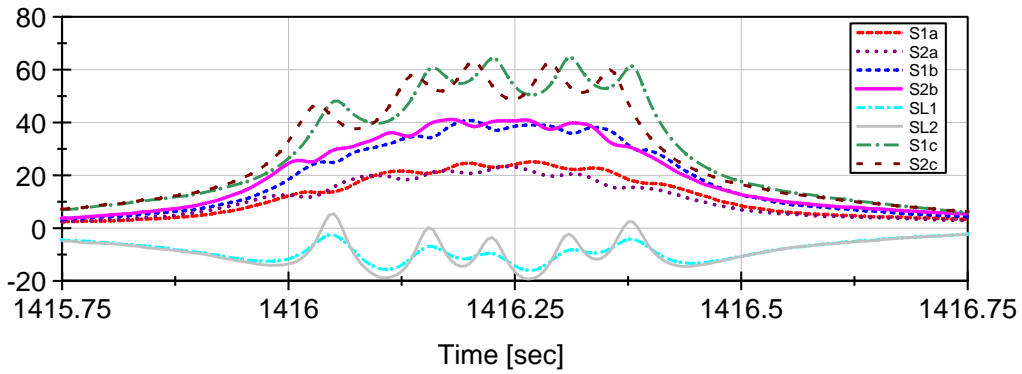
Figure B.3. Strain on rebars during Test 3.

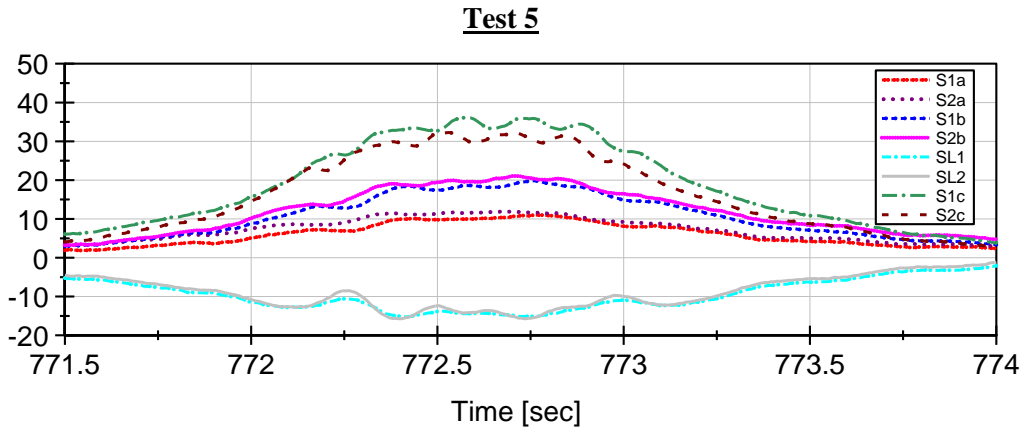
Figure B.7. Strain on rebars during Test 5.

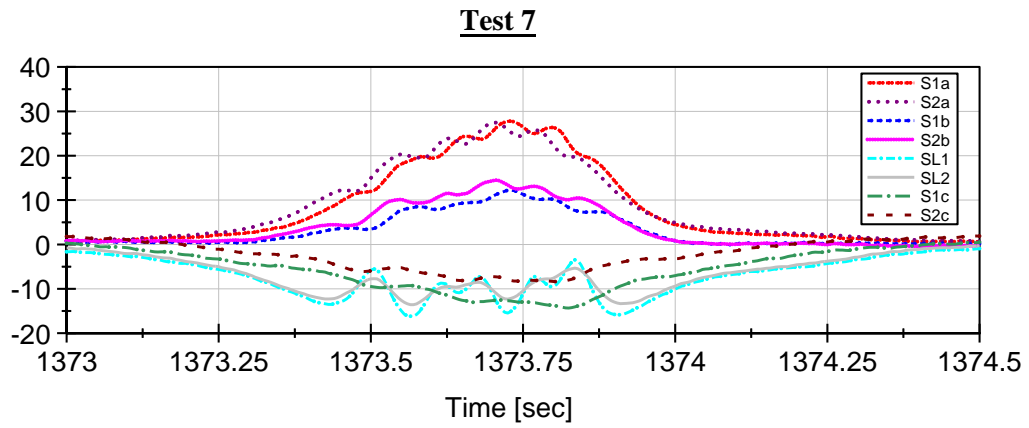
Figure B.11. Strain on rebars during Test 7.

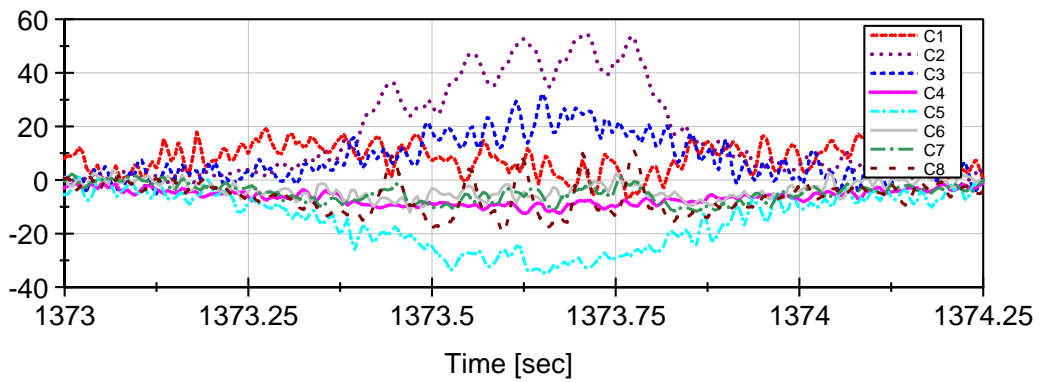
Figure B.12. Strain on concrete during Test 7.
