# EARTHQUAKE SPECTRA

# Understanding Poor Seismic Performance of Concrete Walls and Design Implications

The 2010/2011 Canterbury earthquakes in New Zealand revealed: 1) Improved structural response resulting from historical design advancements; 2) Poor structural performance due to previously identified shortcomings being insufficiently addressed in design practice; and (3) New deficiencies that were not previously recognized because of premature failure resulting from other design flaws. This paper summarizes damage to concrete walls observed in the February 2011 Christchurch earthquake, proposes links between the observed response and specific design concerns, and offers suggestions for improving seismic design of walls in the following areas: amount of longitudinal reinforcement in wall end regions, suitable wall thickness to minimize the potential for out-of-plane buckling, and minimum vertical reinforcement requirements.

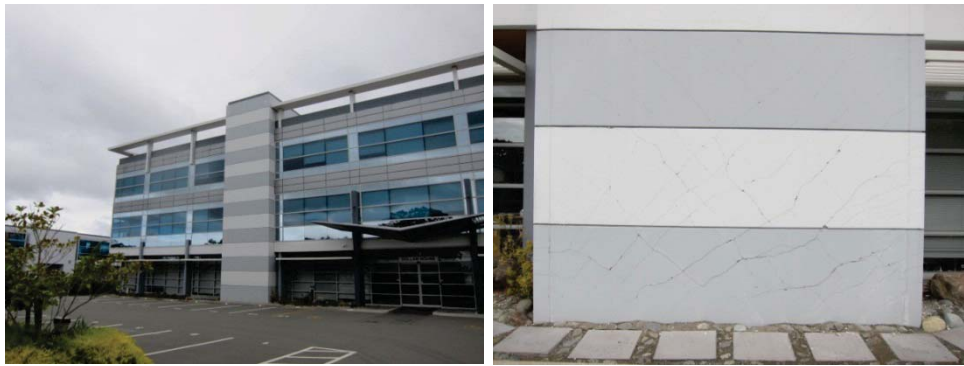
The concrete wall shown in **Figure 5** experienced noticeable distress due to the earthquake motion. Three observations from this figure are: (a) The intensity of ground motion at this site was significant enough to cause cracking but not spalling of cover concrete in the plastic hinge region near the wall base; (b) Use of increased longitudinal reinforcement

in the end regions of wall seems to have controlled the crack width in these regions; and (c) Relatively wider cracks with large spacing apparent on the wall surface in the web regions confirm the use and possible consequence of lightly reinforced concrete in that region. **Figure 6** shows a concrete wall in a 14 story hotel building that had well distributed flexural cracking. As described by Wilson and Lewis (2011), the plastic hinge region in this case was located above level 4 where the building footprint was reduced. The 8 m long and 0.3 m thick wall was designed in accordance with current NZS 3101 standards (2006) and had 1 m long boundary elements with a  $\rho_l$  of 2.7% and the web region contained well-distributed longitudinal reinforcement with a  $\rho_l$  of 1.0%. The resulting crack widths were between 0.5-0.8 mm and the wall was easily repaired.

**Figure 5** Observed distress to a concrete wall with minimal damage (Photos: Courtesy of Elwood)

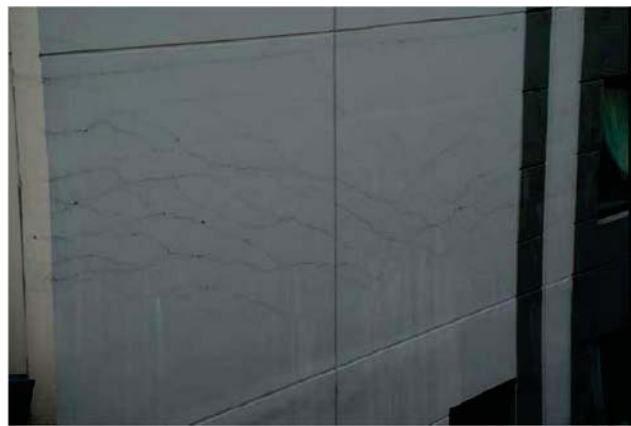
**Figure 6** Well-distributed flexural cracks on a wall (Wilson and Lewis 2011)

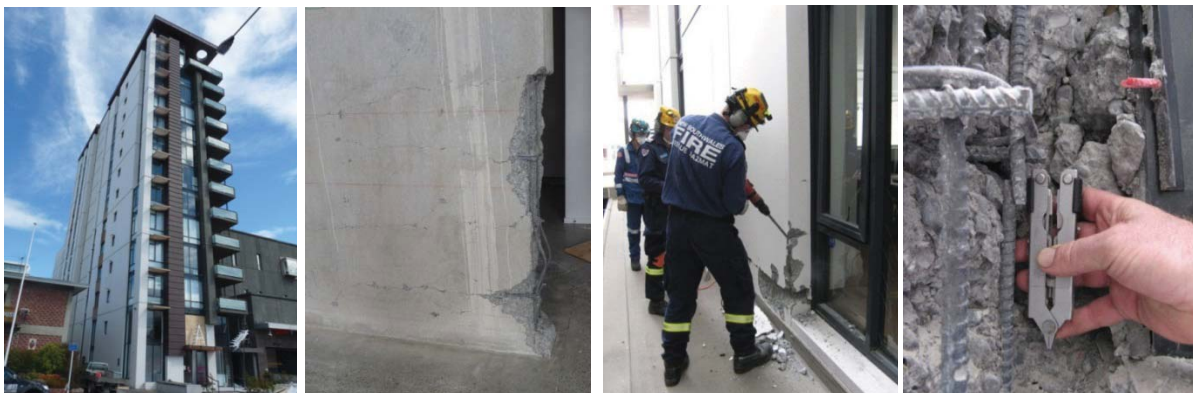
Two examples of this type of wall behavior were observed in multi-story Gallery Apartment building built in 2006 (see **Figure 7** and **Figure 8**). Damage to both walls was characterized by formation of only few flexural cracks in the plastic zone. In the first example (see **Figure 7b**), it appears that the cover concrete spalled off first followed by the buckling of the longitudinal reinforcement. **Figure 8** shows the second example, in which a wall with a single flexural crack and fracture of multiple longitudinal bars is seen. This type of damage was particularly concerning due to the fact that the fractured bars were hidden behind what appeared to be relatively minor damage. Subsequent reports prepared by CERC (2012) and Smith and England (2012) highlighted several deficiencies in the Gallery Apartment building including a mismatch in the assumed ductility and wall detailing. Additionally, the walls in the building were designed prior to the introduction of more stringent minimum vertical reinforcement limits in NZS 3101 (2006). The grid-F wall shown in **Figure 8** had a total vertical reinforcement ratio of 0.16%; only 55% of the vertical reinforcement required by NZS 3101 (2006). The low vertical reinforcement content combined with measured concrete strengths that were significantly higher than the specified strength likely contributed to the observed lack of flexural cracking.

(a) Overall view    (b) Wall damage    (a) Concrete removal    (b) Fractured bar

**Figure 7** Observed distress to a concrete wall in a multi-story apartment building (Courtesy of Elwood)

**Figure 8** Unexpected damage to another wall in the building shown in Fig. 7a

Detailed finite element analysis was also completed to investigate the failure of one of the RC walls in the Gallery Apartment building in Christchurch. As shown in **Figure 8**, the RC

wall on the east face of the building experienced a single concentrated crack at the wall base with fractured vertical reinforcement. This wall, which was described as the grid-F wall in the report prepared for the Canterbury Earthquakes Royal Commission by Smith and England (2012), was 4300 mm long, 325 mm thick, with a total height of 39 m. The vertical and horizontal reinforcement consisted of two layers of 12 mm diameter grade-500 bars at 460 mm and 400 mm centers, respectively. The axial load from the self-weight of the wall and the tributary floor area was equal to 2250 kN.

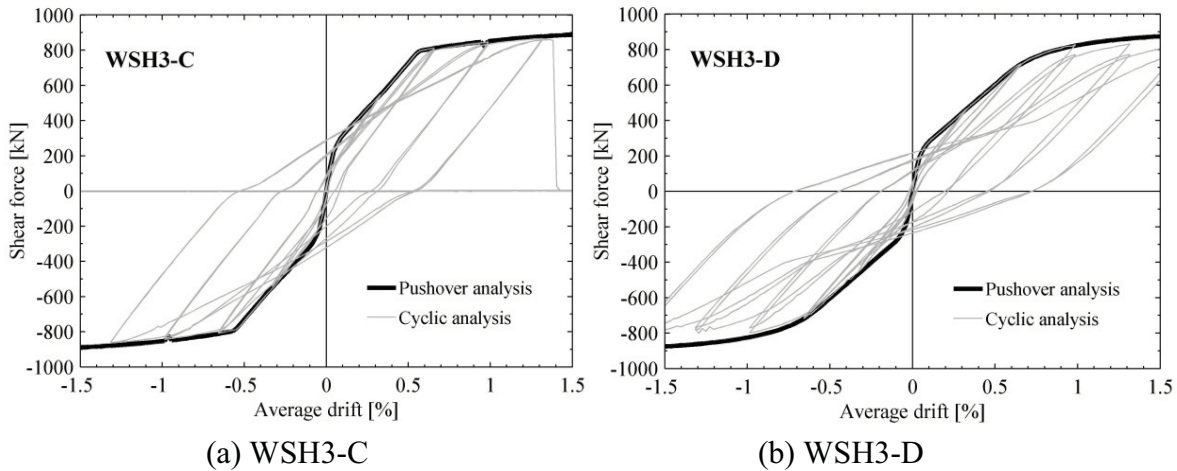
As targeted, both walls provided a similar shear and base moment resistance (see **Figure 12b**, **Table 1**). **Figure 13** shows the force-displacement responses obtained for the two hypothetical walls subjected to both monotonic and cyclic loading. While both cyclic analyses appear to produce stable hysteretic responses up to 1.3% drift, WSH3-C failed at this point due to sliding failure at the large base crack. This failure mode was preceded by short branches of almost zero lateral stiffness during unloading and reloading response of WSH3-C in the previous load cycles. When compared to WSH3-D, WSH3-C resulted in somewhat broader hysteresis loops, indicating development of larger inelastic steel strains and therefore a small increase in energy absorption capacity at a given drift. This difference in energy absorption will have, however, only relatively small impact on the peak displacement demand during an earthquake (Priestley, 2003).

**Figure 13** Comparison of simulated force-displacement responses

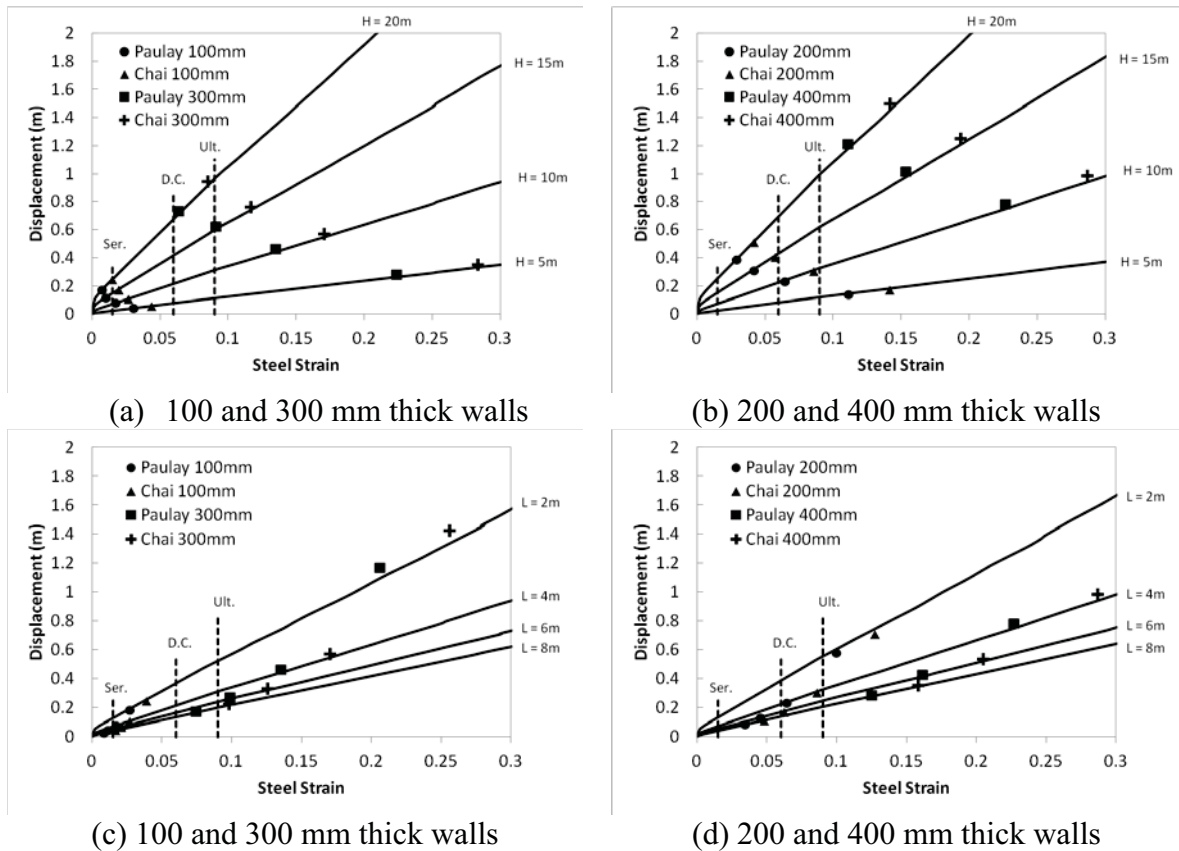
In terms of importance, it was found that wall geometric properties (i.e., b, L and H) had the greatest impact on results. Possible variability of  $L_P$  also had a significant impact. Consider **Figure 16**, which represents the results of the study with regards to impact of wall height, length and thickness. **Figure 16a** and **b** depict the relationship between cantilever wall top displacement and steel tension strain as obtained from a moment-curvature analysis for walls of height 5, 10, 15, and 20 m and wall thicknesses of 100, 200, 300, and 400 mm. Note that the lines in each figure represent the average responses obtained for the two different wall thicknesses since they were relatively close to each other. Superimposed on these graphs are the limit strains predicted by both the Paulay and Priestley (1993) and the Chai and Elayer (1999) stability models. Also shown in the graphs are approximate values for serviceability (defined using a concrete compression strain of 0.004 or a steel tension strain of 0.015, whichever occurred first), damage control (defined using Eq. 7 as suggested by Paulay and Priestley (1992) or a steel tension strain of 0.06, whichever occurred first), and ultimate limit states (defined using a concrete compression strain of 1.5 times Eq. 7 or steel tension strain of 0.09, whichever occurred first).

From **Figure 16**, the importance of wall thickness and height on the stability strain is evident, and follows the expected trend, i.e., thinner and taller walls are more likely to suffer out of plane stability due to in-plane forces. According to the stability models discussed in this paper, if that failure mode is to be avoided, walls thickness of at least 400 mm would be required for 20 m tall walls, and 200 mm thick walls would be required for 5 m tall walls. In all cases, this data was for a wall of 4 m in length. **Figure 16c** and **d** represent similar data for 10-m tall walls as a function of wall length, which show that walls of longer length are more likely to suffer from out of plane stability due to in plane loading. The data shown in **Figure 16** assumes an axial load ratio of  $0.1f'_c A_g$  in the displacement calculation. Note that the critical tensile strain for both buckling models, i.e., Eqs. 1 and 4, are independent of the wall axial load ratio. But the calculation of wall lateral displacements at a given level of strain is impacted by the axial load ratio since changes in the axial load will impact the neutral axis depth, which in turn affects the curvature and hence the displacement. Thus any axial load ratio different from the assumed  $0.1f'_c A_g$  is expected to influence the strain-displacement relationships and the displacements at the onset of buckling presented in **Figure 16**. Different values of axial load ratio would simply result in a different scale applied to the vertical axis.

**Figure 16** Stability analysis of walls of varying thicknesses, heights and lengths

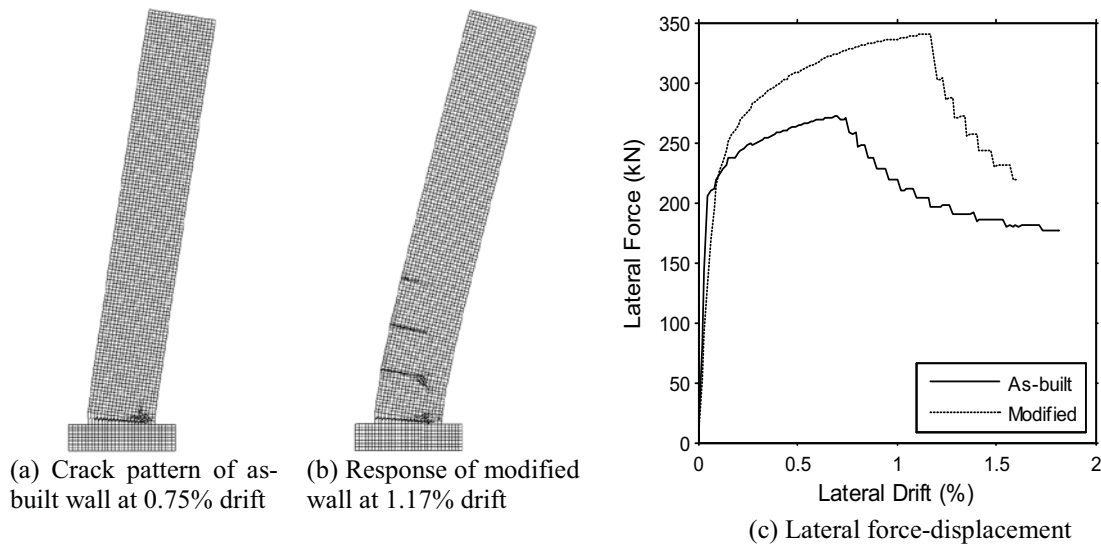
The crack pattern and lateral force-displacement response from the finite element analyses of the as-built grid-F wall are shown in **Figure 17**. The analytical crack pattern correlated well with the observed performance of the wall, with cracking concentrated at a single primary crack at the wall base with no secondary crack formation. The wall response was elastic until the first crack developed at a lateral force of 205 kN and the peak strength was reached at a lateral drift of 0.7% before fracture of the vertical reinforcement occurred. The analysis confirms the findings of other reports that concluded based on section analyses that the vertical reinforcement content in the grid-F wall of the Gallery Apartments building was insufficient to initiate secondary cracking, resulting in a concentration of inelastic actions at the wall base (CERC 2012; Henry 2013).

**Figure 17** Predicted response of grid-FEM wall

A further analysis of the grid-F wall was conducted with an increased vertical reinforcement to comply with the current limits in NZS 3101:2006 (i.e., Eq. 5). Using the specified concrete strength of 30 MPa, the resulting vertical reinforcement content of 0.274% was used. Additionally, the 30 MPa specified concrete strength with a corresponding tensile strength of 2.9 MPa was used. The resulting crack pattern and lateral force-displacement results of the modified grid-F wall are also shown in **Figure 17**. Instead of a single crack at the wall base, four primary flexural cracks were obtained for the modified grid-F wall with minimal secondary cracking. Both the lateral strength and drift capacity increased with the additional reinforcement before fracture of the vertical reinforcement occurred. These results confirm that although the wall performance would have been improved if current levels of

minimum vertical reinforcement were used, a lack of well distributed secondary cracks and premature fracture of the vertical reinforcement would still be expected.
