Seismic response of a 4 storey building with reinforced concrete and unreinforced masonry walls

BEYER, KATRIN¹; TONDELLI, MARCO²; PETRY, SARAH³, PELOSO, SIMONE⁴

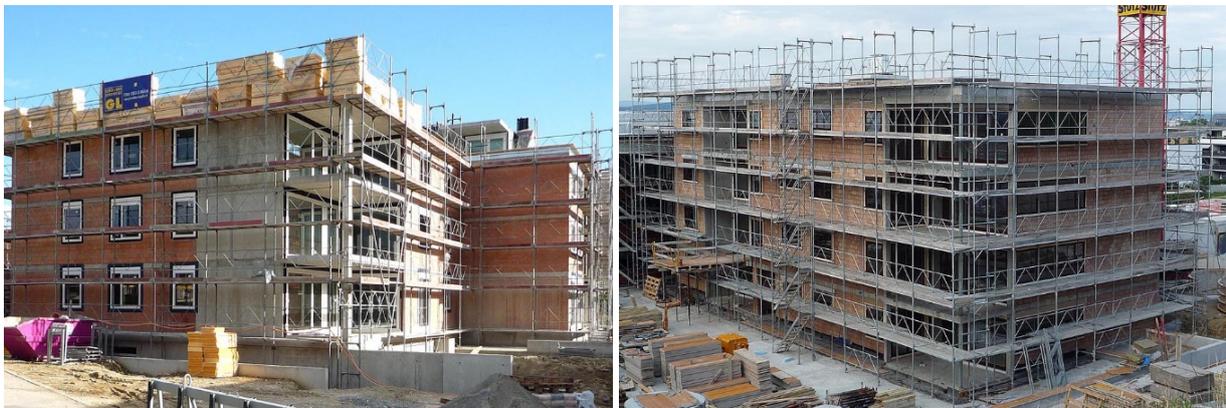
Figure 1. 3- and 4-storey residential buildings with RC wall and URM walls (Photos: Thomas Wenk).

Existing URM structures are often reinforced by adding RC walls or by replacing selected URM walls by RC walls. In Switzerland, many new residential buildings are directly designed as mixed RC-URM wall structures with RC slabs (Figure 1). Although such structures are very common in design and retrofit practice, their seismic behaviour is not well understood and the design often based on very simplifying assumptions. Existing numerical studies addressed the seismic performance of mixed RC-URM structures where the RC walls were not capacity designed and failed before the URM walls [1], while previous shake table tests studied either mixed systems where the RC element was so flexible that it had no influence on the overall performance of the structure [2] or the RC wall was pinned at the base [3].

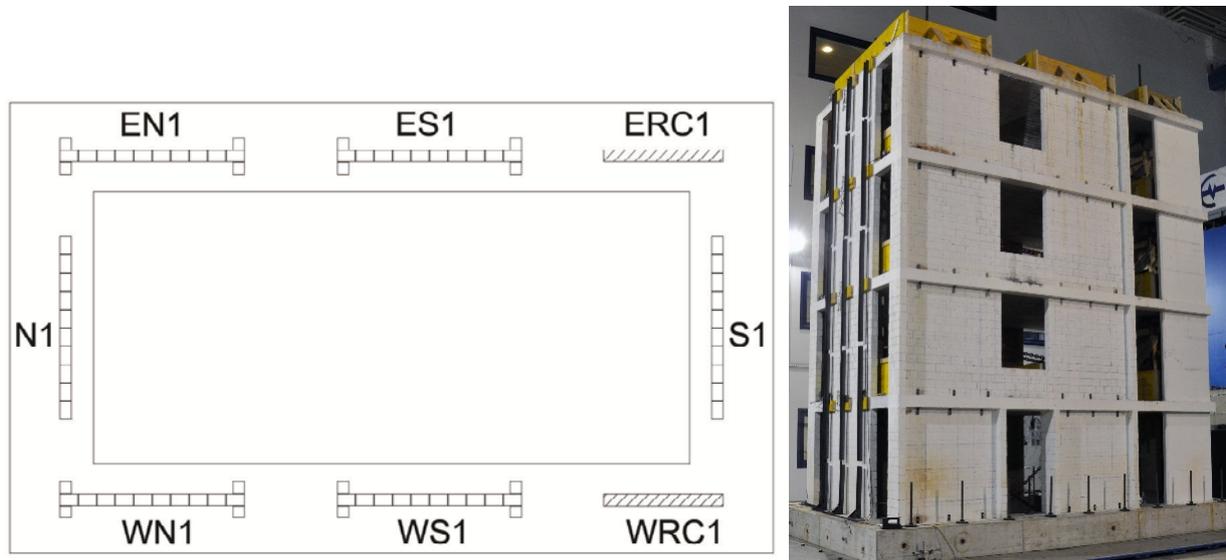
Figure 2. Plan view with cardinal directions (left) and South/West view of the test unit over the shake table (right)

The uni-directional shake table excited the structure along its longitudinal axis in North-South direction (Figure 2). Since the structure was not symmetric about its East-West axis, the behaviour of the structure was different for the two loading directions. This section discusses the damage pattern of the first storey after the final run with a nominal PGA of 0.9g. This run brought the structure near to collapse (Figures 3 and 4).

1. Force of the actuator of the shake table minus the inertia force of table and foundation. The latter can be estimated from the accelerometer mounted on the table.
2. Sum of the inertia forces of the four storeys where the inertia forces are computed from the accelerometers placed on each floor times the storey mass.
3. As point 2 but the floor accelerations are derived from the optical measurements of the markers glued onto the NW and SW piers (Figure 2).

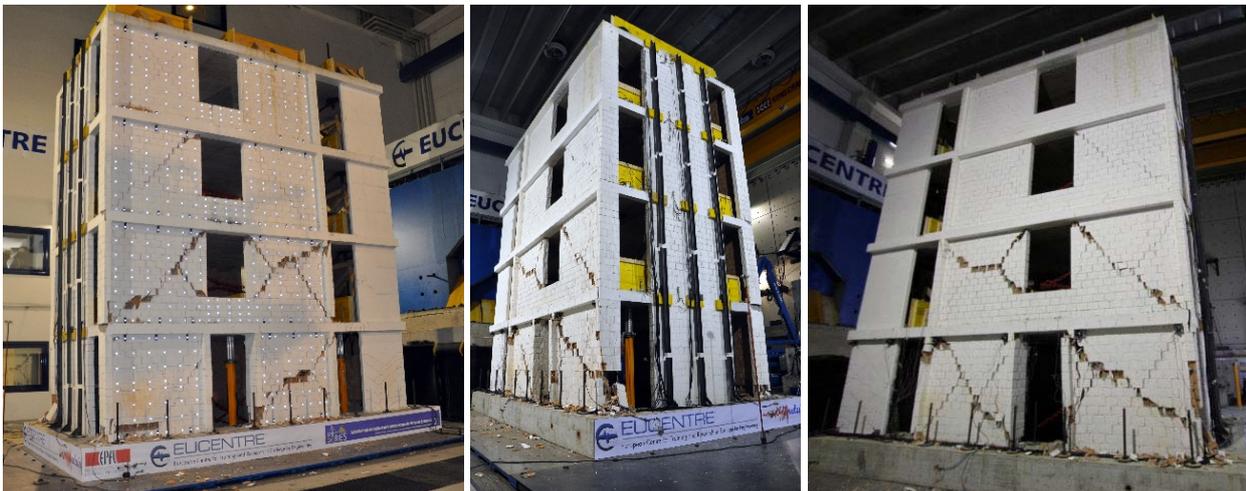
Figure 3. Test unit after final run.

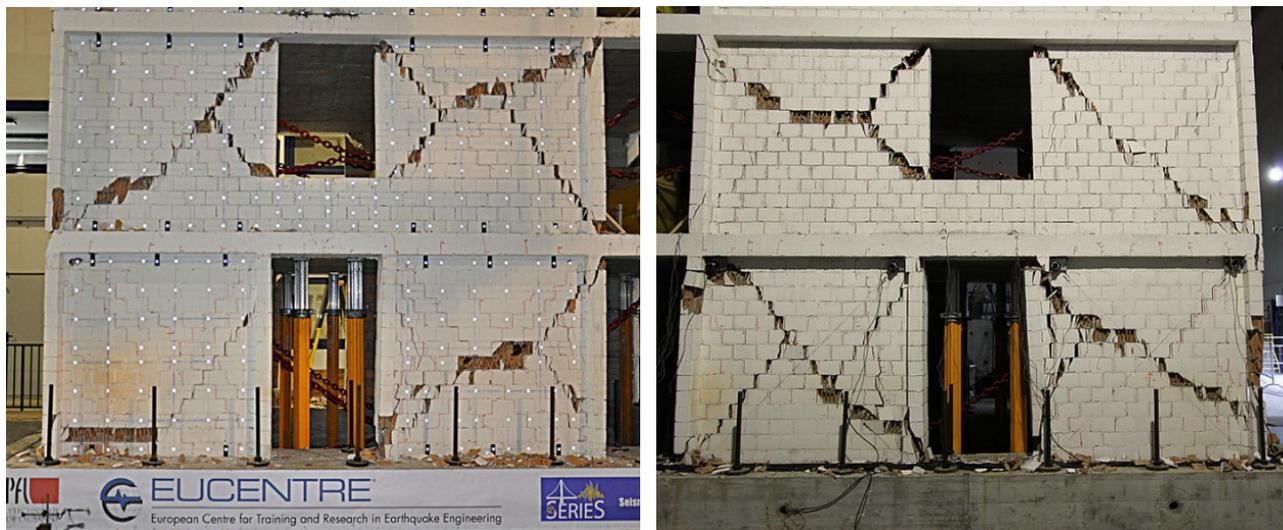
Figure 4. URM piers of first and second storey after final run (Left: West face, right: East face).

When the structure was pushed towards North, the axial force in the URM piers at the North end increased while it decreased in the RC walls and the South URM piers, which were loaded out-of-plane. For the out-of-plane loaded URM piers, an increase in axial force led to reduced out-of-plane movements. For a detailed discussion on the behaviour of the out-of-plane loaded piers during the test see [1]. If only the in-plane loaded walls are considered, loading towards North hence increased the axial force in the outer URM piers while it decreased it in the RC walls. As a result, the RC wall developed shear-flexure cracks over the entire height of the first storey. The axial force in the centre remained approximately equal, though small variations might have been caused by the different types of horizontal elements (RC slab only, RC slab plus masonry spandrel) framing into these URM piers. Since the deformation capacity of URM piers decreases with increasing axial load [9][10], the outer URM piers failed first and developed failure patterns indicating that the failure had occurred for loading towards the North. Pier NW failed due to crushing of the toe while pier NE failed along a diagonal crack and crushing of the web. Hence, although the structure was symmetric along its NS-axis, the behaviour of the East and West face was not exactly identical; most likely due to slight variations in the material properties.

When the structure was pushed towards the South, the axial force in the outer URM piers decreased and led hence to a behaviour which was dominated by a rocking motion (see the video on <http://eesd.epfl.ch/>). The centre piers were subjected to similar demands for the two loading directions and developed therefore the typical X-type crack pattern, which is well known from quasi-static cyclic tests with symmetric cycles. For loading towards South, the axial force in the RC wall increased and – according to numerical investigations – the two RC walls carried at this point approximately two thirds

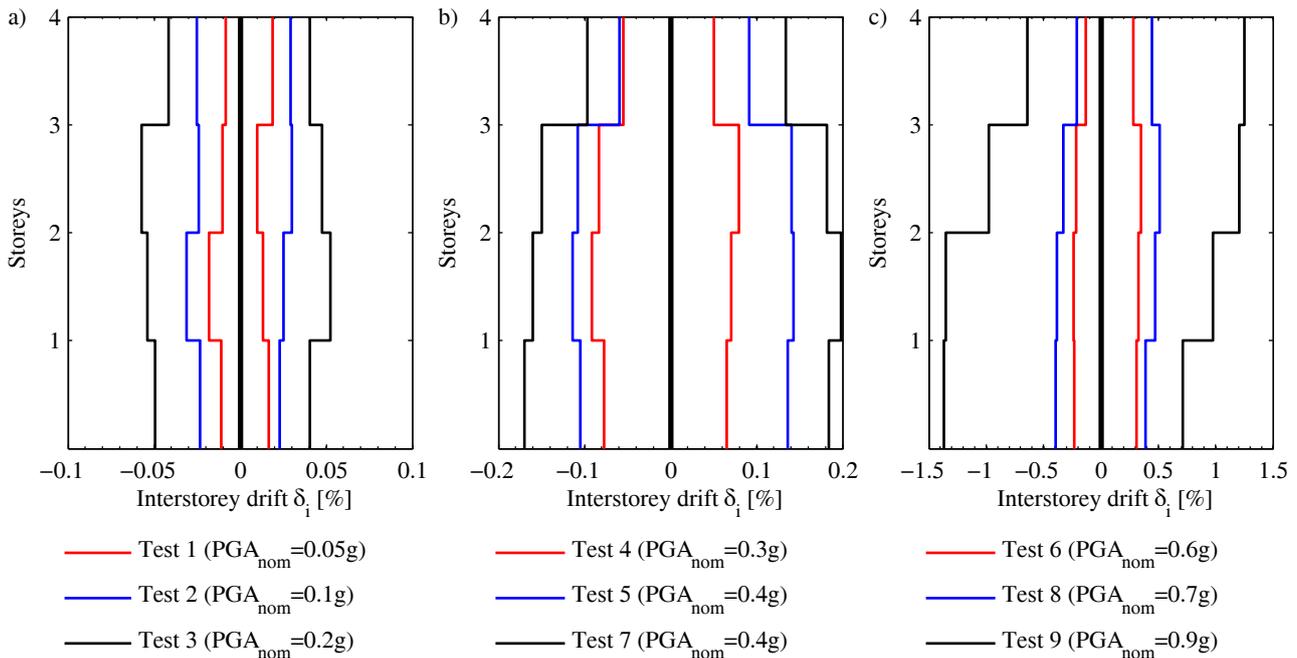
Figure 5. Drift envelopes for the nine runs: Run 1-3 (a), runs 4, 5 and 7 (b), and runs 6,8 and 9 (c)

Figure 5 shows the drift envelopes for all nine runs. Section 3.1 explained the difference in behaviour of the structure for loading in the negative and positive direction. For this reason, the envelopes are constructed for the two loading directions separately. The plots show that up to the second last run, the drift profile is almost constant over the first three storeys while the drift of the top storey is typically slightly smaller. For the last run, for loading in the negative direction (i.e. towards North leading to an increased axial load in the outer URM walls), the interstorey drifts of the bottom two storeys were considerably larger than for the top two storeys reflecting the damage shown in Figures 3 and 4. For loading in the positive direction, the drift profile reflects for this run clearly the displaced shape of a structure dominated by flexural deformations indicating that for this loading direction the behaviour was dominated by rocking URM piers and the slender RC walls, which were for the positive loading direction still largely elastic.

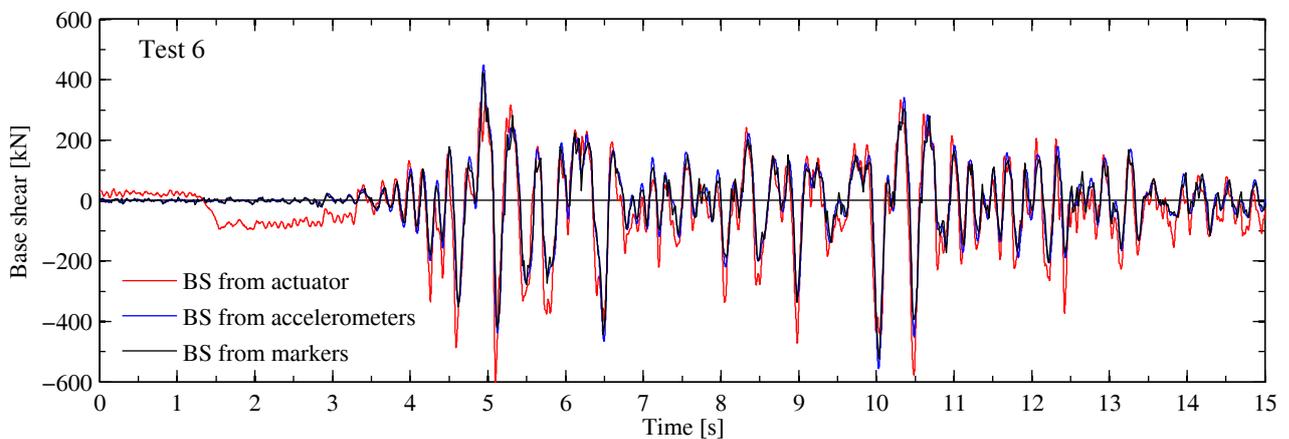
Figure 6. Run 6: Force time-history with the base shear (BS) obtained from load cell in actuator (red line), from accelerometers (blue line) and from markers (black line).

As an example Figure 6 shows the base shear force-histories obtained for Test 6. Test 6 was the test with the largest nominal PGA for which none of the accelerometers saturated ($PGA_{nom}=0.6g$). Run 7 simulated an aftershock and applied a nominal PGA of 0.4g only. For Run 8 and 9 the accelerometers of the third and fourth storey saturated. One can see that the three force measurements lead to rather similar results when the forces are large. However, at the beginning of the test, the base shear computed from the load cell in the actuator (Method 1) deviates significantly from the base shear computed according to Method 2 and 3. This could be possibly linked to friction forces in the actuator, in the hydraulic system or between rails and table. For tests with small nominal PGAs the base shear computed from the load cell measurement is therefore not reliable (Figure 7). This underlines that for shake table tests the force measurements are somewhat ambiguous and not as clearly defined as for quasi-static cyclic tests.

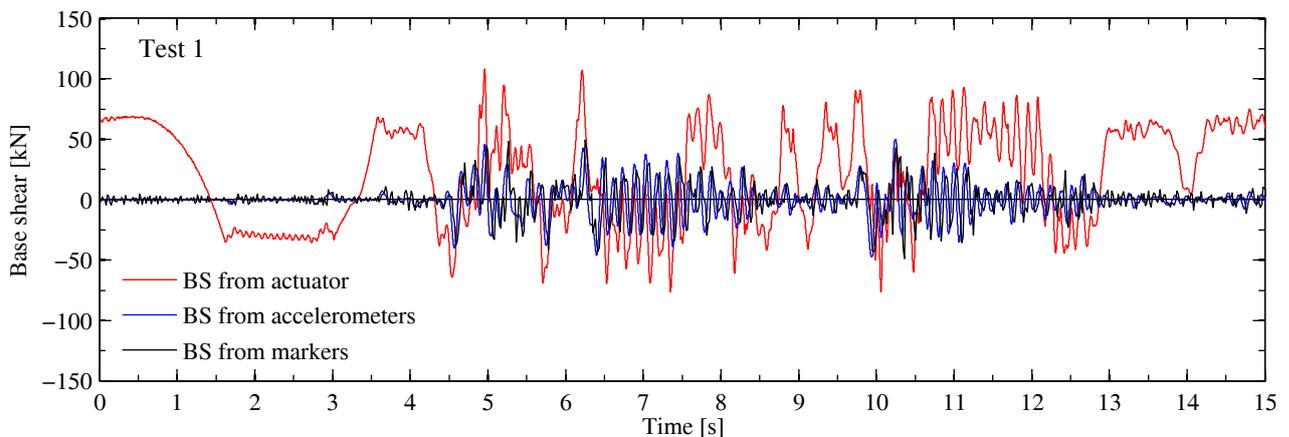
Figure 7. Run 1: Force time-history with the base shear (BS) obtained from load cell in actuator (red line), from accelerometers (blue line) and from markers (black line).

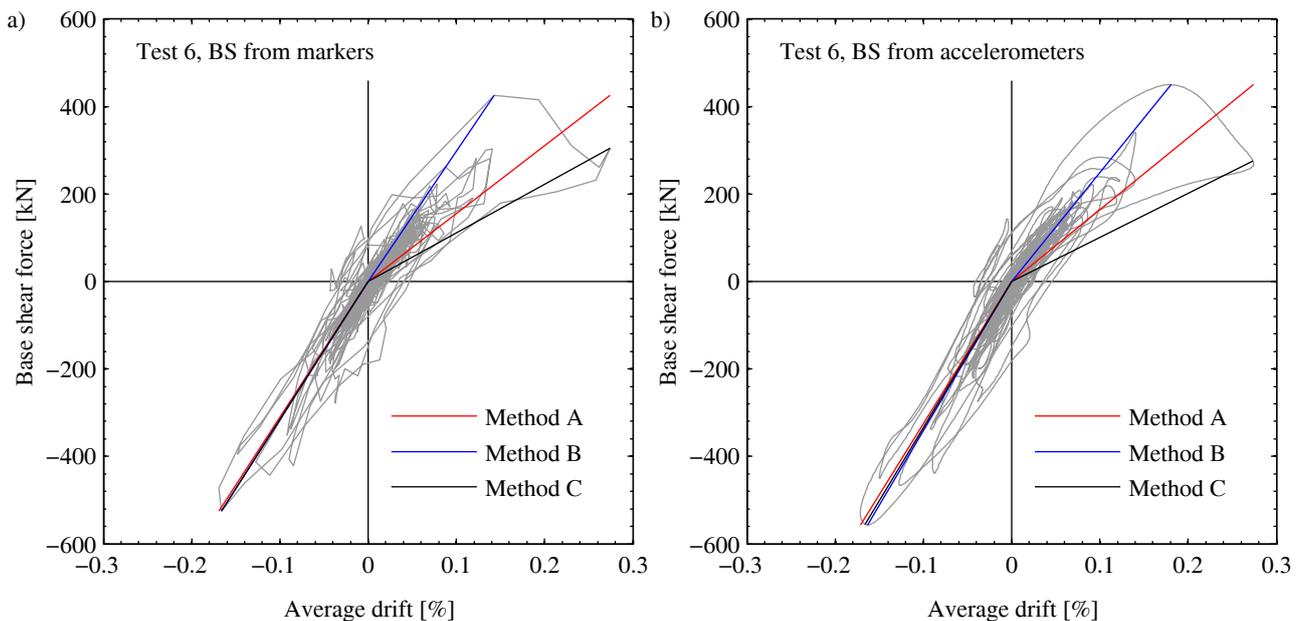
Figure 8. Force-displacement response: Hysteretic response of Run 6 where base shear is obtained from displacement of markers (a), and from accelerometer measurements (b).

Figure 8 shows the force-drift hysteresis of Test 6 using two different force-measurements, Method 3 where the base shear is computed from the displacement of the markers (Figure 8a) and Method 2 where the base shear is computed from the accelerometers placed at every storey (Figure 8b). Due to the larger measurement rate of the accelerometers, the hysteresis in Figure 8b is smoother than the hysteresis in Figure 8a.

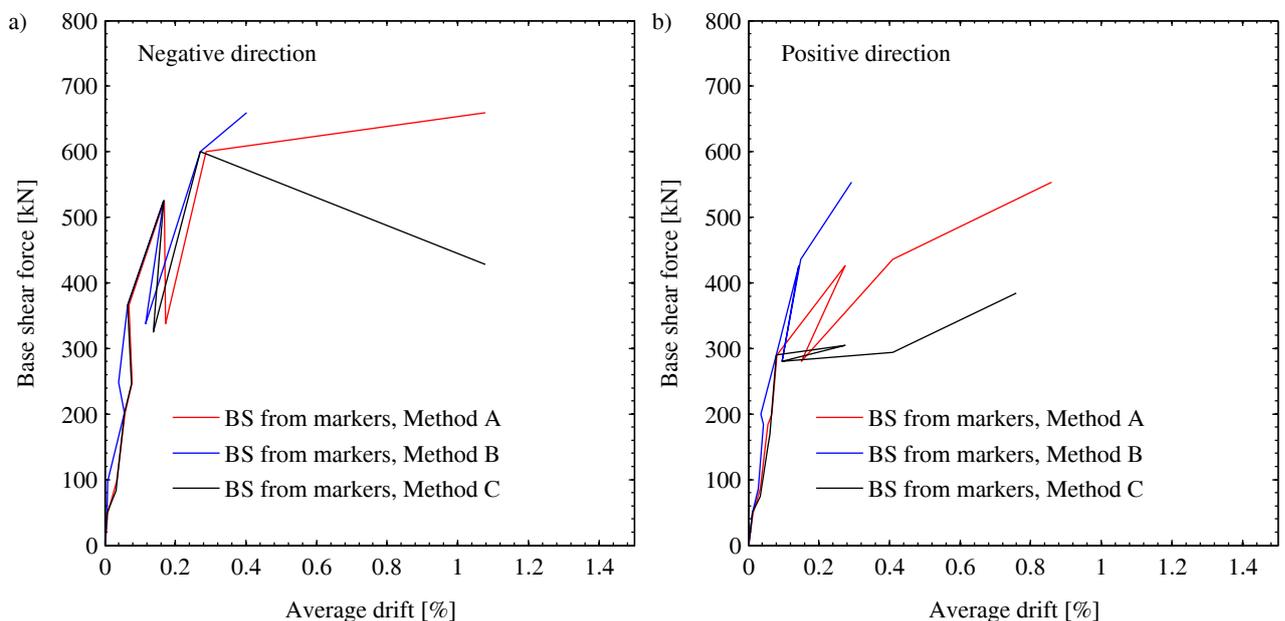
Figure 9. Pushover curve for negative (a) and positive (b) loading direction. Base shear was computed from marker displacements and pushover curve defined using three different methods.

Figure 8 visualises these three ways of defining the force/ displacement couple for run 6. For this run, the behaviour in the negative loading direction was largely elastic and hence the three methods lead to similar force/ displacement couples. For the positive loading direction, the behaviour was already largely inelastic and as a result the three force/ displacement couples are rather different. Figure 9 shows the pushover curves according to the three methods. The plots confirm that the methods lead to rather similar results when the structure behaves elastically but differ considerably in the inelastic range. For comparison with static pushover analyses Method A seems most appropriate since it envelopes forces and displacements and it is not affected by damping forces or the shape of the hysteresis, which cannot be reproduced in static analysis.

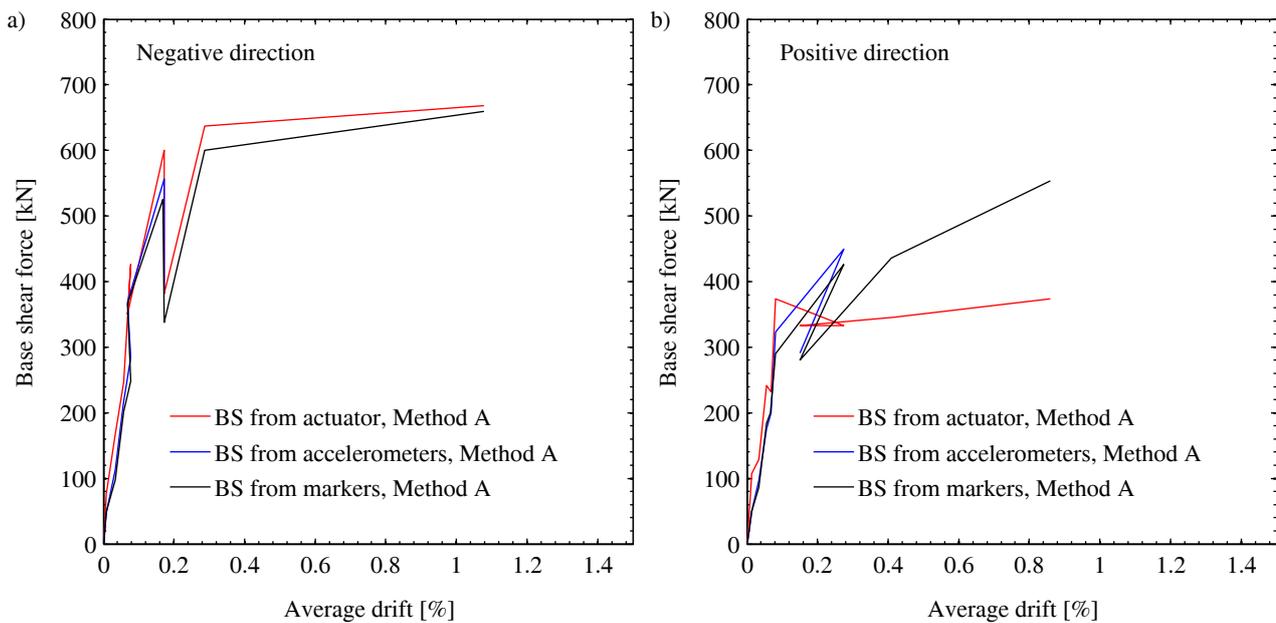
Figure 10. Pushover curve for negative (a) and positive (b) loading direction. Base shear was computed applying Method A to three different approaches for computing the base shear.

Figure 10 shows the curves for Method A which are obtained for the three ways of computing the base shear (Section 4.1). The correspondence between the base shear computed from accelerometer measurements and marker displacements is very satisfactory for both loading directions. For run 8 and 9 the base shear computed from accelerometer measurements is not available. However, it seems reasonable to assume that for these runs the base shear derived from the marker displacements leads also to reliable estimates of the base shear. For the negative loading direction, the latter corresponds also well to the base shear obtained from the actuator force. For the positive loading direction, however, the actuator force does not agree with the force computed for any of the other two approaches. To conclude, it is suggested to compute the pushover curve from the marker displacements since these are available for all runs and seem to lead to reliable estimates of the base shear for both loading directions.

The comparison of the pushover curves for the negative and positive loading direction shows that the stiffness of the structure in the elastic range is rather similar for the two loading directions. This is expected since the asymmetry only appears once significant cracking in the URM piers occurs. The force capacity of the structure is significantly larger for the negative loading direction than for the positive loading direction. For the negative loading direction, the axial force in the outer URM pier increases leading hence to an increase in force capacity while the opposite is the case for the positive loading direction. The capacity of the RC wall is not so sensitive to the change in axial force. The curves show further that the building had reached its maximum force capacity during Run 8 for the negative direction of loading. This agrees with the observation in Section 3 that Run 8 led to the concentration of damage in a single diagonal crack indicating that the peak strength had been reached or passed [10].
