# Evaluation of the seismic retrofitting of an unreinforced masonry building using numerical modeling and ambient vibration measurements

Clotaire Michel<sup>a</sup>, Amin Karbassi<sup>b</sup>, Pierino Lestuzzi<sup>b</sup>

Originally published in *Engineering Structures*, **158**, 124-135, March 2018. doi:[10.1016/j.engstruct.2017.12.016](https://doi.org/10.1016/j.engstruct.2017.12.016)

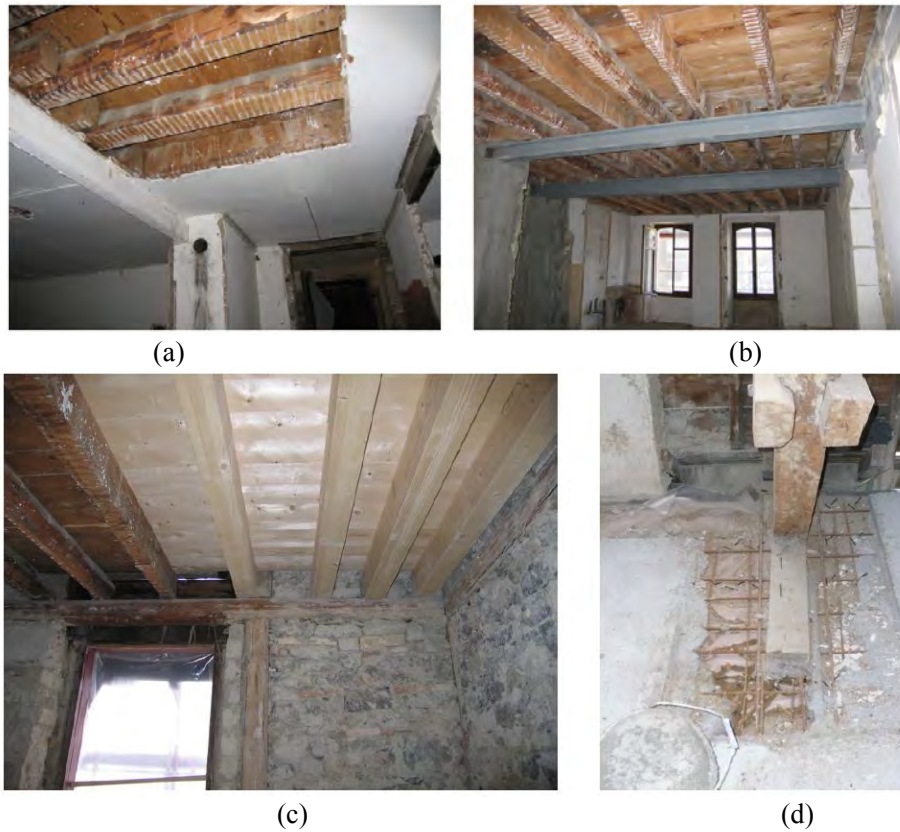
Figure 3. Retrofit of the slabs in the building (a) initial state, (b) added steel beams, (c) renewal of the wooden floors, and (d) added RC slabs

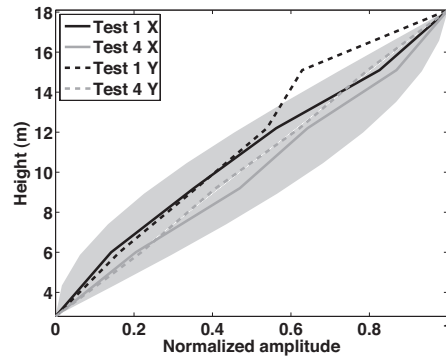
The modal shapes of the first two modes are presented in Figure 6. Their shapes in elevation are similar in both directions. In test 1, the structural behavior is closer to the behavior of the Euler-Bernoulli (pure bending) beam that is typical for stone masonry buildings with timber floors [26]. In test 4, the modal shapes moved towards the pure shear beam behavior, as a result of a loss of flexibility, as previously explained. With the new stiff slabs, the distribution of strains changed from a cantilever to a shear beam. A negative aspect of this, however, is that the ground floor should, in the retrofitted state, sustain larger drifts for the same top displacement.

Figure 6. Comparison of the modal shapes in elevation between the first and the fourth test. The grey-shaded area represents the area between the Euler-Bernoulli (pure bending, upper limit) and the pure shear (lower limit) beams (see also [26])

Figures 6 and 15 show a change in the mode shape between the pre-retrofit numerical model and the one after retrofitting. The total lateral drift in the numerical model after the retrofitting work is governed by the inter-story drift of the first floor. This is different from the behavior of the numerical model before retrofit, in which the lateral drift has a uniform distribution over the height of the building. This difference in behavior shows that the retrofit has a clear effect on the overall seismic behavior of the URM building. Unlike the pre-retrofit structure, for which the failure mechanism is governed by the out-of-plane failure of the URM walls, the installation of the stiff slabs in the building creates a diaphragm effect for those walls. As a result, when the URM building is subjected to strong motions, all the elements contribute to the lateral load resisting system, and the failure mechanism transforms from a local to a global behavior. A higher drop in the normalized modal frequencies in the post-retrofit structure, shown in Figure 14 is a good evidence of this transformation, showing that a higher share of the URM elements contribute to the lateral load resisting system.

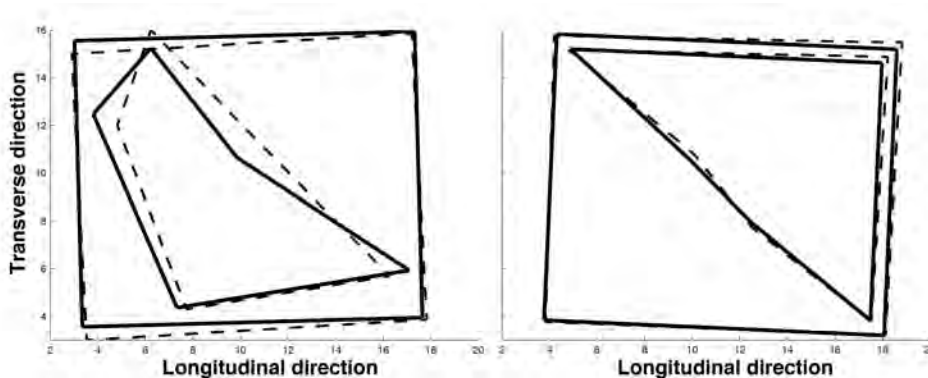
A closer look at the mode shape in the first test (before retrofitting, see Figure 7) indicates that there are internal deformations in the slab. This figure compares the experimental mode shape with a model assuming an average rigid body motion for the slabs. The timber slabs do not ensure the diaphragm effect, whereas in the third test, there are no more internal deformations thanks to the stiff slabs.

Figure 7. Second mode shape of the 5th story of the structure in test 1 (left) and 3 (right): the inner lines are arbitrarily connecting the recording points, whereas the outer rectangle represents the outer walls of the building. Dashed lines connect the points of the observed modal shape and solid lines correspond to an average rigid body motion of the slab assumed non-deformed

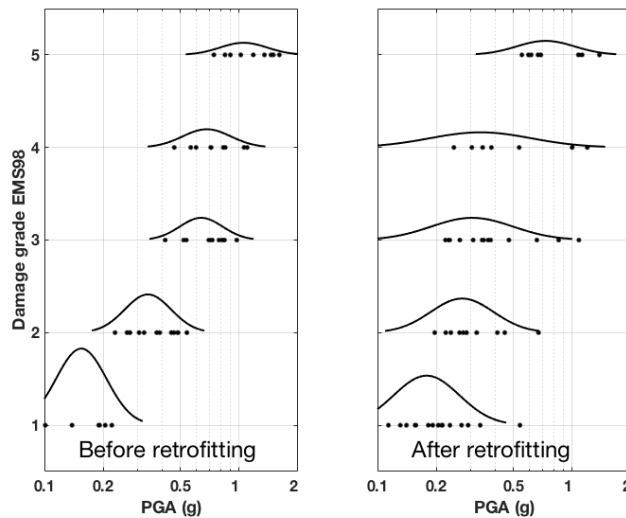
Figure 13 shows the distribution of the damage grades with the peak ground acceleration of the ground motion records used for the nonlinear dynamic analyses. Considering that both components of the records were used simultaneously in the numerical analyses, PGA values shown in Figure 13 are the maximum value of the PGA in X and Y directions.

Figure 13. Lognormal distribution of the peak ground acceleration values for each damage grade

Among the simulations using the same ground motion before and after retrofitting, 17 simulations led to the same damage grade, 8 to a worsening of 1 damage grade and 10 to an improvement of 1 damage grade.

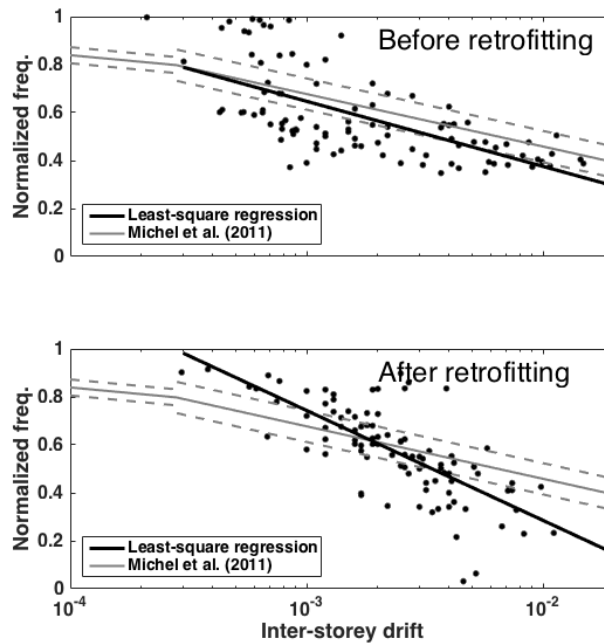
To compare the relation between the changes in the stiffness of the building subjected to strong motions with its displacement capacity, the drop in the natural frequency of each mode, normalized using the initial natural frequencies in Table 7, versus the inter-story drift in each direction is shown in Figure 14. Those values are also compared to an empirical model obtained from laboratory tests of a clay brick URM structure [27]. The different failure mechanisms of the URM building before and after the retrofit work can explain the differences seen in Figure 14. The pre-retrofit failure mechanism in the URM building is a result of local damage in the connection of the slabs with the URM walls, which results in an out-of-plane failure of the URM walls. The post-retrofit failure mechanism of the URM building, on the other hand, is governed by a soft story mechanism in the building involving the in-plane resistance from all the URM walls. The new stiff slabs link the URM walls and make them behave uniformly; therefore, the drop in the overall frequencies

which is related to the overall stiffness of the building [27], and not some local effects, is higher after adding the stiff slabs.

Figure 14. Drop in the modal frequencies (normalized) with the inter-storey drift values

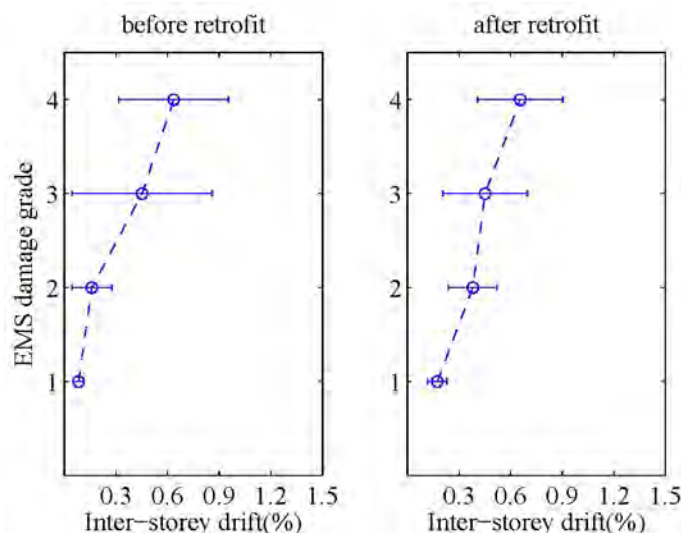
The comparison of the inter-storey drift values from the pre- and post-retrofit numerical models can provide an idea about the change in the displacement capacity and ductility of the URM building, as a result of the retrofit work. Figure 15 shows the mean values of the inter-storey drift at each damage grade (DG1 to DG4) along with the 68% confidence intervals of the data (mean plus/minus one standard deviation). It should be noted that the inter-storey values for DG5 are not shown in this figure because this damage grade corresponds to the collapse of the building, and the inter-storey drift values are difficult to be determined.

Figure 15. Mean plus/minus one standard deviation for the inter-storey drift at each DG

If the damage grade 2 is considered as the yield point at which the URM building enters the nonlinear phase, and damage grade 4 is assumed to be the ultimate point before the building collapses (damage grade 5), the displacement ductility of the URM building before and after the retrofit work can be estimated from the mean values of the inter-storey drift as shown in Table 8.
