SHAKE-TABLE TEST OF A STRENGTHENED STONE MASONRY BUILDING AGGREGATE WITH FLEXIBLE DIAPHRAGMS.

A unidirectional shake-table test was performed on the half-scale prototype of a natural stone masonry building aggregate, to investigate the seismic performance of this type of historical construction and to assess the effectiveness of two retrofit solutions. The specimen represented a building aggregate with two adjacent three-storey units, connected along one side as if they were built at different times. Double-leaf stone masonry with undressed blocks and river pebbles was used for the walls. Timber floors constituted flexible diaphragms in their planes. Roofs with different timber truss configurations and heights covered the two units. Improved wall-to-diaphragm connections and tie rods were pre-installed, although initially not fastened, on the prototype. Both retrofit systems were activated after significant damage was reached testing the unstrengthened specimen. This paper describes the seismic behaviour of the prototype, focusing on the effects of the retrofit interventions on damage mechanism evolution, lateral displacement demand, hysteretic response, and dynamic properties deg

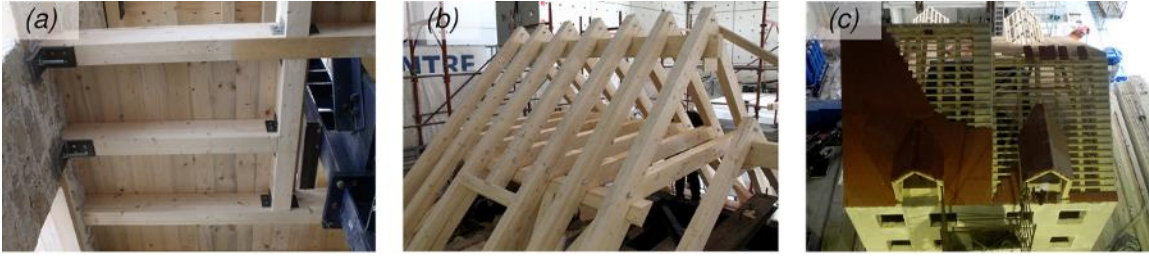
Figure 2. Floor and roof diaphragms: (a) timber floor, view from below; (b) roof trusses with 45° slope; (c) clay tiles, tile battens, and dormers.

and a secondary structure constituted by secondary rafters and horizontal beams (Figure 2b). As typical for Basel historical buildings, the in-plane stiffness of the roof pitches was increased by inverted-V (North unit) or cross (South unit) bracings. Clay tiles were mounted on tile battens directly nailed to the truss rafters, without timber planks (Figure 2c). Four dormers completed the roof. Additional construction details can be found in Senaldi et al. (2019).

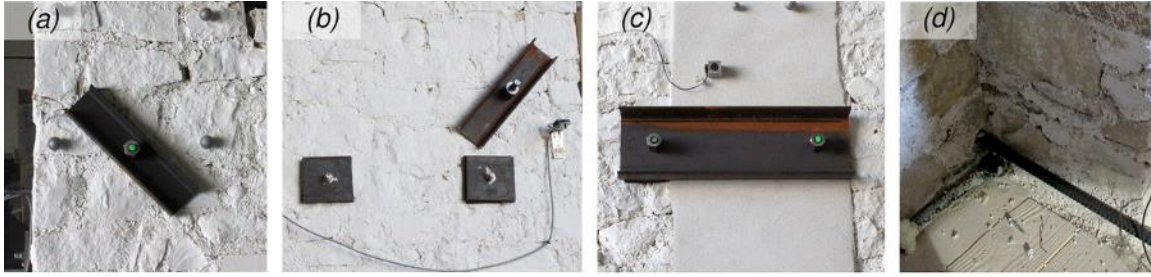
Figure 4. Tie rods: (a) steel anchor of a single tie rod, West façade; (b) steel anchor for a single tie rod and anchor plates for diaphragm connections, North façade; (c) steel anchor for two tie rods adjacent to the vertical structural joint, West façade; (d) perpendicular tie rods crossing above the timber floor.

The second strengthening system consisted of metallic tie rods located at each floor level, as shown in Figure 4, obtained from Dywidag 18WR post-tensioning threaded bars. This technique, traditionally applied to absorb arch thrusts, has proved effective in increasing the lateral displacement capacity (Calderini et al. 2015; Calderini et al. 2019). Also these rods were pre-installed within 30-mm-diameter ducts through the masonry thickness during construction, but initially left without anchor plates. They were manually post-tensioned only after testing with active wall-to-diaphragm connections, to allow increasing further the intensity of shaking.

To ensure good transmission of stresses between rods and masonry, UPN steel profiles were used as anchor plates, with the flanges serving as stiffeners. In particular, 400-mm-long UPN80 were used for the tie rods running along the perimeter walls (Figure 4a and b), while 660-mm-long UPN200 connected the rods running adjacent to the transverse party wall (Figure 4c) across the joint. The transverse tie rods of the South unit were located 150 mm away from the party wall, to avoid additional discontinuities in correspondence of the vertical joint and to induce less stress concentration at the edges of this unit's longitudinal walls, which were not built integrally with the party one. The tie rods ran parallel to the masonry walls in the longitudinal and transverse directions above the floor planks (Figure 1e), except for the third-floor transverse rods which were mounted below the diaphragm. Conflicts between orthogonal rods were eliminated by placing the ducts in the masonry at slightly different heights above the floor surface (Figure 4d).

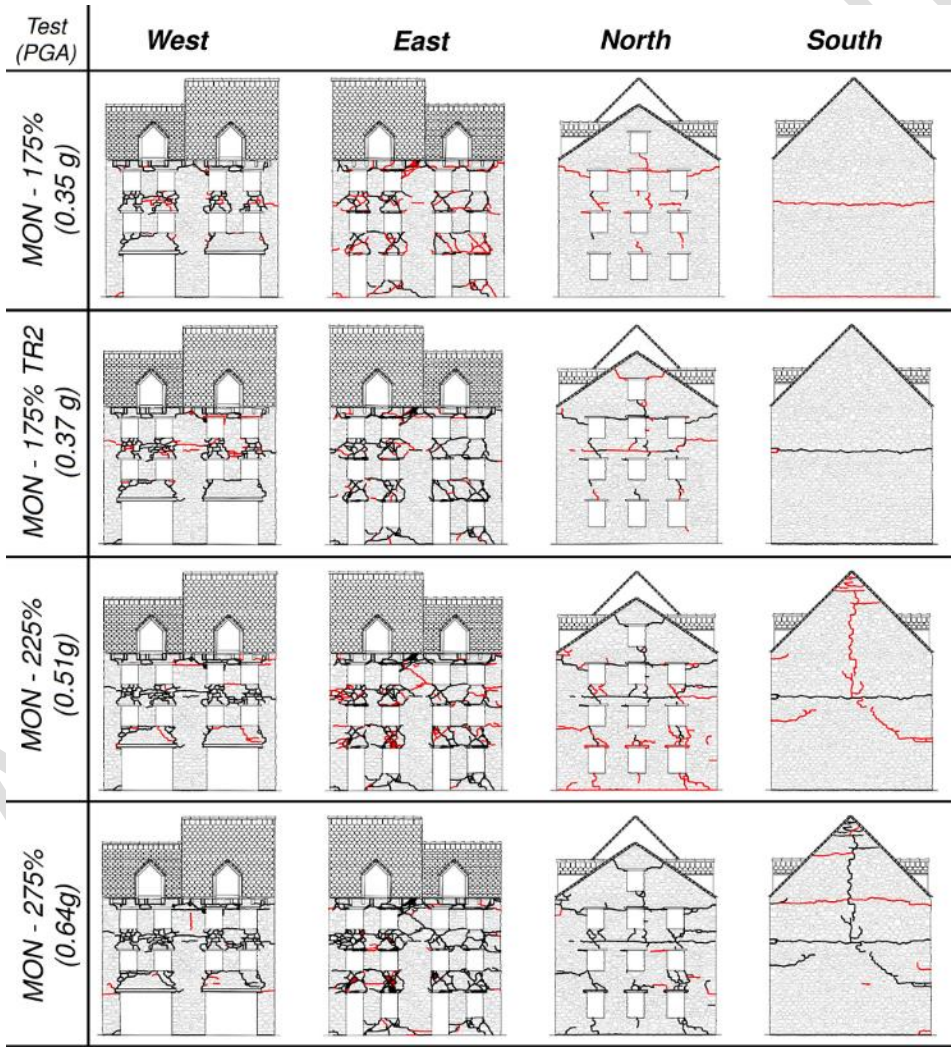
Figure 6. Evolution of the crack pattern. Crack segments marked in red opened during the current test. Crack segments marked in black had been previously detected.

Extensive structural damage was experienced during test MON-175% (PGA of 0.35 g), that affected the spandrels of the longitudinal East and West façades significantly (Figure 6), with residual crack widths of 3÷7 mm, de-cohesion of some blocks, and permanent horizontal elongations up to 15 mm at the second-floor spandrel level on the two units.

After test MON-175%TR2, the level of damage in the spandrels increased, with further elongation and widening of existing cracks and opening of new ones (Figure 6). Flexural-rocking response of the central pier at third storey of the West façade was detected. New cracks due to out-of-plane overturning mechanisms appeared also in the North façade: in particular, they became more evident at the second-floor level, where the masonry thickness decreased from 300 mm to 250 mm. An overturning mechanism involving the upper portion of the North gable above the timber lintel was evidenced by inclined cracks originating from the upper corners of the gable window.

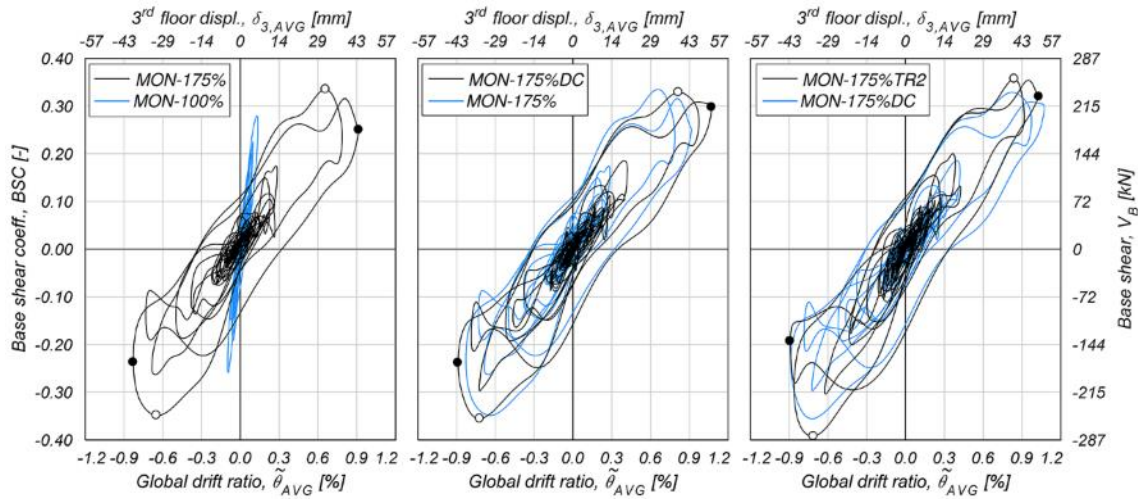
Figure 11. Global hysteretic response, accounting for residual displacements during the un-retrofitted testing phase. Tests with “MON” signal scaled at 175% before and after activation of the retrofit interventions.

Figure 11 depicts the hysteretic behaviour of the prototype during the tests under MON signal scaled at 175%. In particular, the left-hand-side graph compares the response of the un-retrofitted specimen during test MON-175% (PGA of 0.35 g) with the one during test MON-100% (PGA of 0.20 g), when it experienced only minor structural damage: significant stiffness degradation and energy dissipation can be observed. Peak global drift ratio and base-shear coefficient of 0.92% and 0.35, respectively, were recorded in test MON-175%. The central plot of Figure 11 shows that activation of the wall-to-diaphragm connections allowed repeating the test (MON-175%DC, PGA of 0.34 g) with a stable

hysteretic response: maximum global drift ratio of 1.1% and base-shear coefficient of 0.36 were obtained, without appreciable stiffness degradation. Furthermore, tensioning the tie rods resulted in a similar response under two additional repetitions of the same input motion, up to test MON-175%TR2 (PGA of 0.37 g; right-hand-side graph), with a peak global drift ratio reduced to 1.0% and a base-shear coefficient increased to 0.39.

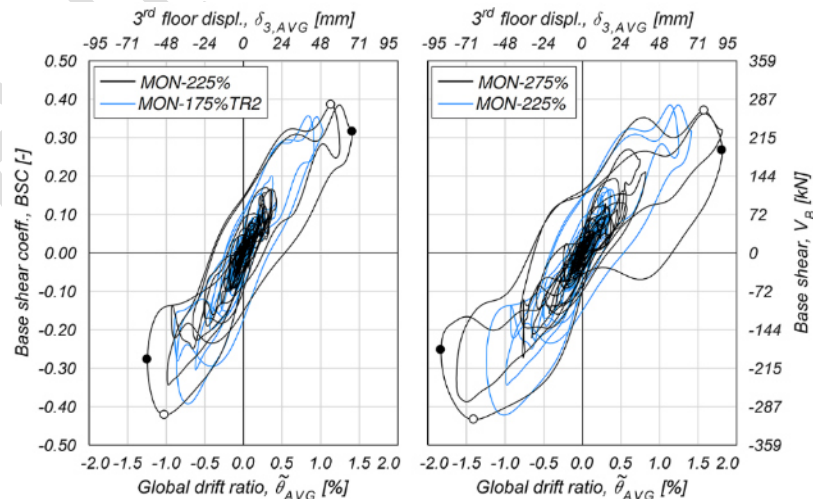
Figure 12. Global hysteretic response. Tests with “MON” signal scaled at 225% and 275%, after activation of the retrofit interventions.

When subjecting the retrofitted prototype to higher-intensity table motions (Figure 12), the prototype maintained its cracked stiffness and strength characteristics nearly unvaried, reaching peak drift ratios of 1.4% and of 1.8%, and base-shear coefficients of 0.42 and 0.43, during tests MON-225% (PGA of 0.51 g) and MON-275% (PGA of 0.64 g), respectively. Figure 13 shows the envelope of the prototype global hysteretic response in the positive (northward) direction, including all tests performed in the unstrengthened configuration. The backbone curve was built connecting the points with maximum base shear demand during each test, plus the point corresponding to the maximum displacement from test MON-275%. Cumulative residual displacements were accounted for as previously described. The envelope denotes a small strength enhancement due to retrofit activation and, more importantly, the ability of the strengthened structure to maintain its strength through the end of the testing sequence.

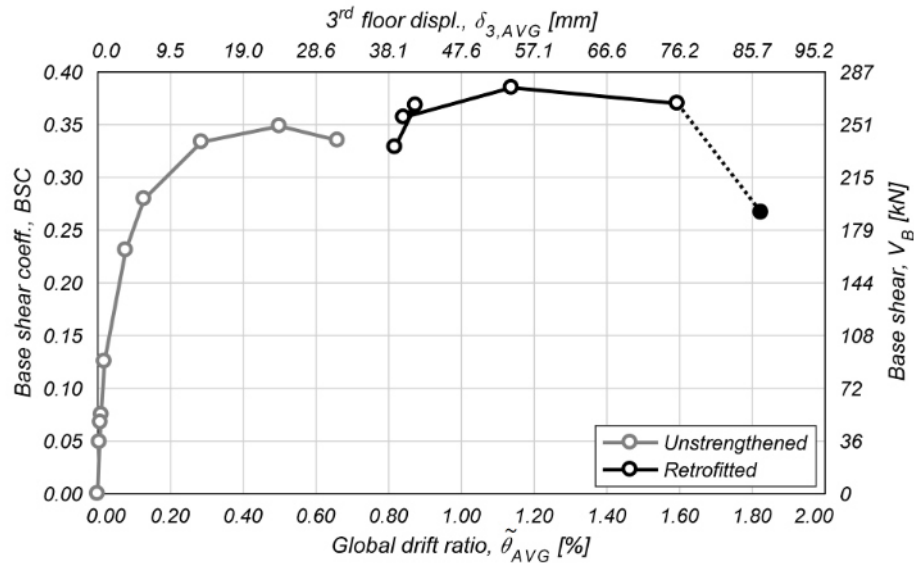
Figure 13. Envelope of the complete testing sequence, accounting for residual displacements during the un-retrofitted testing phase.
