Shake table test of a masonry building retrofitted with shotcrete

Amirhossein Ghezelbash¹, Katrin Beyer², Kiarash M. Dolatshahi^{1*}, and Mohammad Yekrangnia³

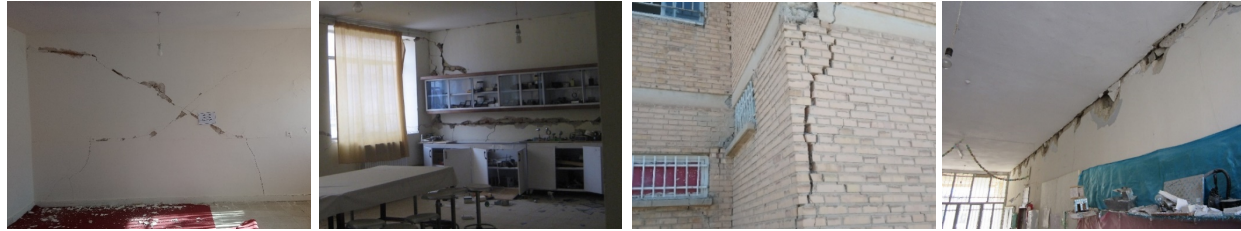
(a) Diagonal crack of walls (b) Concentrated cracks (c) Separation of walls (d) Sliding of the roof

Figure 1. Failure modes observed in previous earthquakes [23]

The failure modes observed in URM buildings are generally categorized to (1) in-plane diagonal and horizontal cracks of load-bearing and non-bearing walls, (2) out-of-plane overturning of load-bearing and especially non-bearing walls, (3) rocking of the piers adjacent to openings, (4) toe crushing or crack propagation at the corner of the walls and openings, and (5) sliding of the floor slabs on the walls. Figure 1 shows the failure modes observed in masonry buildings during the November 2017 Kermanshah earthquake in Iran. The most common failure was diagonal shear

cracks of walls, shown in Figure 1(a). In many cases, the walls openings had influenced the crack pattern of the perpendicular walls. For example, in Figure 1(b), the crack of the wall was developed from the point which corresponds to the corner of the window in the perpendicular wall. In a few cases, such as the one in Figure 1(c), separation of perpendicular walls was observed at the corner of the buildings. Moreover, some cases exhibited sliding between the roof and the internal walls, as shown in Figure 1(d), due to improper roof-to-wall connection detailing.

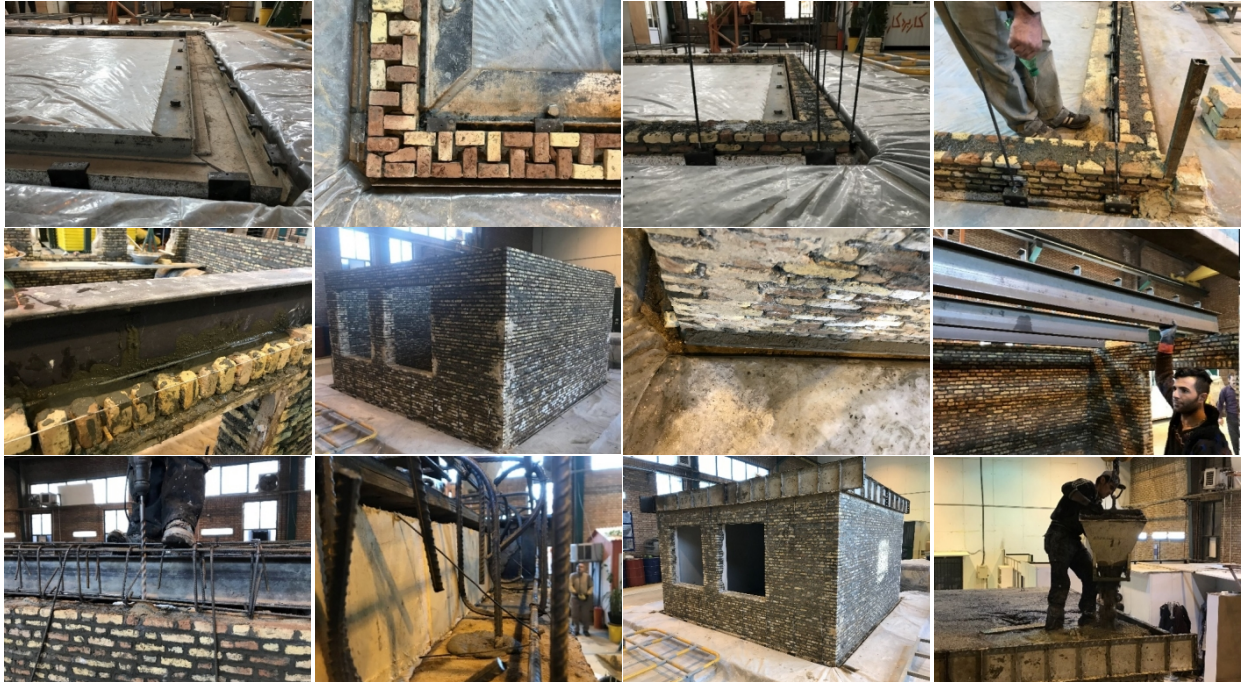
Figure 6. URM specimen construction procedure

Summary of the construction process is shown in Figure 6, highlighting the primary steps in chronological order. The four-part steel foundation was connected to the shake table using four M20 bolts for each part, and the foundation connection angles were installed. The wall-to-foundation connection rebars were bolted to the steel angles before adding the second brick row. The mortar and masonry samples were collected during the construction phase. The empty areas of each brick row were filled with mortar. The finished rows and the material samples were cured after the end of each row. No frame was used for the door and window openings to allow free movement of the piers. Before building the roof, the foundation was filled with fresh grout to prevent lateral movement and separation between the specimen and the table. The roof beams and steel grid were installed, and the walls were drilled to add the roof-to-wall connection hooks. The wall-to-shotcrete connection hooks were installed before the roof concrete was cast.

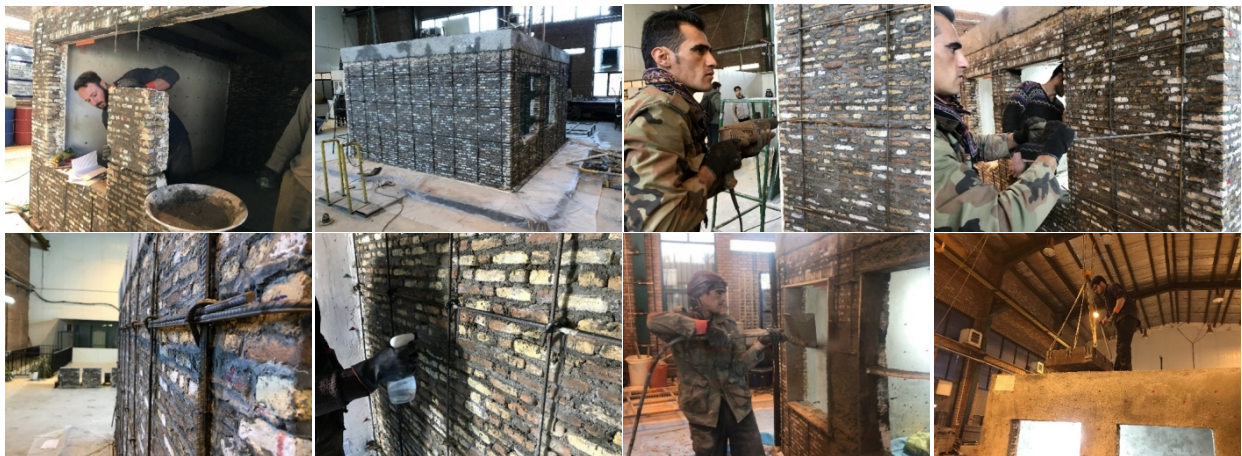
Figure 7. Specimen rehabilitation procedure

The rehabilitation of the damaged URM specimen was carried out after the URM tests were completed, in the order shown in Figure 7. At first, the collapsed parts of the specimen during the URM test were relocated. In follow, the vertical shotcrete rebar were spliced to the foundation rebar and roof hooks, and the horizontal rebar were then attached to the vertical rebar. The steel grid was connected to the walls by drilling through the thickness of the walls and installing the wall hooks. The northwest and the southeast holes were drilled, and the wall-to-wall connection hooks were added to each corner of the specimen. The walls were moisturized with water before applying the shotcrete layer, and the concrete and rebar samples were collected during the application of the shotcrete layer. The whole retrofitting procedure was carried out in one day. In the end, the additional mass blocks were placed on the roof, and steel cable with 12 mm diameter was used to fix the blocks to a series of closed hooks pre-installed in the center and corners of the roof concrete during the construction process.

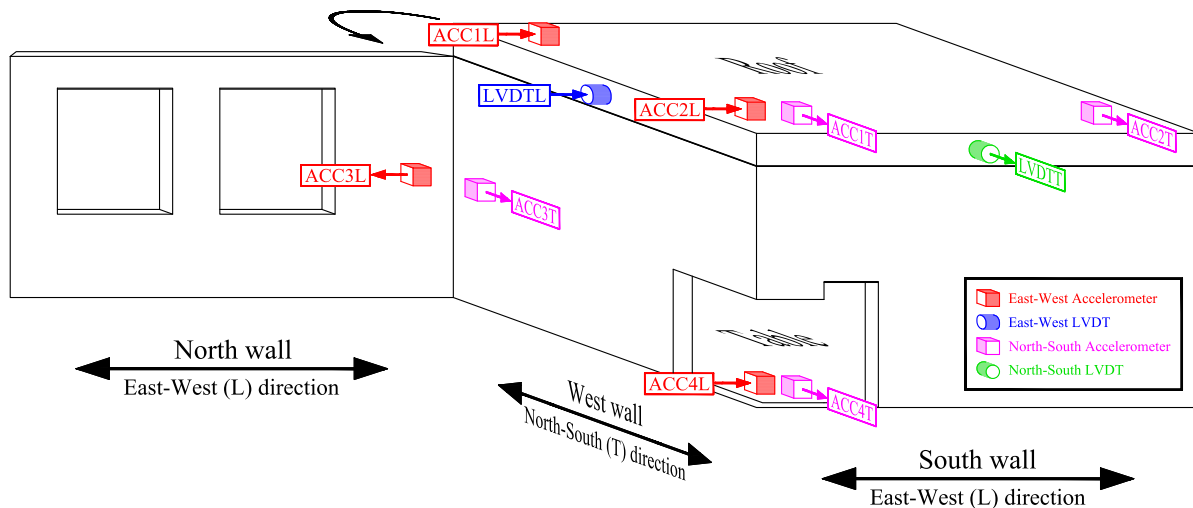
Figure 9. Arrangement of the sensors on the specimen

A total of ten instruments consisting in eight accelerometers, and two Linear Variable Displacement Transducers (LVDTs) were used to capture the acceleration and displacement in the key points of the specimen during both URM and RM tests. The layout of the sensors is shown in Figure 9, with the arrows indicating the positive direction of each sensor. The two LVDTs were attached to the middle of the south and west roof tie-beams to measure the roof displacement in each direction. For each direction, two accelerometers were installed at the roof elevation at the sides of the walls to capture the roof torsion as well as in-plane wall drifts, one accelerometer was attached to the northwest corner at the middle of the wall height to investigate the onset of rocking movement at the vicinity of the window opening, and another accelerometer was placed on the base at the southwest corner to derive the Fourier transfer functions and to measure the changes in the frequency content of the specimen response. In addition to the sensors, the motion of the specimen was recorded by high-resolution cameras with a 60 frames-per-second capture rate. After each step, the walls were inspected visually and by capturing high-definition photos to follow the extent of the cracks.
