Ultrasonic Doppler flow velocity measurements as a co-indicator for the eco-morphological assessment in a residual flow reach

Robin Schroff¹, Christian Mörtl¹, Giovanni De Cesare¹

¹ Platform of Hydraulic Constructions (PL-LCH), Ecole Polytechnique Fédérale de Lausanne (EPFL), Station 18, 1015 Lausanne, Switzerland

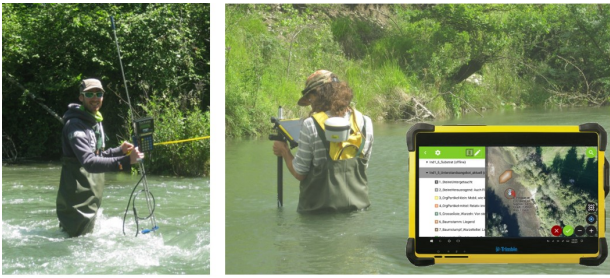
Figure 3: Field equipment used for surveying: The handheld Acoustic Doppler Velocimeter FlowTracker by SonTek (left), field tablet Trimble T10 and GNSS antenna Trimble R2 (right)

For the field work, a digital mapping environment was set up. It consisted of a field tablet (Trimble T10), a survey-grade GNSS antenna (Trimble R2) and a comprehensive project for the mobile GIS application QField [11]. This set-up allowed for GNSS and orthophoto based mapping and provided decision support for the placement of cross sections. The field equipment is shown in Figure 3. Field work took place in summer 2020 and lasted two weeks. Sunny conditions and moderate turbidity provided for good visibility of the streambed substrate.

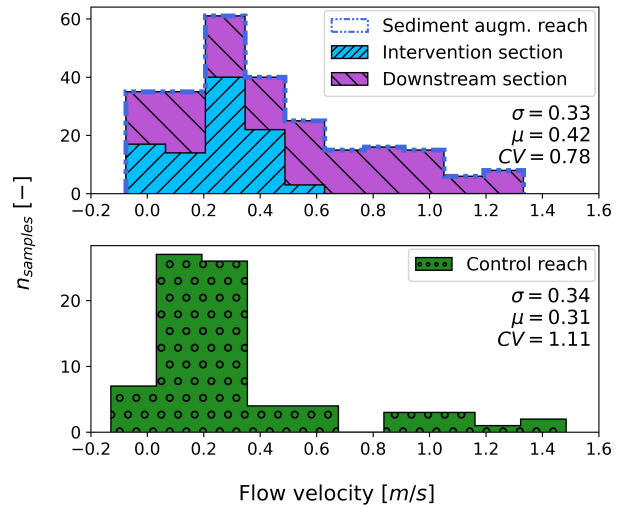
Figure 4: Histograms of flow velocity samples in the sediment augmentation reach (top) and the control reach (bottom). The intervention section and downstream section samples are stacked to form the sediment augmentation reach histogram

Figure 4 shows the histograms of flow velocity measurements. The flow velocity histogram of the intervention section is dominated by relatively slow flow velocities (v_{\max} (IS) = 0,54 m/s). In the rapids zones of the downstream section and the control reach, flow velocities up to v_{\max} (DS) = 1.33 m/s and v_{\max} (CR) = 1.48 m/s were measured. The smaller number of cross sections and measurement points in the intervention section is the reason for the smaller size of its attributed area in the stacked histogram, compared to the downstream section. The coefficients of variation of water depth and flow velocity in the intervention section and downstream section were significantly lower than the CV values for the entire sediment augmentation reach (Table 3).
