PLATTENBAUS IMPROVED

**Adaptive reuse of LPS-buildings in Poland
by increasing occupancy comfort while
reducing energy consumption**

ENONCE THEORIQUE
DE MASTER EN ARCHITECTURE

Paweł Grajda

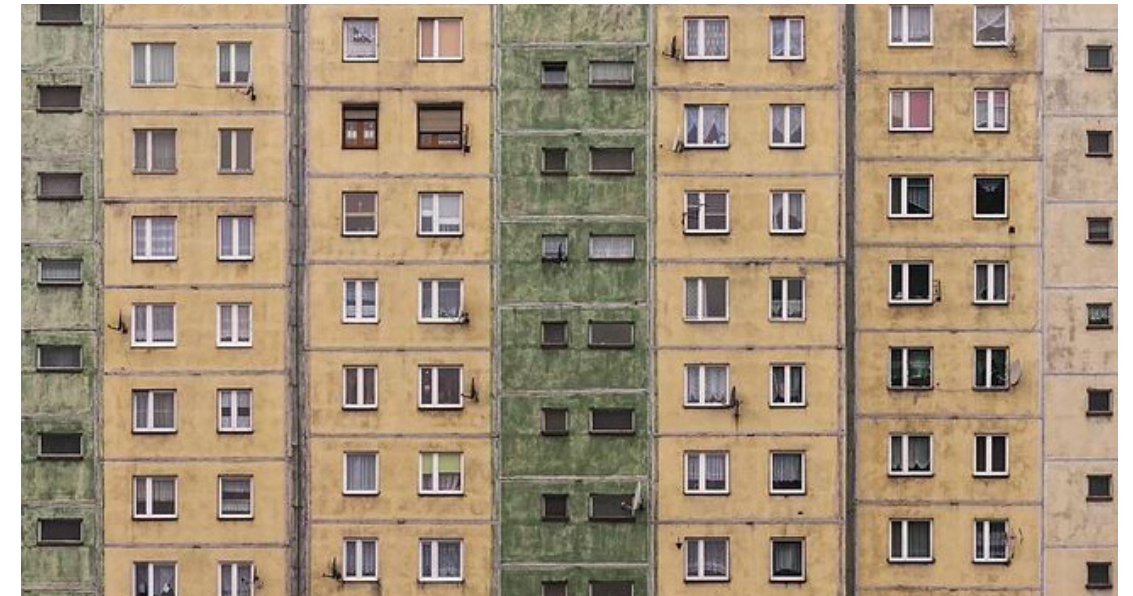
Façade of the W-70 system building

The catalogues included typologies of centrally typified elements – identical elements produced in stationary or field production plants all over the country. The system included the possibility of using additional elements taking into account the needs of a region (regional typification) and produced for the needs of a single housing estate (local typification).

In the middle of 70's the decision was made to buy factories of houses in West Germany and to use them for production of prefabricated elements of W-70 system. However it was not possible to produce hollow core slabs, therefore the Wk-70 system without this type of elements was developed. In this variation additional ceiling span (300 cm) and additional storey height (330 cm) were introduced, hollow core floor slabs were replaced with 16 cm thick solid slabs, external walls made of expanded concrete were no longer used.

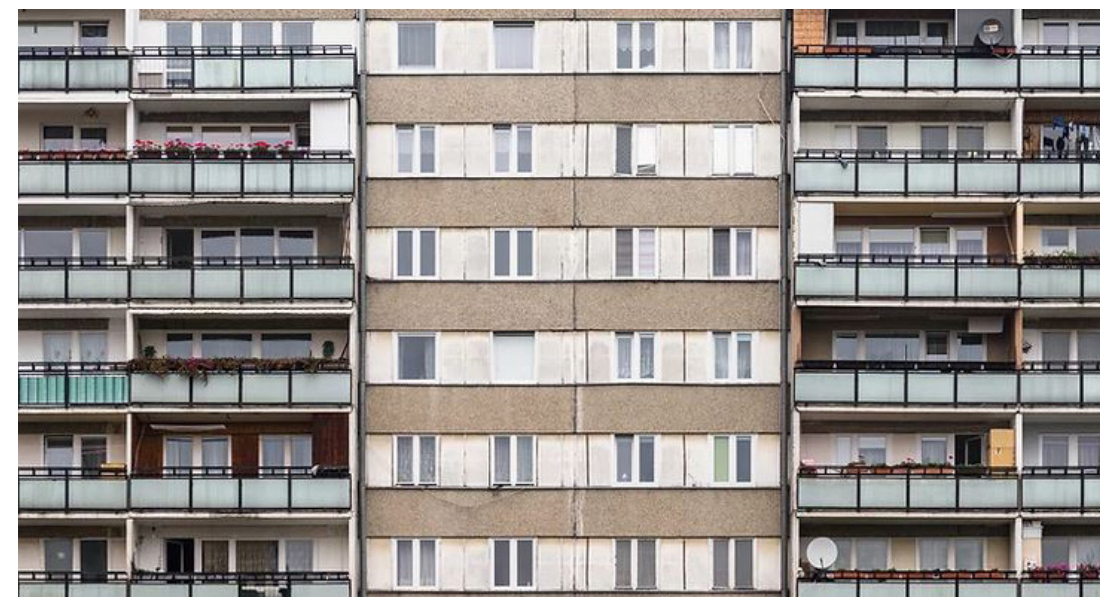
Façade of the OWT-67 system building

The material solution of the system: internal walls and ceilings – 14 cm thick reinforced concrete slabs, external three-layer walls 16 cm thick (longitudinal walls) or 24 cm thick (gable walls) with a 5 cm thick polystyrene insulation layer (the difference in thickness resulted from a different thickness of the reinforced concrete bearing layer – 6 or 14 cm respectively).

In 1975 the variant marked OWT-75 was developed, increasing not only the size of typical flats, but also the height of a storey up to 280 cm. A modular grid of 120 × 120 cm was also used, with the depth of the housing tract – 480 cm, and with widths of: 240, 360, 480, 600 cm (where the width of 240 cm was used as a supplementary). The thickness of ceilings was also increased to 16 cm, of internal walls to 15 cm and of external longitudinal walls to 19 cm.

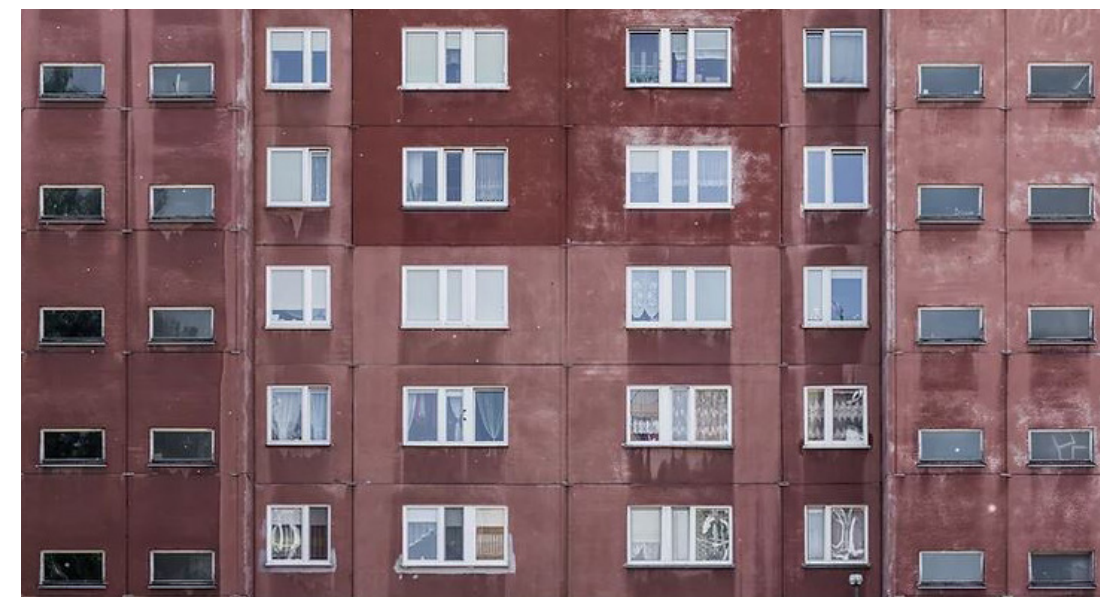
Façade of the Szczecin system building

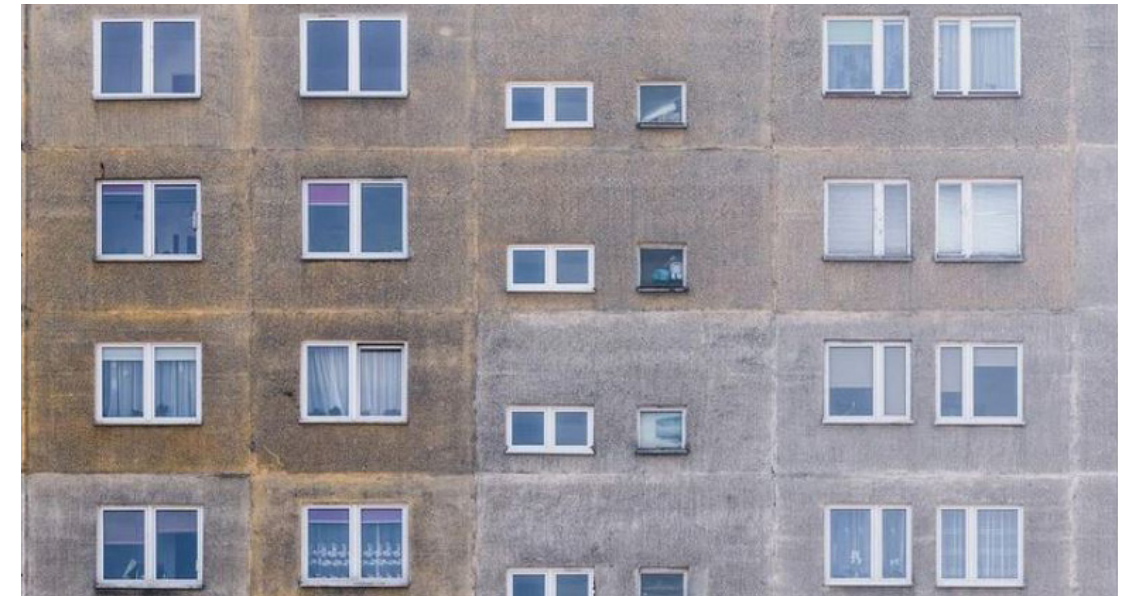
Façade of the WUF-T system building

The basic units were based on a 480 × 480 cm and 480 × 240 cm grid, and later elements of 480 × 155 cm and 240 × 155 cm were also added. The basic spacing of the load-bearing walls was 480 cm, and the transverse arrangement of the walls was the basis for shaping the layout of the building. The floor slabs, unidirectionally reinforced, were 14 cm thick, the internal load-bearing wall slabs were 15 cm thick, and the

partition wall slabs were 5 cm thick. The external walls made of expanded concrete had two thicknesses: 40cm for the load-bearing walls and 36cm for the curtain walls. Sanitary facilities, stairwells, lift shafts etc., as well as basement walls, were also prefabricated. Initially, the forced-assembly method was used, but due to technological problems and lack of sufficient accuracy, it was later changed to the free-assembly method. This is the system with the highest concrete usage rate of all systems found in Poland.

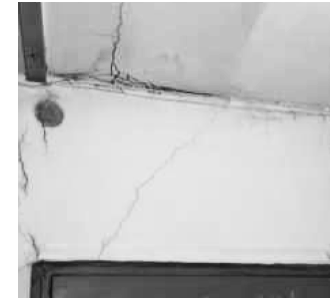
Visible cracking on joints

From the structural point of view, the basic element distinguishing Plattenbau buildings from monolithic ones is the occurrence of joints between the prefabricated elements, which are much more exposed to the risk of cracking. The individual plates were joined by means of welds and then by concrete. The durability of the construction joints is reduced if these operations have not been carried out accurately. This may lead to a reduction in resistance or, in the case of insufficient steel bar covering, to more frequent corrosion. This may be exacerbated by dampness caused by leaks, freezing of walls and inadequate ventilation of rooms. According to a study⁶, in 11% of the cases there were deficiencies in the reinforcement and in 4% there were defects in the execution of the reinforcement and the installation pitches. It is also noticeable that the concrete cover falls off and tears appear in the joint lines of prefabricated elements.

From the conducted research, including the ITB report, it results that the state of prefabricated elements joints is good, the occurring defects do not threaten the stability of the structure and the integrity of the buildings. However, it is necessary to periodically verify their con-

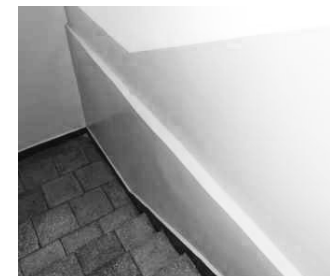
Assembly errors, no common wall axis.

Research⁸ shows that the largest systematic error was in the height of the precast wall panels. External wall slabs made flat have too large dimensions. This is due to hinge loosening with mould usage. Internal walls, made in vertical battery moulds are mostly too low. This could be due to the concrete not being poured to the correct height or shrinkage during accelerated maturation. There was a similar problem with the precast floor slabs, which were also made vertically.

With such a lack of accuracy in assembly, deviations increased with each successive storey. For example, the height of the flats could increase by as much as 10-20 mm, which might seem to benefit the residents, but the threshold at the balcony, which was designed to be 70 mm high, became too low, causing rainwater to leak into the building. The increased height of the storey also had a negative effect on the staircases. Stair treads had to be supported at an angle, which resulted in poorer stability and also increased the chance of slipping from steps that were not perfectly horizontal.
