Appendix C - Technical Report n° CCLab2000.1b/3

Experiments on Simple, Continuous and Bonded GFRP Beams

Julia de Castro San Román

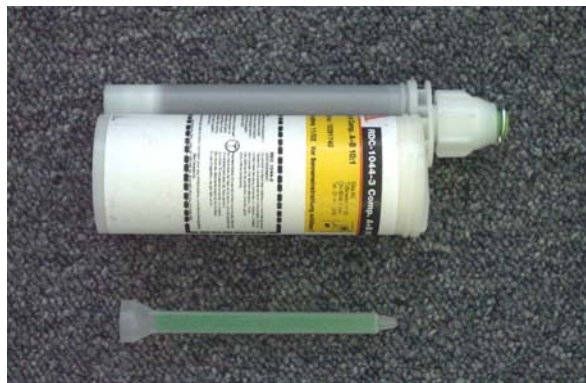
Figure 8 ADP (SikaFast 5221) in a cartridge (250 ml), used for small series, and the appropriate static mixer tube

The adhesive used in this experimental study was the acrylic-based two-component SikaFast 5221 structural adhesive, based on ADP (Acrylic Double Performance) technology, developed by SIKA AG. ADP technology offers a new generation of fast-curing elastic adhesives designed to substitute welding and mechanical-fastening techniques. The adhesive choice was based on preceding experiments on bonded GFRP double-lap joints using epoxy, polyurethane and acrylic adhesives (de Castro 2005 a). It is a highly nonlinear and flexible adhesive allowing good load transfer in joints, increasing failure load and development of large deformations. The SikaFast 5221 adhesive is designated ADP adhesive in this experimental report.

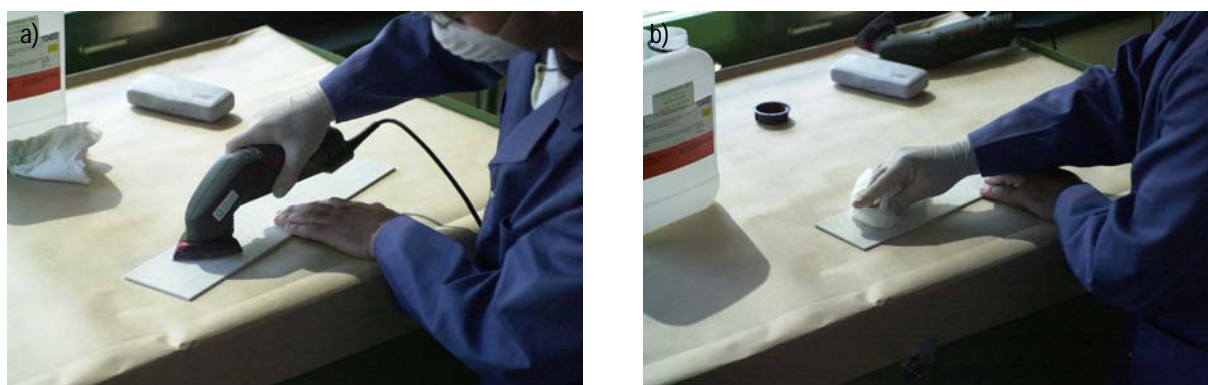
The joint's resistance and durability depend on the adhesive and surface treatment. Surface treatment eliminates the layers of greases and release agents as well as low-cohesion layers (dust, oxides) and improves anchorage between adhesive and adherends by increasing the latter's roughness. In this study, surface treatment of the GFRP beams and laminates started with degreasing, sanding and cleaning the future bonded area (Figure 10). Isopropanol or acetone solvents compatible with the polyester, the composite material resin, were used to degrease surfaces. A Bosch GDA280E sander with 80-grit abrasive paper was used to remove the polyester and surface veil until the mat appeared at a depth of approximately 0.1 mm. This mechanical treatment was applied until the shiny surface disappeared, taking care not to damage the first fiber layer. The bonded areas were degreased again with the solvent to remove deposited abrasive particles. The ADP adhesive required the application of two additional products: an activator and primer number 215 from SIKKA (AG) (de Castro 2005 b). They were applied according to the supplier's (SIKA AG) specifications.

Figure 10 Surface treatment (a) sanding and (b) degreasing

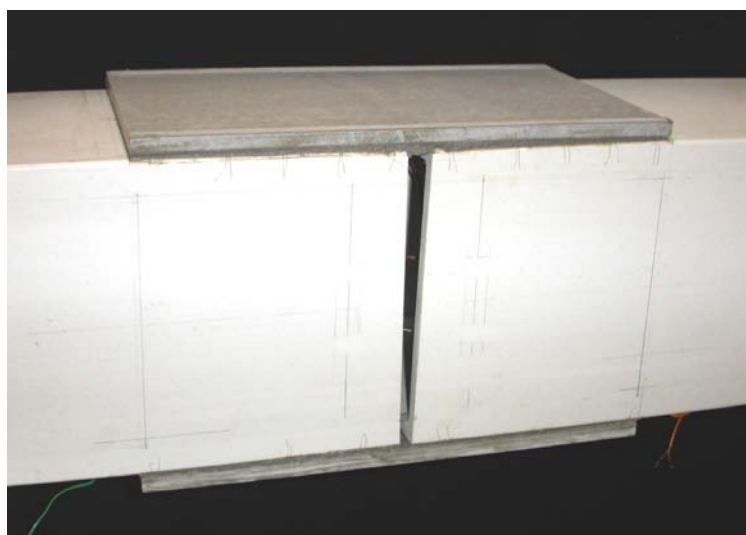
Figure 12 Adhesively-bonded connection of beam PH2

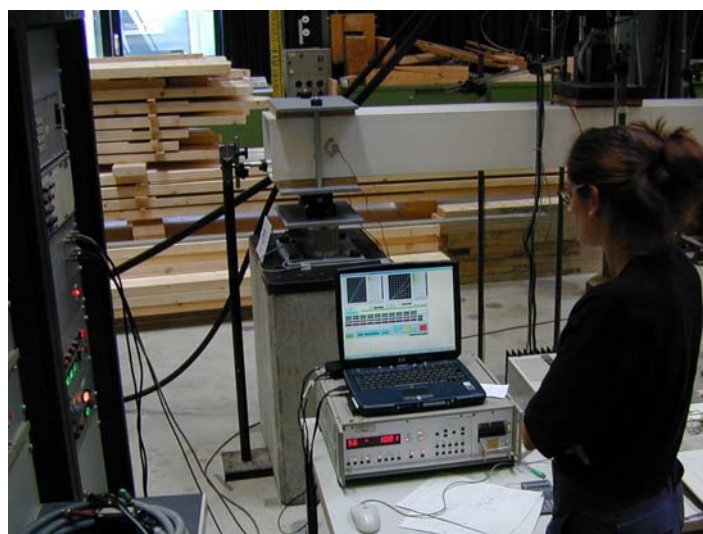
Figure 17 Data acquisition unit

All experiments except the creep experiment were performed with automatic measurements every 2-3 s. The data-acquisition unit was an HBM UPM 60 with 60 channels for beams PS1-3 and PC1 and an HBM UPM 100 with 100 channels for beams PC2-3 and PH1-4 (Hottinger Baldwin Messtechnik GmbH, Darmstadt, D). A data-acquisition program was developed in LABVIEW programming language for this experimental study. This program allowed the test evolution to be followed and data acquisition to be verified on different graphs. The recorded data were:

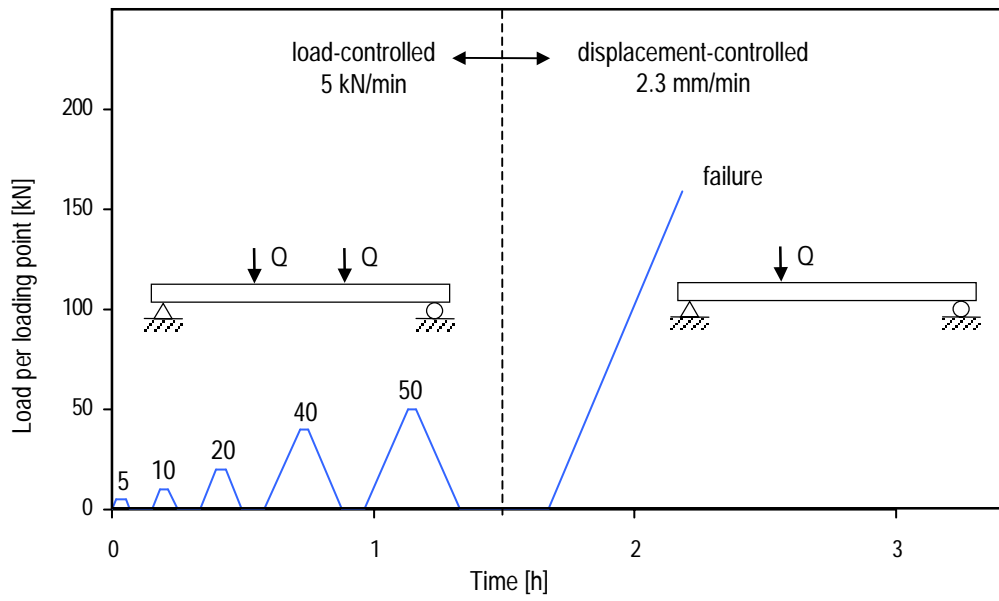
Figure 22 Loading procedure, beam PS2

In the first phase, each beam was subjected to several loading cycles at different load levels to observe beam behavior and check that instrumentation was operating correctly. Cycles were mostly performed load-controlled at a rate of 0.5 kN/min. For beams PS1-3, each cycle included a 1 min plateau after loading and a 5 to 10 min plateau after unloading. For beams PC1-3 and PH1-4, each cycle included a 5 min plateau after loading and unloading. For beams PH1-4, maximum load levels corresponded to the first cracking sound, when loading was stopped to identify any permanent large deformation. In the second phase, beams were loaded up to failure, under displacement-control at 2.3 mm/min (PS1-3), 1.2 mm/min (PC1-3) and 1.5 mm/min (PH1-4). Displacement-controlled rates corresponded to the load-controlled rates of the first phase.

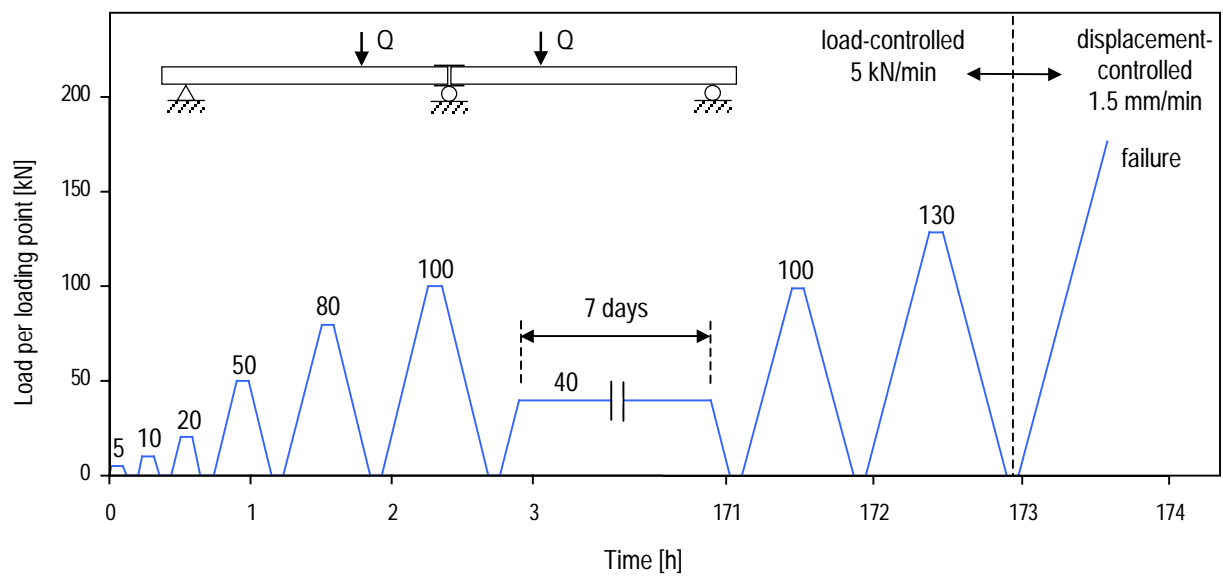
Figure 23 Loading procedure, beam PH2

With regard to the very flexible adhesive used, a 7-day creep experiment was performed on beam PH2 between the cycle and loading-up-to failure phase. The applied load was 40 kN per loading point, corresponding to an immediate mid-span deflection-to-span ratio of 1/400. This ratio is in the order of magnitude of admissible deflection ratios at serviceability limit state (e.g. according to Eurocode).

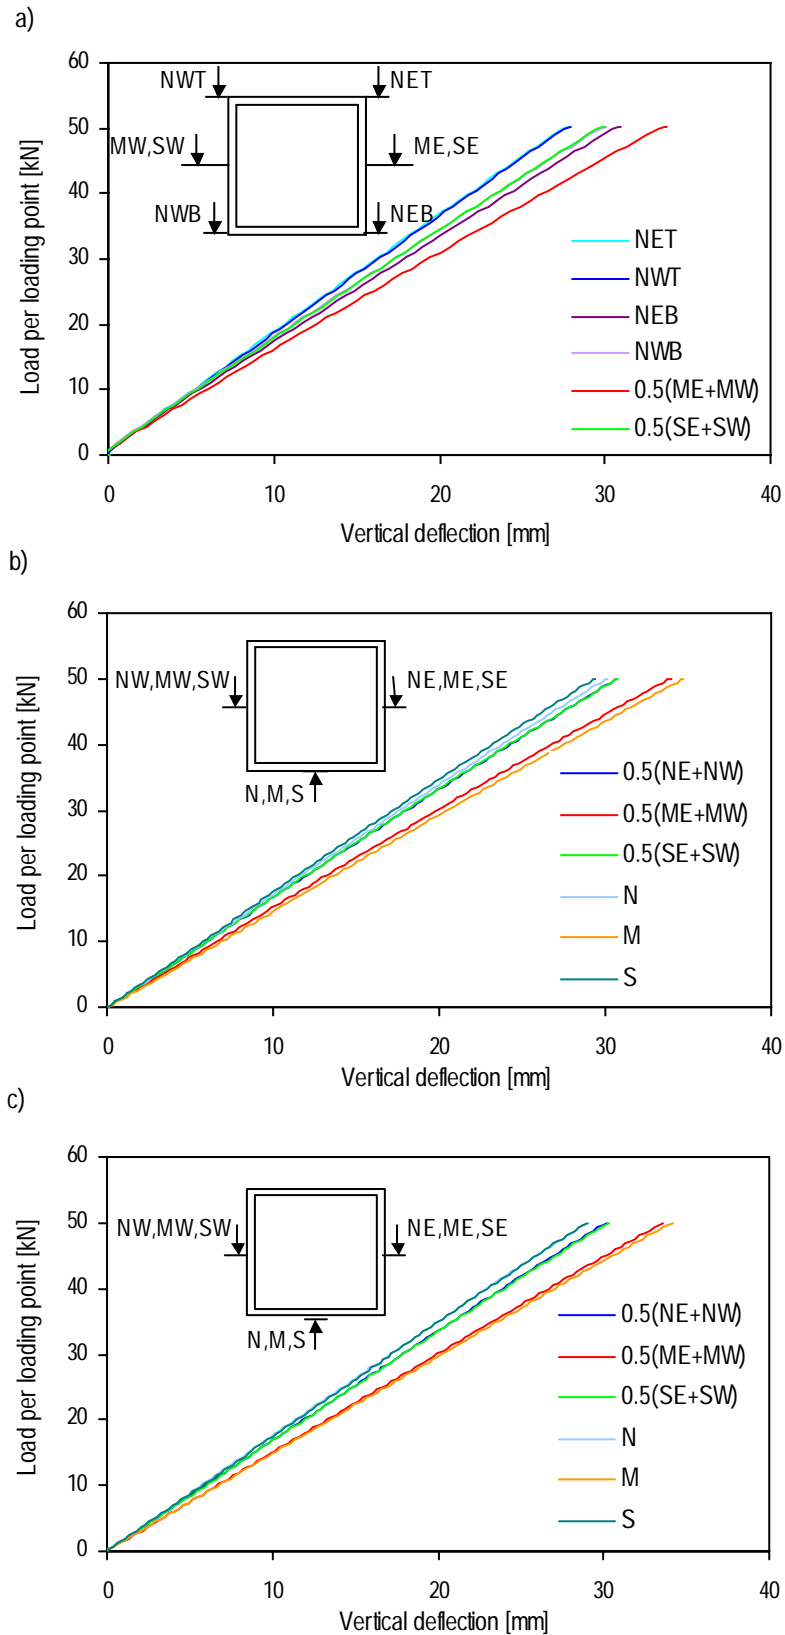
Figure 27 Load-deflection results at mid-span and third-points at 50 kN for beams (a) PS1, (b) PS2, (c) PS3

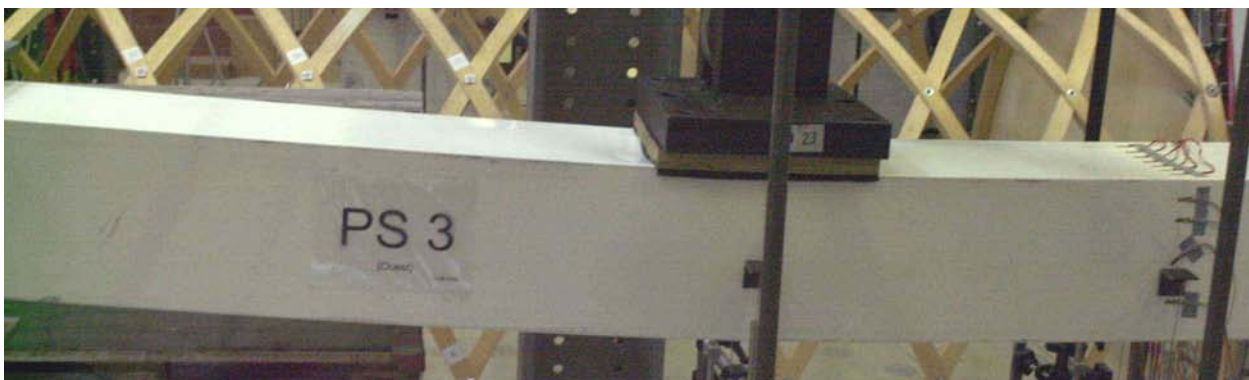
Figure 29 Buckling deformation in beam PS3

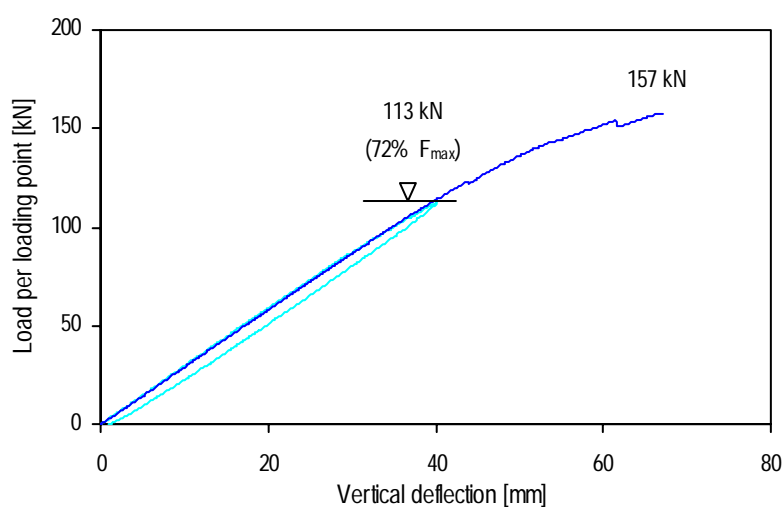
Figure 30 Load-deflection results at loading section for beam PS3

Beams PS1 and PS2 were subjected to a three-point loading up to failure. Beam PS3 was first subjected to a loading cycle over 113 kN (approximately 72 % of failure load), the first cracking sound, then to loading up to failure (Figure 30).

As previously mentioned, beam PS3 was first subjected to a loading cycle up to 113 kN (approximately 72% of failure load), subsequently it was loaded up to failure. The load-deflection curves on the load-application axis of beam PS3 are plotted in Figure 30. The load-deflection curves were similar. Beam behavior was linear-elastic and stiffness remained constant.

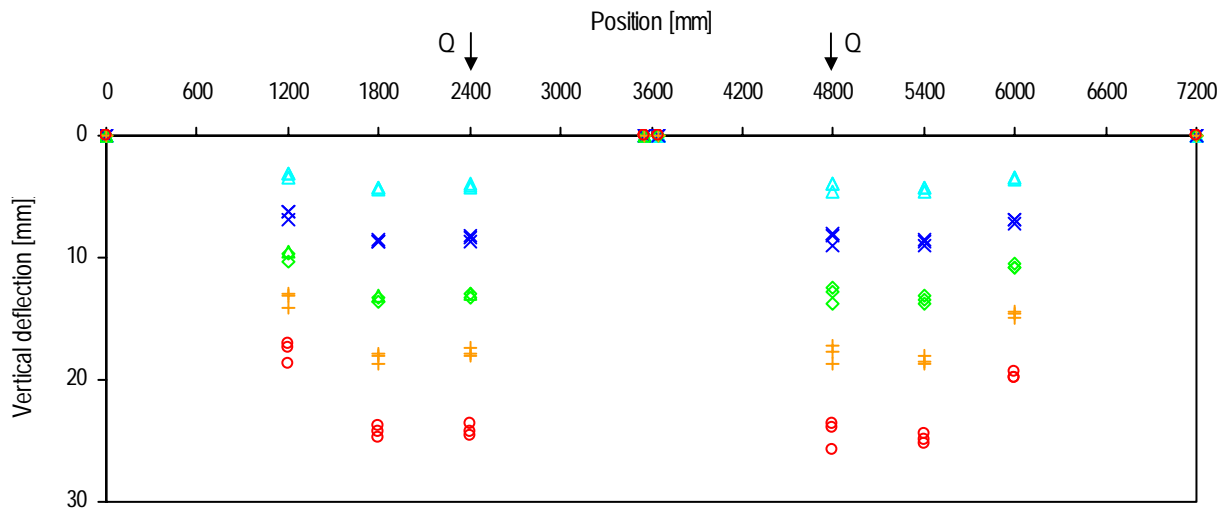
Figure 49 Deflections in longitudinal direction at 25, 50, 75, 100, 125 kN for beams PC1-3

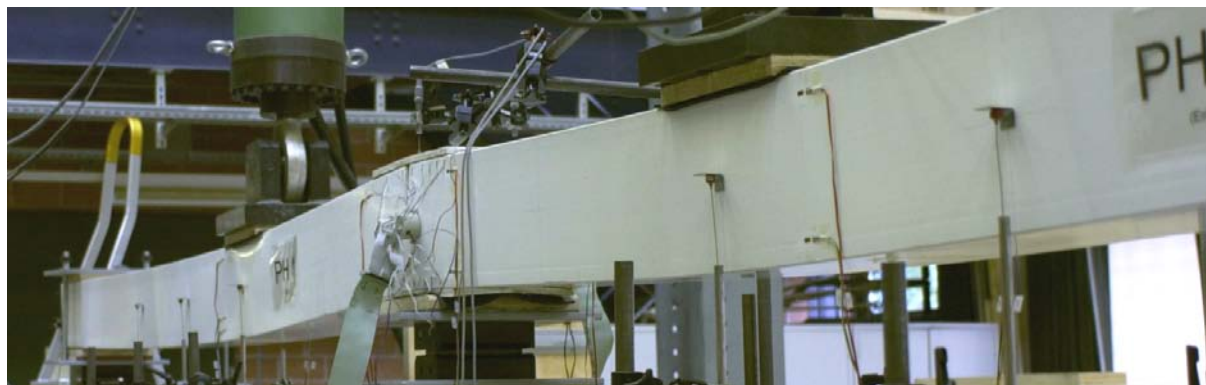
Figure 59 Loading of beam PH1
