TECHNICAL REPORT

Fire Reaction Experiments

Charring Experiments 02 & 03 (CE02-CE03)

GFRP Specimens on Small Horizontal Oven

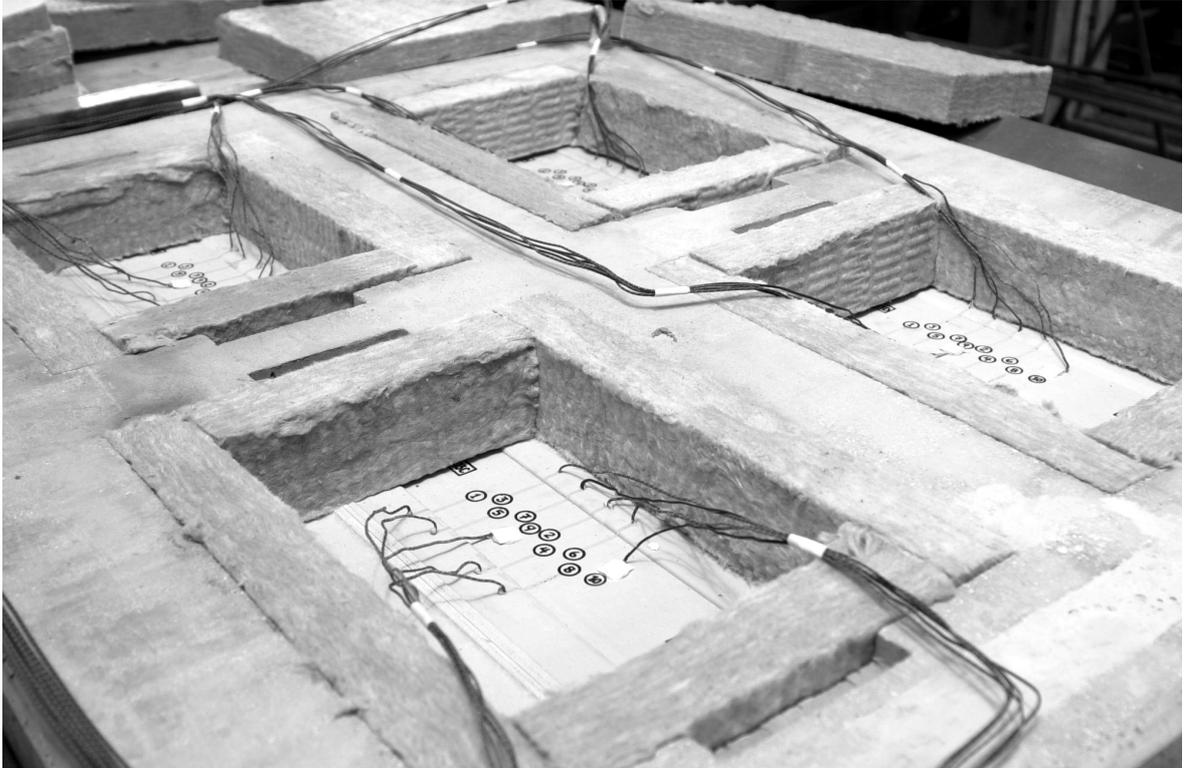
Figure A-9. CE02 - Ceramic wool insulation used to prevent the escape and spread of flames

The method of sealing the gaps around the specimens using ceramic wool had its advantages and disadvantages. Although it did prevent the spread of flames to the cold side of the specimens, it also changed the boundary conditions on that face. While the central portions of the cold faces were cooled by natural convection of air at ambient temperatures, the portions below the insulation were not. As mentioned in the previous sections, this effect resulted in more severe conditions and, thus, more damage around the edges than in the centers of the cold faces (see Figure A-19). One possible solution would be to equalize the boundary condition by covering the entire cold faces of the specimens with the insulation material.

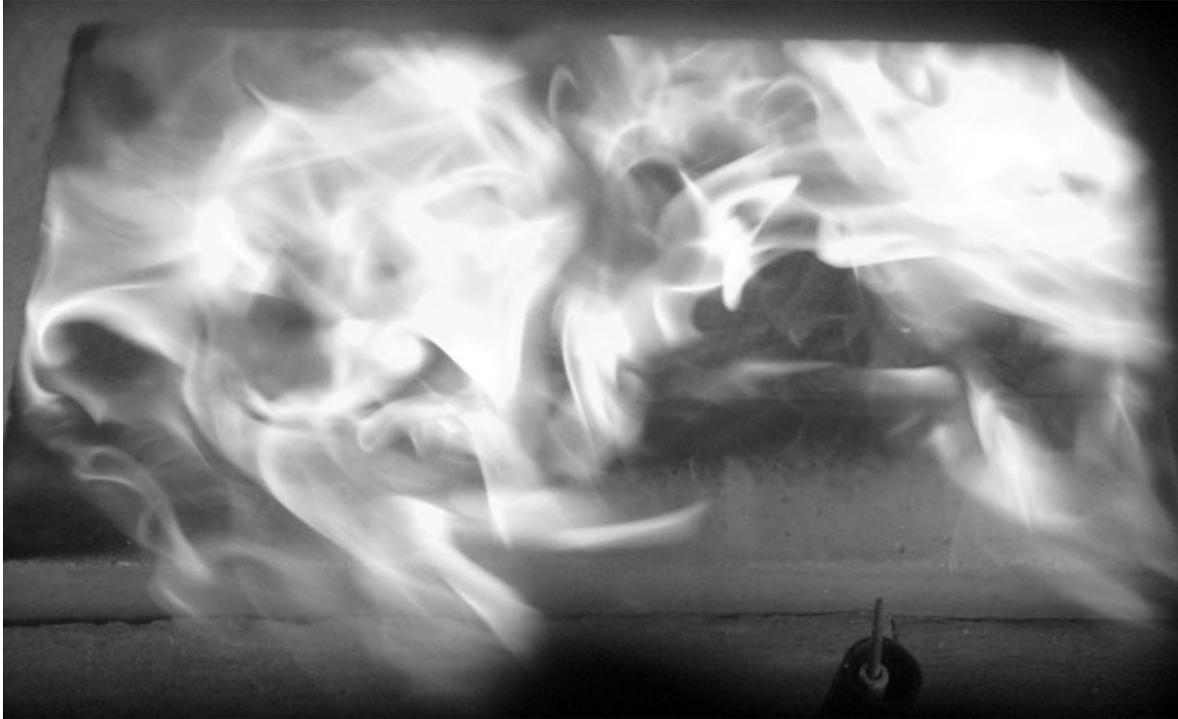
Figure A-11. CE02 - 12 Minutes - Flaming combustion engulfing hot face of specimen

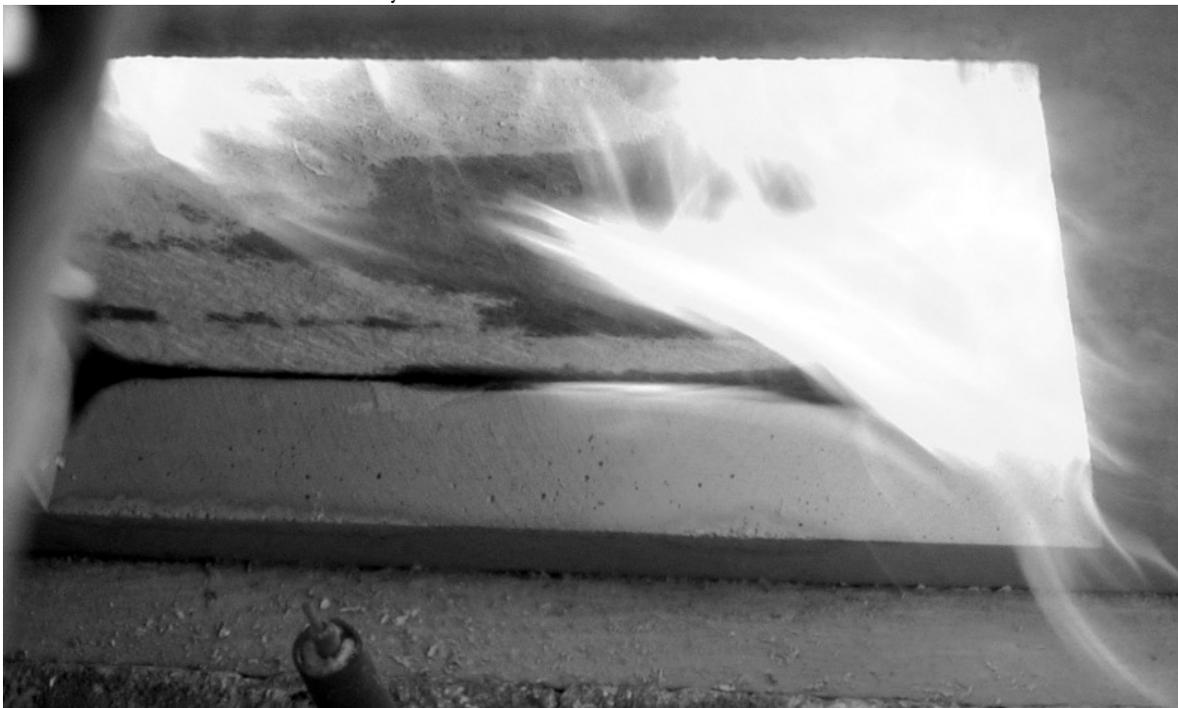
Figure A-12. CE02 - 34 Minutes - Black char from resin mostly cleared out from hot face, white glass fiber char from random mat clearly visible

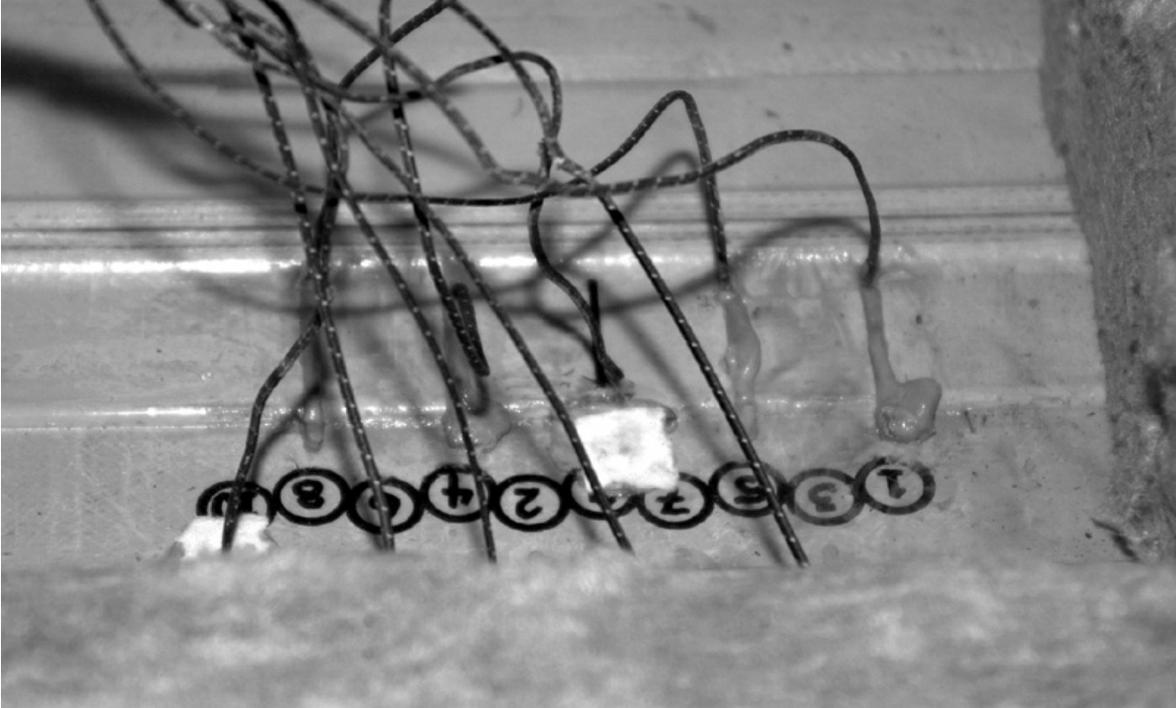
Figure A-15. CE02 - Epoxy used to fill in slots over thermocouples 1, 4, 5, and 8 of specimen 02D softening and flow out of slots

During CE02, the epoxy used fill in the slots on specimen 02D began to flow out after approximately nine minutes (Figure A-15). When the sample finally cooled, the epoxy hardened to its proper state. This is most likely the result of mixing the epoxy in improper proportions of the two components. Normally there is little possibility of error when the entire

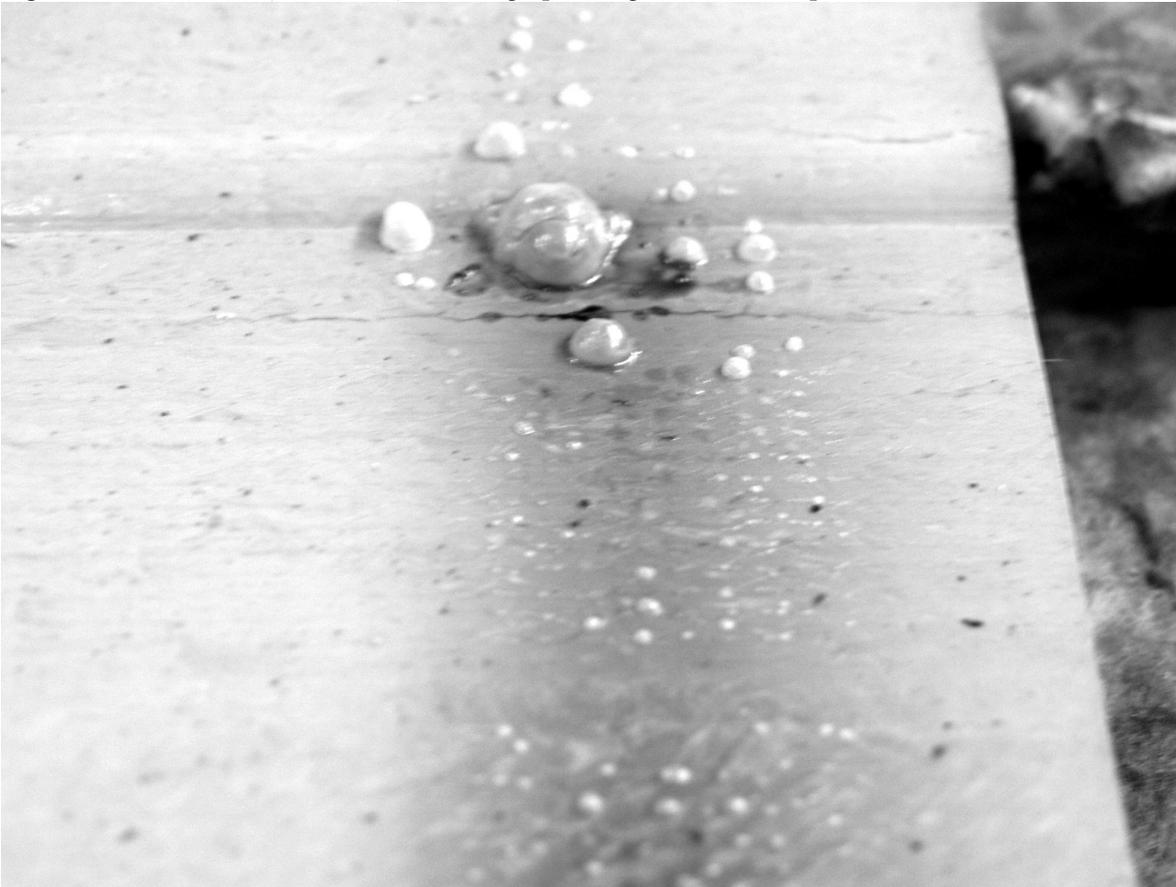
Figure A-16. CE03 - Styrene slowly bubbling up through cold face of specimen 03D

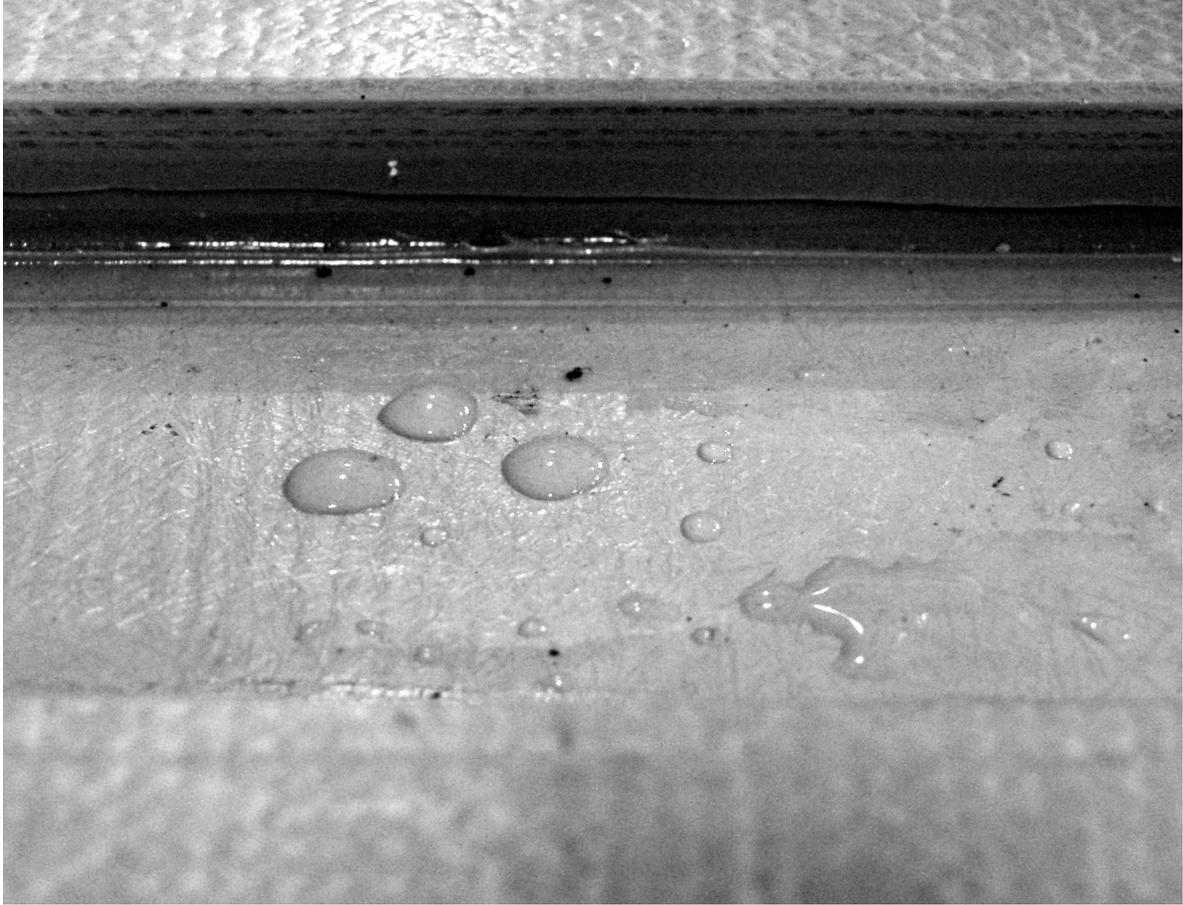
Figure B-12. High pressure in LC02 causes water to leak up through pinholes in the thin plates used to cover the access holes

As seen in Figure B-12, the high pressure in LC02 caused water to leak up through pinhole-sized imperfections in the thin plates. The decrease in negative gas pressure in the oven also suggests that some water was leaking into the oven. Though invisible to the eye, small amounts of water leaking into the oven would turn to vapor immediately and their increased volume would have the effect of lowering the negative oven pressure. This possibly occurred as the material below the thermocouple slots was removed and a passage for the water was created.

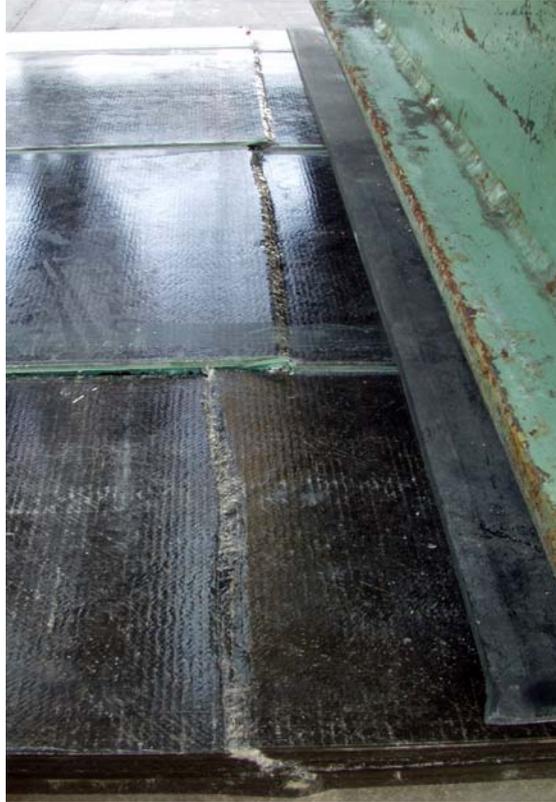
Figure C-16. SLC03 - Failure of upper face sheet

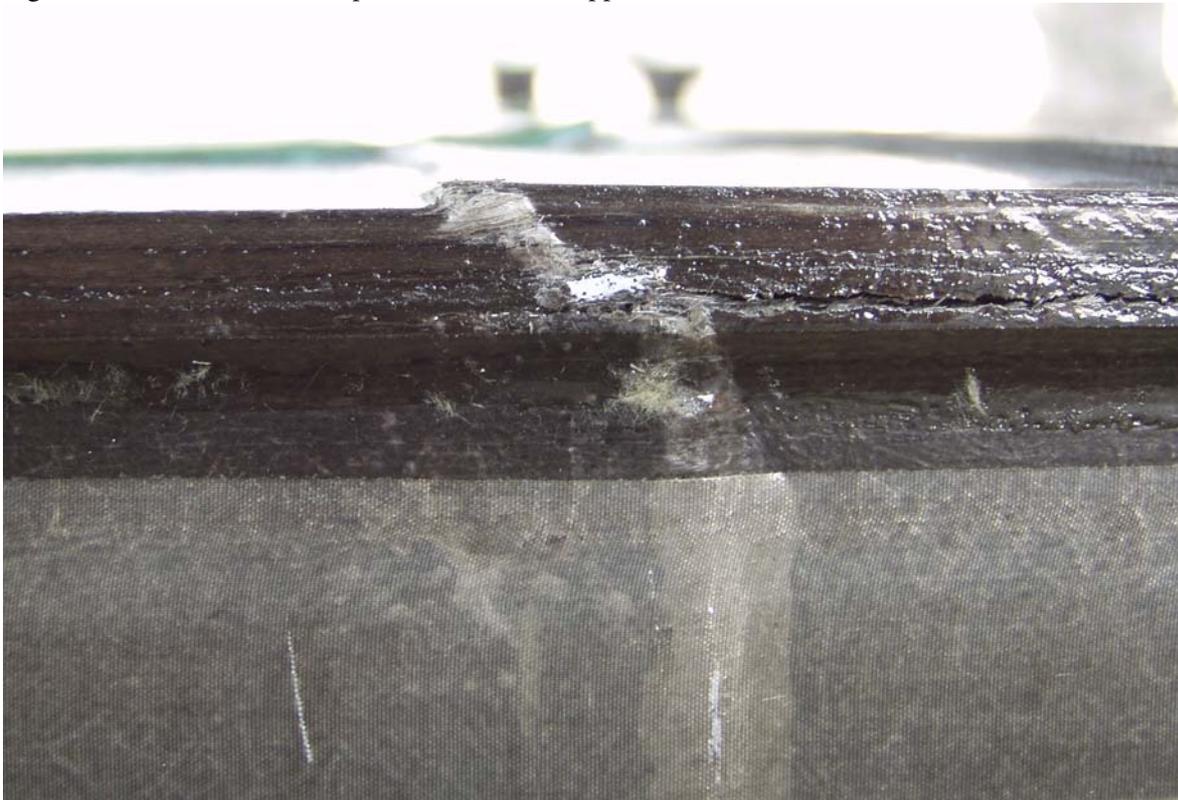
Figure C-17. SLC03 - Close-up view of failure in upper face sheet
