STRUCTURAL BEHAVIOR AND DURABILITY OF MULTIFUNCTIONAL FIBER-REINFORCED POLYMER COMPONENTS

THÈSE N° 3695 (2006)

Laboratoire de construction en composites

ÉCOLE POLYTECHNIQUE FÉDÉRALE DE LAUSANNE

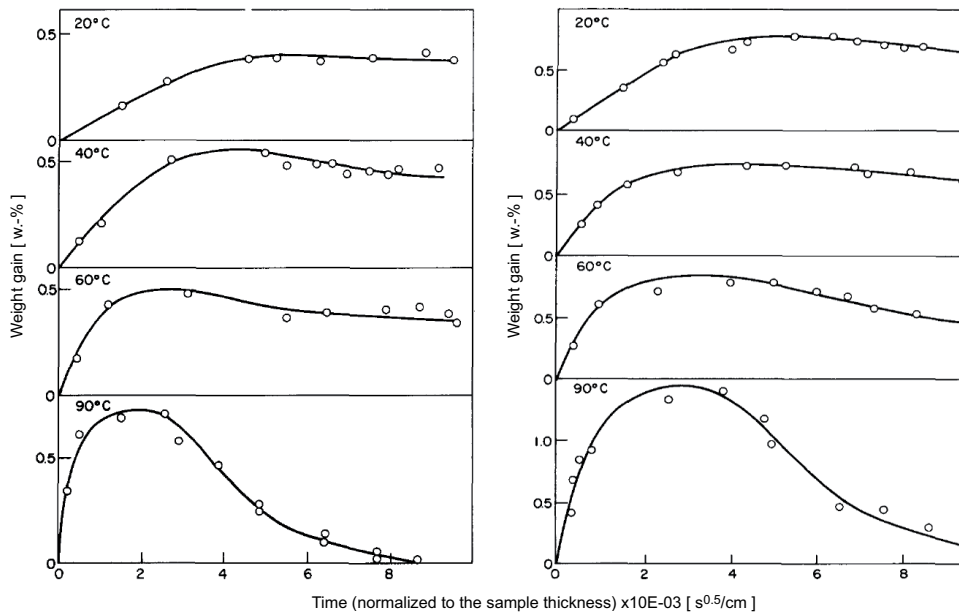
Figure 2.3: Weight gain of pure resin (left) and GRP composites (right) immersed in water at different temperatures (taken from Apicella et al. [8])

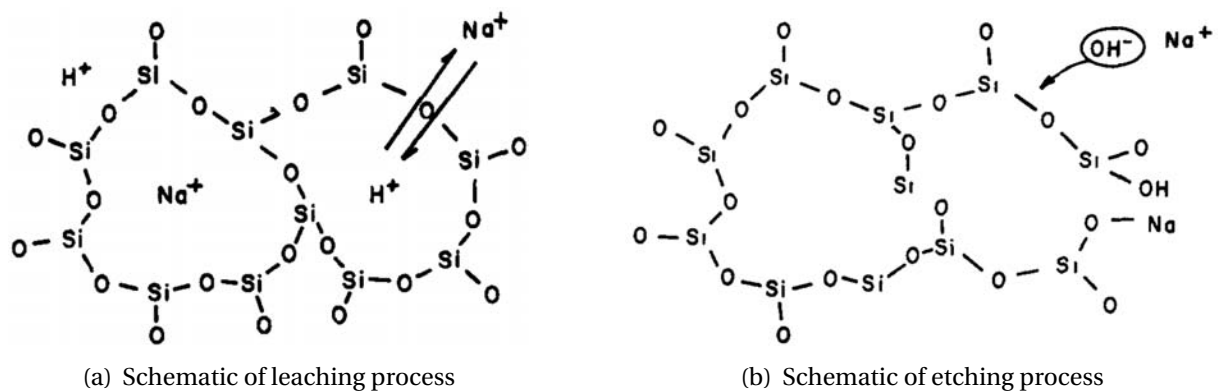
Figure 2.5: Two principle types of glass degradation (taken from Adams [2])

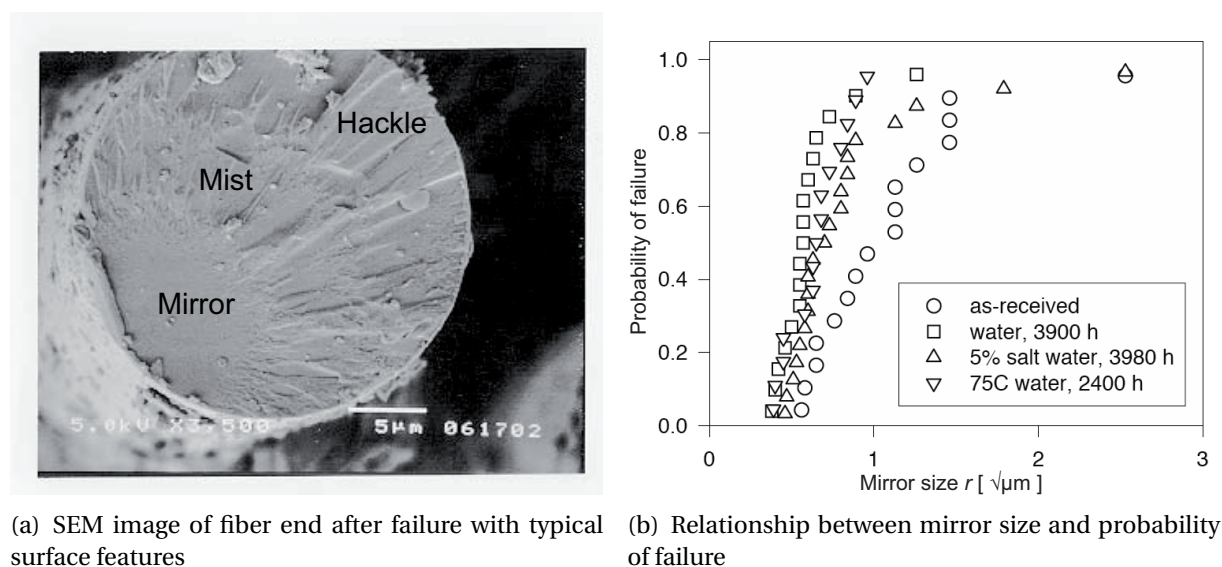
Figure 2.8: Features on broken-fiber surfaces and their relationship to failure probability (taken from Liao et al. [69])

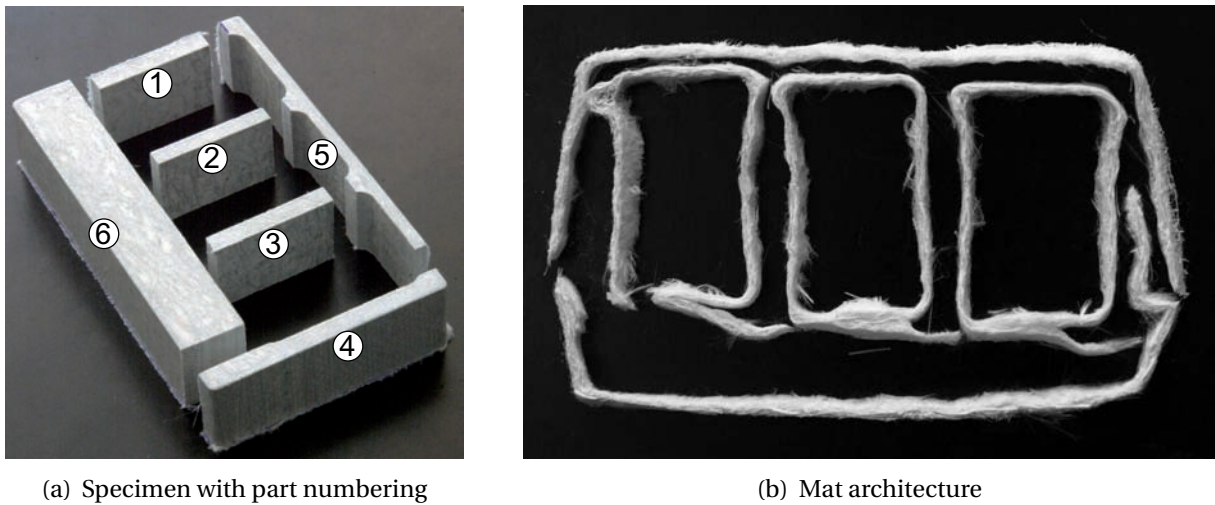
Figure 3.3: Specimen for the burn-off test with part numbering before and after the test.

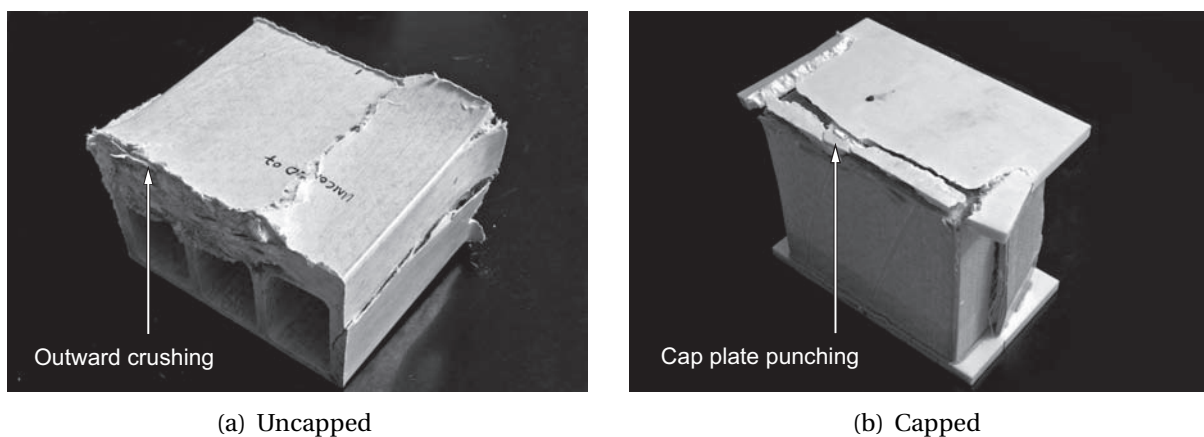
Figure 3.6: Typical failure of unconditioned elements

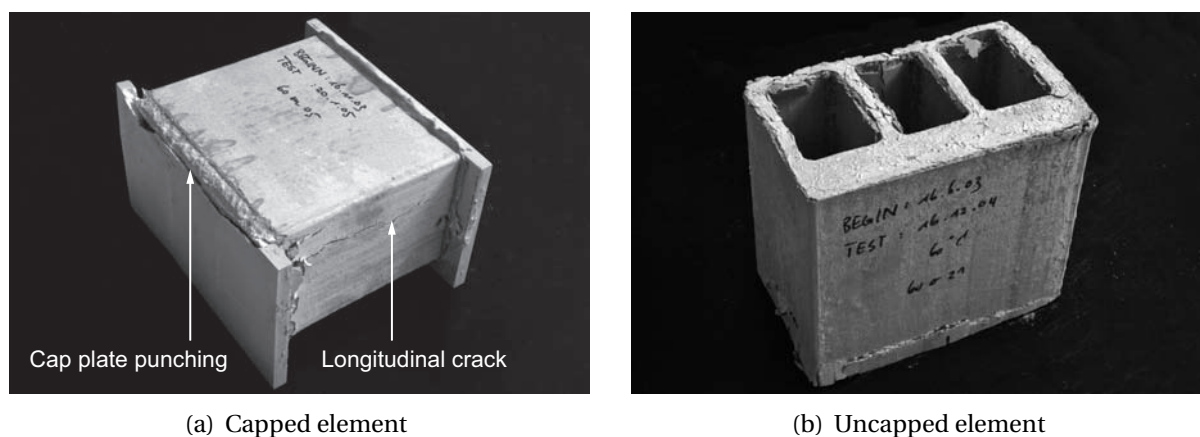
Figure 3.9: Typical failure of elements after long-term exposure at 60°C

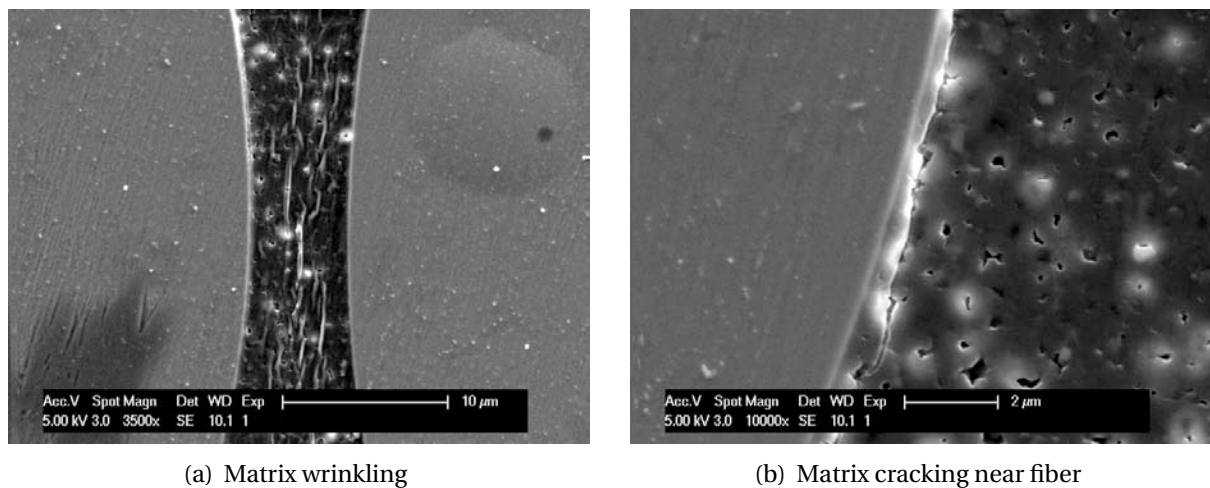
Figure 3.23: SEM images from specimen exposed at 60°C for 13 days

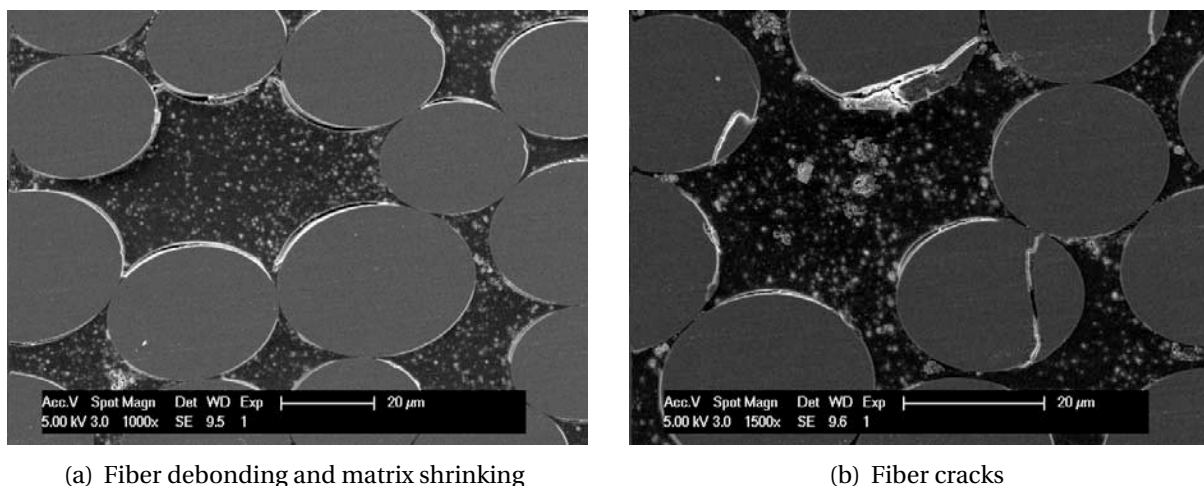
Figure 3.25: SEM images from profile section (near center) exposed to 60°C liquid for 800 days

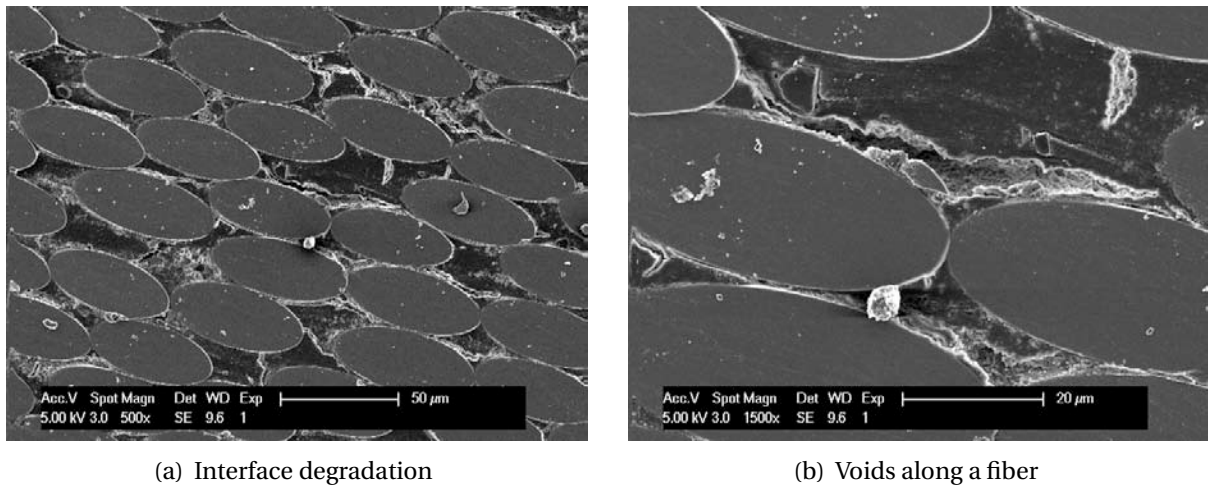
Figure 3.26: SEM images from profile section (near cut end) immersed at 60°C for 800 days

Figure 3.26 shows images from a specimen extracted near a cut edge of the profile, which

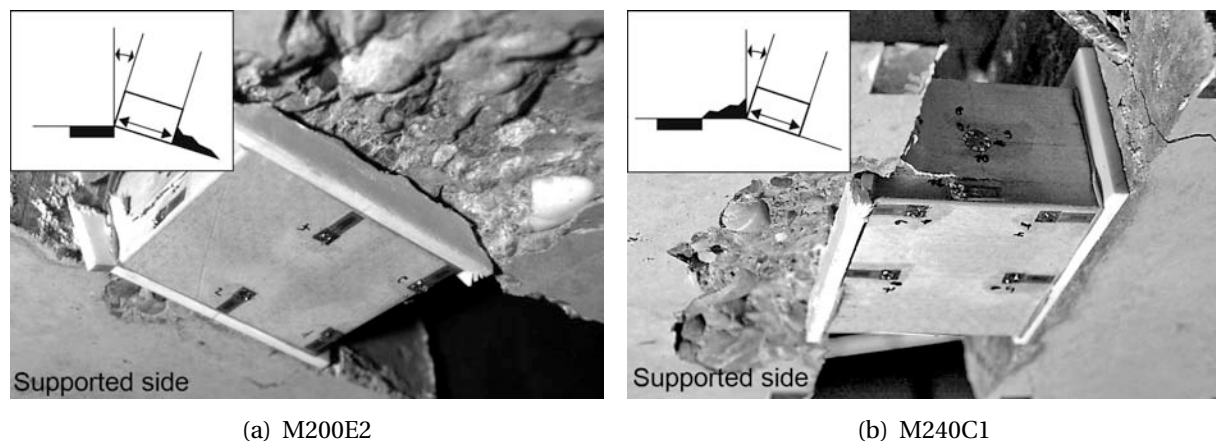
Figure 4.12: Failure modes in moment mode, view from below. (a) Concrete failure at loaded side, no damage at supported side; (b) Concrete failure at supported side, no damage at loaded side

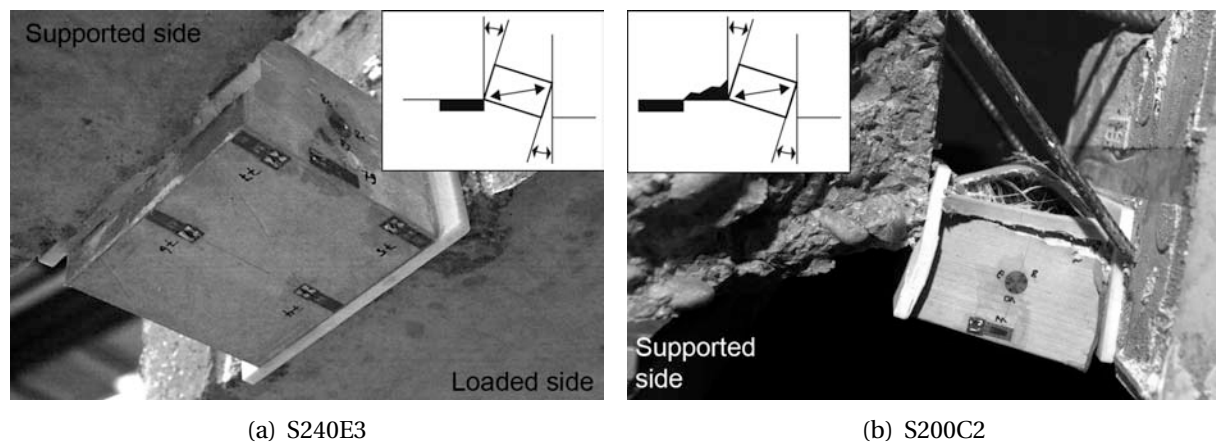
Figure 4.13: Failure modes in shear mode, view from below. (a) Concrete undamaged, steel bar failure, debonding failure (secondary); (b) Concrete failure at supported side, no damage at loaded side

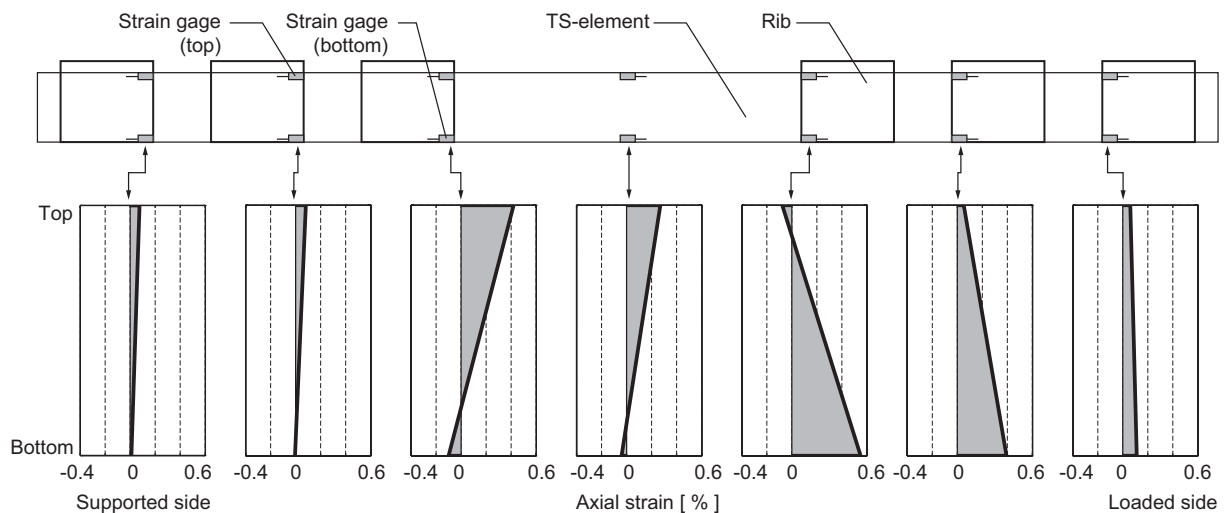
Figure 4.26: Measured axial strain distribution on TS-element's lateral surfaces (average of both sides) through the depth of its cross section at ultimate failure load (S3E1)

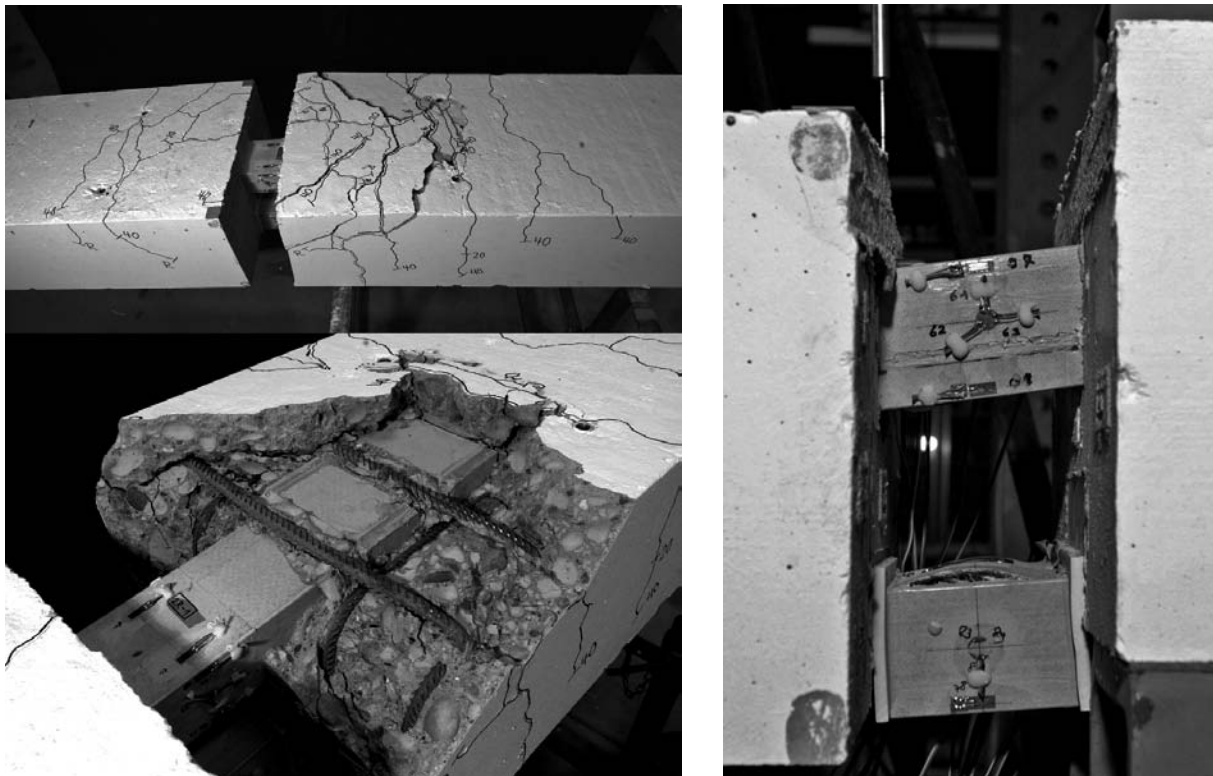
(a) Anchorage failure of beam M2E1 on supported side, deformed retaining steel bars

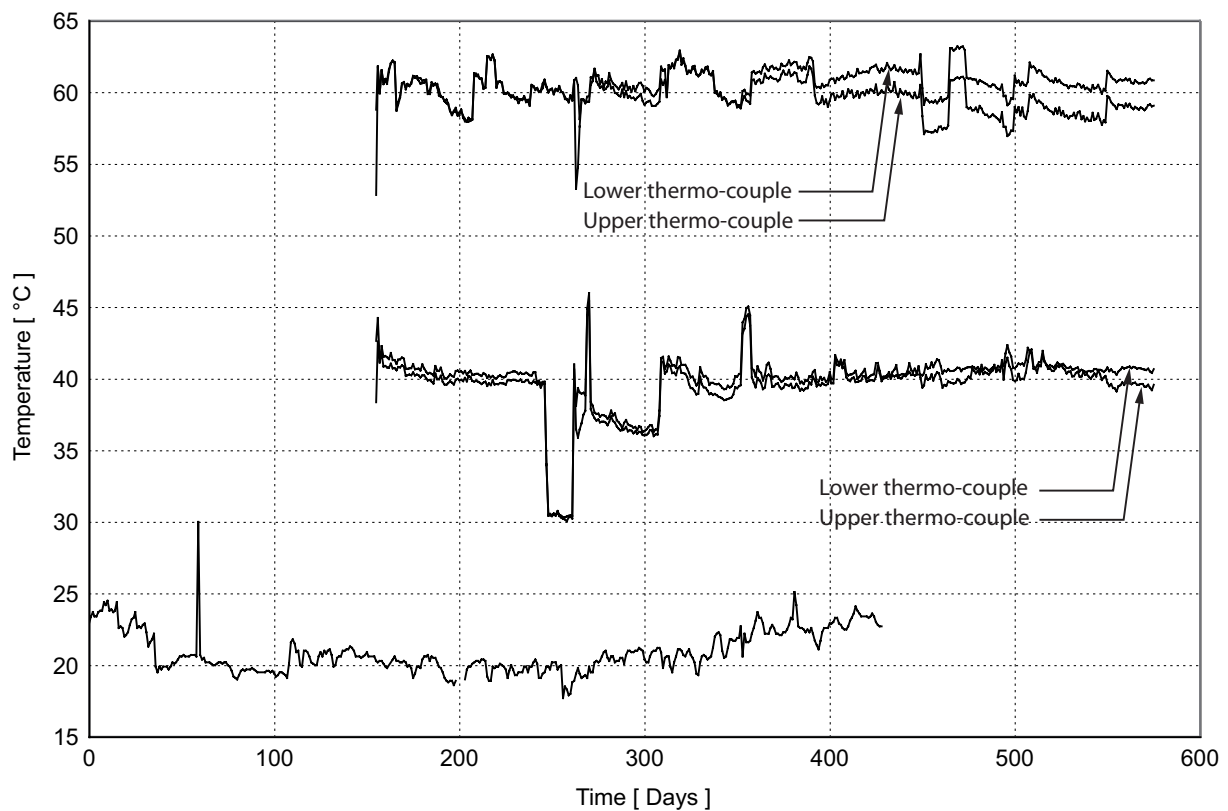
Figure A.1: Measured temperatures in baths and climate tent

Figure A.1 shows the measured temperatures during conditioning. In 40 and 60°C baths the temperatures were measured directly in the baths, while for the 20°C bath they were measured in the climate tent. The electronic recording for 40 and 60°C was installed only after 157 days, so data were only available from this point. Analysis of the data output for measurements in the 20°C climate tent revealed malfunction of the recording after 428 days. The subsequent temperature was displayed and checked but not recorded.

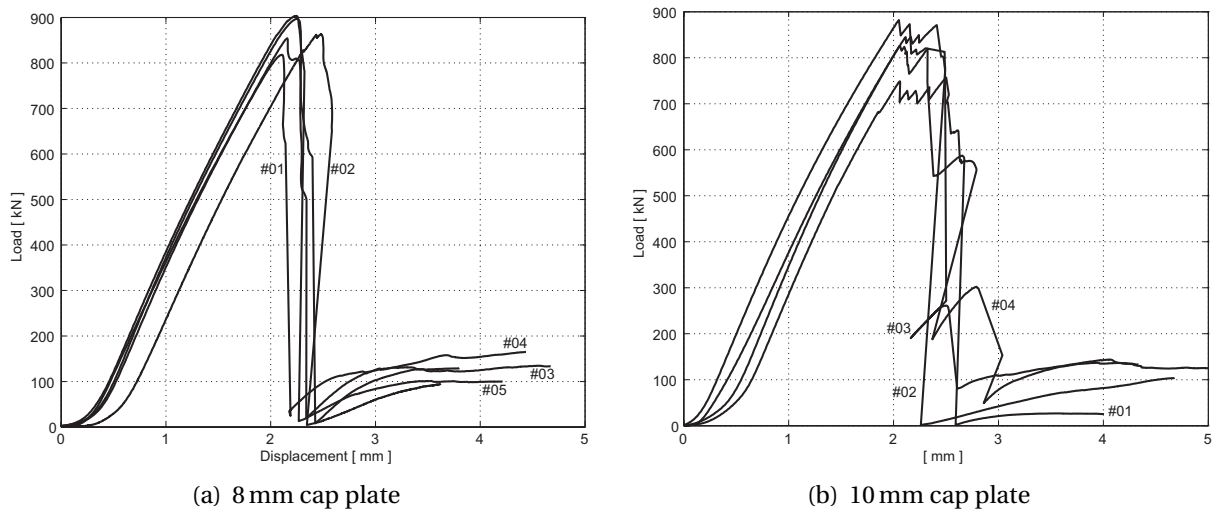
Figure B.26: Load-displacement diagrams of CS-elements with different cap-plate thicknesses

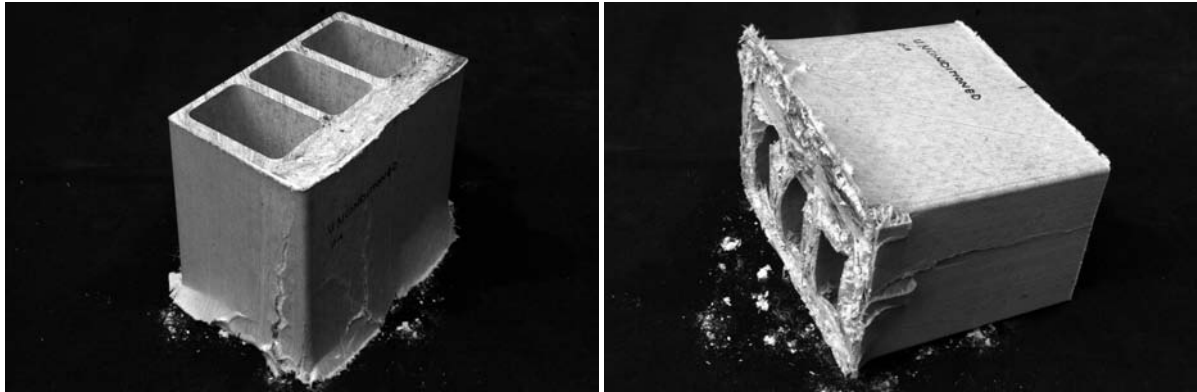
Figure B.90: Uncapped element 01

(a) Longitudinal crack on outer web

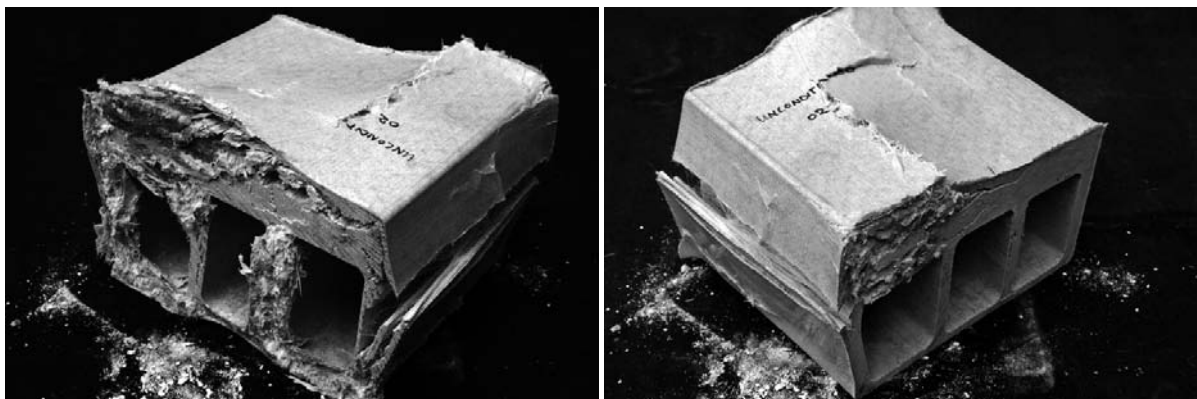
Figure B.91: Uncapped element 02)

(a) Severe asymmetric crushing

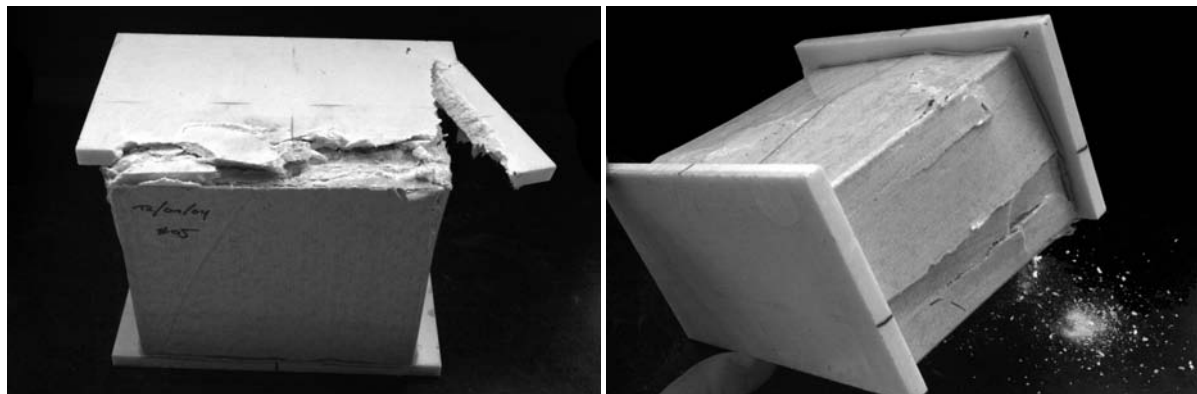
Figure B.96: Capped 05

(a) Punching of cap-plate at upper side

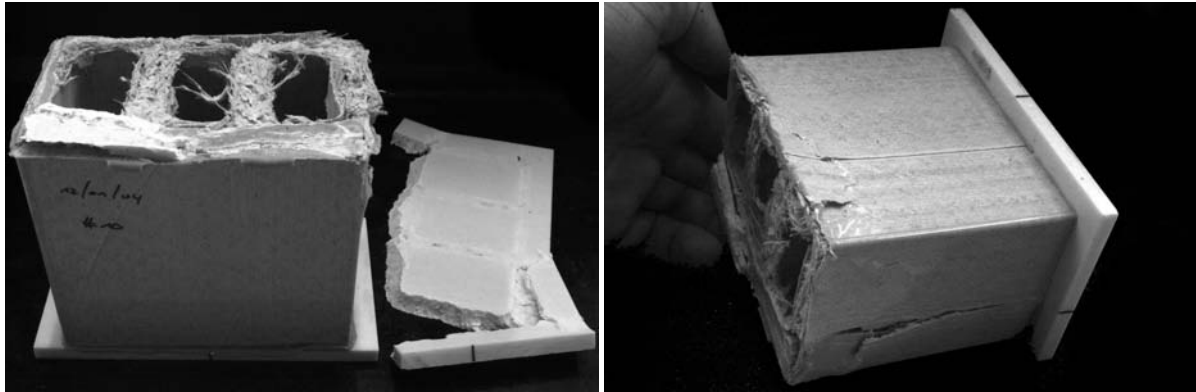
Figure B.97: Capped 10

(a) Outward crushing at upper side and punched cap plate (b) Vertical cracks at at junction outer webs/thick flange

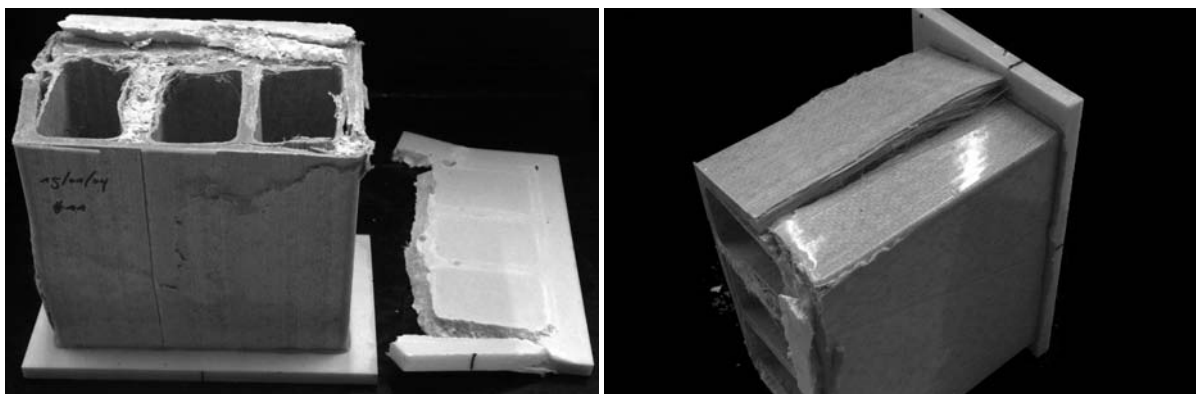
(a) Local wrinkling and punched cap plate (b) Vertical crack on a lateral web

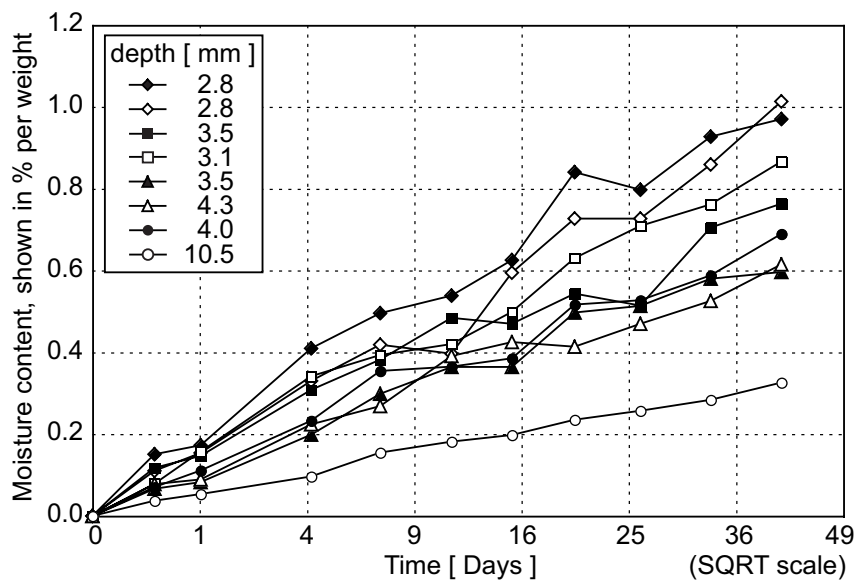
Figure C.1: Weight gain of sealing material

The sealing material (SikaGard-63N[®]) was tested for its weight gain in 20°C alkaline solution. The testing program involved altogether eight specimens with areas of 18×73 mm² and depths between 2.8 and 10.5 mm. Their weight gain as a function of time is shown in Figure C.1. The calculated diffusion coefficient was $0.00032 \cdot 10^{-4} \frac{\text{mm}^2}{\text{sec}}$ and the maximum moisture content, M_{∞} , was 2.51 %. This value, however, was obtained by fitting, since the moisture uptake had not reached an equilibrium as can be seen in the figure.

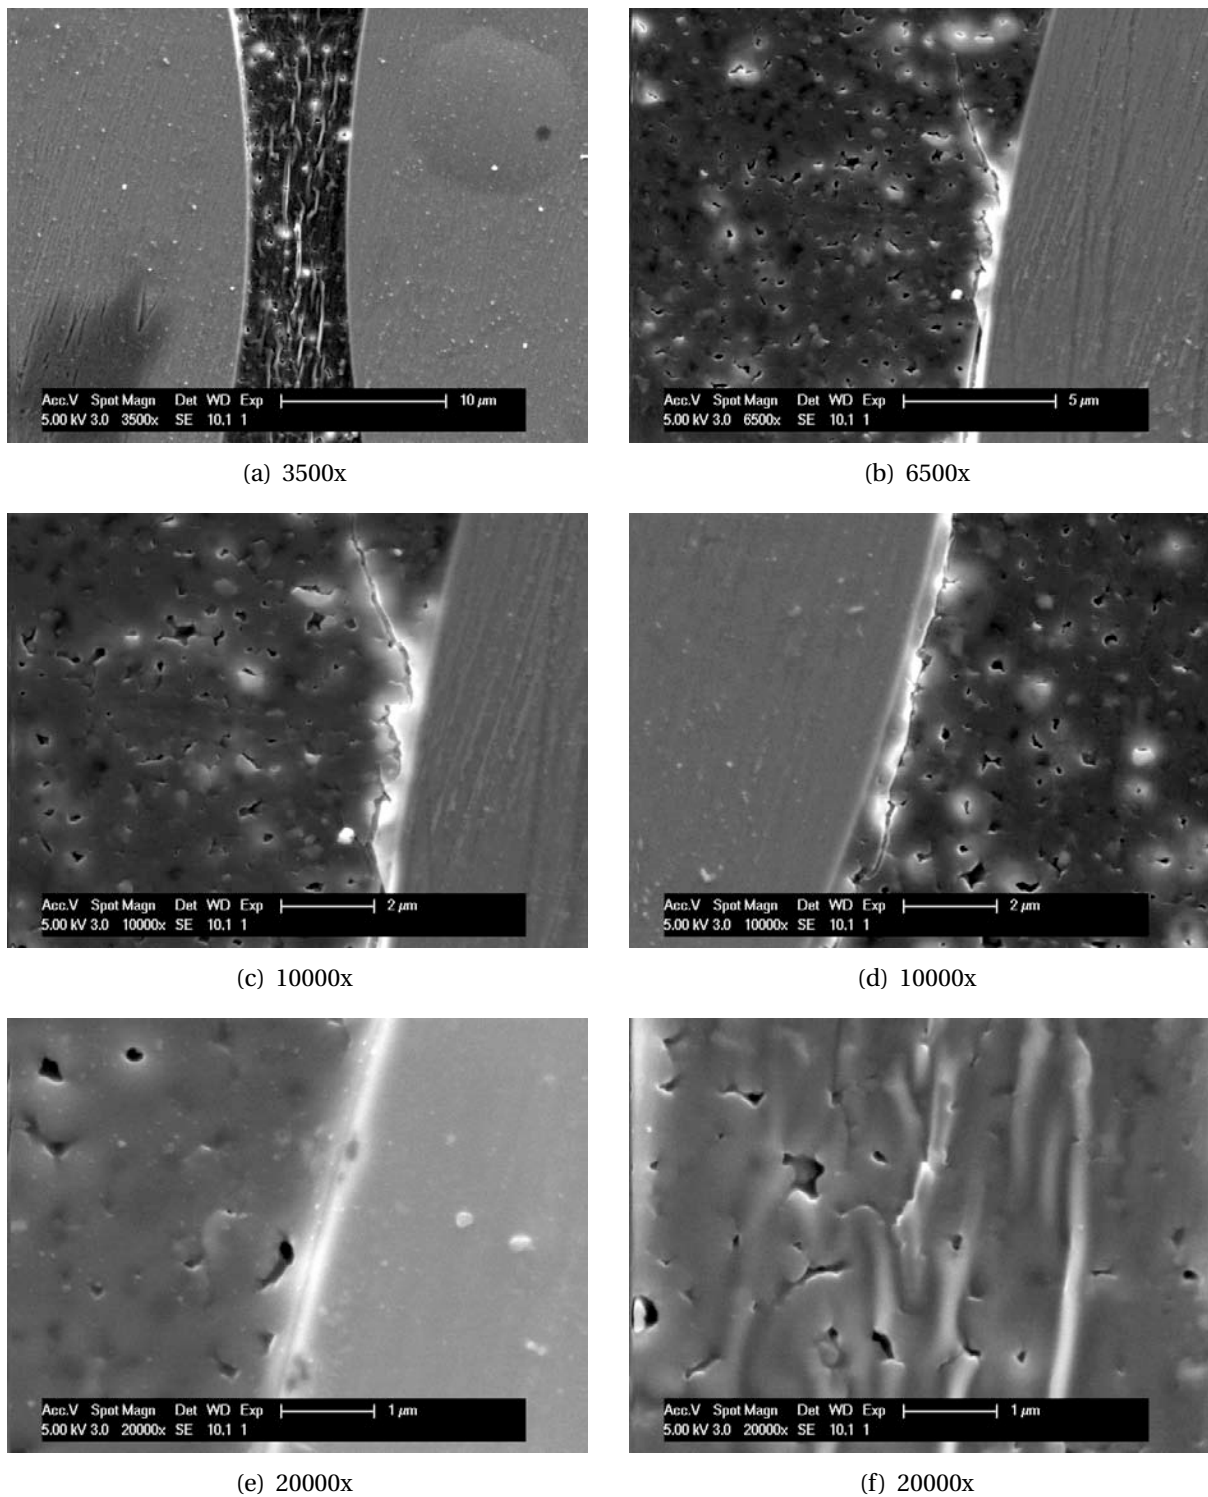
Figure D.5: SEM images taken on a sample polished at an angle to the pultrusion direction and then exposed at 60°C for 13 days

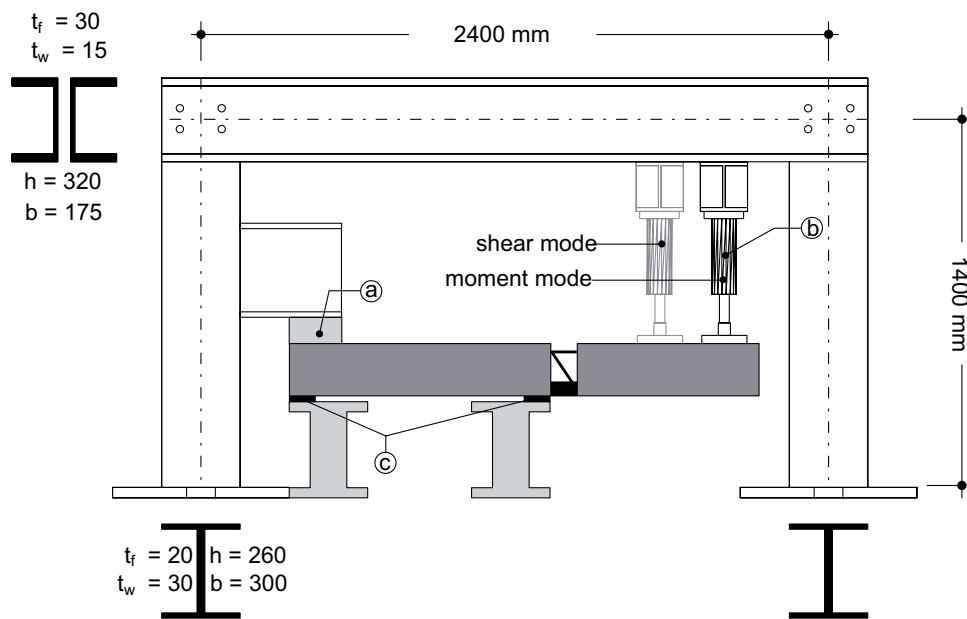
Figure F.1: Experimental set-up of hybrid beams: a) counter bearing, b) loading cylinder, c) steel plates

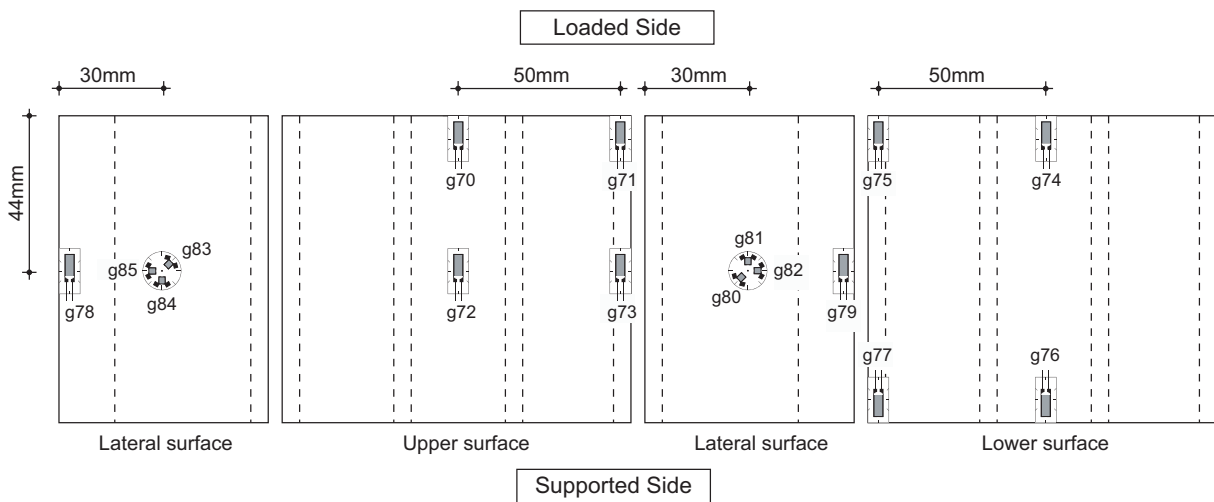
Figure G.5: Distribution of strain gages on CS-element
