Appendix B

Experiments on materials on DVD

B.1 Introduction

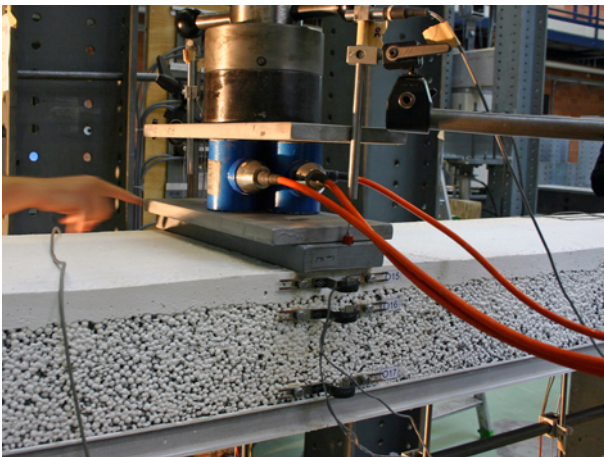
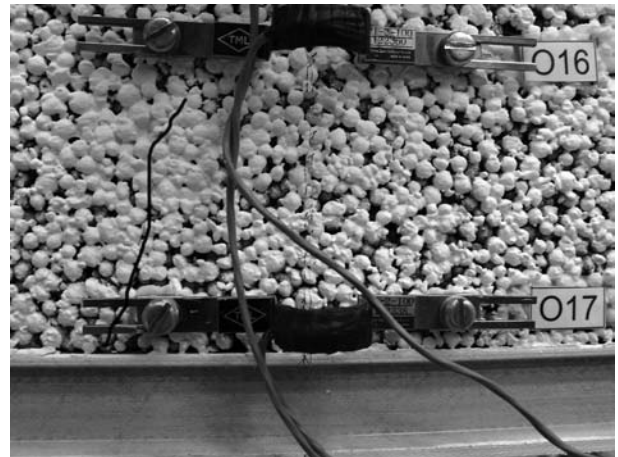
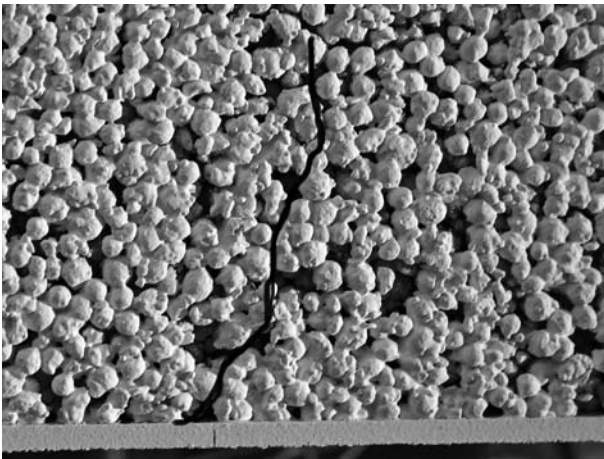
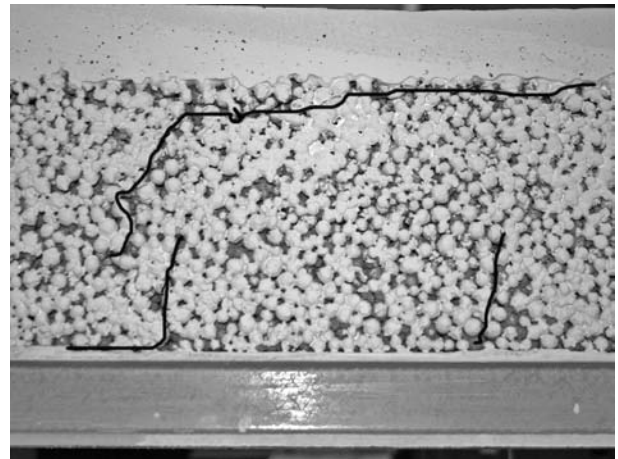
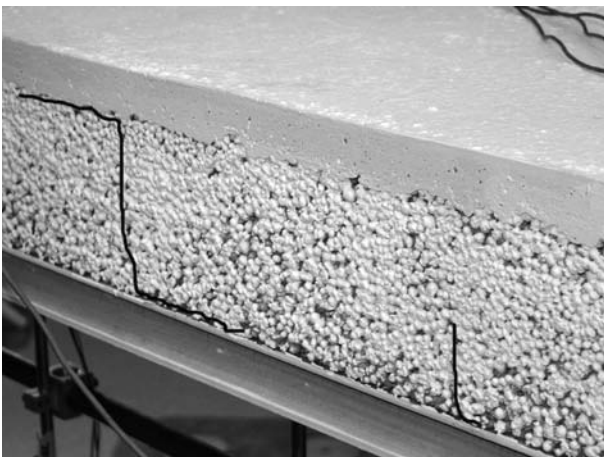
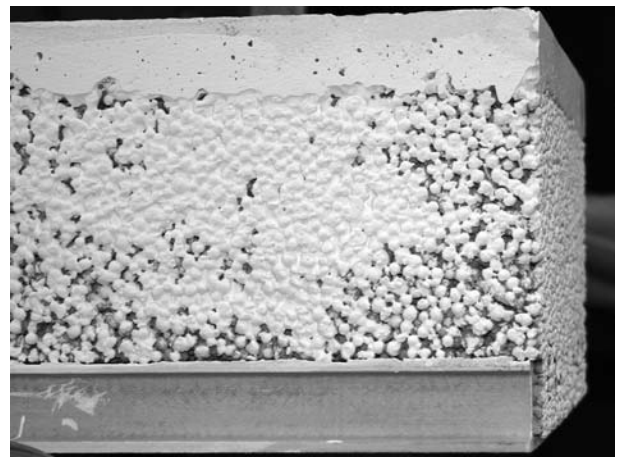
Figure C.17: 900-1: Failure process.

The failure process of beam 900-1 is illustrated in Figures C.17, C.18, C.19 and C.20. This started with audible inner cracking at a load of 5.0 kN. The first obvious cracks appeared at a load of 6.8 kN at mid-span (Figure C.17-b). The ultimate load was reached at $F_u = 9.3$ kN with corresponding deflections of 11.5 mm to 17.3 mm. At this time only very small, short cracks could be observed in the tension zone at distances of up to 45 cm from the mid-span (Figure C.17-c).

Further jack displacement did not increase the load, which remained between 8.5 and 9.0 kN. The cracks started to propagate throughout the LC layer, followed by the LC debonding from the GFRP profile, and the LC being pushed out of the GFRP profile (Figure C.17-d-f). The load dropped to below 7 kN, when one of the cracks on the east side of the beam started to open significantly. It started in the tension zone in the LC at 42 cm east of the mid-span (Figure C.18-a), propagated nearly vertically towards the NC layer and horizontally along the top of the T-webs. Subsequently the crack developed horizontally through the LC core just below the LC-NC interface. Cracks also occurred on the western beam side, and LC debonding occurred progressively on both sides while the crack propagated to the supports (Figure C.18-b) and a significant pushing out of the LC could be observed (Figure C.18-c). The failed specimen is illustrated in Figures C.21 and C.22.

(a) Loading condition

(b) First crack at 6.8 kN at mid-span - north

(c) Crack max load $F_u = 9.3 \text{ kN}$ at 25 cm from mid-span - south west

(d) First continuous vertical crack at 8.6 kN (post-peak) at 42 cm from mid-span - north east

(e) Debonding at 8.4 kN (post-peak) on north west side

(f) LC being pushed out of GFRP profile at 8.3 kN (post-peak) at beam axis F

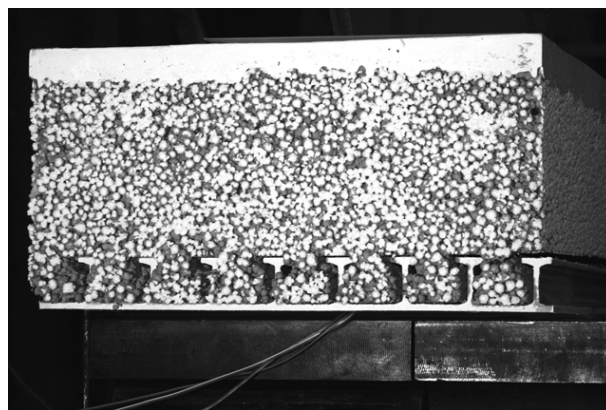
Figure C.18: 900-1: Failure process (post-peak).

(c) View of east end of failed beam

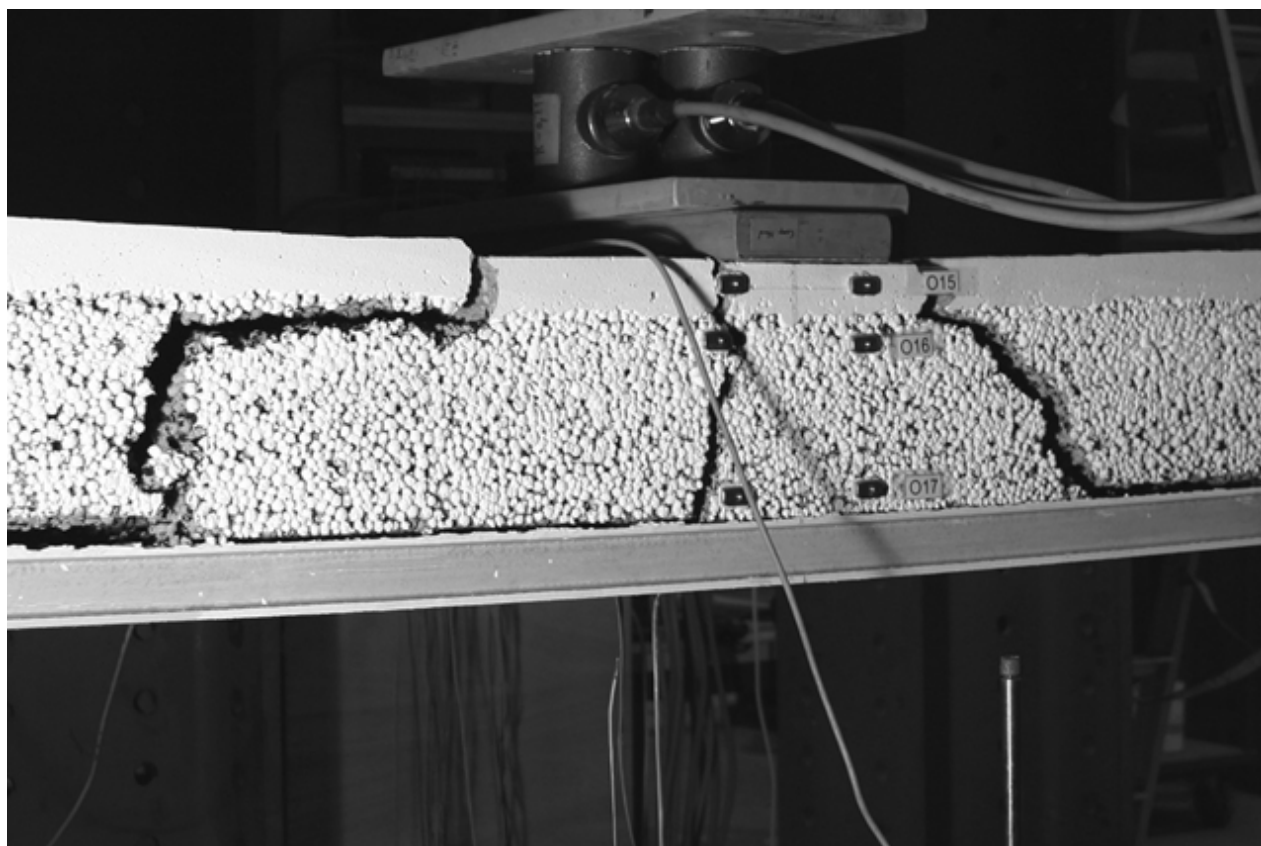
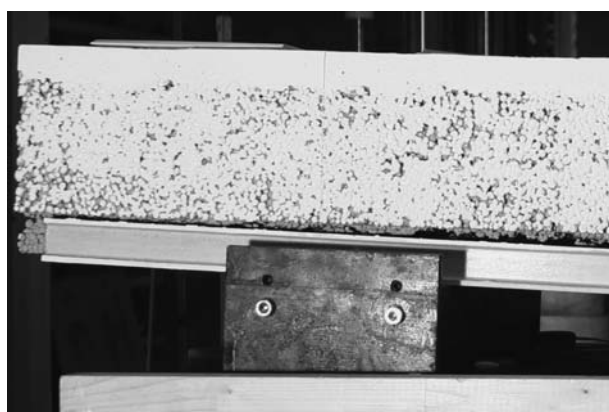
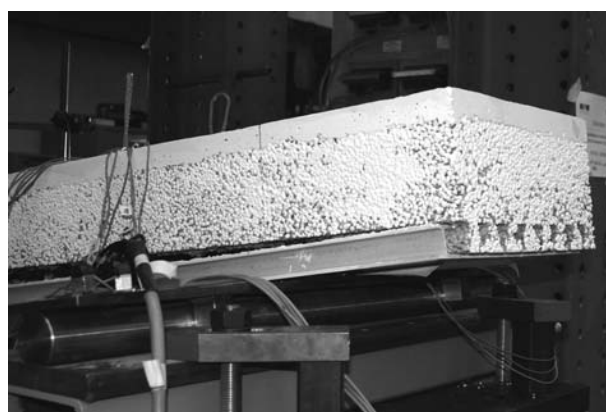
Figure C.21: 900-1: Failed beam after experiment, still loaded - north.

(a) View from north - mid-span

(b) View from north - axis B

(c) View from north - axis F

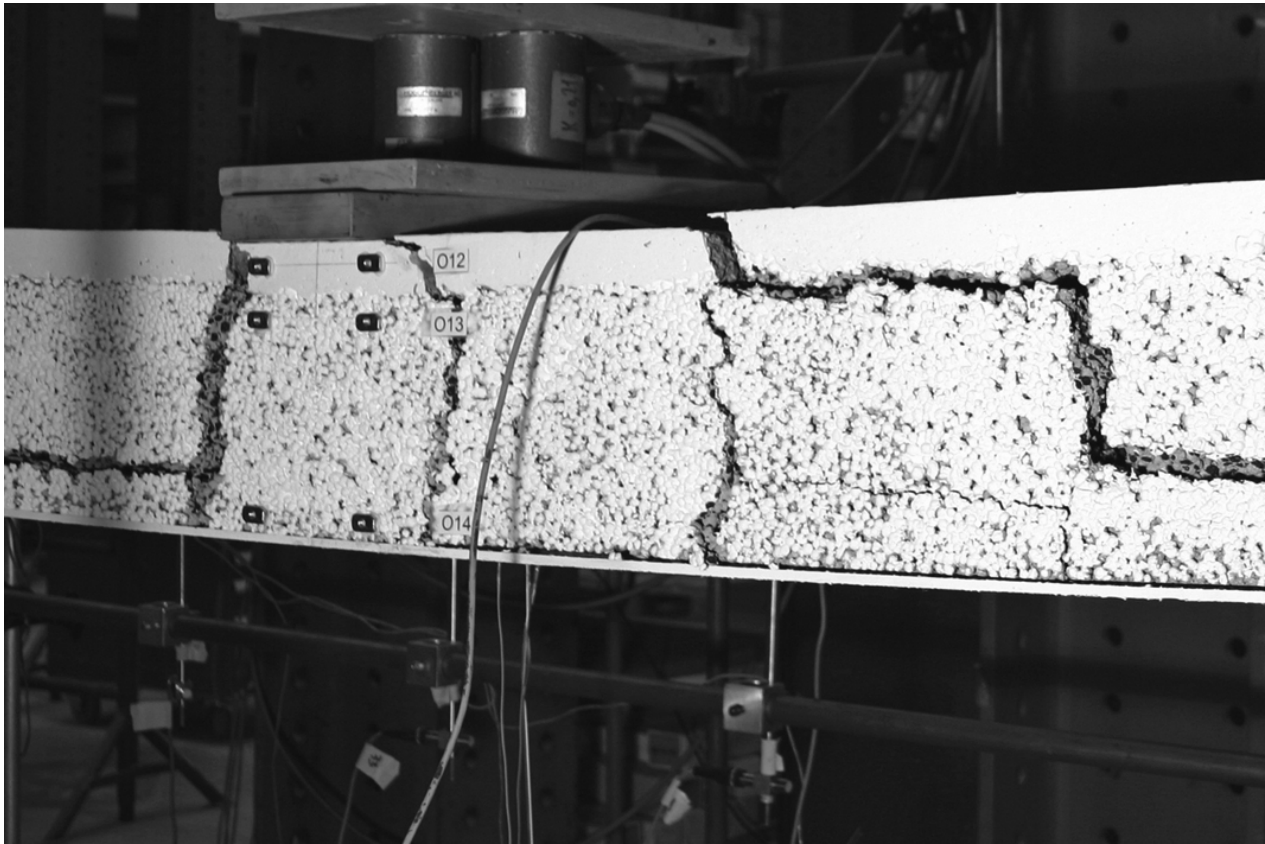
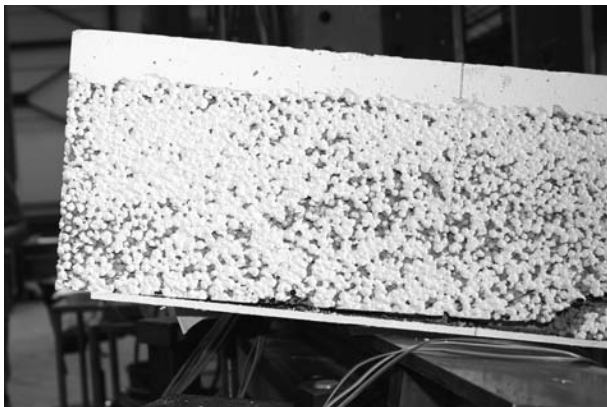
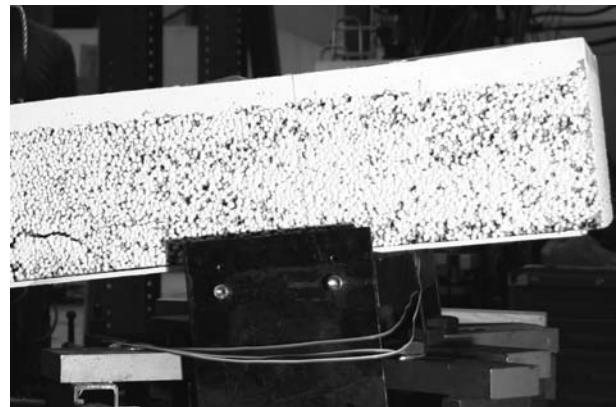
Figure C.22: 900-1: Failed beam after experiment, still loaded - south.

(a) View from south - mid-span

(b) View from south - axis F

(c) View from south - axis B

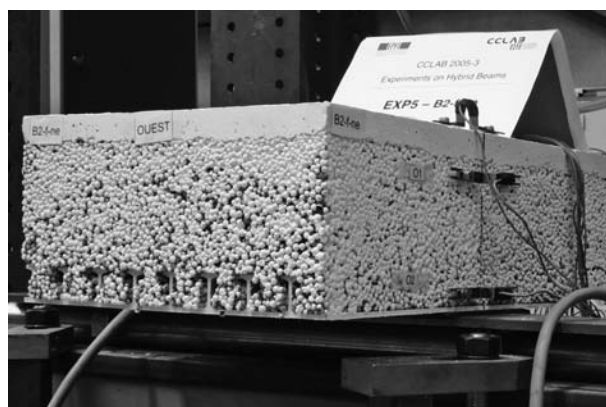
Figure C.31: 900-2: Crack development after second load cycle (post-peak).

(c) LC being pushed out of GFRP profile at west end

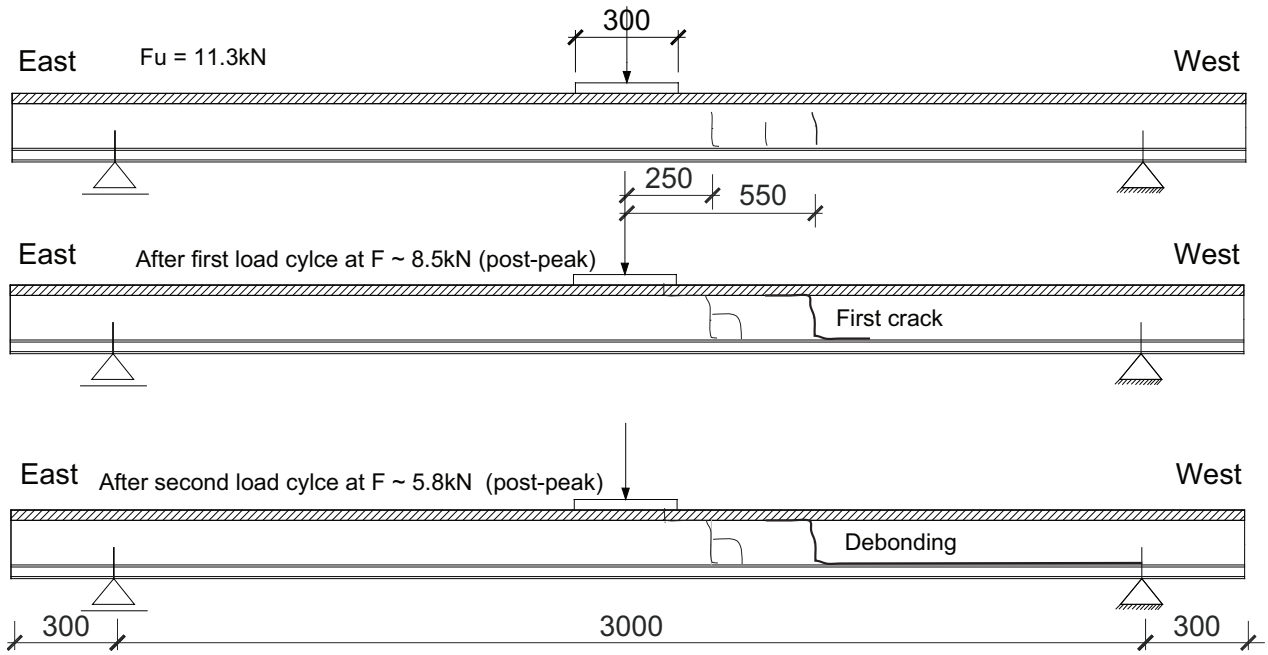
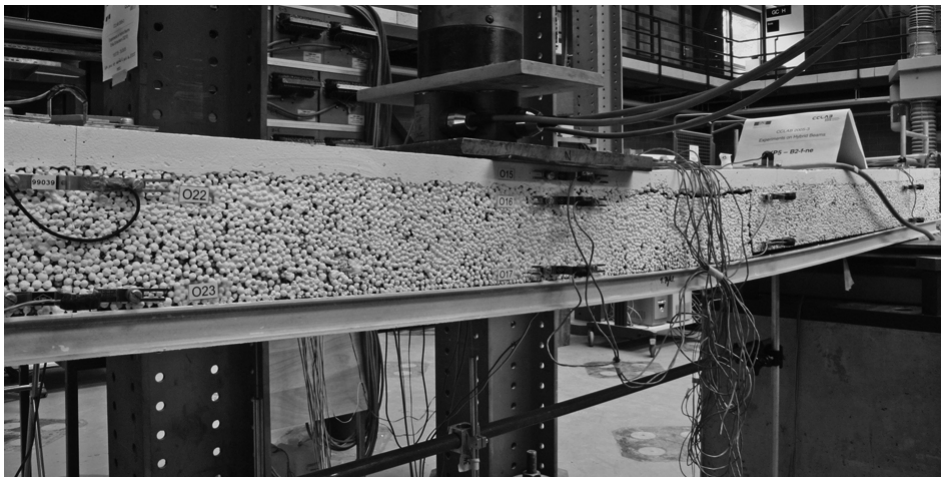
Figure C.32: 900-2: a) Failure process and b) still loaded failed beam after experiment - north.

(a) View from north - failure process

(b) View from north

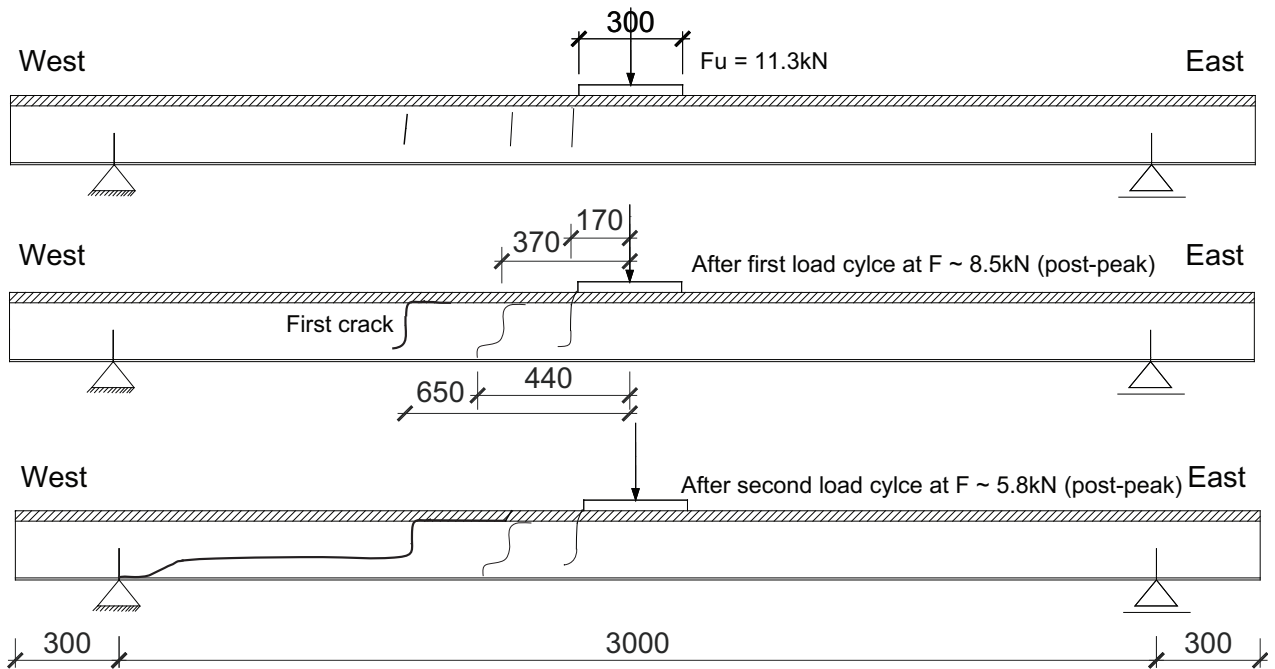
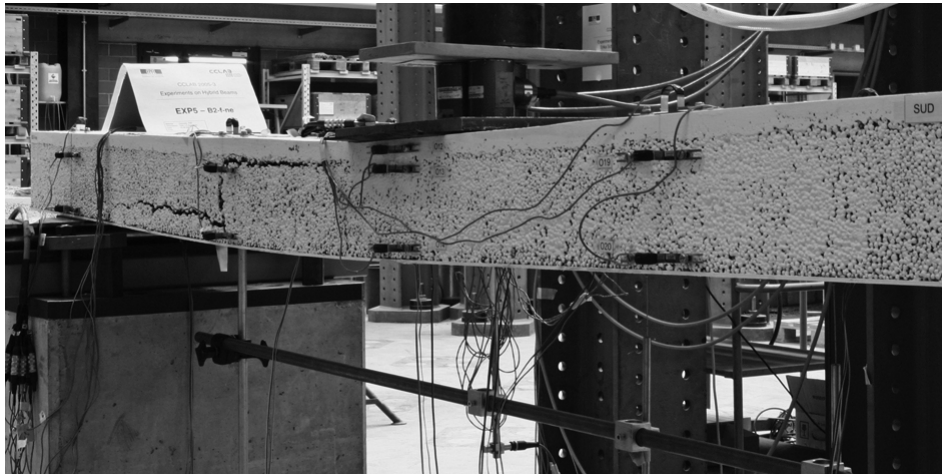
Figure C.33: 900-2: a) Failure process and b) still loaded failed beam after experiment - south.

(a) View from south - failure process

(b) View from south

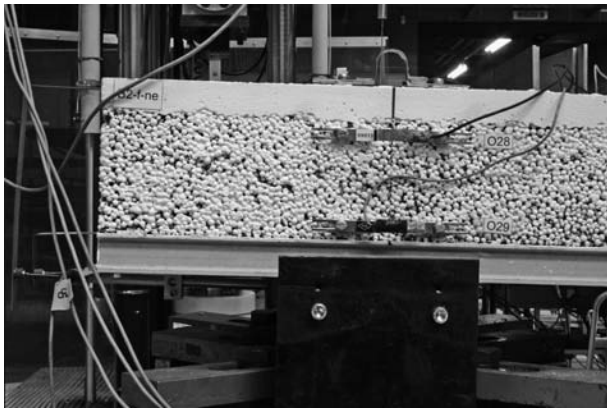
Figure C.34: 900-2: Failed beam after experiment, still loaded - north.

(a) View from north - axis B

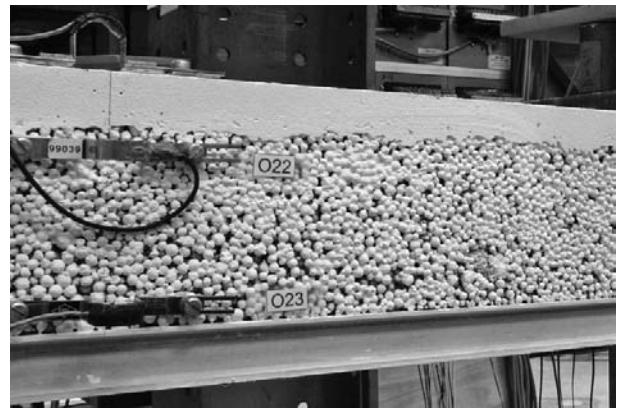
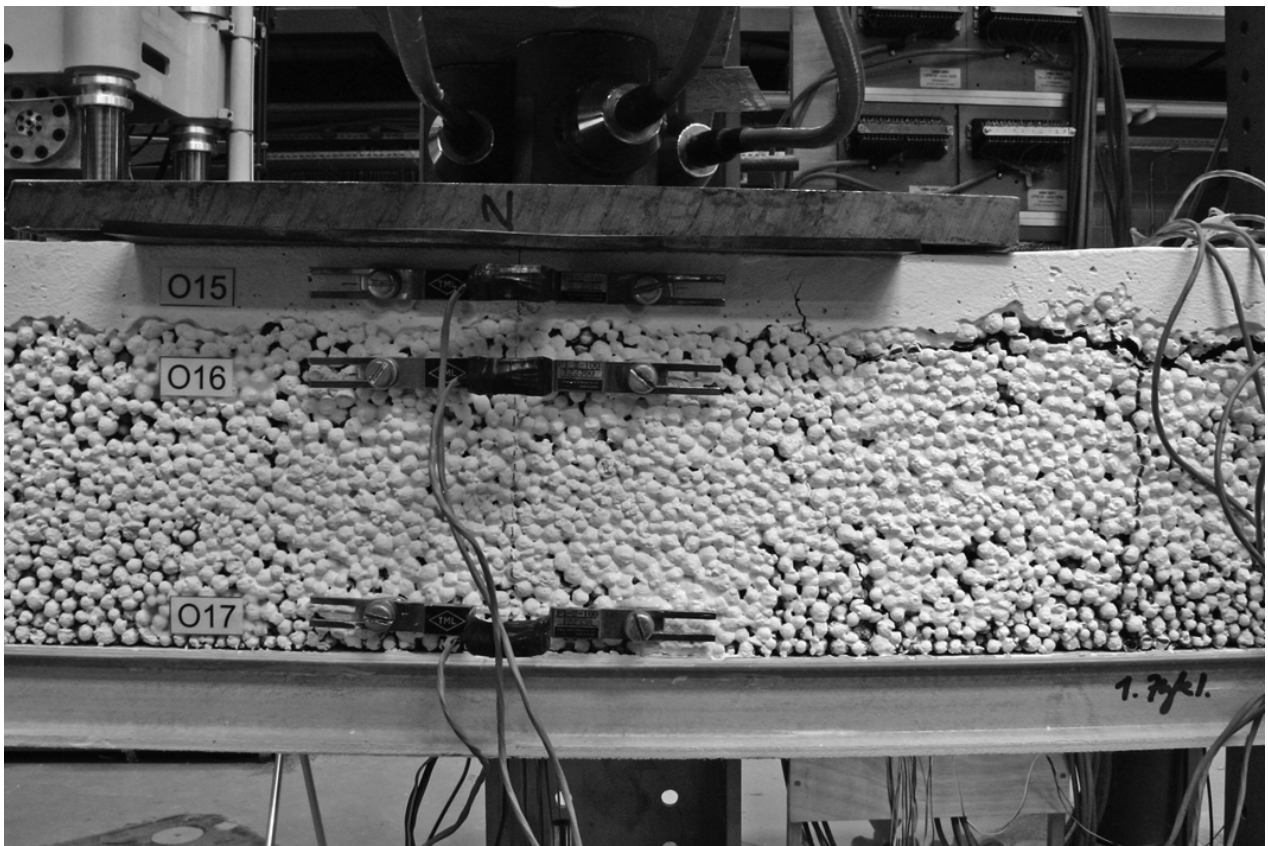
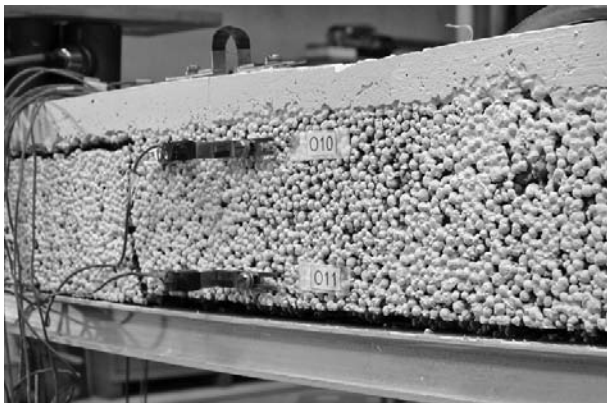
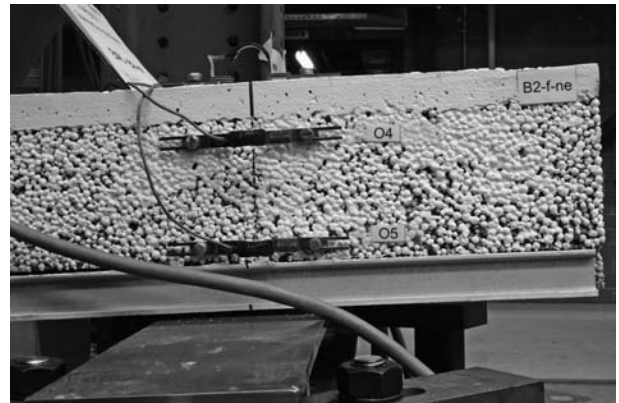
The failure process of beam 900-2 is illustrated in Figures C.30, C.31, C.32 and C.33. The first noises were audible at a load of 4 kN and the first loud crack occurred at 9.2 kN, followed by LC debonding on the south-east side of the beam. The maximum load was reached at $F_u = 11.5$ kN with a corresponding deflection of 9.4 mm. At this load, three vertical cracks extended through the entire depth of the LC layer. A load cycle was conducted at a deflection of 10 mm. During the unloading process the cracks closed slightly and then reopened during the reloading process. The load increased up to 10.3 kN. Subsequently the load dropped to 8.6 kN and the vertical cracks started to propagate horizontally at the LC-NC and FRP-LC interfaces. The most significant vertical crack was situated approximately 55 cm west of the mid-span. At a mid-span deflection of 20 mm a third load cycle was performed. Again, after reloading a load of approximately 8.8 kN could be reached, which did not change significantly up to a mid-span deflection of 31.8 mm. The experiment was stopped after a further drop in the load to 5.6 kN. The failed specimen is illustrated in Figures C.34 and C.35.

(b) View from north - axis C

(c) View from north - mid-span

(d) View from north - axis E

(e) View from north - axis F

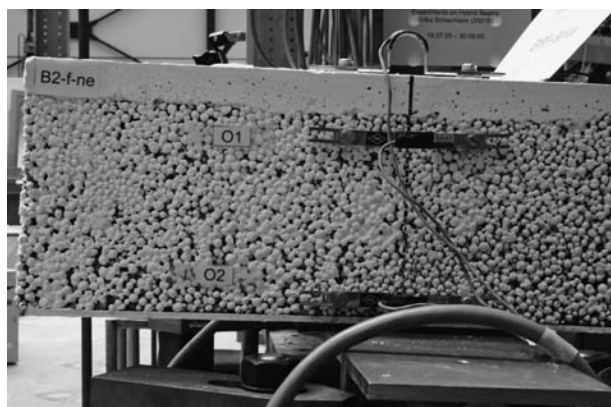
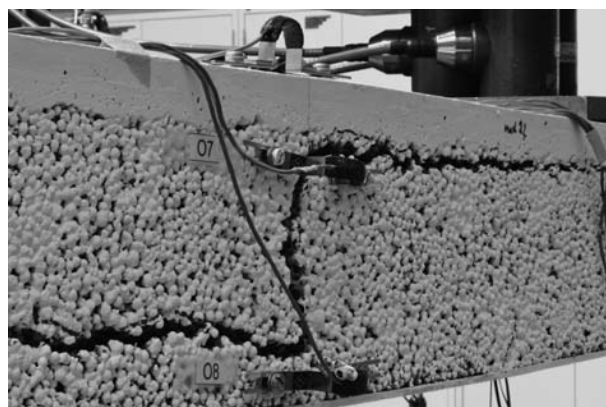
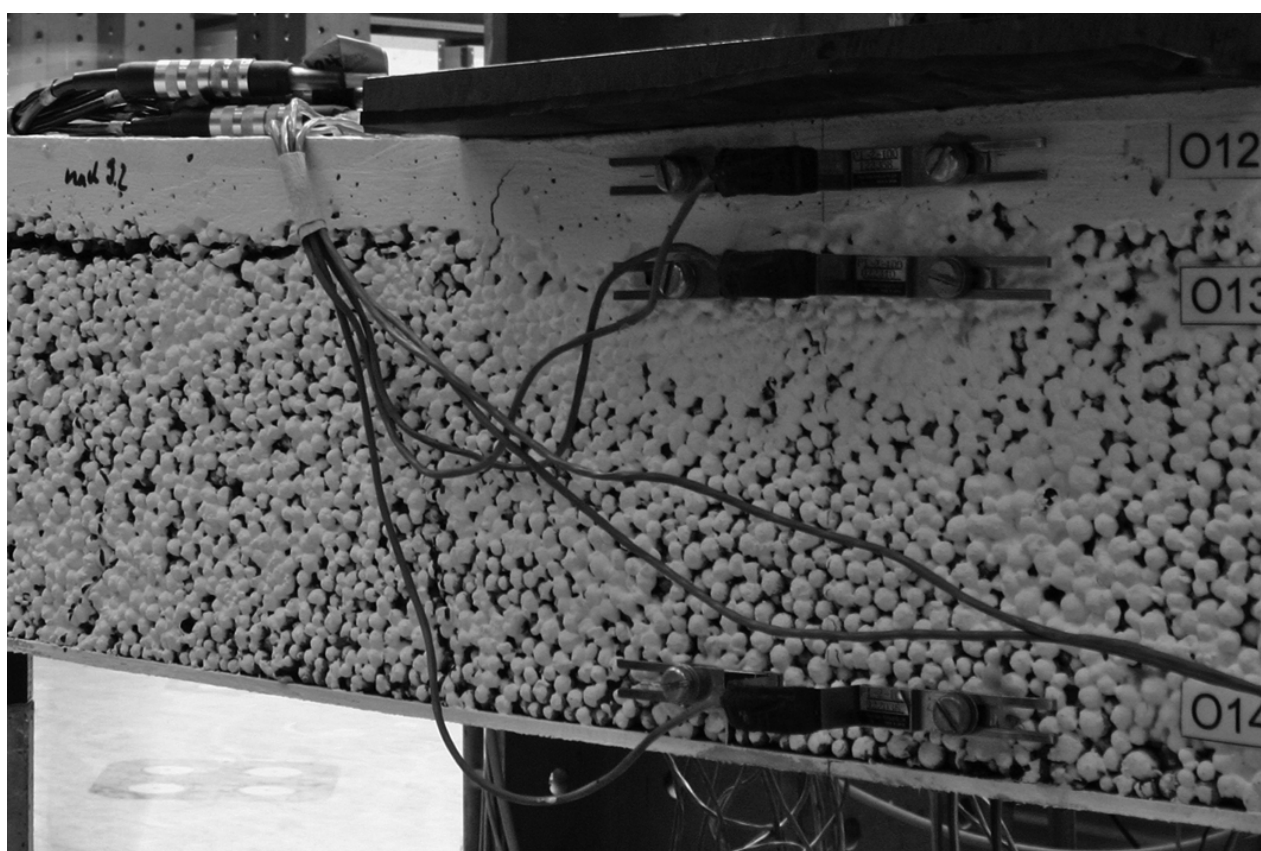
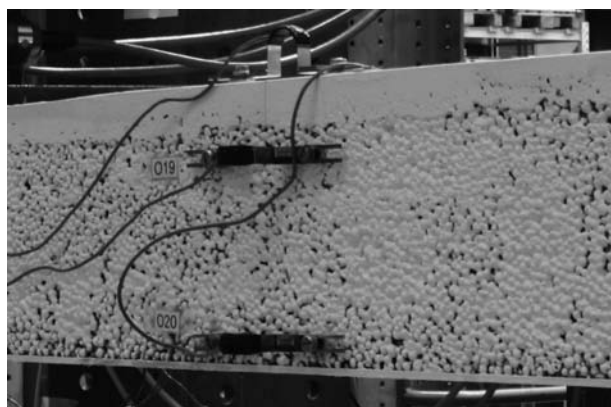
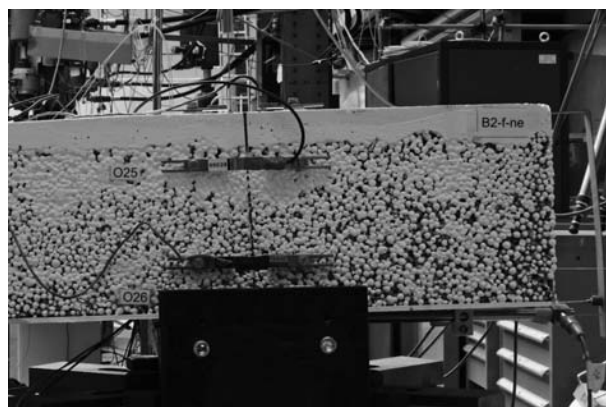
Figure C.35: 900-2: Failed beam after experiment, still loaded - south.

(a) View from south - axis F

(b) View from south - axis E

(c) View from south - mid-span

(d) View from south - axis C

(e) View from south - axis B

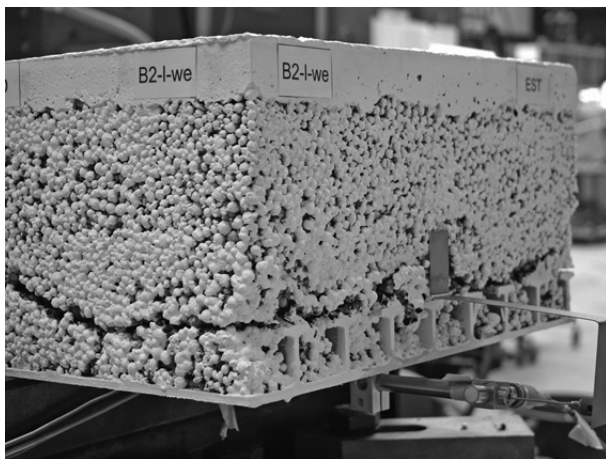
The failure process of beam 900E-1 is illustrated in Figures C.46, C.47 and C.48. The first noise occurred at a load of 15 kN. From 20 kN onwards, some small cracks could be observed in the tension zone of the LC layer next to the loading plate. The beam failed at the ultimate load of $F_u = 31.2$ kN and the corresponding deflection was 8.7 mm. The failure was an immediate and brittle shear failure of the lightweight concrete. The diagonal crack occurred at approximately 60 cm from the mid-span. The crack at the FRP-LC interface developed horizontally along the top of the T-webs up to the beam end (Figure C.46-a). The cracks propagated through the lightweight aggregates and the FRP-LC interface with the epoxy resin remained undamaged, (Figure C.46-b). After failure, the load decreased immediately to the final value of 3 kN, where the experiment was stopped. The failed and still loaded specimen is shown in Figures C.49 and C.50.

(a) Crack up to beam end

Figure C.46: 900E-1: LC shear failure.

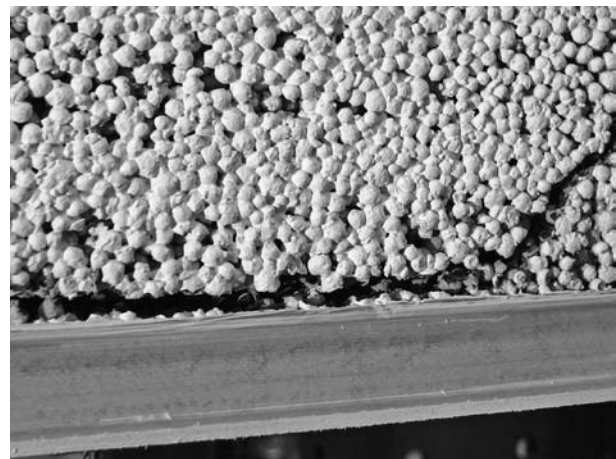
(b) Shear failure through aggregate

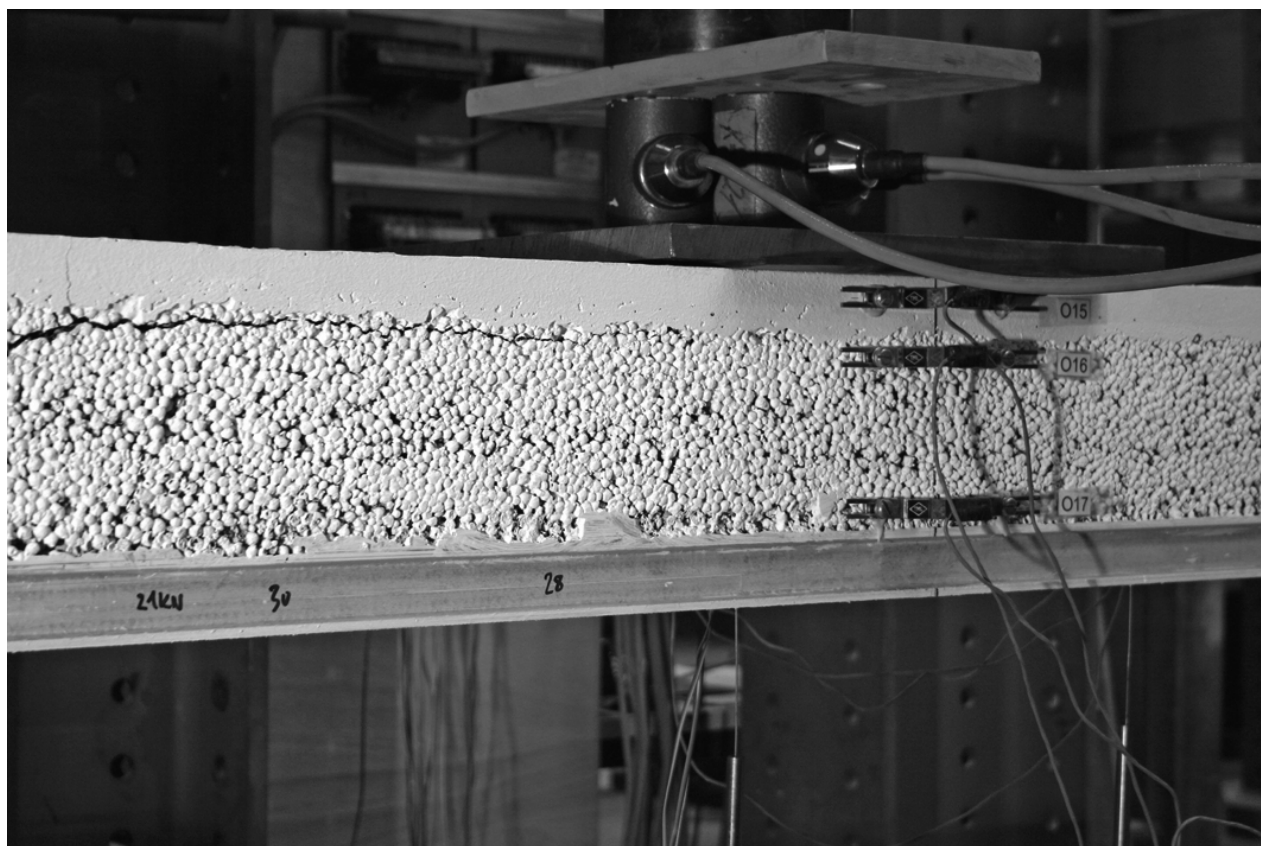
(a) View from north - mid-span

Figure C.49: 900E-1: Failed beam after experiment, still loaded - north.

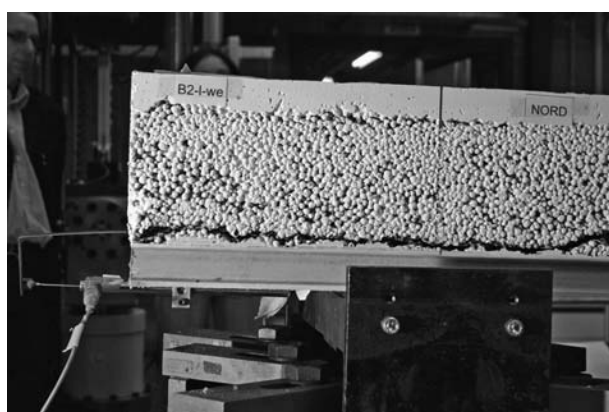
(b) Crack through eastern beam end

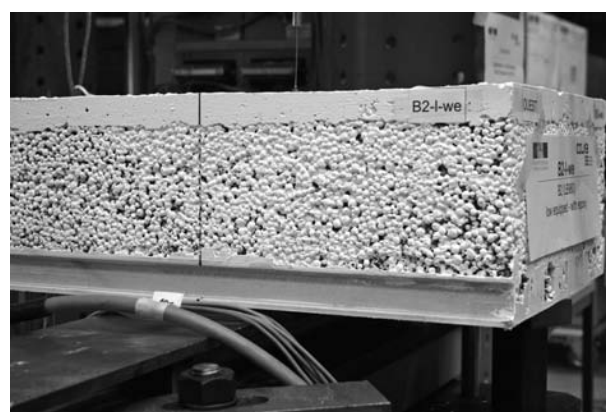
(c) Undamaged western beam end

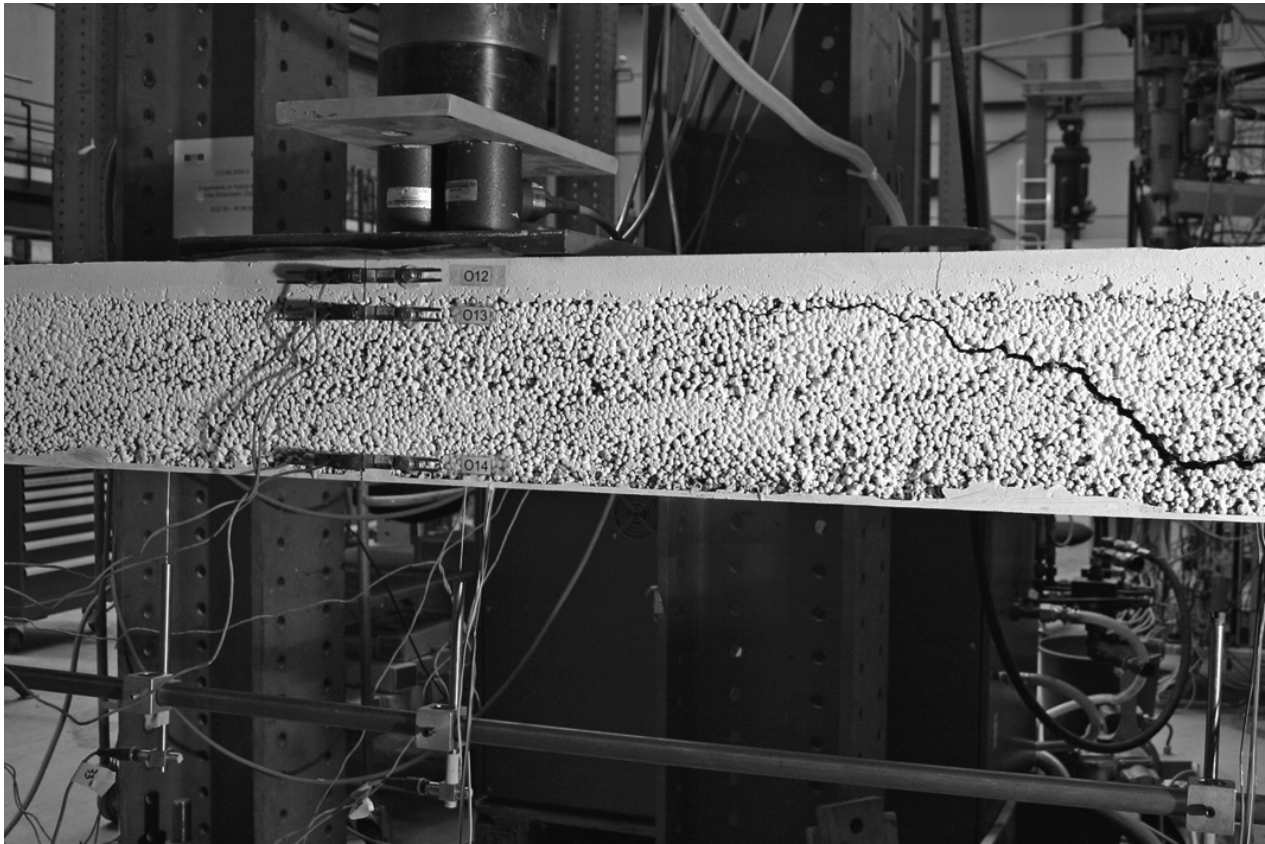
(a) View from south - mid-span

Figure C.50: 900E-1: Failed beam after experiment, still loaded - south.

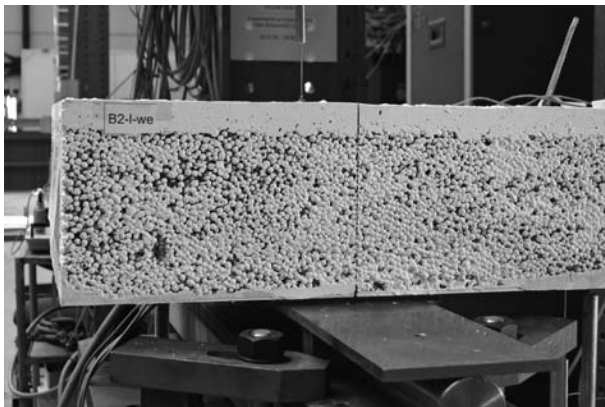
(b) Undamaged western beam end

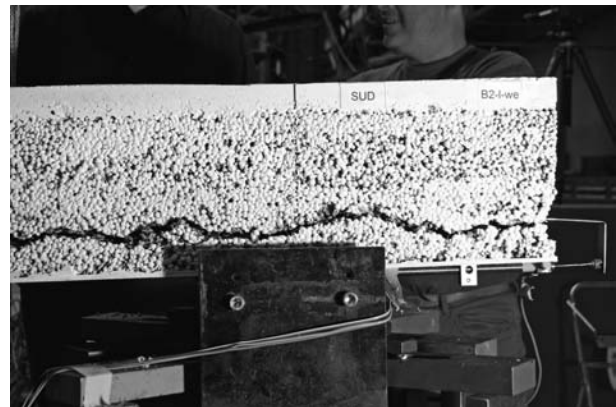
(c) Crack through eastern beam end

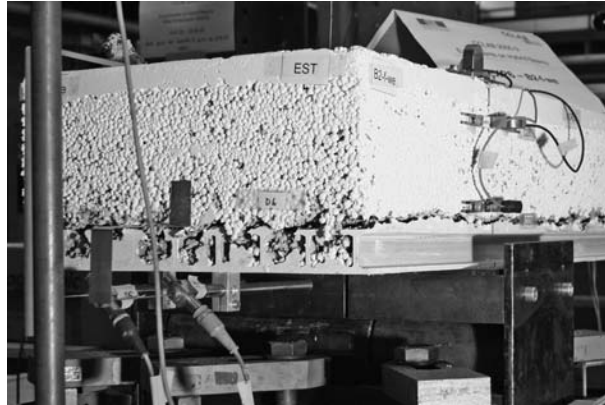
The failure process of beam 900E-2 is illustrated in Figures C.58 and C.59. The first small vertical cracks occurred at a load of 26.6 kN in the tension zone of the beam and distributed along the beam length. As already observed in bonded beam 900E-1, failure was immediate and brittle. The ultimate load was $F_u = 30.4$ kN with a corresponding deflection of 8.1 mm. The final crack occurred diagonally through the LC layer and then immediately propagated horizontally up to the beam end. The bonded interface remained undamaged. The still loaded and failed specimen is shown in Figures C.60 and C.61.

Figure C.58: 900E-2: View of beam end after experiment.

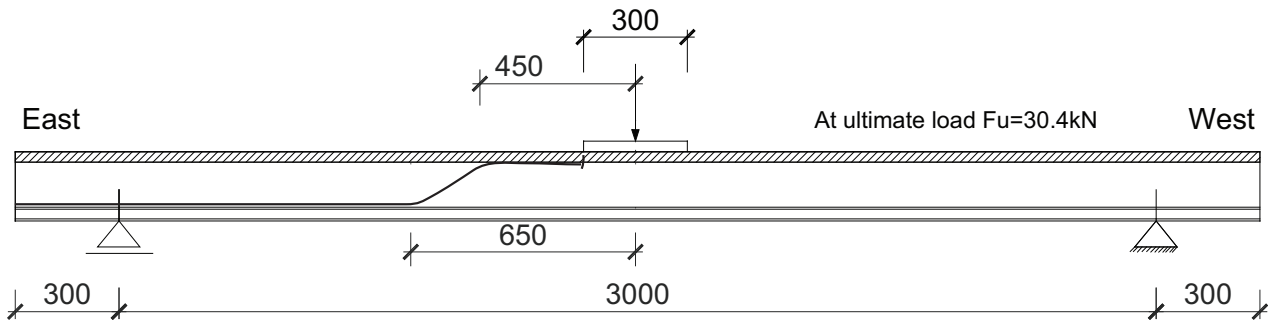
(a) View from north - cracked beam

Figure C.59: 900E-2: a) Failure process and b) still loaded failed beam after experiment.

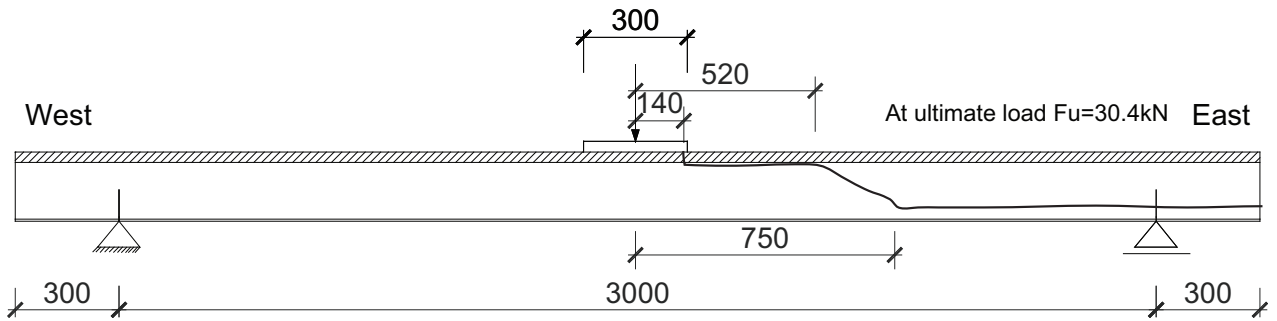
(c) View from south - cracked beam

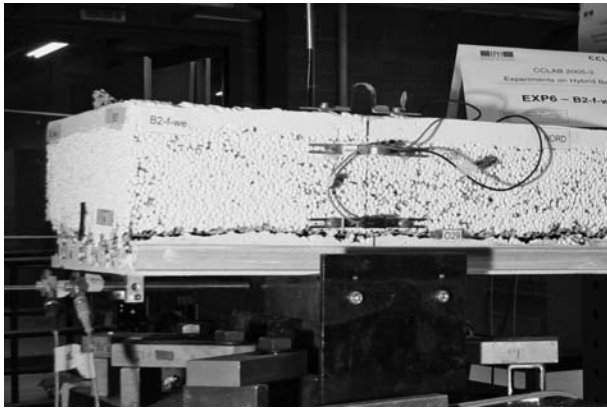
(a) View from north - axis B

Figure C.60: 900E-2: Failed beam after experiment, still loaded - north.

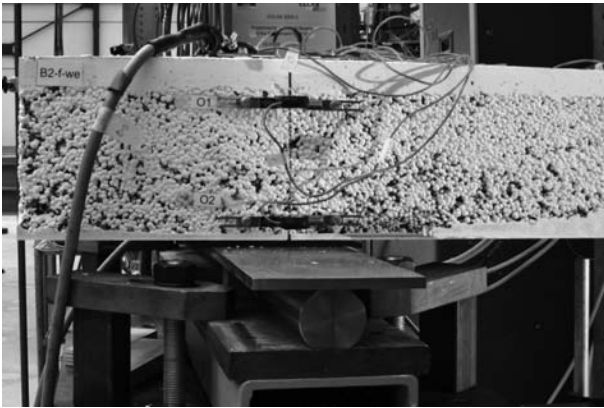
(a) View from south - axis F

Figure C.61: 900E-2: Failed beam after experiment, still loaded - south.

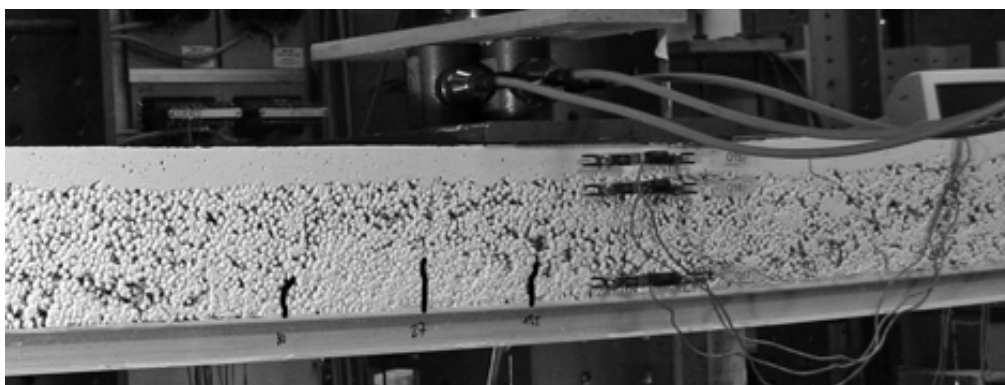
The failure process of beam 1300-1 is illustrated in Figures C.71, C.72, C.73 and C.74. It started with noises at a load of 7.2 kN. The first small vertical cracks occurred at a load of ~ 11.5 kN in the tension zone of the lightweight concrete below the loading plate. First LC debonding from the GFRP profile was observed at a load of 17 kN on the north-east side of the beam. A pushing out of the LC could be observed as from a load of 20.7 kN on the east beam end. The cracks then started to propagate vertically through the lower half of the beam depth next to the loading plate. Figure C.71 shows the cracks in the northern side of the beam at a load of approximately 30 kN. The cracks were all more or less vertically distributed and crossed the lightweight aggregates.

Figure C.71: 1300-1: Failure process before reaching ultimate load at 30.0 kN and 26.9 mm.

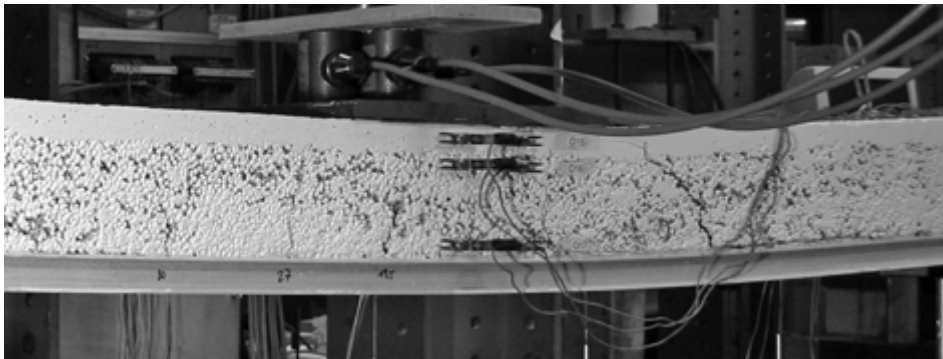
The beam then regained stiffness and the load could be increased again up to the ultimate load of $F_u = 32.1$ kN with a corresponding mid-span deflection of 48 mm. At this load, two vertical cracks 25-36 cm from the mid-span propagated through the LC layer and the load dropped to 16 kN, (Figure C.72-a). The continuous crack in the east side opened significantly and the contact between the GFRP and LC was lost over an extensive area (Figure C.72-b). A load decrease to 12.5 kN followed and the experiment was stopped at a mid-span deflection of 88 mm. The failed specimen is shown in Figures C.75 and C.76.

(a) Cracks propagating through LC layer at ultimate load $F_u = 32.1$ kN and 47.8 mm

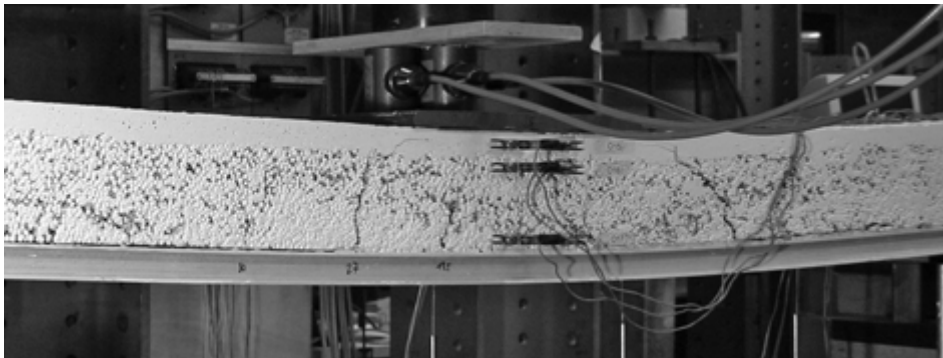
(b) Extensive LC debonding at 16.4 kN (post-peak) and 55.1 mm

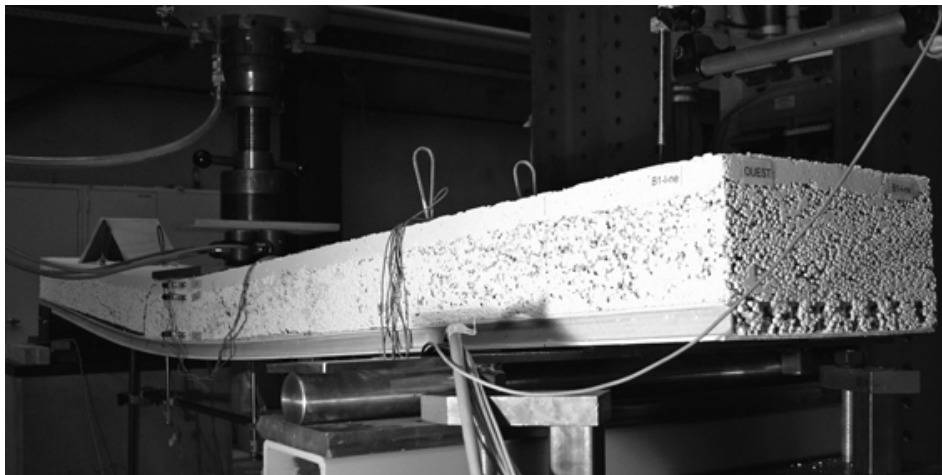
(b) View from north

Figure C.73: 1300-1: a) Failure process and b) still loaded failed beam after experiment - north.

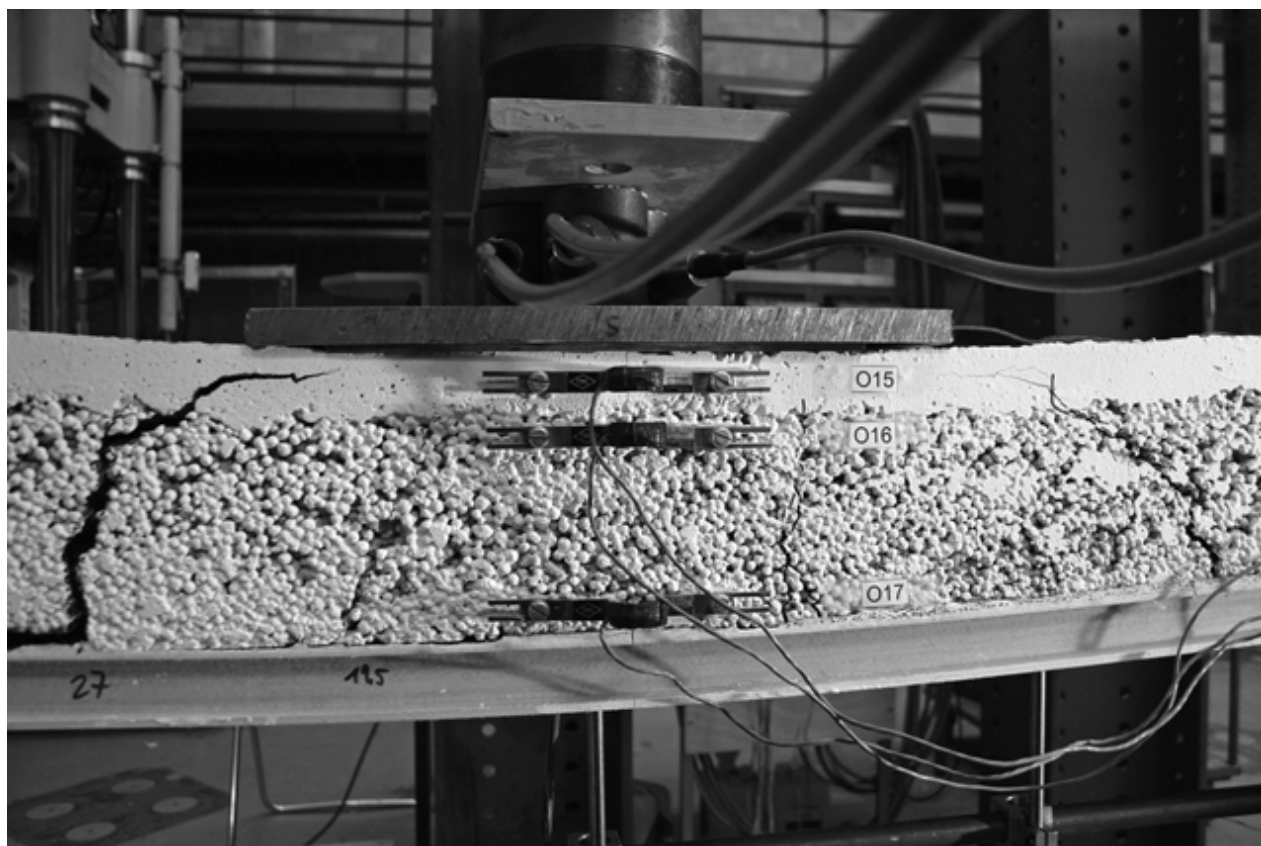
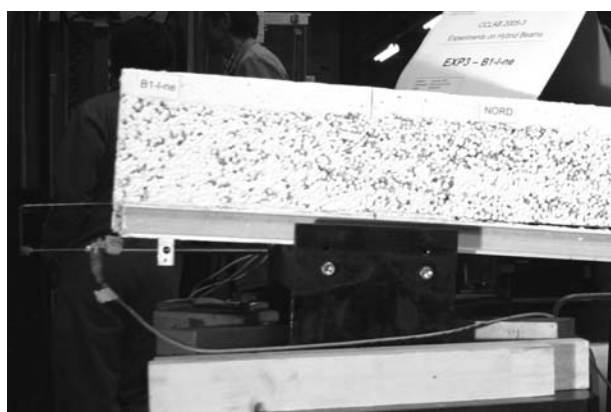
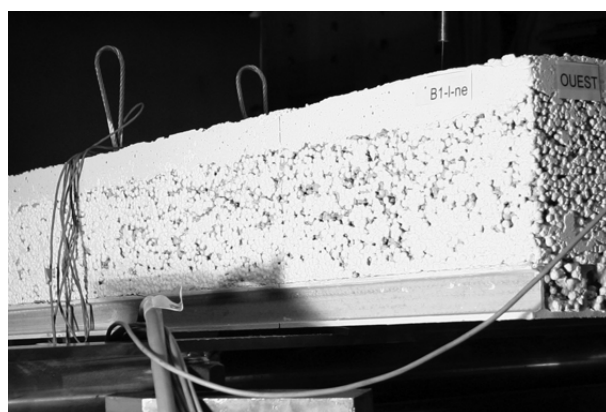
Figure C.75: 1300-1: Failed beam after experiment, still loaded - north.
