Appendix B

Experiments on materials on DVD

B.1 Introduction

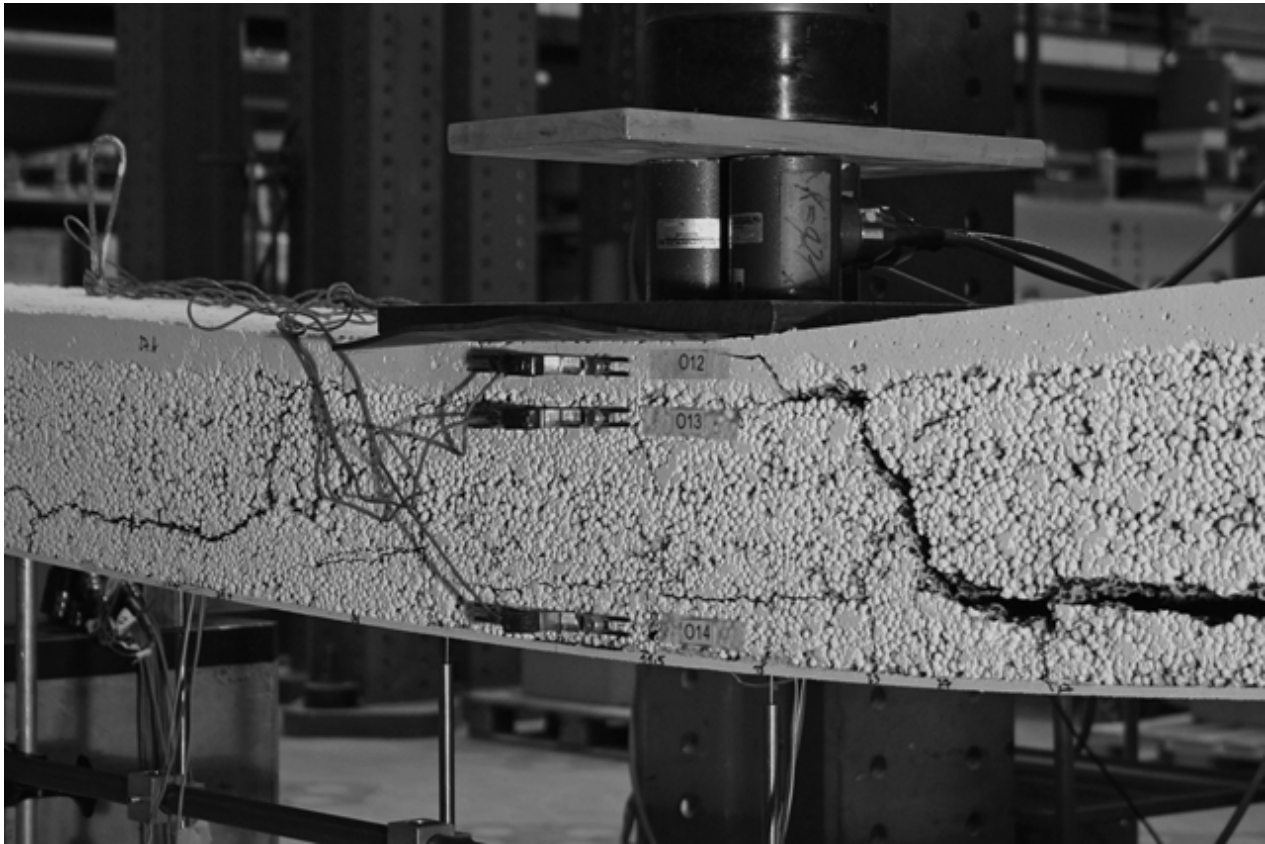
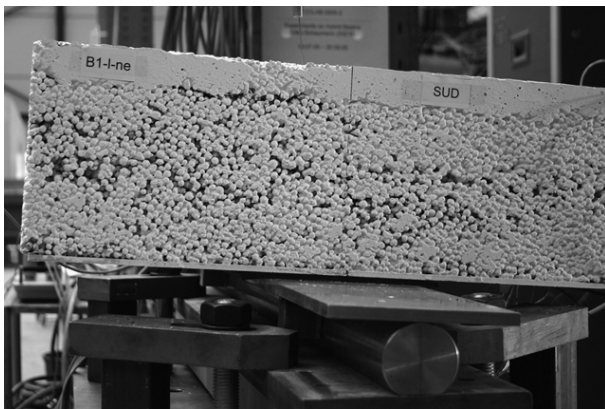
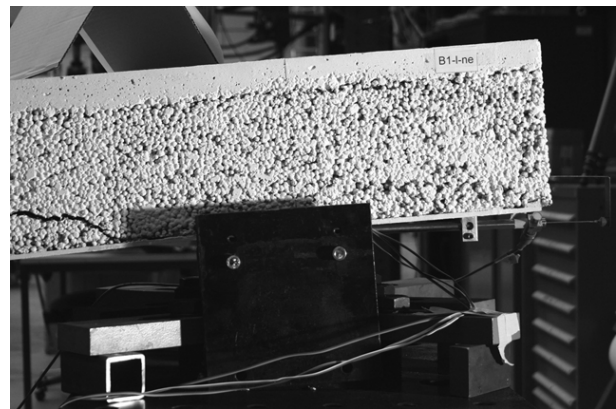
Figure C.76: 1300-1: Failed beam after experiment, still loaded - south.

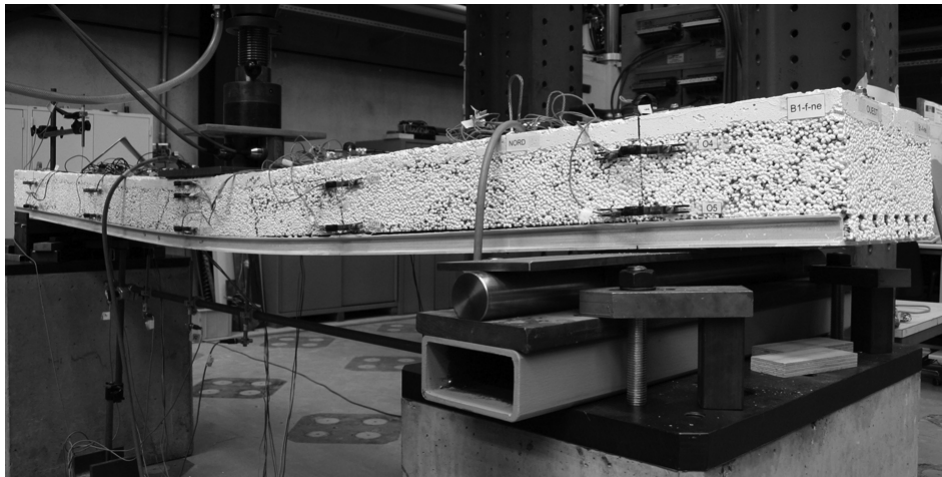
(b) View from north

Figure C.85: 1300-2: a) Failure process and b) still loaded failed beam after experiment - north.

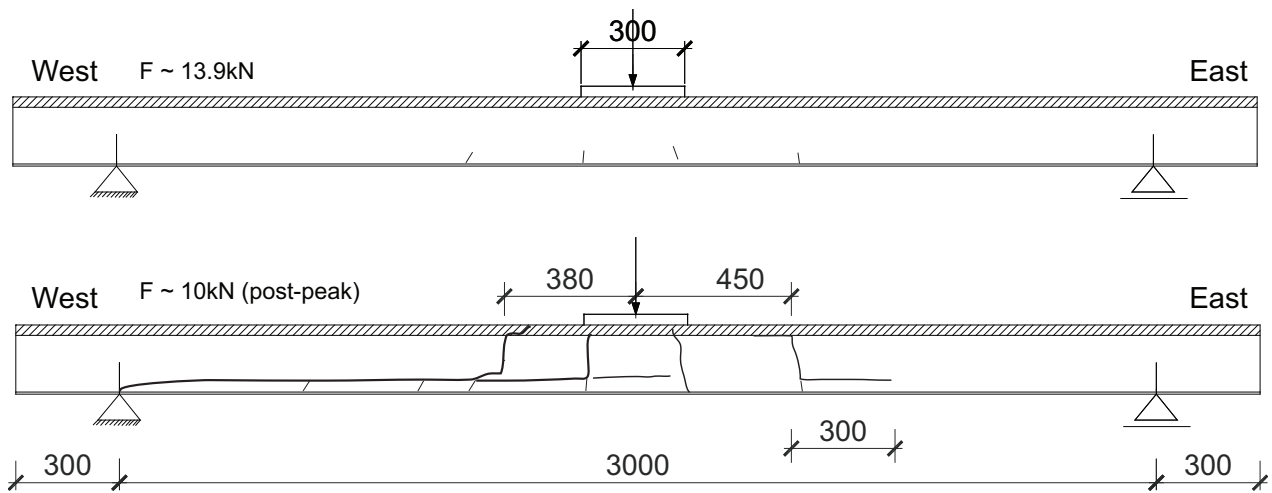
(a) View from south - cracked beam

Figure C.86: 1300-2: a) Failure process and b) still loaded failed beam after experiment - south.

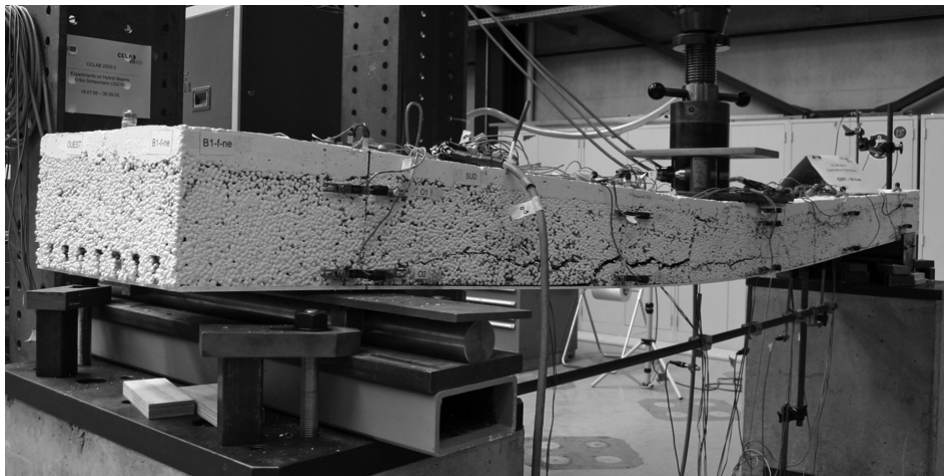
The failure process of beam 1300-2 is illustrated in Figures C.84, C.85 and C.86. The first noises were audible at a load of 8 kN, although no cracks could be observed. The first loud crack occurred at a load of 13.9 kN, followed by the development of vertical cracks spaced at a distance of 40 cm in the tension zone of the lightweight concrete next to the loading plate. Slight debonding started on the northern side at a load of 17.0 kN. The second load cycle was started after a mid-span deflection of 10 mm and corresponding load of approximately 17 kN were reached. During unloading, the vertical cracks closed but remained visible. After reloading, as from the load of 20.7 kN, audible cracks and some new vertical cracks could be observed (Figure C.84-a). At the first peak load of 23.0 kN a mid-span deflection of 18.8 mm was reached. Subsequently, an oscillating phase occurred, during which the applied load varied between 21 kN and 22.7 kN, each time accompanied by an audible inner crack (Figure C.84-b). A third load cycle was performed at the deflection of 33 mm with a corresponding load of 22.5 kN. After reloading, a slight but steady load increase was observed up to the ultimate load of $F_u = 23.3$ kN with a corresponding deflection of 40.4 mm. The cracks started to propagate horizontally and slowly up to the support (Figure C.84-c). The beam lost its stiffness and the experiment was stopped. The failed specimen is shown in Figures C.87 and C.88.

(b) View from south

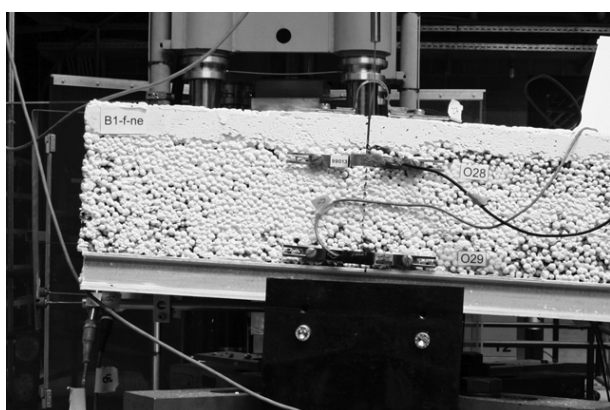
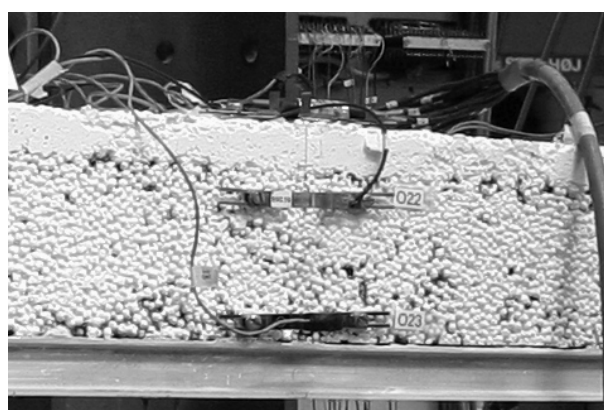
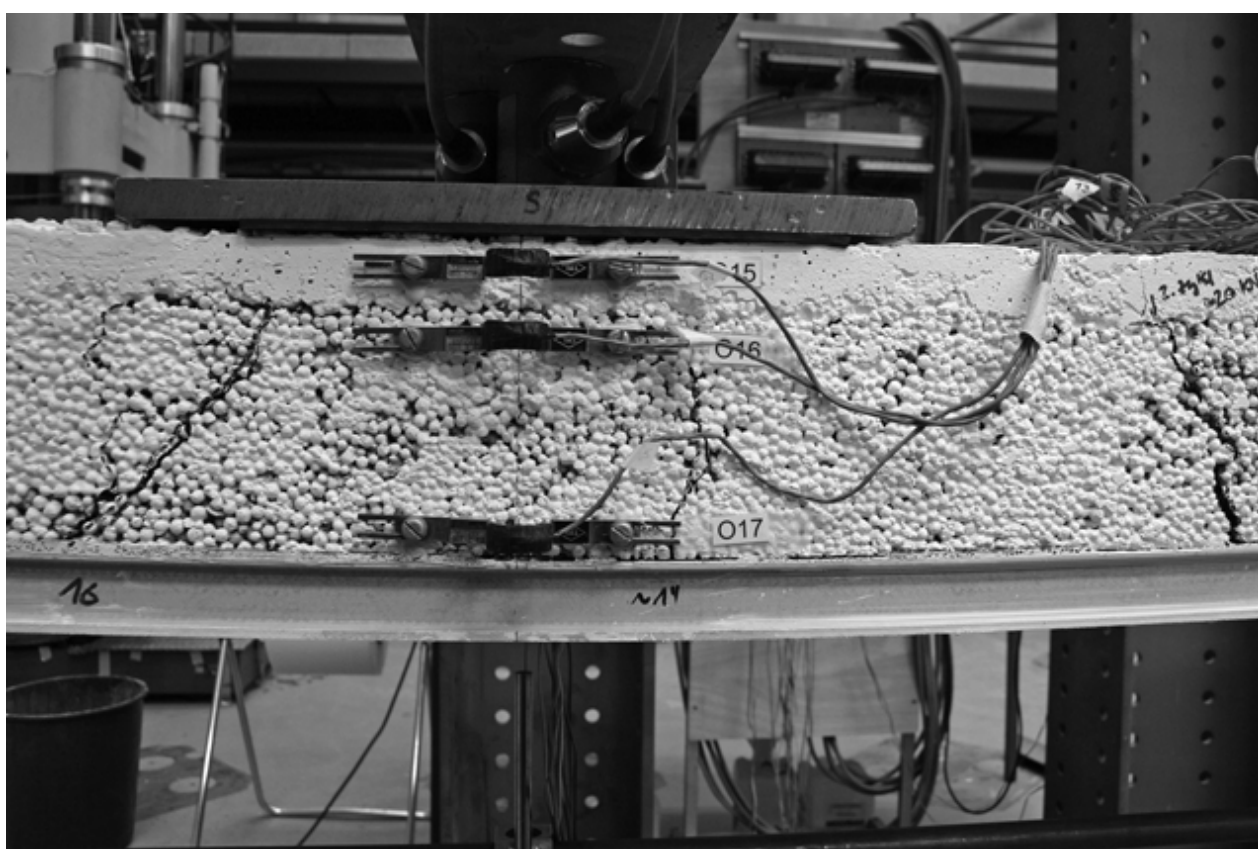
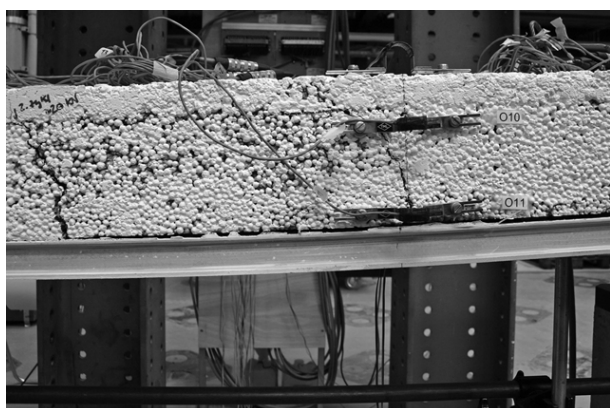
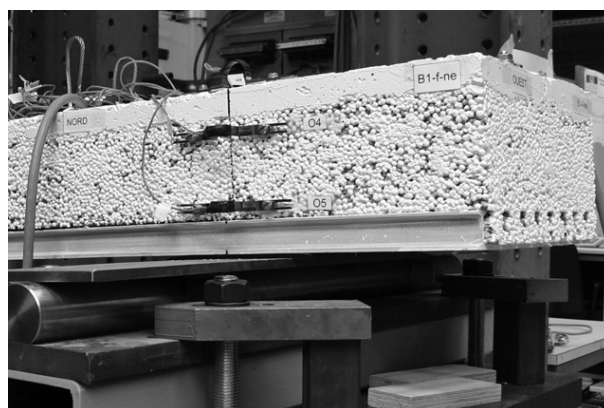
Figure C.87: 1300-2: Failed beam after experiment, still loaded - north.

(a) View from north - axis B

(b) View from north - axis C

(c) View from north - mid-span

(d) View from north - axis E

(e) View from north - axis F

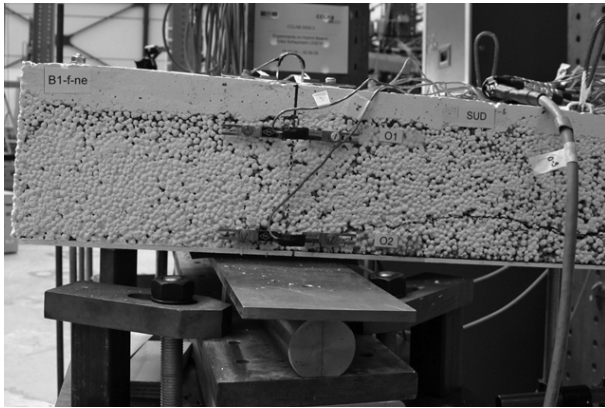
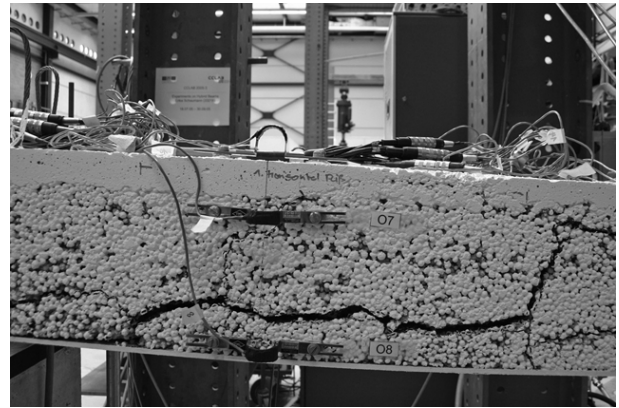
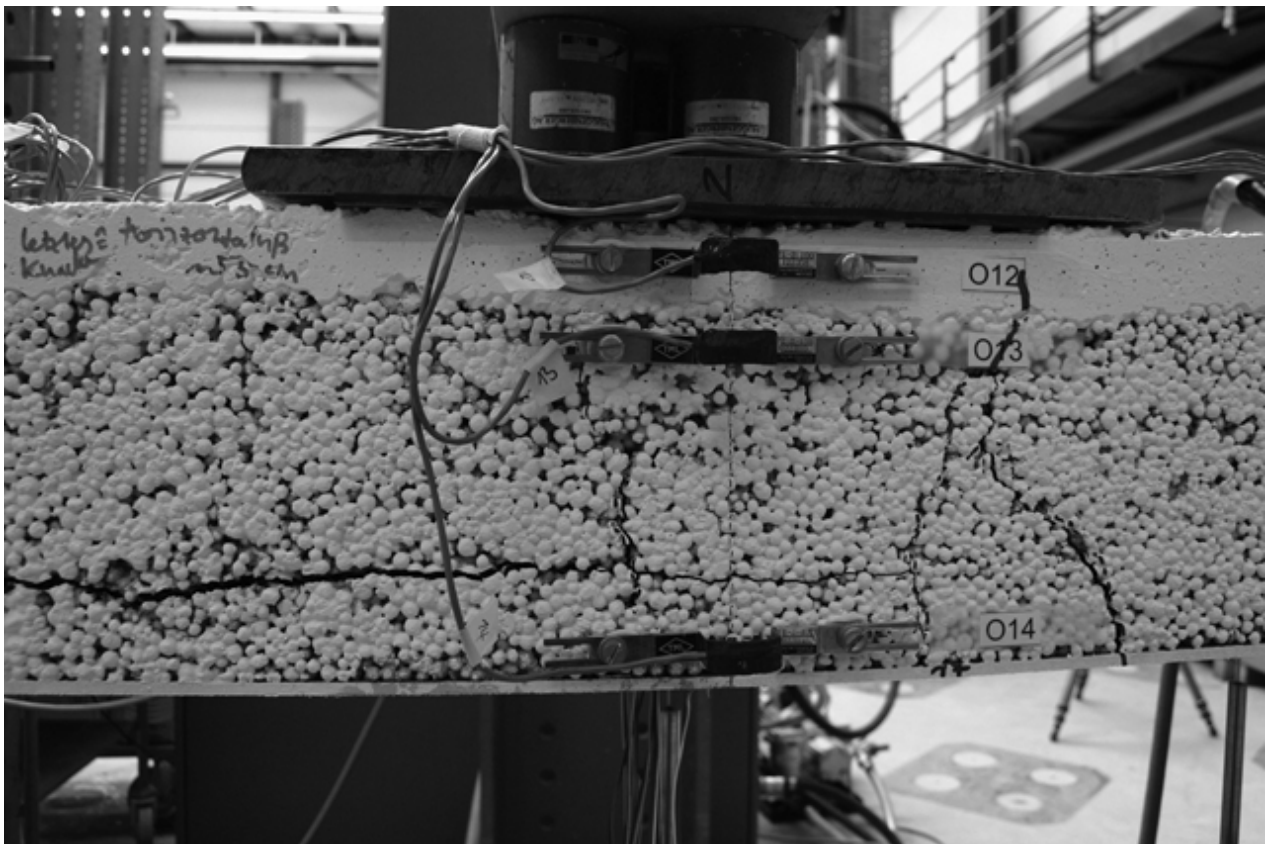
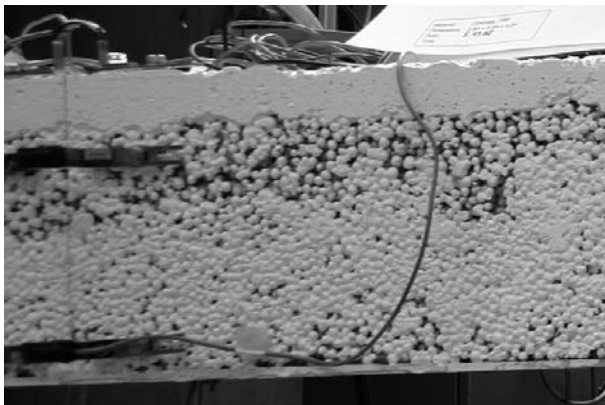
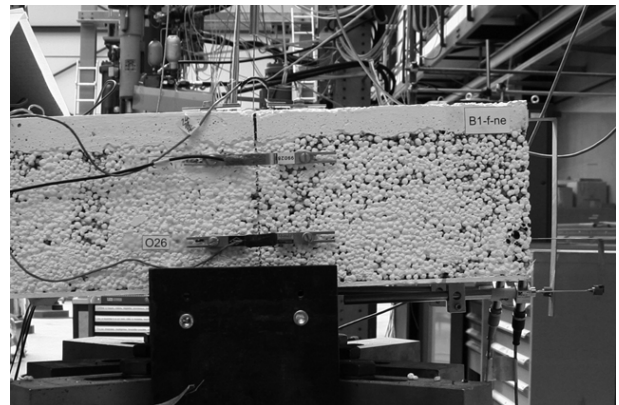
Figure C.88: 1300-2: Failed beam after experiment, still loaded - south.

(a) View from south - axis F

(b) View from south - axis E

(c) View from south - mid-span

(d) View from south - axis C

(e) View from south - axis B

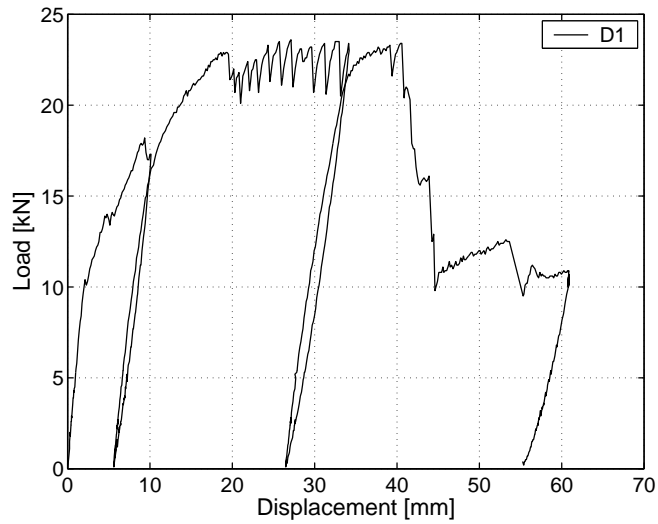
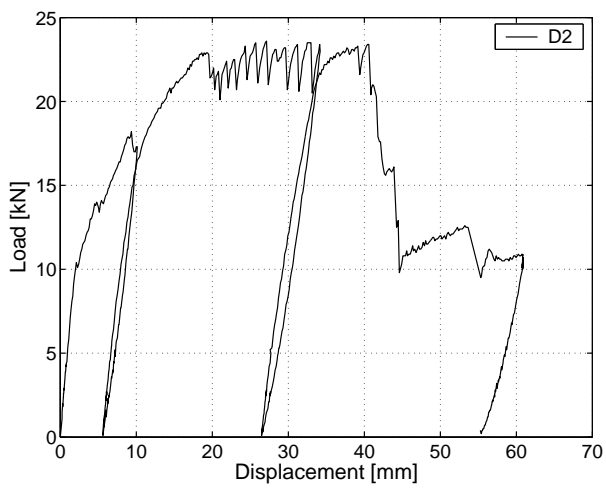
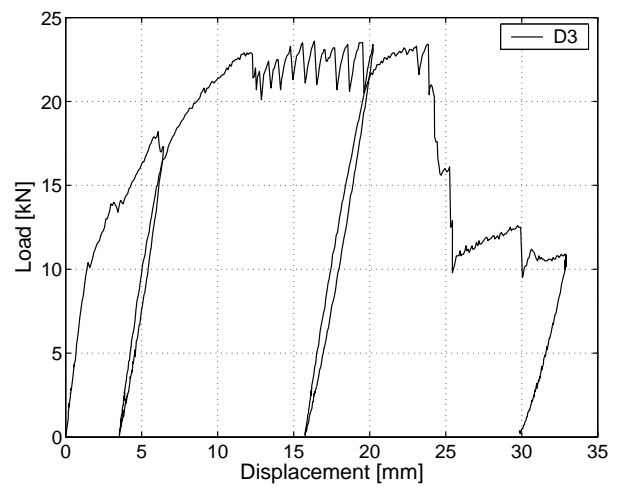
Figure C.89: 1300-2: Displacement at mid-span, at 0.75 m and 2.25 m.

The load deflection response in Figure C.89 indicates that beam stiffness remained constant up to the cracking load of approximately 10 kN (Figure C.90-c). Stiffness then decreased slightly and the first debonding was measured at the beam end at 17 kN. At 18.1 kN a second load cycle was performed. The beam exhibited no significant stiffness changes during unloading and reloading. Subsequently, an oscillating phase occurred at a deflection of 6 to 10 mm, during which the applied load varied between 21 kN and 22.7 kN, each time accompanied by an audible inner crack.

A third load cycle was performed at the deflection of 33 mm with a corresponding load of 22.5 kN. After reloading, a slight but steady load increase was observed up to the ultimate load of 23.3 kN with a corresponding deflection of 40.4 mm, followed by a drop in the load to 10 kN. A slight increase in stiffness could be noticed. The experiment was stopped at a deflection of 60 mm at load of 10.8 kN.

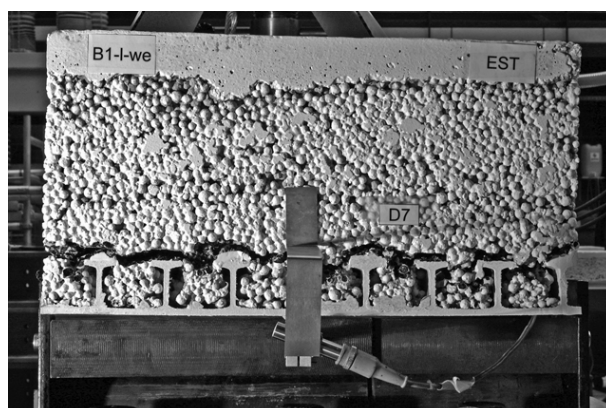
Figure C.98: 1300E-1: beam end after experiment.

The failure process of beam 1300-1 is illustrated in Figures C.98, C.99 and C.100. The first small crack occurred next to the loading plate at a load of 20 kN (Figure C.99-a). Subsequently several small vertical and slightly inclined cracks in the tension zone of the LC developed and started to grow as from a load of 35 kN (Figure C.99-b-c). The ultimate load was reached at $F_u = 42.8$ kN with a corresponding deflection of 12.3 mm, where one of the cracks suddenly propagated through the beam depth and along the LC-NC interface to the loading plate and along the top of the GFRP T-upstands. As deflections increased, the load rapidly decreased to 36.7 kN and then to the final value of 3.4 kN. The crack simultaneously developed horizontally over the support to the beam end (Figure C.99-e-f). The experiment was then stopped. The epoxy-bonded interface remained undamaged and no debonding of the LC from the GFRP occurred. The failed specimen is shown in Figures C.101 and C.102.

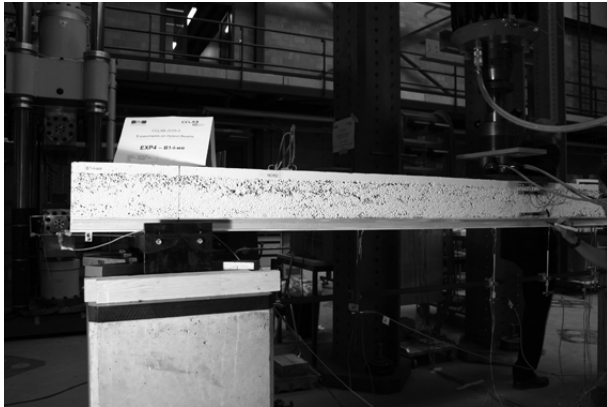
(a) First crack under loading plate at 20 kN

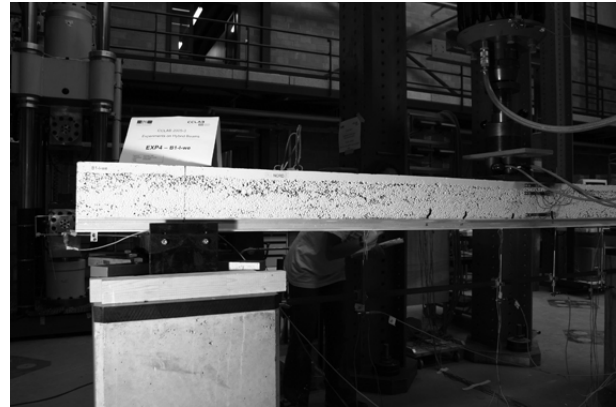
(b) Several small cracks, at 32.3 kN and 8.12 mm deflection

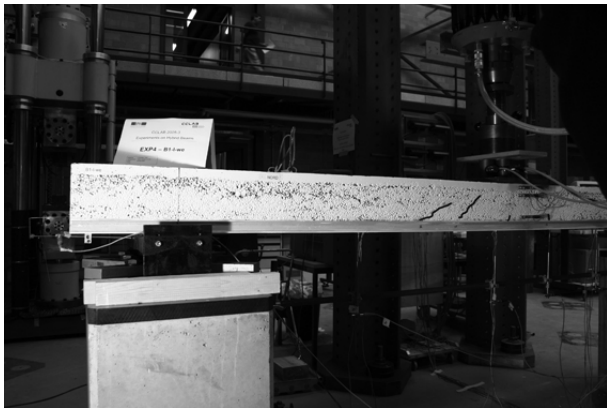
(c) Longer cracks through LC core at loads above 35 kN

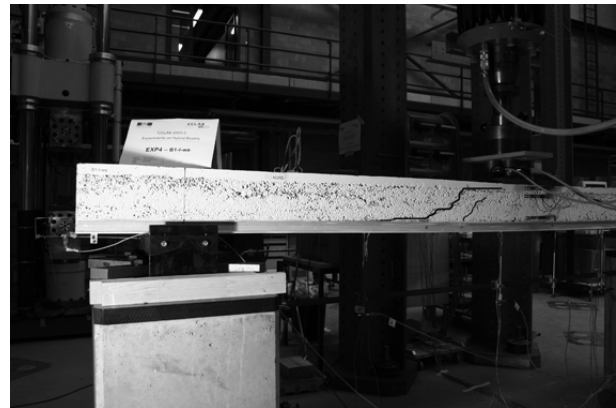
(d) Cracks at ultimate load at 42.8 kN and 12.3 mm deflection

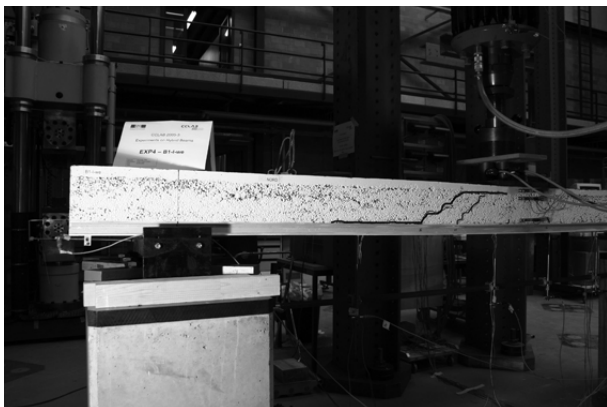
(e) Cracks through beam at 26.7 kN and 13.7 mm deflection

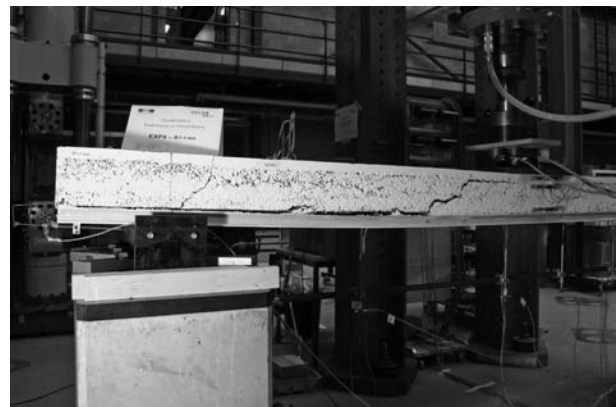
(f) Failed beam at 3.4 kN and 16.4 mm deflection

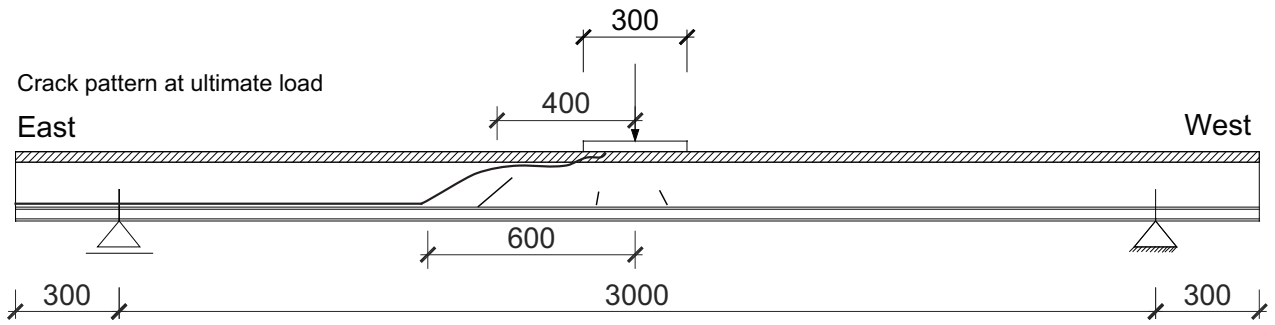
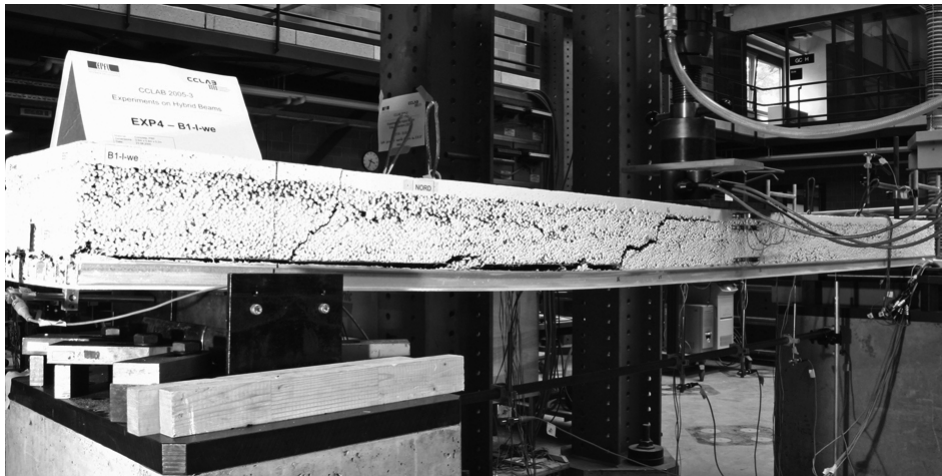
(a) View from north - cracked beam

Figure C.100: 1300E-1: Failed beam after experiment, still loaded.

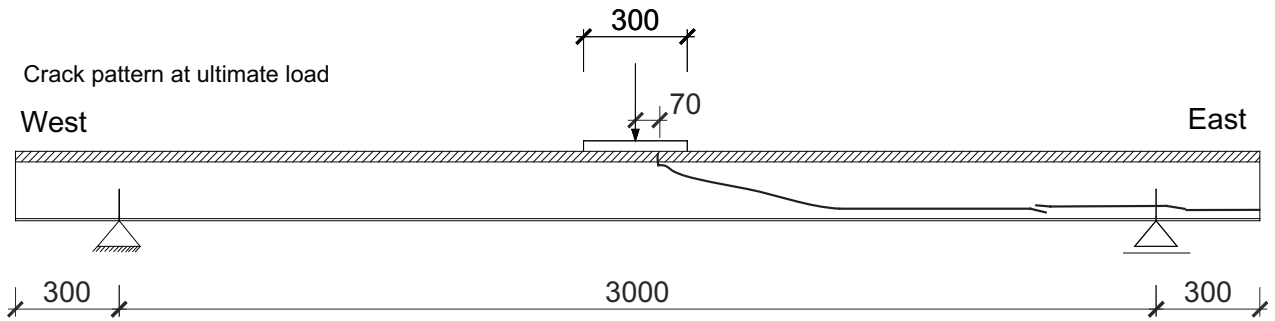
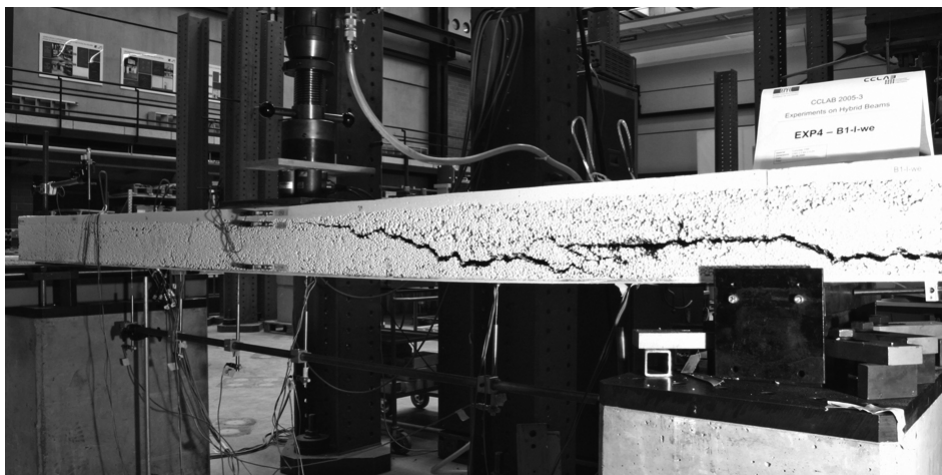
(c) View from south - cracked beam

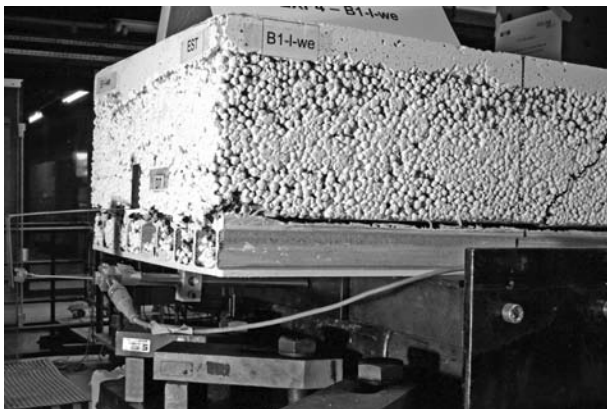
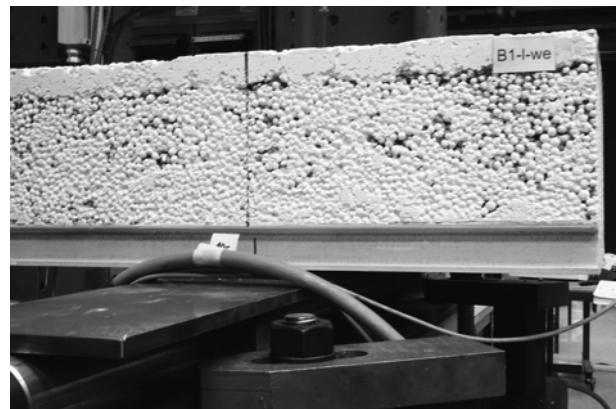
Figure C.101: 1300E-1: Failed beam after experiment, still loaded - north.

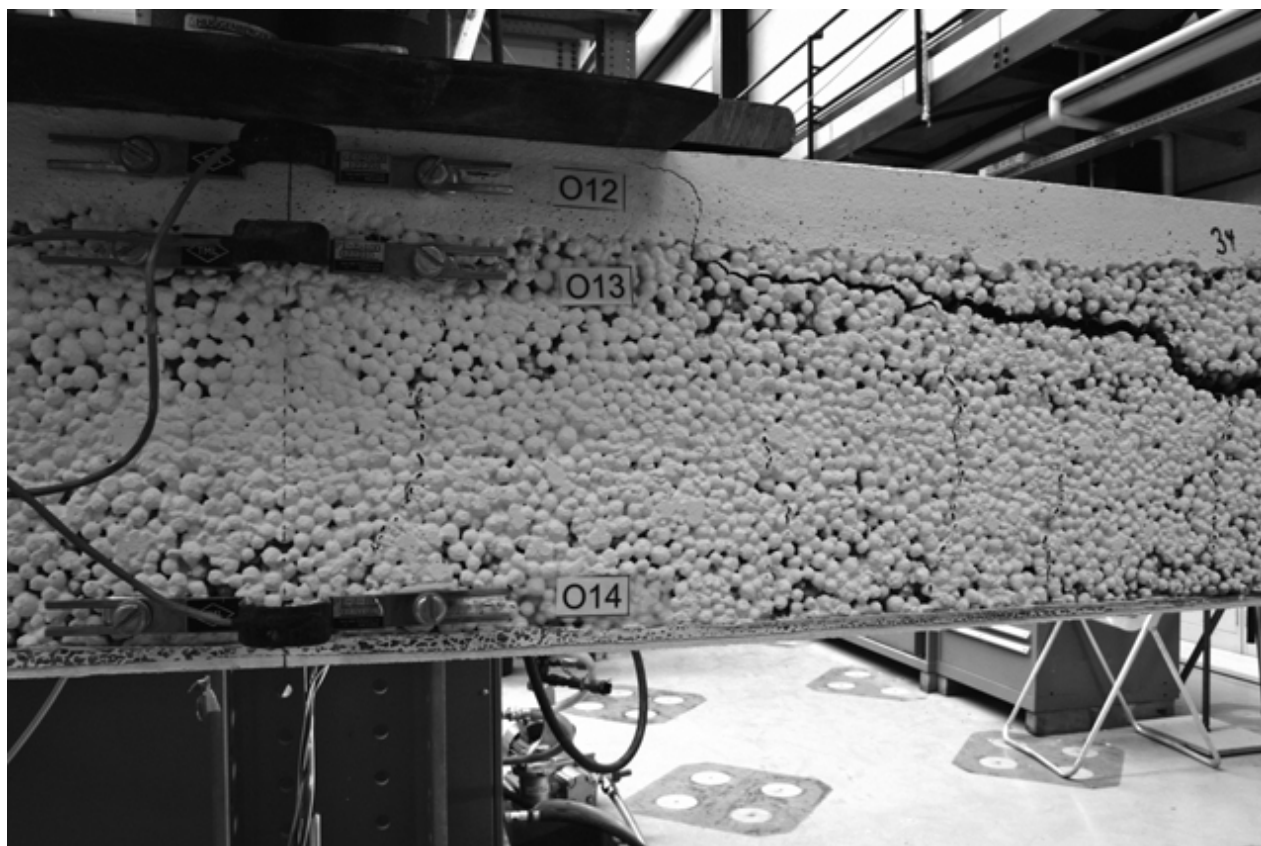
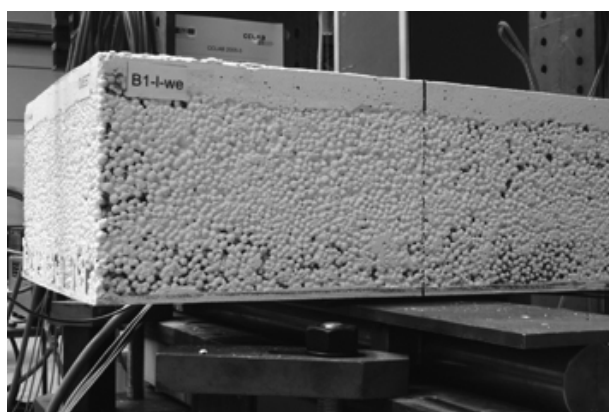
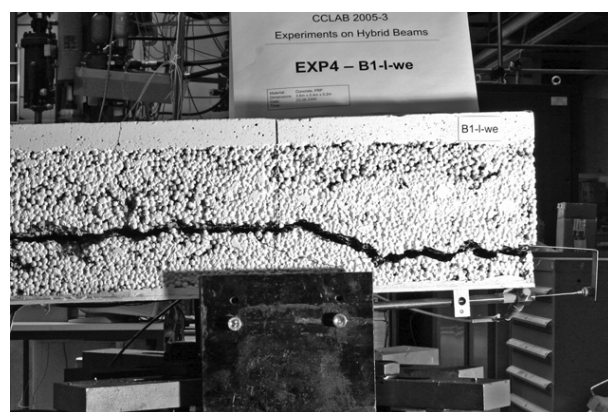
(a) View from south - mid-span

Figure C.102: 1300E-1: Failed beam after experiment, still loaded - south.

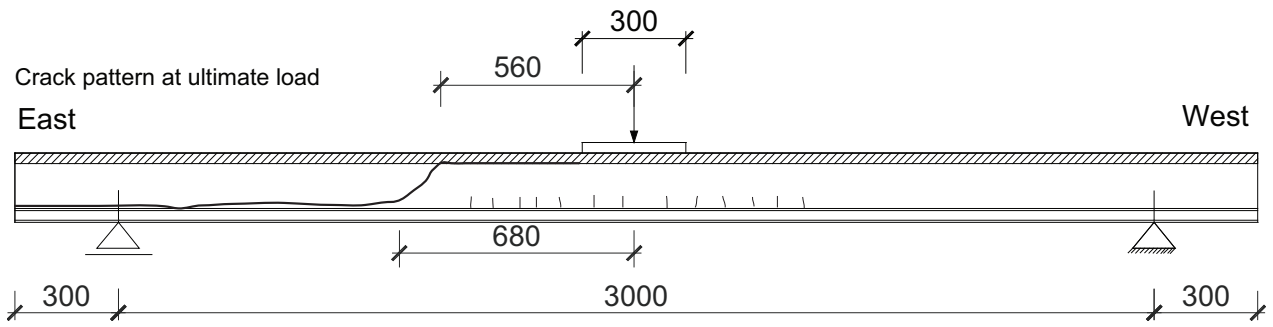
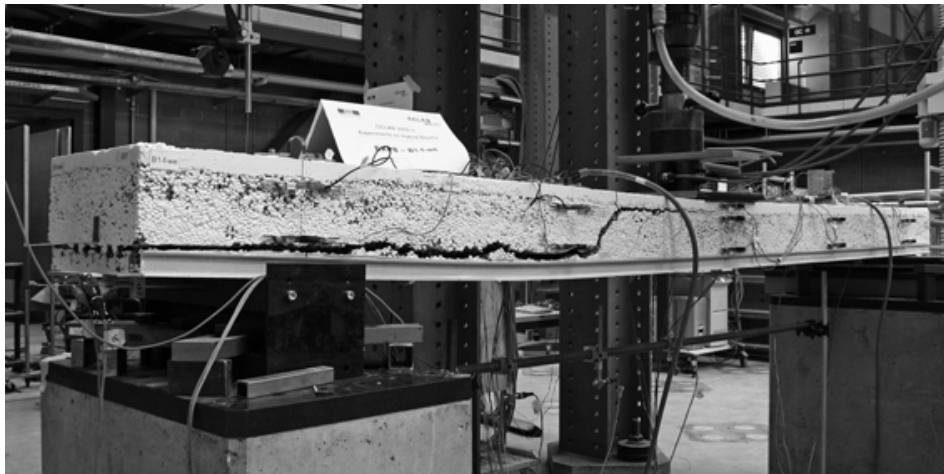
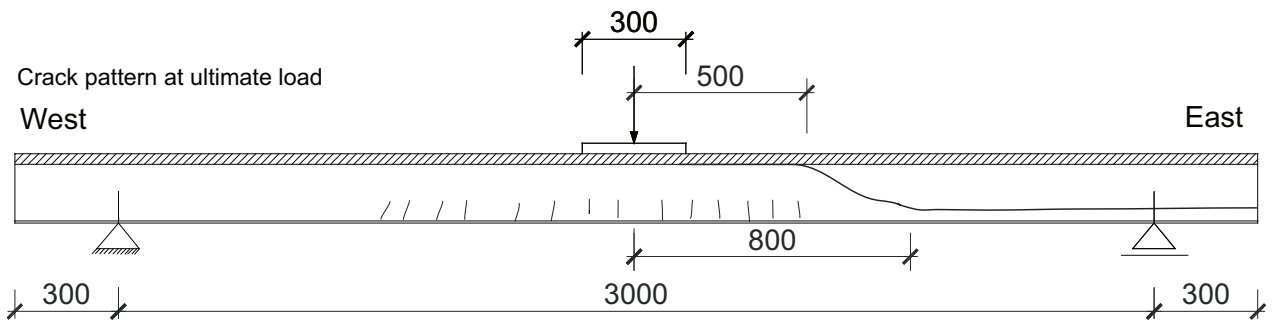
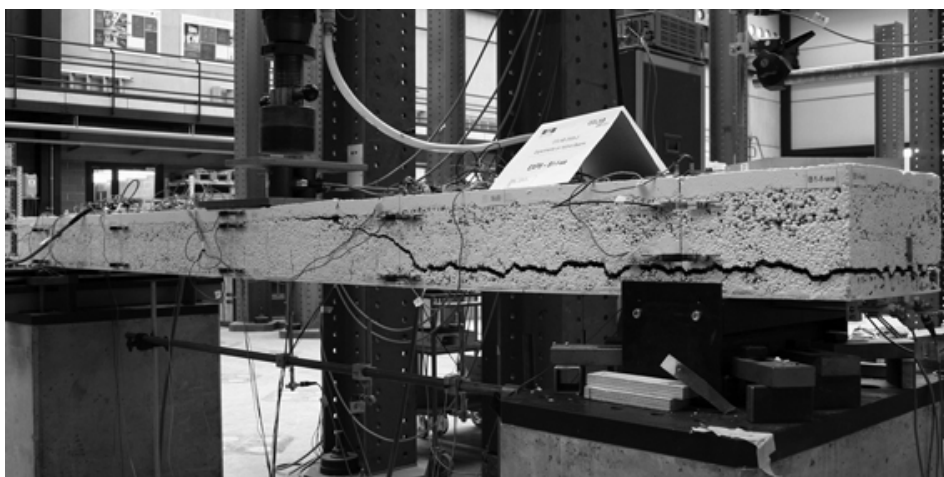
The failure process of beam 1300E-2 is illustrated in Figures C.110, and C.111. Up to a load of 35.4 kN and mid-span deformation of 8 mm, where a second load cycle was performed, no cracks or noises occurred. During the reloading process the first small cracks in the tension zone of the lightweight concrete started to develop at 25 kN below the loading plate. All cracks were very small and vertically distributed with a spacing of approximately 10 cm. The first small noises were audible at a load of 36.3 kN. A loud noise at 43 kN next to omega-shaped extensometer O22 indicated the imminent failure. The beam failed in a brittle and immediate manner at the load $F_u = 50.5$ kN and a corresponding deflection of 14.1 mm. Since the epoxy-bonded interface remained undamaged, no debonding of the LC from the GFRP occurred. The failed specimen is shown in Figures C.112 and C.113.

(a) View from north - Cracked beam

(b) View from north

(c) View from south - Cracked beam

(d) View from south

Figure C.111: 1300E-2: Failed beam after experiment, still loaded.

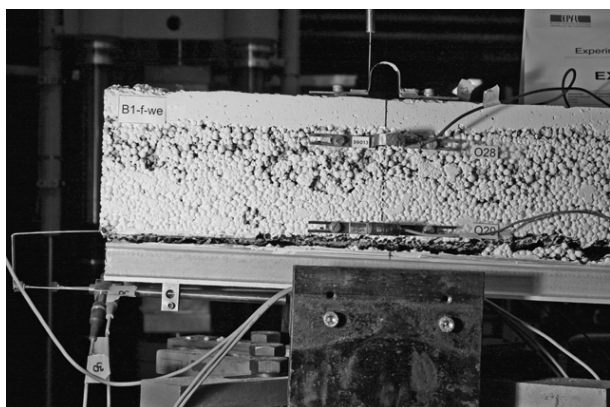
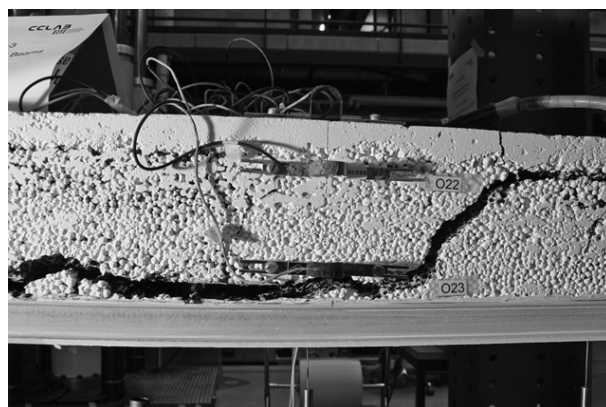
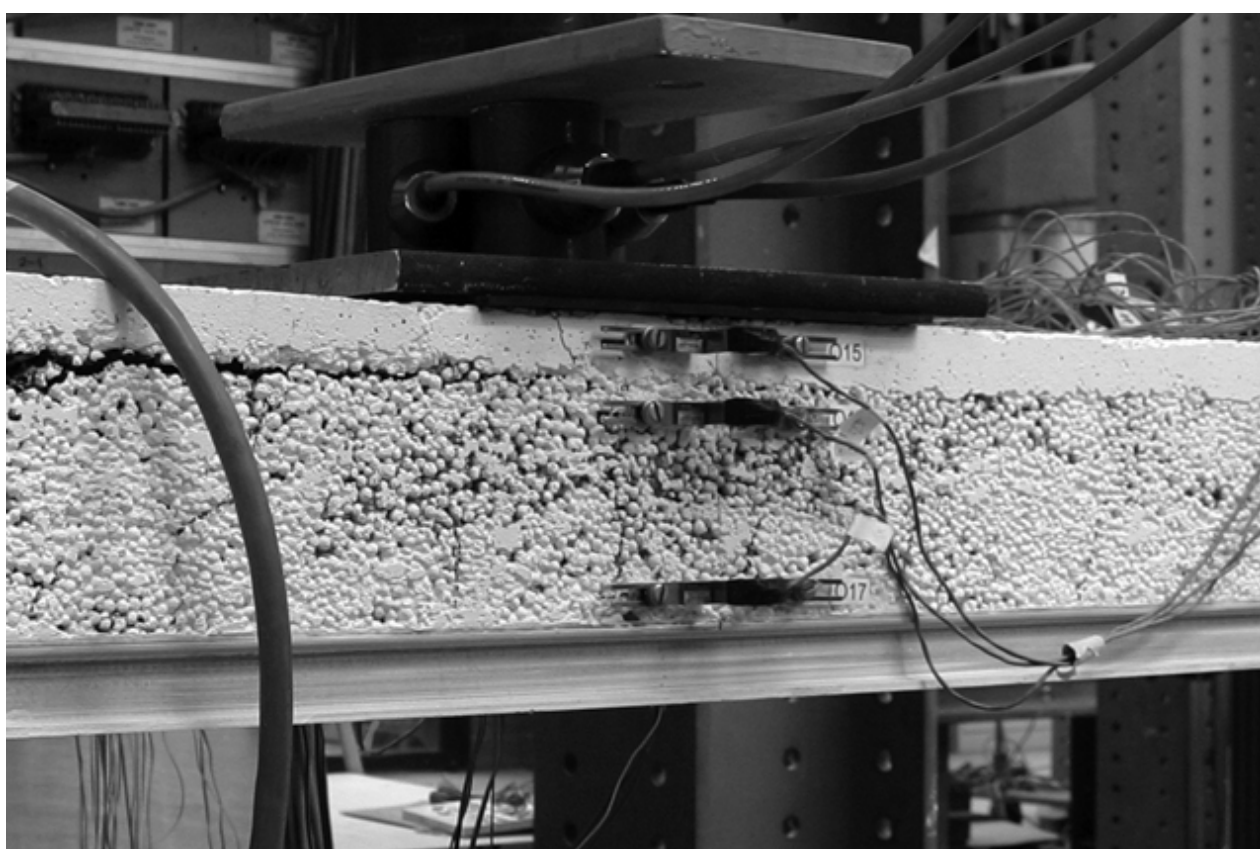
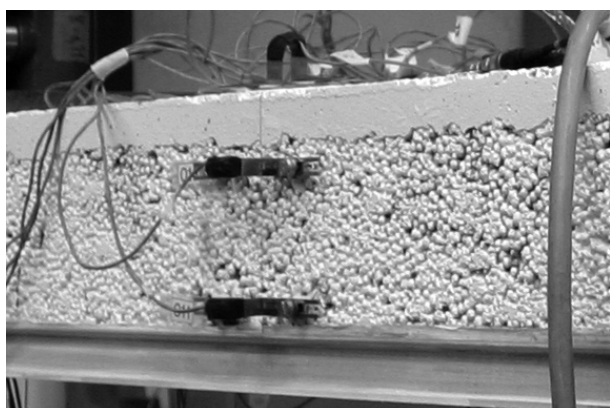
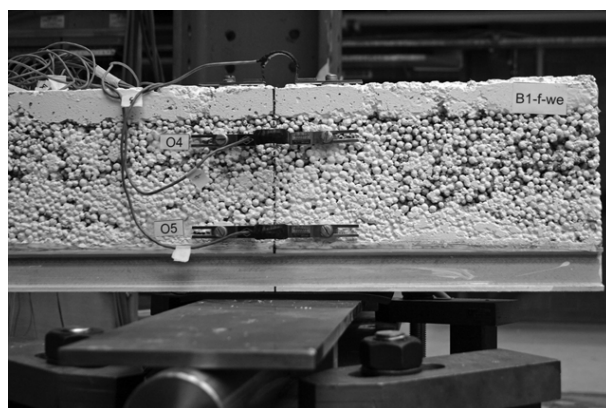
(a) View from north - axis B

(b) View from north - axis C

(c) View from north - mid-span

(d) View from north - axis E

(e) View from north - axis F

Figure C.112: 1300E-2: Failed beam after experiment, still loaded - north.

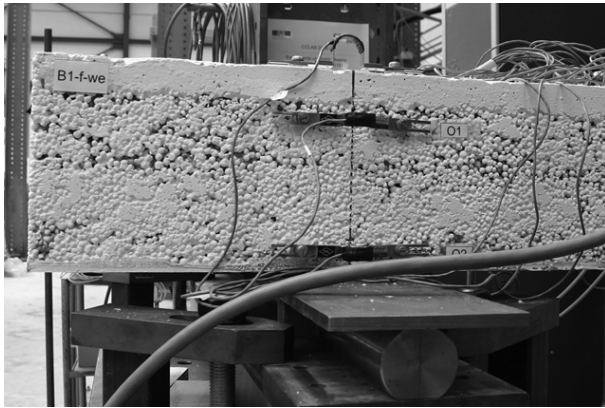
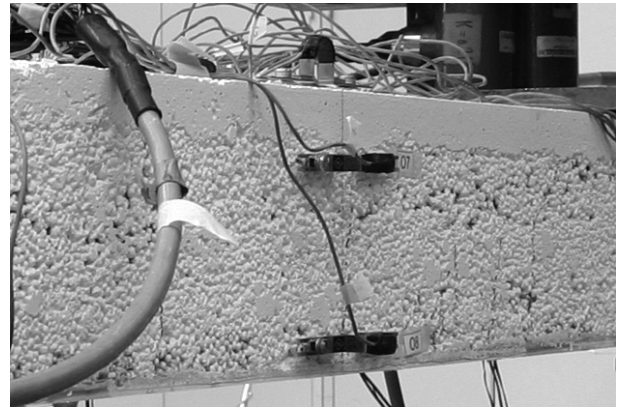
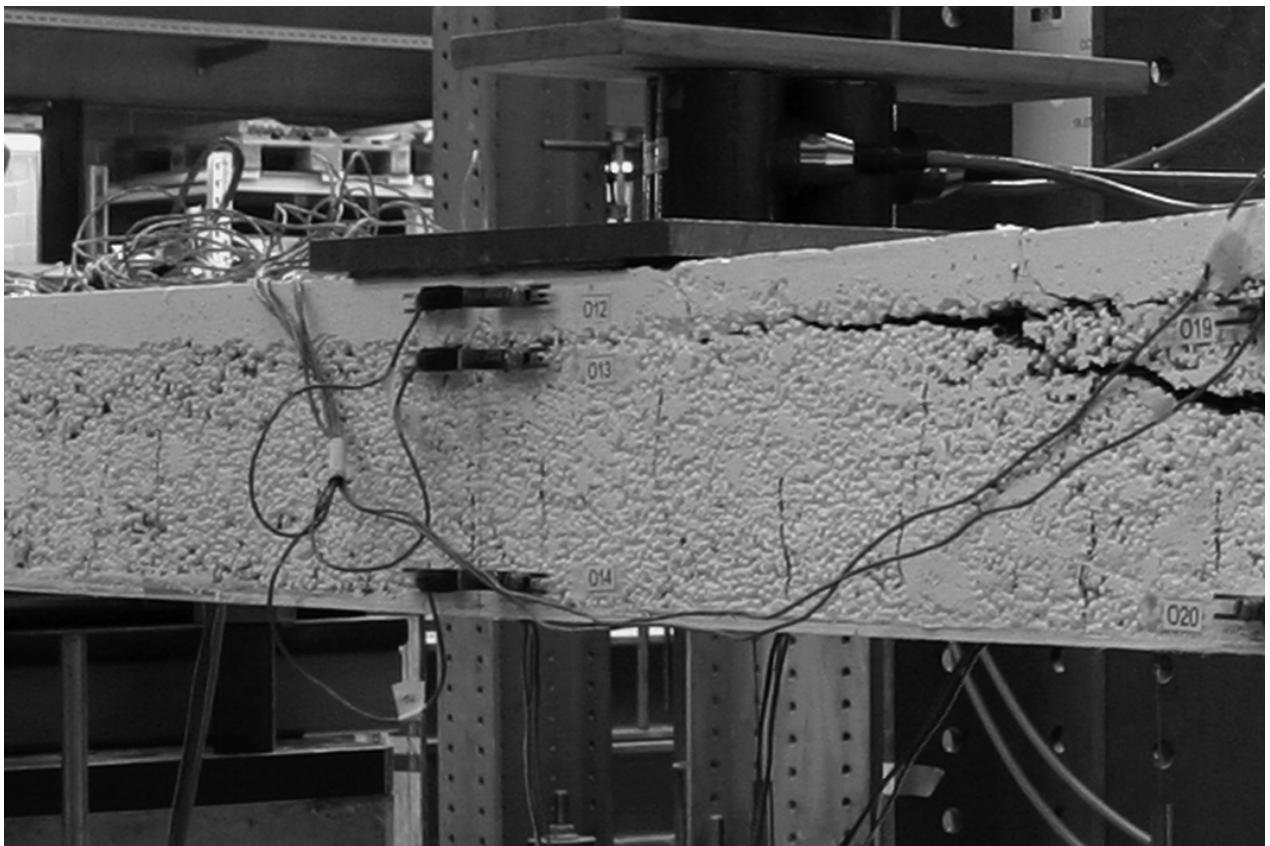
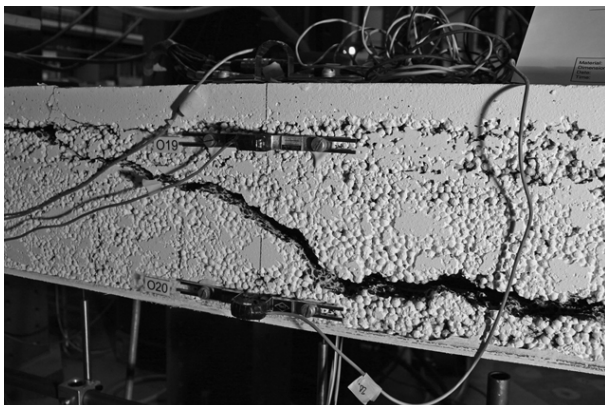
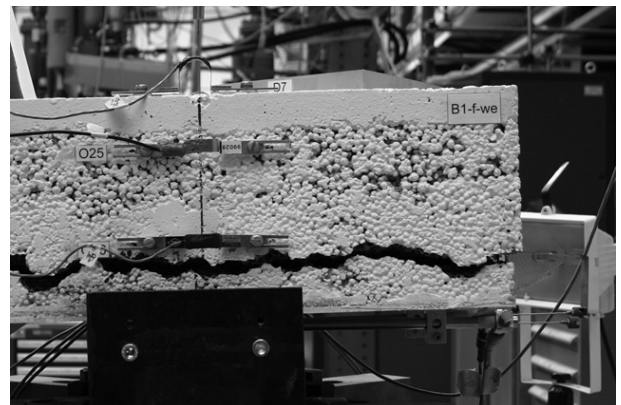
(a) View from south - axis F

(b) View from south - axis E

(c) View from south - mid-span

(d) View from south - axis C

(e) View from south - axis B

Figure C.113: 1300E-2: Failed beam after experiment, still loaded - south.

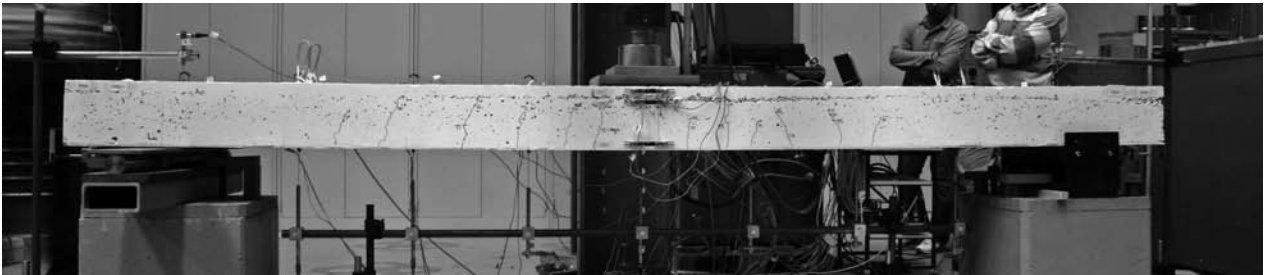
(a) Crack distribution at 25.0 kN - first load cycle

The failure process of the beam started with inner cracking resulting in small noises at a load of 6.0 kN. The first obvious but small cracks appeared at a load of 9.0 kN under the loading plate in the west and east sides and four more short ones occurred in the east side with an average spacing of 32 cm. Further loading resulted in cracking and at a load of 15 kN the cracks got longer and additional new vertical cracks could be observed on average every 23 cm in the east side and 19 cm in the west side. The crack opening was approximately 0.01-0.05 mm. The cracks subsequently started to develop vertically up to the NC layer, although their opening remained approximately 0.05 mm. Some new vertical cracks developed, and the average crack spacing at 20 kN was thus reduced to 15 cm on the east side and 14,4 cm on the west side. At this load the first cracks reached the LC-NC interface. At 25 kN a load cycle was performed. The cracks closed during the unloading process.

During reloading several audible cracks could be noticed under loads of 5.8, 7, 8.8, 14, 18, and 20 kN. Reloading was performed constantly up to 30 kN, where the further cracking process was documented. At this load, horizontal cracks in the LC-NC interface were first observed. The crack opening was between 0.10 and 0.15 mm.

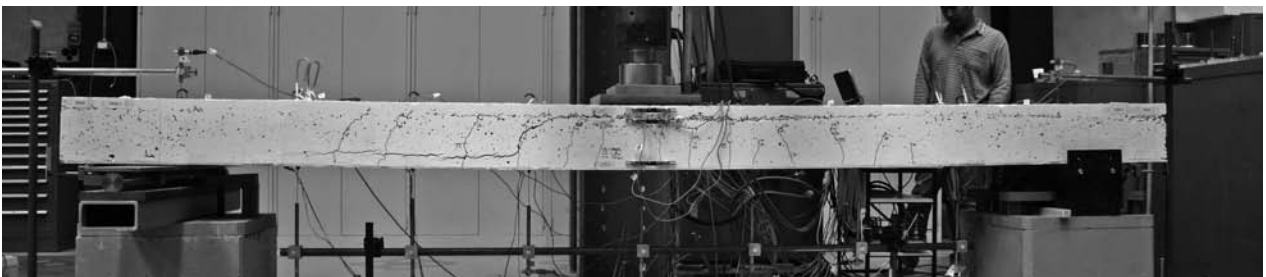
(b) Development of main crack at max load 35.0 kN

At a load of 35 kN the jack was stopped in order to observe the crack development properly, but immediately the beam failed and one vertical crack turned and propagated horizontally in the northern beam part, approximately 40 cm from the mid-span. The load dropped to 23 kN. The beam was however able to slightly regain its stiffness. At the same time the LC started to be pushed out of the GFRP profile. While the load increased to 27 kN the main crack propagated towards the support. Subsequently the load dropped again and the main crack developed along the top of the T-upstands to the end of the beam. Figure C.127 illustrates the pushing out and shear failure of the LC along the top of the T-upstands. The southern end of the beam remained almost undamaged.
