Appendix B

Experiments on materials on DVD

B.1 Introduction

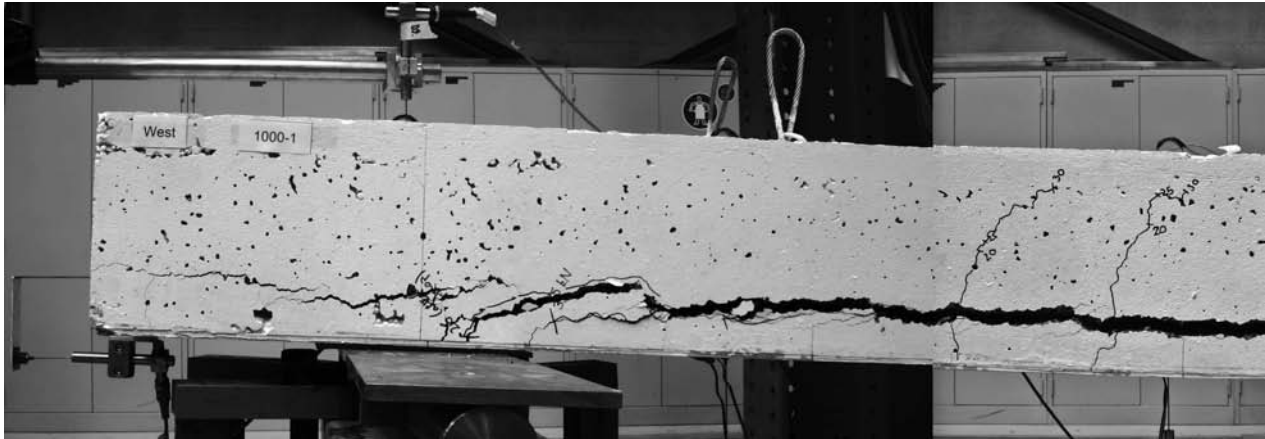
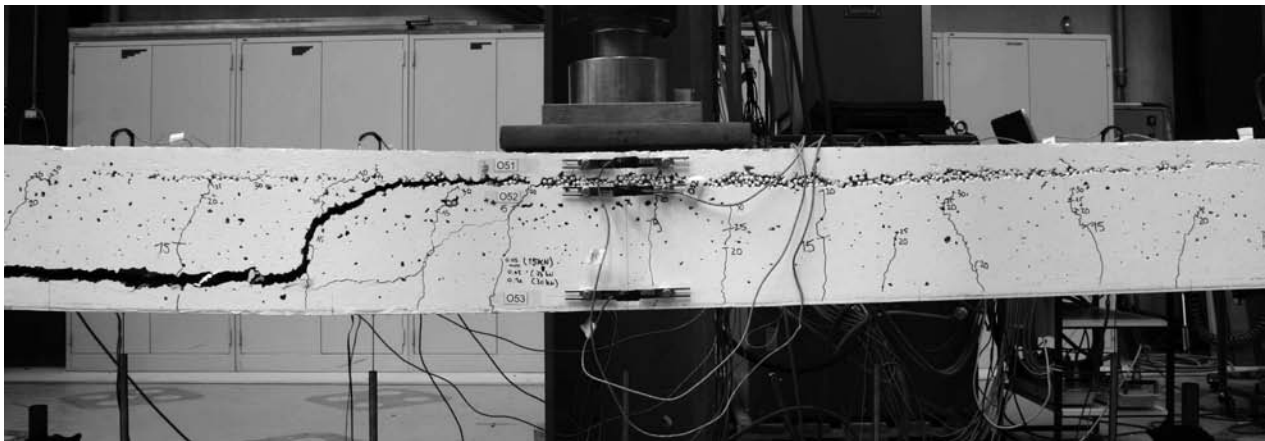
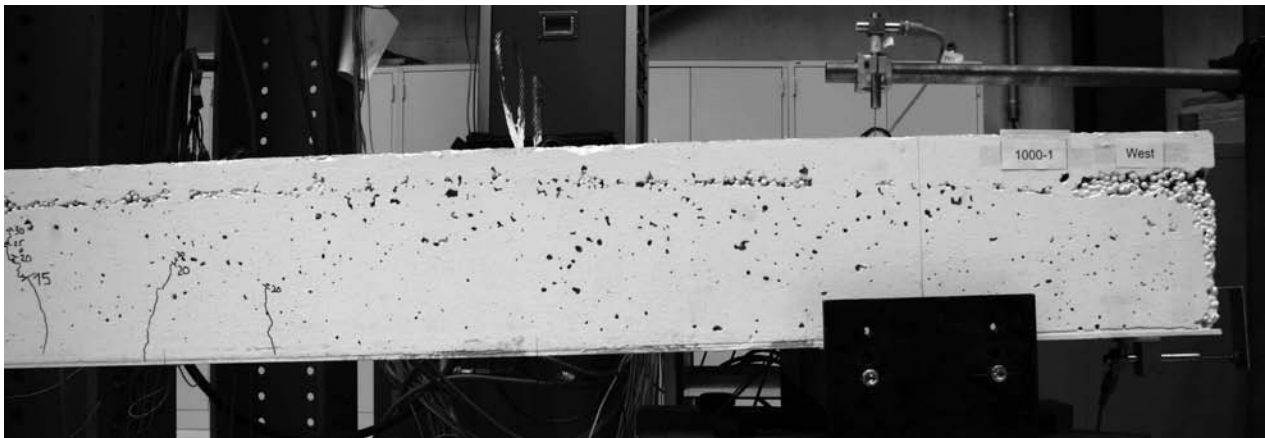
Figure C.125: 1000: West side of cracked beam after experiment, still loaded.

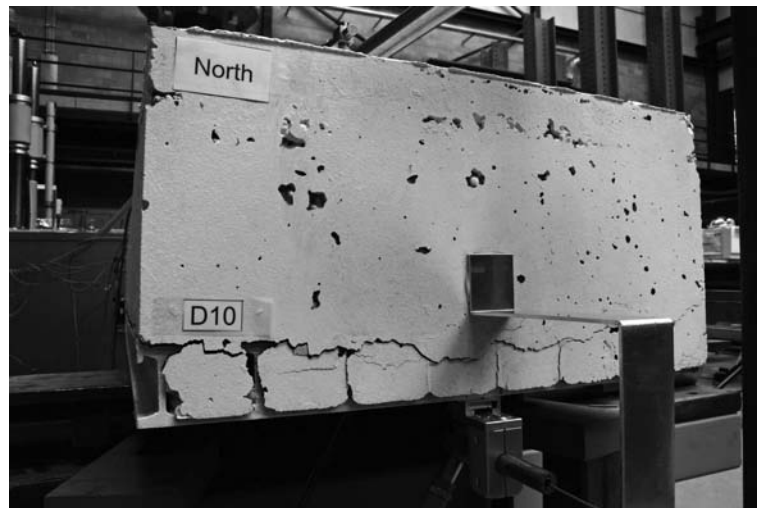
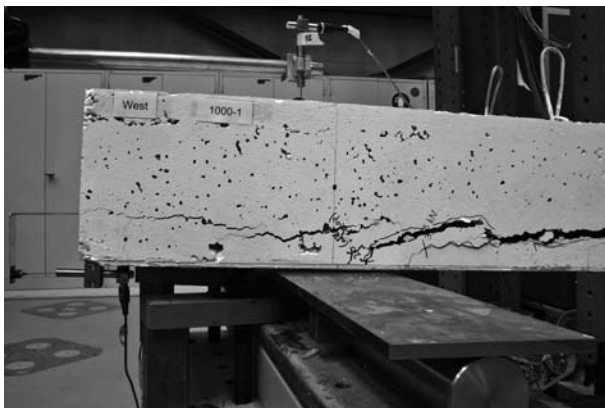
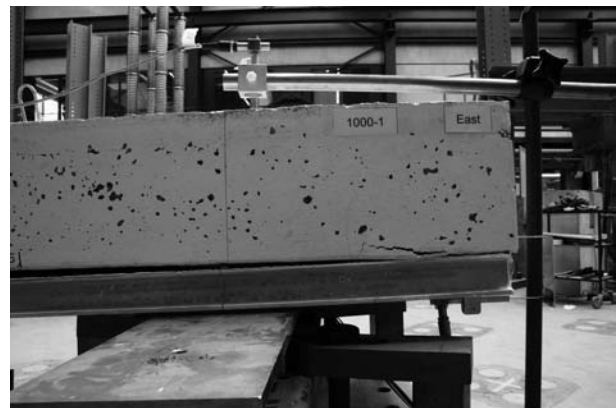
Figure C.127: 1000: LC being pushed out of GFRP profile at northern beam end.

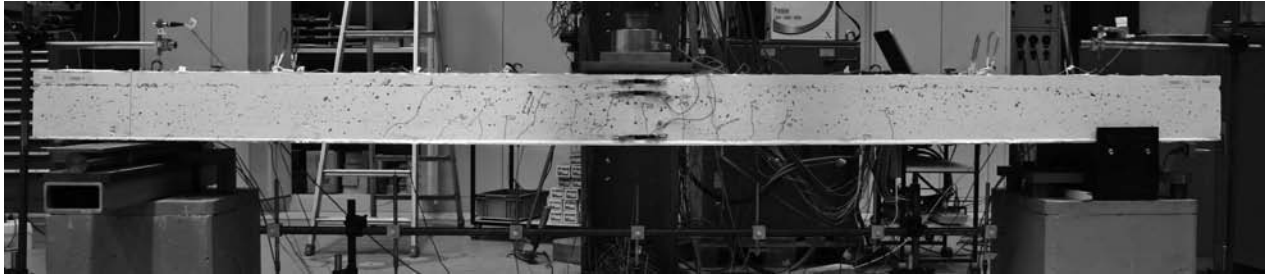
The first two visible cracks were noticed at a load of 8.0 kN. Subsequently, beam stiffness decreased slightly and cracks developed more or less vertically next to the loading plate. The crack length ranged between 4 and 15 cm. At a load of 15 kN the width of the crack next to the loading plate was approximately 0.01 mm. At this load a new inclined crack crossing the LC layer and developing at the LC-NC interface was observed. Subsequently further cracks developed with reduced crack spacings. At a load of 20 kN the width of the cracks next to the loading plate was 0.02 mm, while the opening of the inclined crack in the northern part reached 0.1 mm. At a load of 25 kN the cracked region was approximately 150 cm wide. On the southern side of the beam the cracks were vertically distributed with an average crack spacing of 8 cm. The cracks on the northern side were more and more inclined and the closer they were to the supports, the greater their spacing. Several cracks propagated through the LC-NC interface towards the mid-span.

(a) Crack pattern at 20 kN - first load cycle

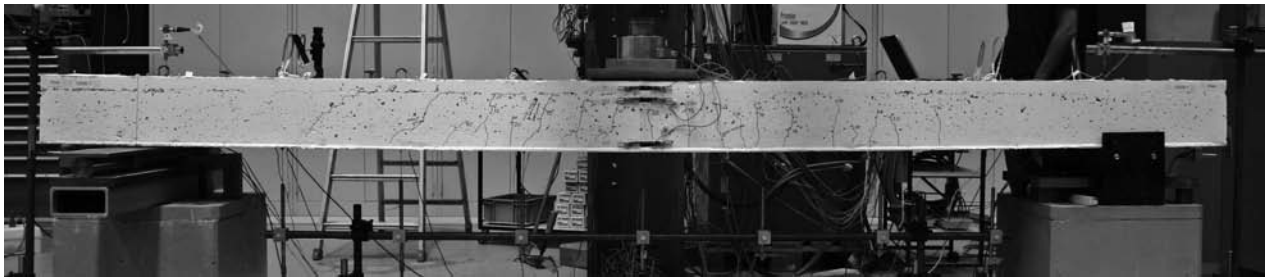
At 30 kN a load cycle was performed. The cracks closed during the unloading process. Reloading was performed constantly up to 30 kN, where the further cracking process was documented. The crack pattern remained unchanged with the exception of a new crack in the southwest side of the beam.

(b) Crack pattern at 30 kN - second load cycle

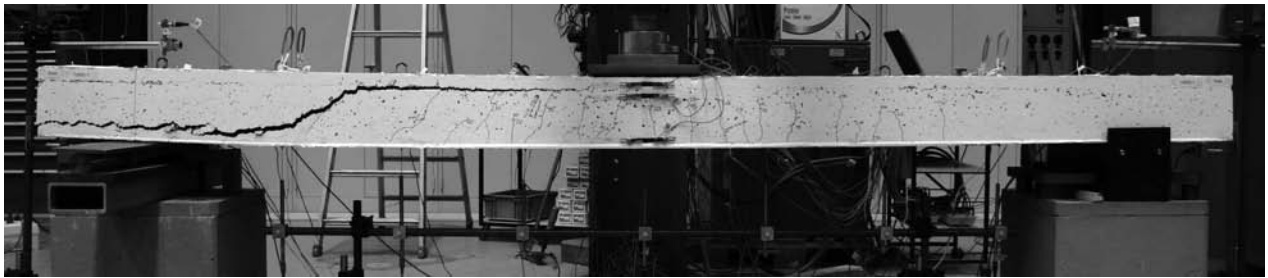
At a load of 39.2 kN the most inclined crack on the northern side suddenly propagated through the depth of the beam, along the LC-NC interface to the loading plate in one direction and along the top of the FRP T-upstands, just above the FRP-LC interface, to the support and up to the beam end in the other direction.

Up to the end of the experiment, no debonding of the LC from the GFRP occurred and no slippage at the beam end was measured. After the brittle failure, the load dropped and the experiment was stopped.

(c) Crack pattern at ultimate load

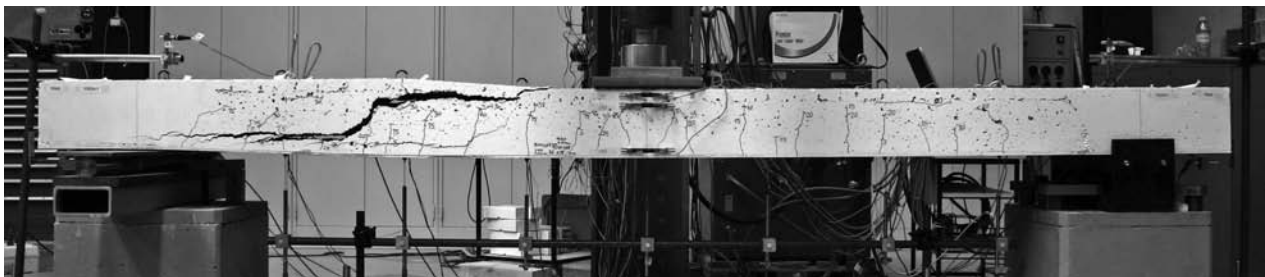
At a load of 32 kN three loud noises occurred. However, no obvious change could be noticed. At 37.8 kN the beam failed when a crack suddenly propagated through the depth of the LC on the northern side. This crack was slightly inclined and developed further along the LC-NC interface and along the top of the FRP T-upstands, just above the FRP-LC interface, up to the anchor block. The load dropped to a value of 19.9 kN, where a short stabilization could be noticed followed by a load cracking and second drop in the load. At the same time, omega-shaped extensometer O6 detached from the concrete surface. The experiment was then stopped. The anchor blocks remained undamaged, and no slippage at the beam ends was measured.

(e) Failed beam after experiment, still loaded

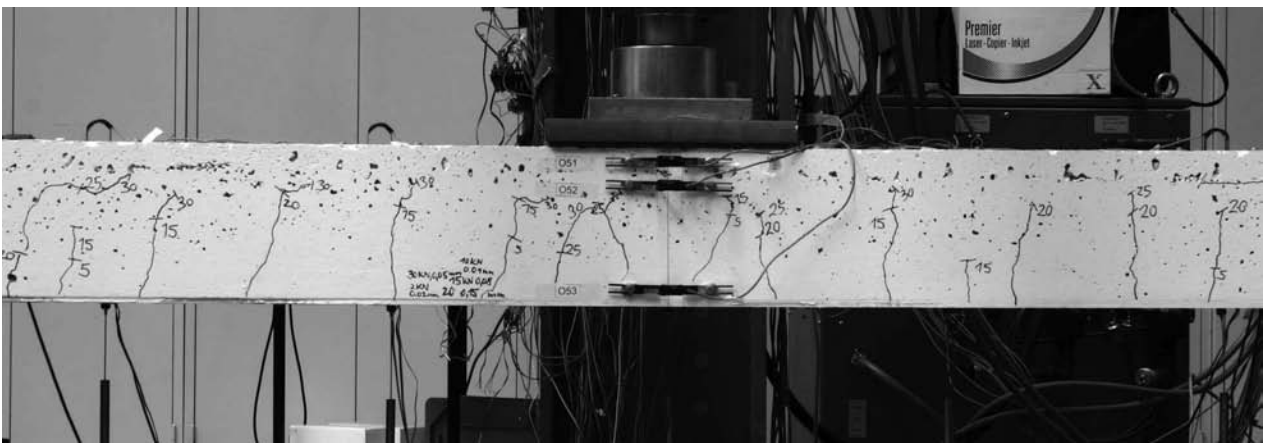
(b) At 30.0 kN - second load cycle

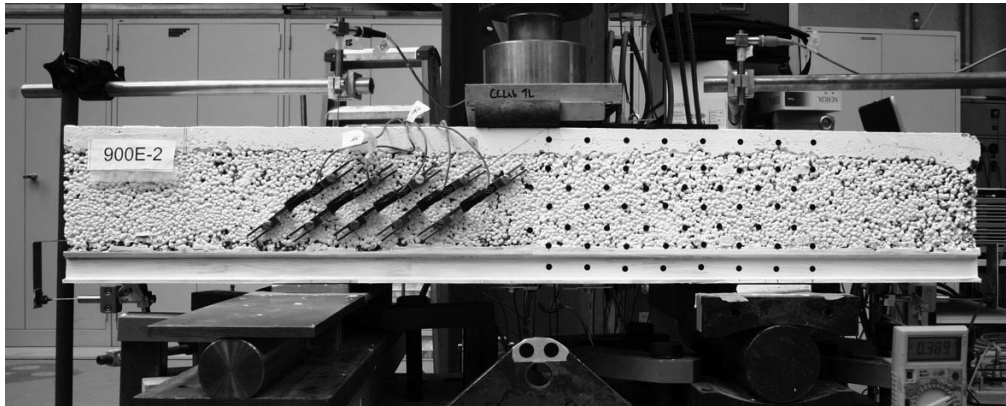
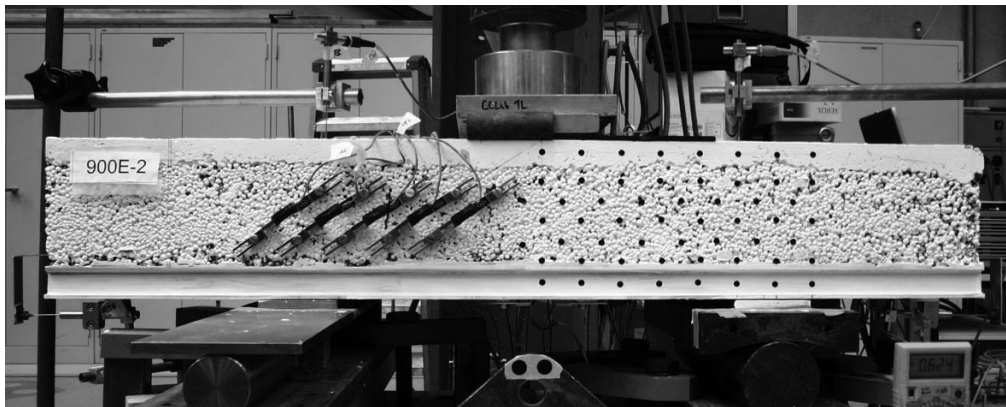
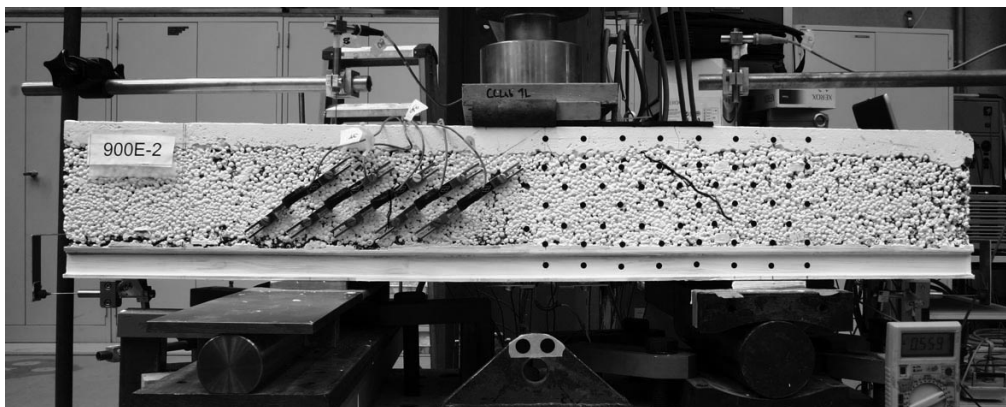
Figure D.9: 900Es-2: Failure process on west side (north left, south right).

The failure process and crack development in the specimen up to the end of the experiment are shown in Figures D.9 and D.10. The first audible cracks were noticed at a load of 60 kN. Although no obvious cracks were observed, noises occurred at a load of 76 kN in the south-east part of the specimen. Only at a load of 80 kN could the first crack be observed on the north-west side, next to O37 and crossing O36. The ultimate load was reached at 83 kN and simultaneously the diagonal cracks in the north-east part of the specimen crossing the attachment points of O26-O27 became evident. A second drop in the load occurred when a diagonal crack opened in the southern part of the specimen, through O20-O24 on the east side. At the same time the FRP-LC interface on the north-west side of the specimen failed starting from the crack propagating towards the northern specimen end, (Figure D.9-c). Subsequently the northern crack opened continuously and developed along the LC-NC interface towards mid-span. The load remained more or less constant for some minutes with a slight load minimum when the NC layer broke above the loading plate. When a mid-span deflection of 6 mm was reached, the cracked specimen regained stiffness and the load could be increased up to 109 kN, where the jack reached its deformation limit. The crack development after the first load drops is shown in Figure D.10-a-c. The experiment was stopped here.

(a) At 50 kN - no cracks observed

(b) At ultimate load 83 kN

(c) At 73 kN (post-peak)

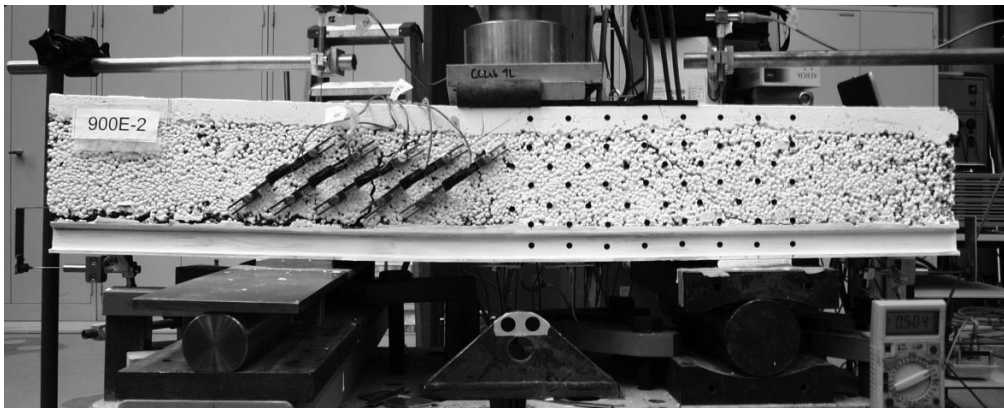
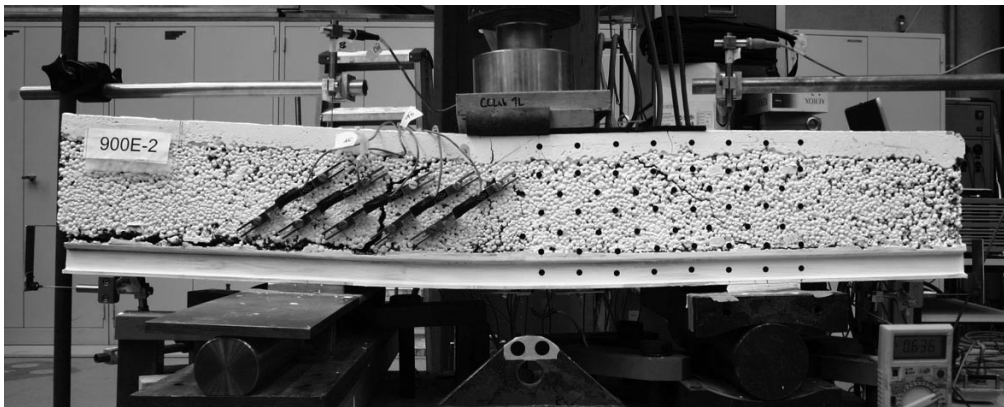
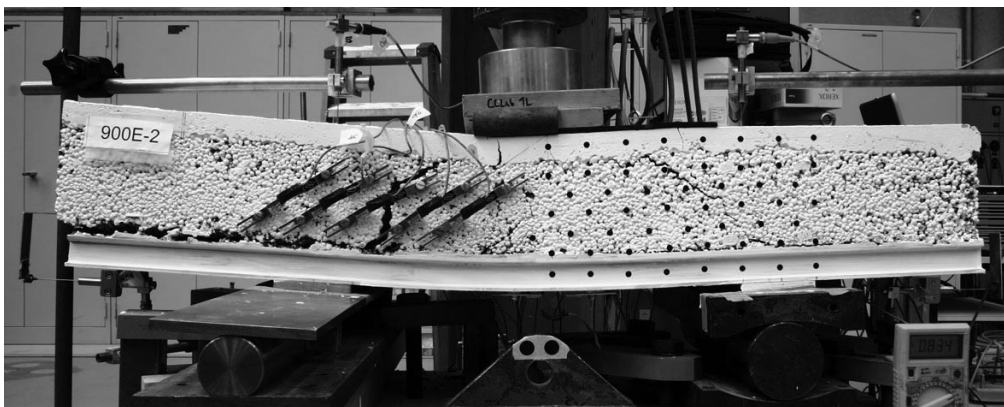
Figure D.10: 900Es-2: Post-peak failure process continuation on west side (north left, south right).

(a) At 69 kN (post-peak)

(b) At 83 kN (post-peak)

(c) At 109 kN (post-peak)

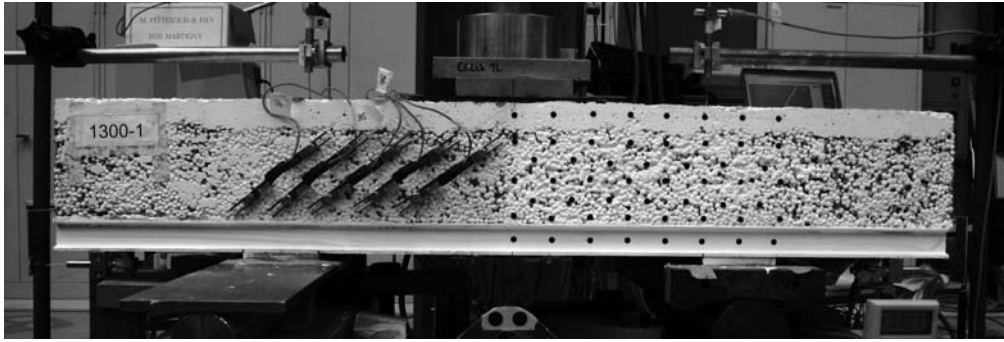
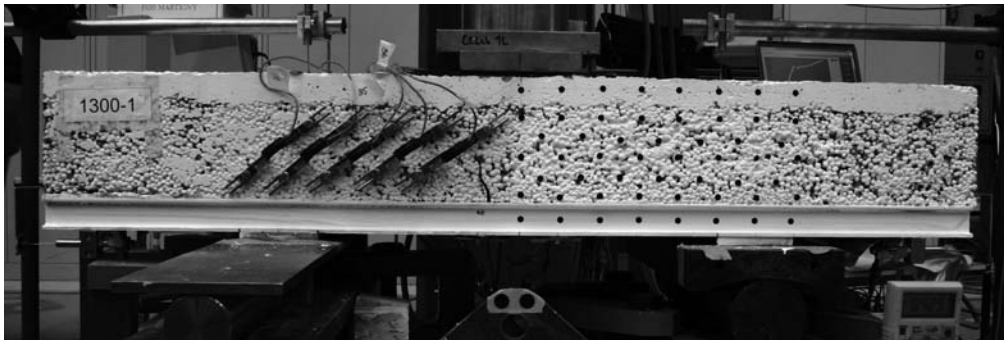
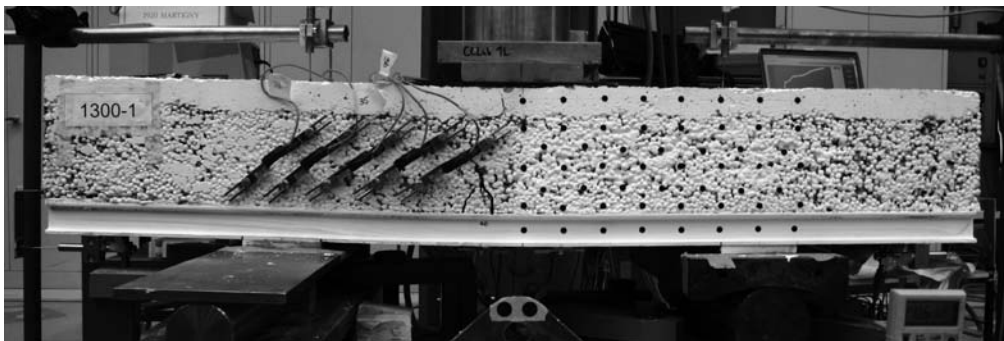
Figure D.15: 1300s-1: Failure process on west side (north left, south right).

The failure process and crack development in the specimen up to the end of the experiment are illustrated in Figures D.15, D.16 and D.17.

The first crack and a kink in the load deflection response were noticed at a load of 40 kN crossing the LC layer on the east part of the specimen, just next to extensometer O31. Subsequently the specimen started to slip out of the GFRP profile on the northern side. The crack width was already 0.5 mm. At the west side of the specimen, next to the loading plate, a vertical crack started to develop, see Figure D.15-b, and as from a load of 55 kN, the crack started to cross the NC layer through the gage length of O30. The NC layer was half cracked at a load of 70 kN. The LC layer continuously slipped out of the GFRP Plank profile and both vertical cracks - on the east and west sides - continued to open. At a load of approximately 80 kN horizontal cracks could be observed in the eastern part of the specimen, just above the T-upstands, one on the northern and one in the southern part of the span, see Figure D.17-a. A loud noise occurred at a load of 80 kN, although no further cracks developed; only the vertical crack, separating the southern LC layer from the northern part of the specimen, got wider and the LC slipped out of the northern side of the specimen. Only as from a load of 90 kN, could slippage of over 0.04 mm be measured at the southern end of the specimen. At 132 kN loud noises were noticed, followed by a drop in the load. The crack width at mid-span was approximately 15 mm, indicating that the GFRP was the only load-bearing element. Despite several (3-4) loud noises and load drops, the load could be slightly increased up to the ultimate load of 143 kN. Then a drop in the load occurred and the outer T-webs of the GFRP Plank profile started to buckle, see Figure D.16-d. The experiment was then stopped.

(a) At 40 kN - no cracks observed

(b) At 55 kN

(c) At 80 kN

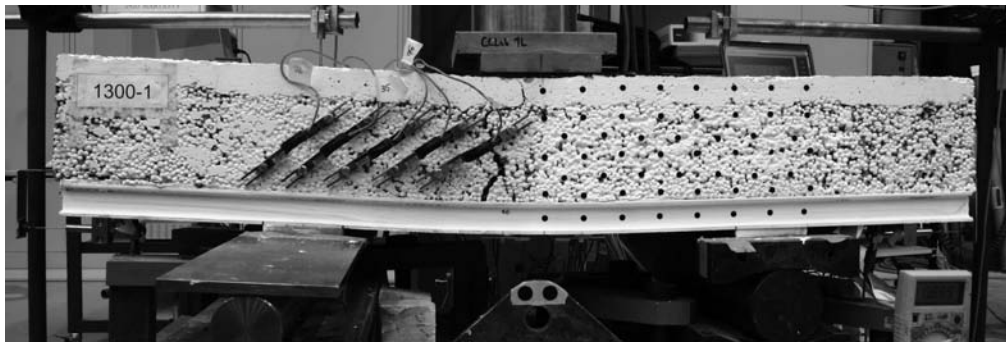
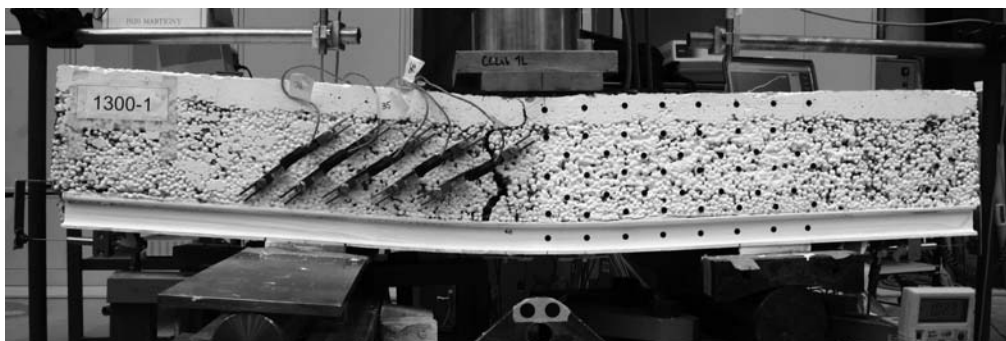
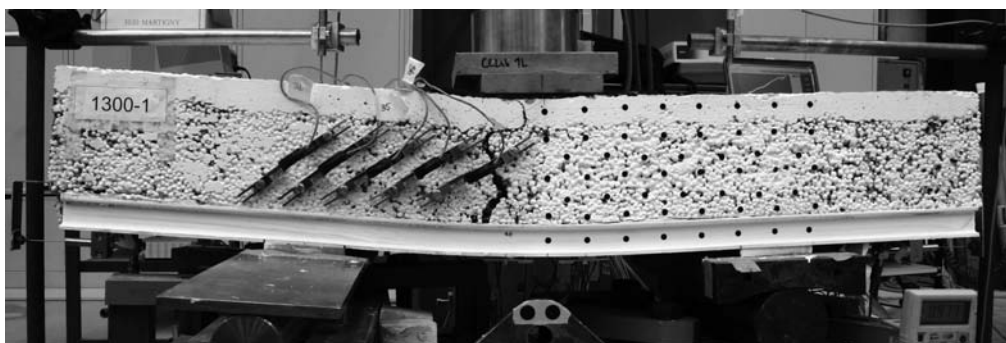
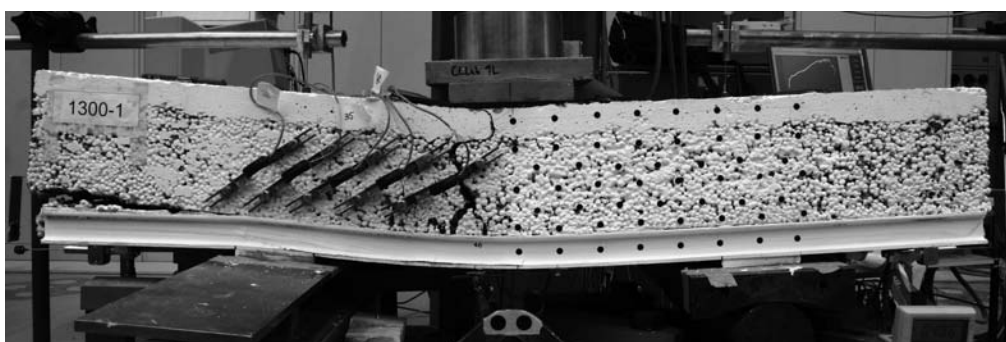
Figure D.16: 1300s-1: Failure process on west side, continuation.

(a) At 115 kN

(b) At ultimate load approx. 140 kN

(c) At 130 kN (post-peak)

(d) FRP failure

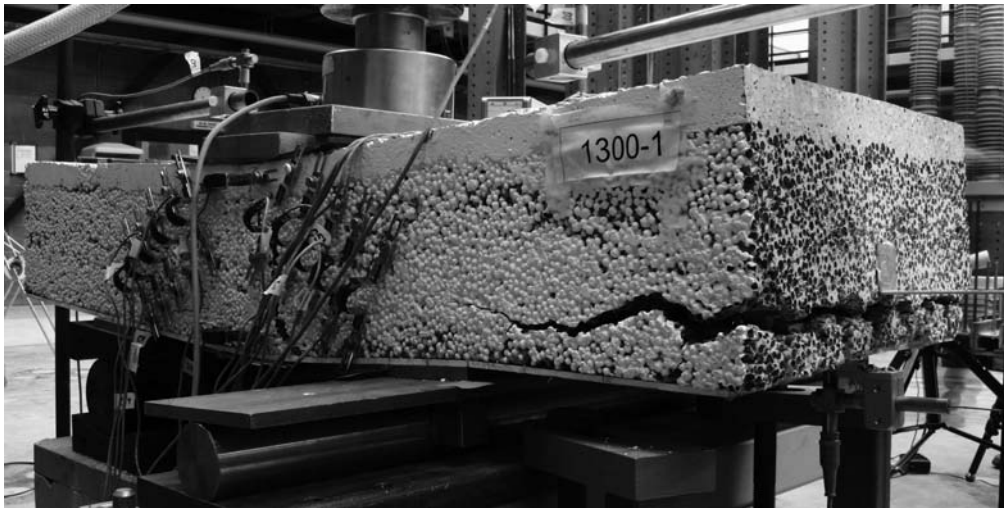
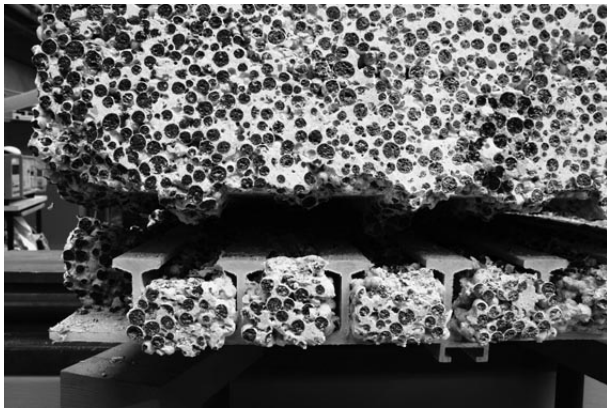
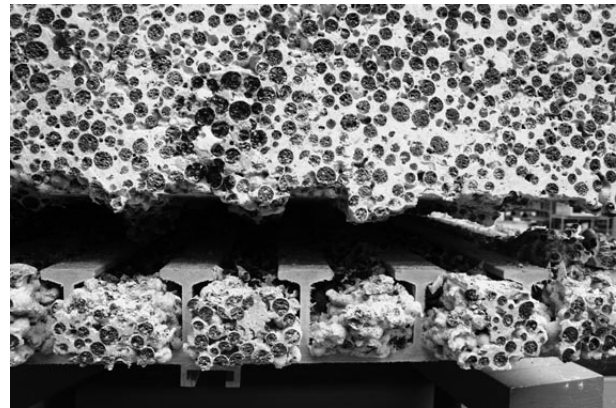
Figure D.17: 1300s-1: Failed specimen and slippage in interfaces.

(a) Failed specimen east part

(b) Failed FRP-LC interface north-east

(c) Failed FRP-LC interface north-west

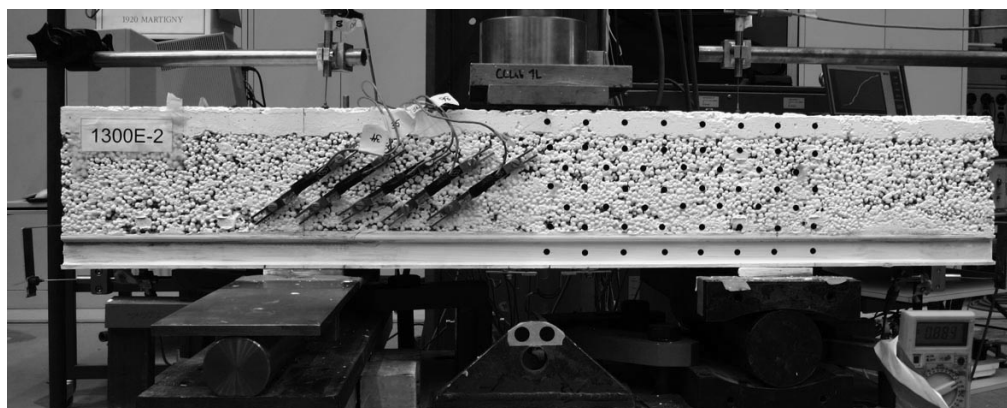
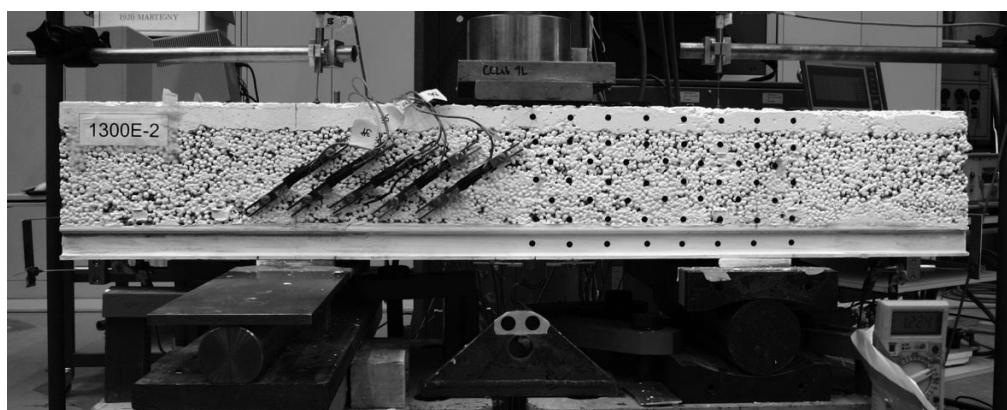
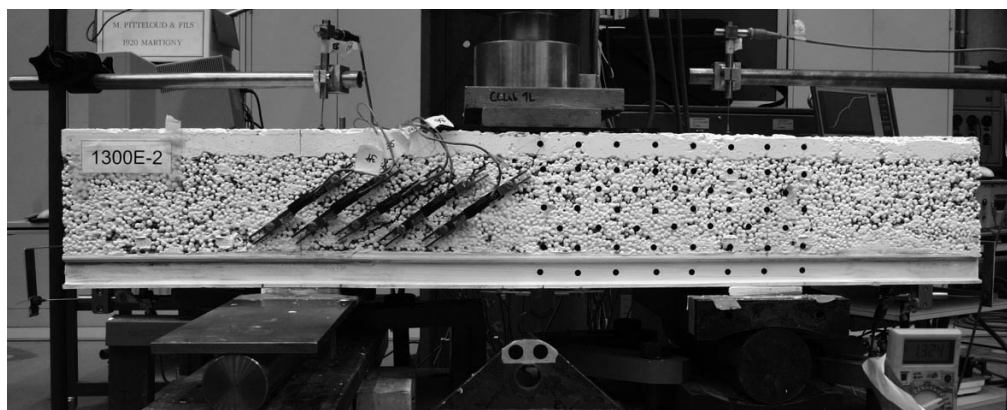
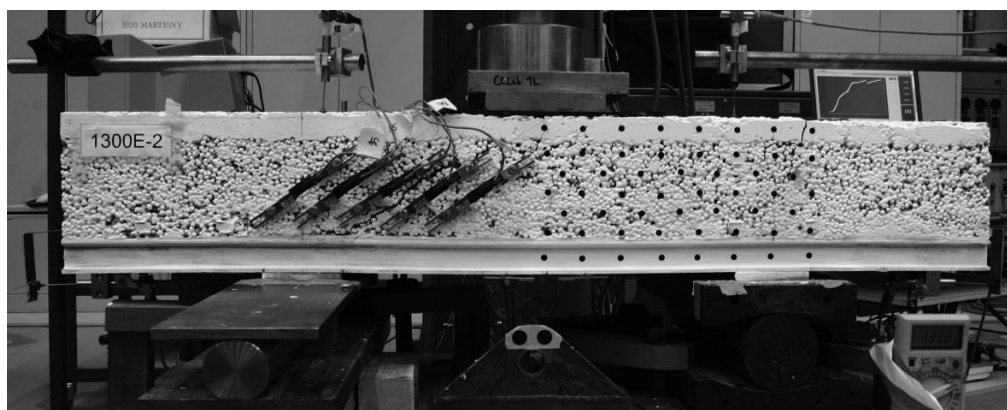
Figure D.35: 1300Es-2: Failure process on west side (north left, south right).

The failure process is illustrated in Figures D.35, D.36 and D.37. The first audible cracks were noticed at a load of 85 kN. Although no obvious cracks were observed, crack noises were audible on the southern support at 90 kN. Subsequently a diagonal crack was observed between O20 and O21, which developed slowly through O22, O21 and O20. At a load of 106 kN a loud noise was followed by the propagation of the crack through the NC surface. At 153 kN the NC layer was broken across the total width on the south-east side. Besides the crack on the top of the specimen and the diagonal crack on the north-eastern part, as illustrated in Figure D.37, no other cracks could be observed in the LC layer. However, it was noticed that O24 detached from the LC surface. The first peak load was observed at 179 kN, when a diagonal crack propagated diagonally on the north-west side, between O36 and O37. The specimen regained stiffness and a plateau could be maintained around the ultimate load of 185.2 kN. O21 and O22 detached and further cracks on the NC surface could be observed. As a consequence, a short jump in the load deflection was measured. When a mid-span deflection of 6.5 mm was reached, the load dropped to 146 kN due to the opening of the diagonal crack through the LC on the north side (Figure D.36-a-c). The experiment was stopped at a mid-span deflection of 11.8 mm as no further load increase could be expected.

(a) At 114 kN - no cracks observed on west side

(b) At 159 kN - diagonal crack between O36 and O37

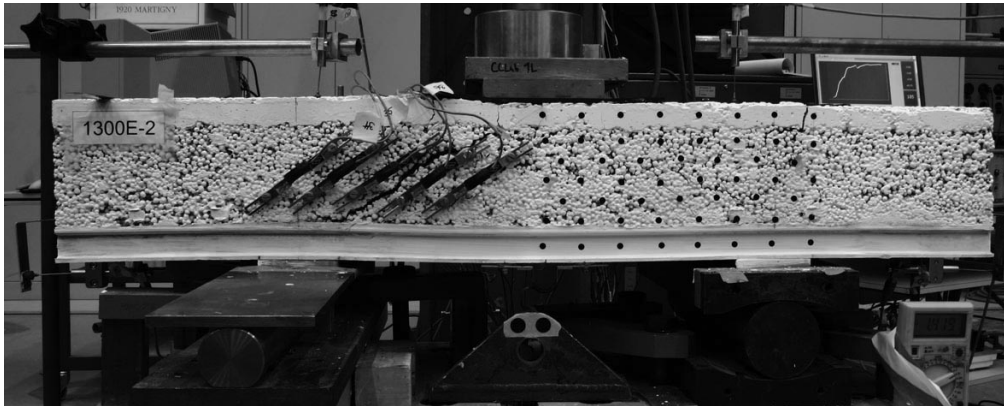
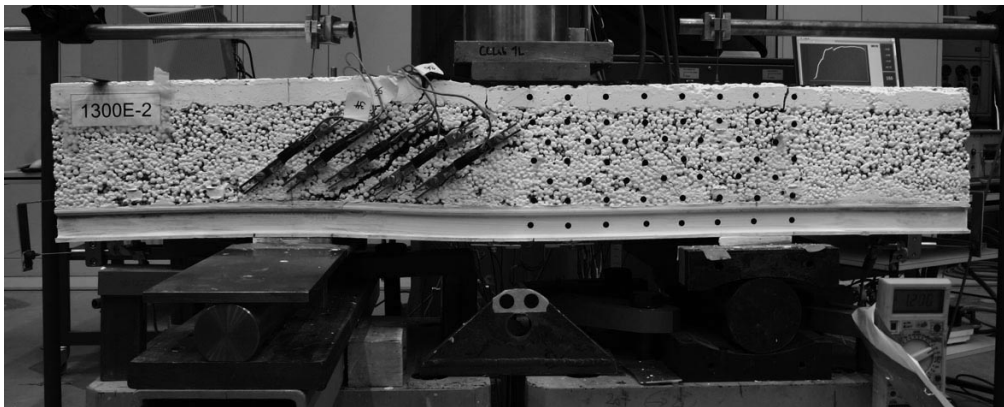
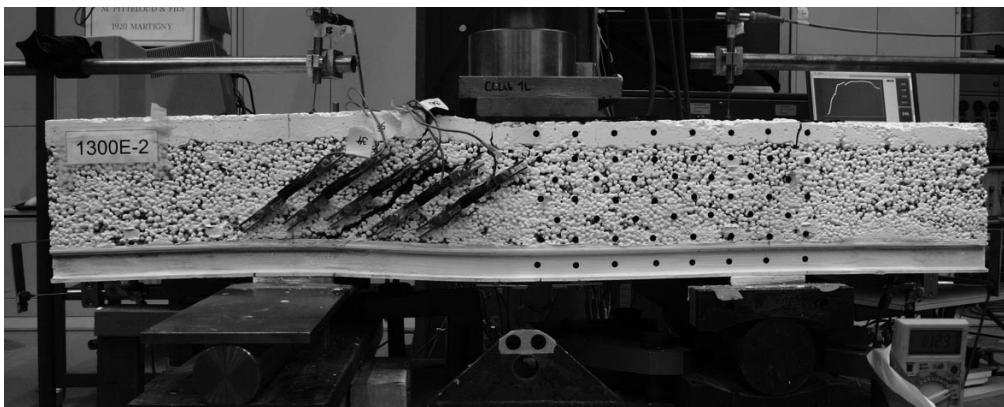
Figure D.36: 1300Es-2: Failure process on west side, continuation.

(a) At 185 kN (post-peak)

(b) At 166 kN (post-peak)

(c) At 146 kN (post-peak)

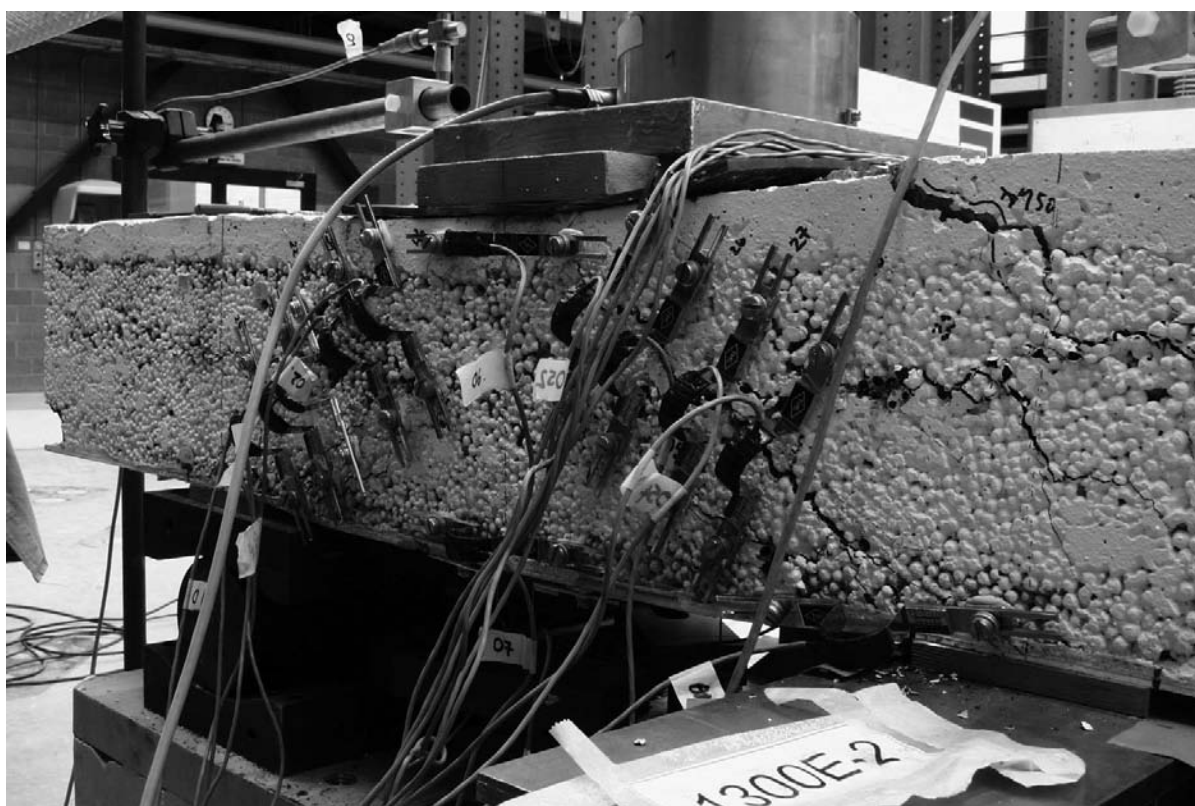
Figure D.37: 1300Es-2: Crack development in eastern part of specimen.

(b) After ultimate load F_u

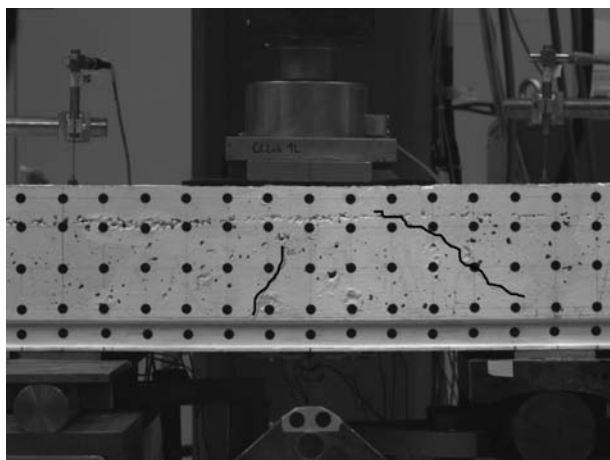
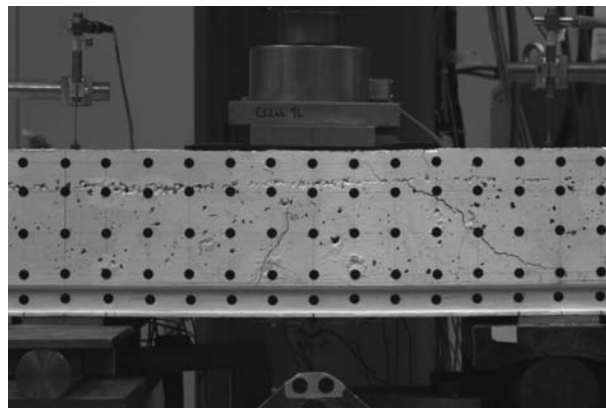
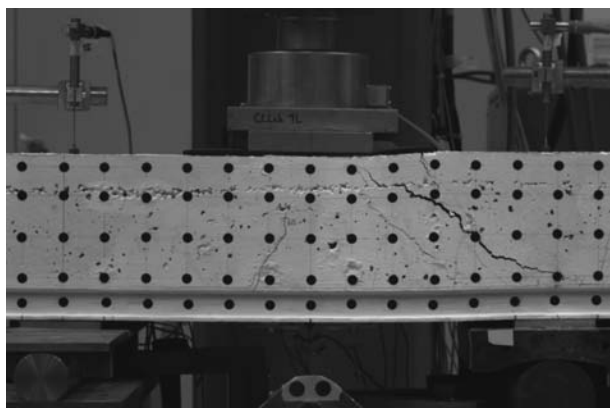
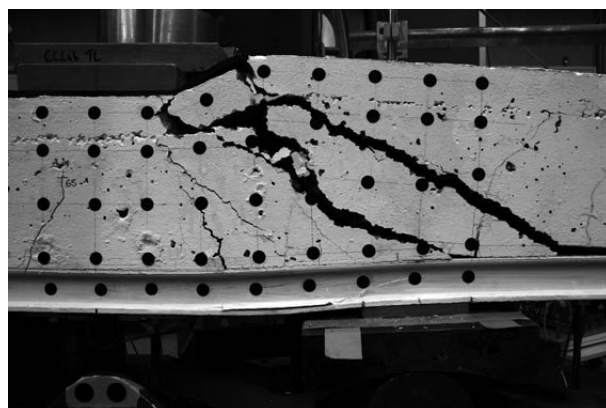
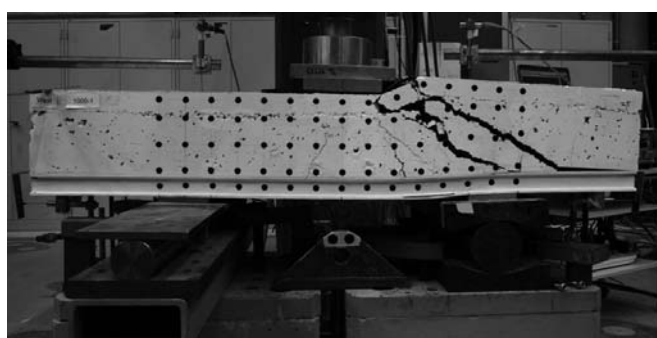
Figure D.42: 1000s: Failure process on west side (north left, south right).

The failure process is illustrated in Figures D.42 and D.43. The first audible cracks were noticed at a load of 42 kN. The first visible diagonal cracks were observed at a load of 44 kN in the eastern part of the specimen between O21 and O22 and next to O23 and O24. Short vertical cracks in the lower part of the LC were also observed. At 44 kN the jack stopped for several seconds due to insufficient pressure, and therefore the measurements differed slightly and a short deloading had to be carried out. Subsequently, a loud noise was noticed at a load of 45 kN, followed by a pronounced crack between omega gages O20, O21 and O22, and next to O23 and O24. At 65 kN the crack width was 0.2 mm on the western side. On the eastern part of the specimen, where only one crack at mid-span was observed, the crack width amounted to 0.12 mm. Starting at a load of 70 kN, several almost parallel cracks propagated on the south-east side. At 80 kN a diagonal crack on the north-east was observed, propagating between O27, O28 and O29, see Figure D.43-a. At this point, all the cracks on the south-east side developed up to the NC layer. The crack width increased, reaching values of between 0.3 and 0.4 mm at 95 kN. At the loading of 130 kN, the diagonal cracks were very well pronounced through the whole LC depth on the north-east and south-east sides. At 150 kN, a crack width of 0.5 up to 1.5 mm could be observed in the south-eastern part and the LC started to push out of the GFRP on the southern side while the crack in the northern part did not exceed 0.8 mm. At 130 kN the crack propagated through omega gage O30. At 163.9 kN the ultimate load was reached. Subsequently a load of 160 kN was maintained until a new crack started to grow above the omega gages, parallel to the theoretical diagonal in the south-east part of the specimen. The load then dropped slightly down to 130 kN while the southern cracks grew significantly. The final drop in load was reached when the whole southern LC-NC unit broke open, as illustrated in Figure D.43. The experiment was then stopped.

(a) At ultimate load

(b) At 160 kN (post-peak)

(c) At 150 kN (post-peak)

(d) Detail of crack (see (e))

(e) At end of experiment

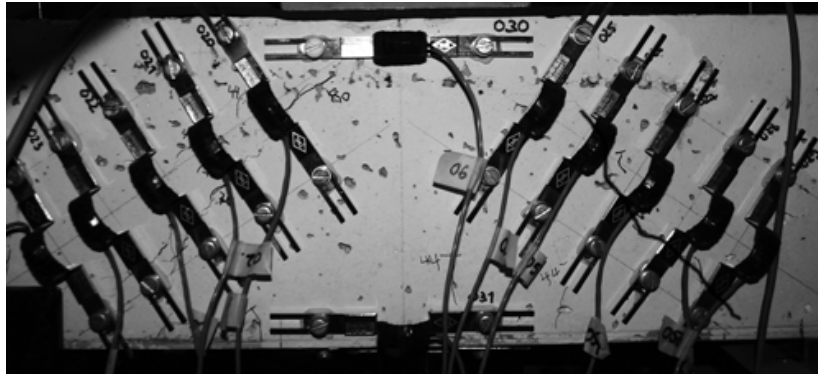
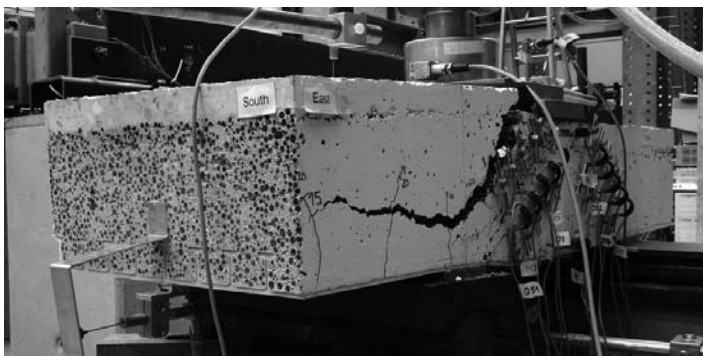
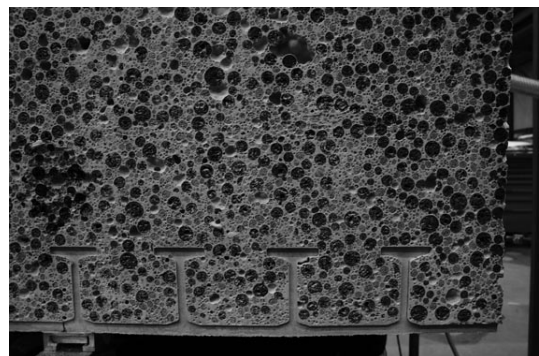
Figure D.43: 1000s: Crack development in east part of specimen and pushing out of LC.

(a) Crack development on east part of specimen at approximately 80 kN

(c) Pushing out of LC block at end of experiment

(d) Pushing out of LC between T-upstands at end of experiment

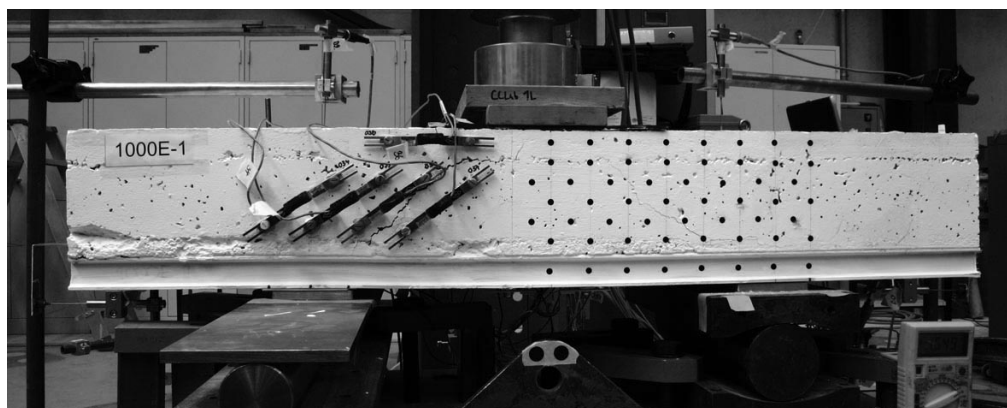
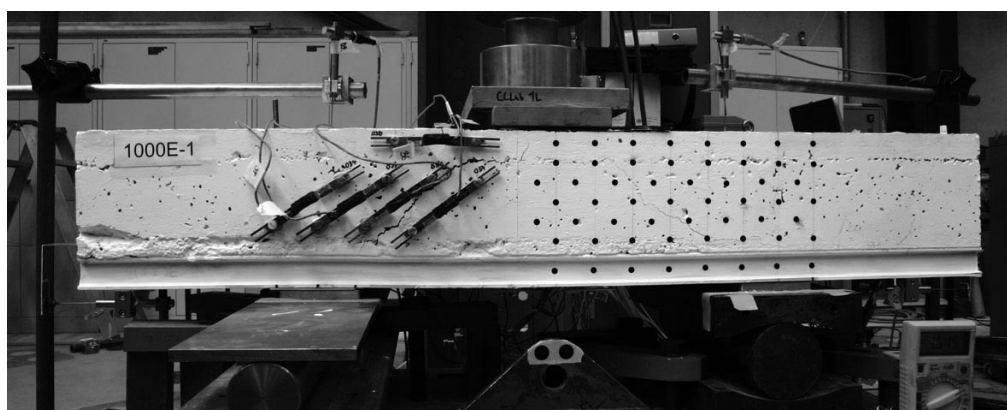
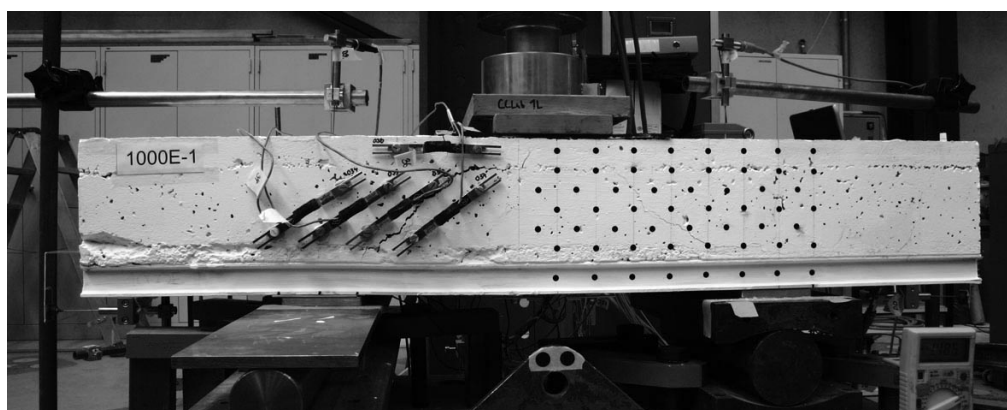
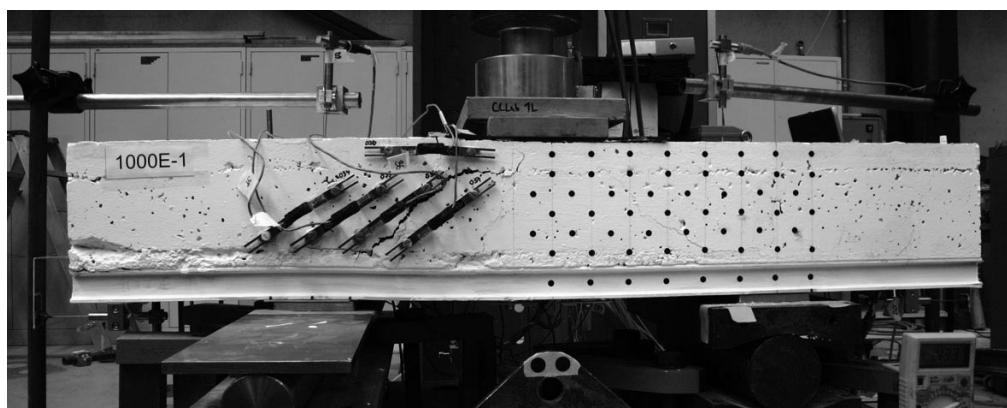
Figure D.47: 1000Es: Failure process on west side (north left, south right).

The failure process is illustrated in Figures D.47, D.48 and D.49. The first very small crack was observed at a load of 35 kN between omega gages O21 and O22, followed by a small noise next to the support at approximately 43 kN. At 50 kN a diagonal crack developed through the midline of O20 to O24 on the south-east side of the specimen. Later, small noises were noticed at a load of 65 kN. At 70 kN a further crack started to develop on the south-east side of the specimen, at the lower fixation of gage O22. Simultaneously, a diagonal crack developed in the north-east part of the specimen, starting next to gage O27. At a load of 80 kN the cracks exhibited an average width of 0.05 mm. All cracks propagated increasingly with increased loading, always from the mid-depth of the specimen towards the upper and lower parts. At approximately 100 kN the diagonal south-east crack reached the LC-NC interface next to the loading plate and developed towards the mid-span, see Figure D.49-a. The first crack in the northern west side of the specimen was observed at approximately 130 kN. Like the other cracks, it developed diagonally between the compression omegas O36 and O37. The diagonal crack in the south-east part of the specimen reached a width of 0.2 mm at a load of 190 kN. The ultimate load of the specimen was reached at 200.8 kN (Figure D.47-a). Subsequently the northern diagonal crack opened more and more. In addition, a second and more vertical crack developed approximately 50 mm from the centerline (Figure D.47-d) and subsequently the principal diagonal crack developed horizontally along the FRP-LC and LC-NC interfaces. The failure process and horizontal crack development up to the end of the experiment are illustrated in Figure D.48. The final drop in load to 95 kN occurred when the FRP-LC interface was totally damaged throughout the whole length, and thus the experiment was stopped here.

(a) At ultimate load

(b) At 196 kN

(c) At 193 kN (post-peak)

(d) At 187 kN (post-peak)
