Appendix B

Experiments on materials on DVD

B.1 Introduction

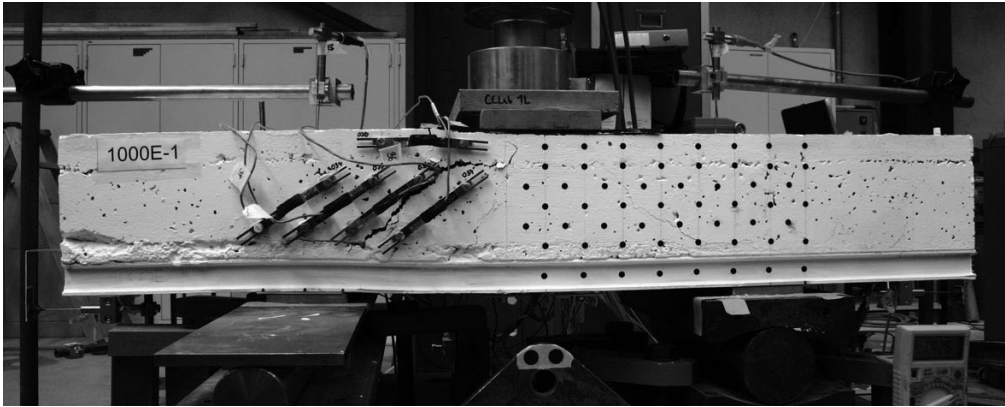
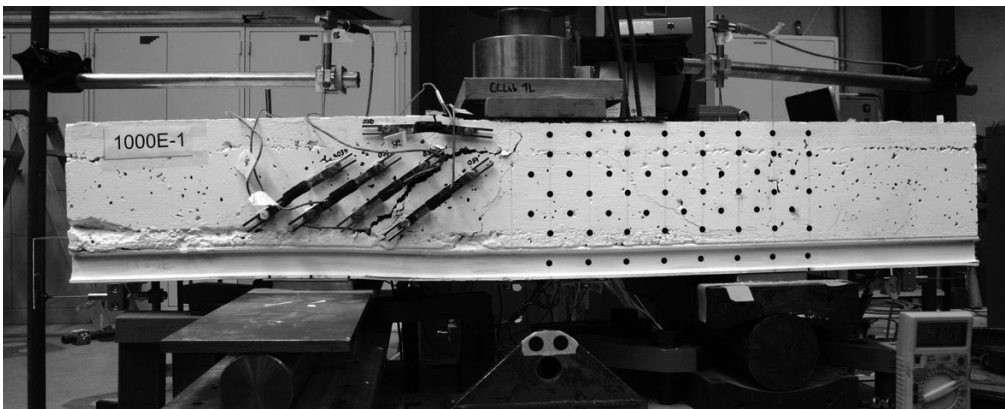
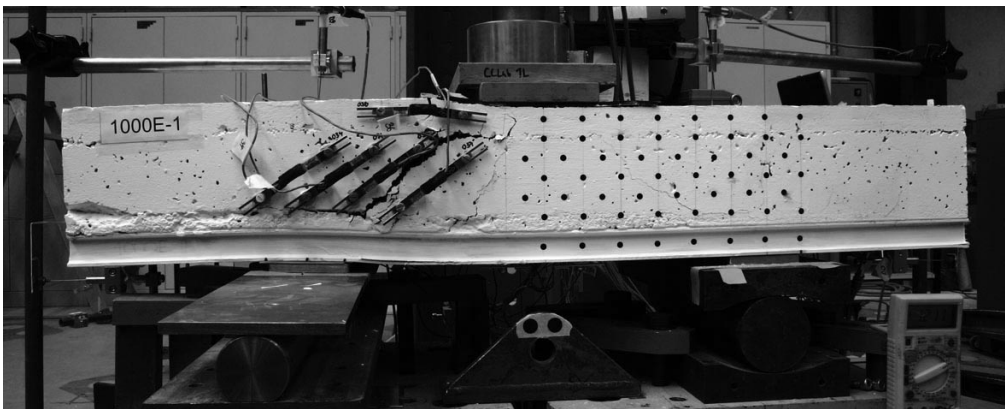
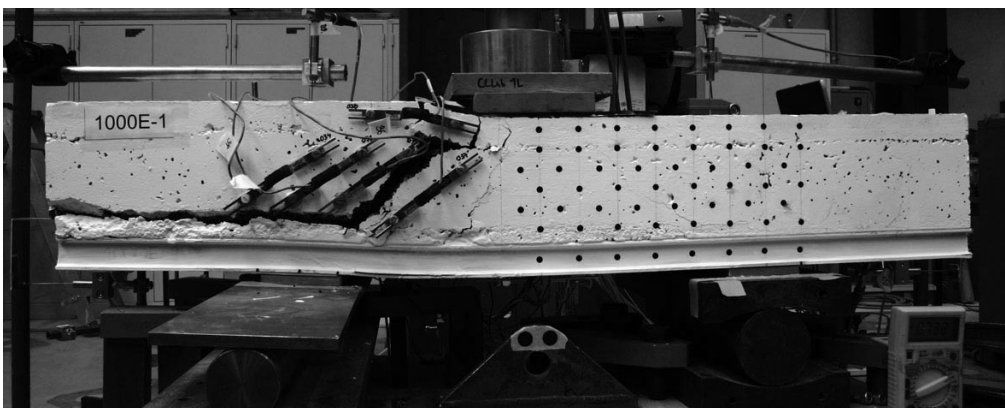
Figure D.48: 1000Es: Failure process on west side, continuation.

(a) At 186 kN (post-peak)

(b) At 180 kN (post-peak)

(c) At 157 kN (post-peak)

(d) At 95 kN (post-peak)

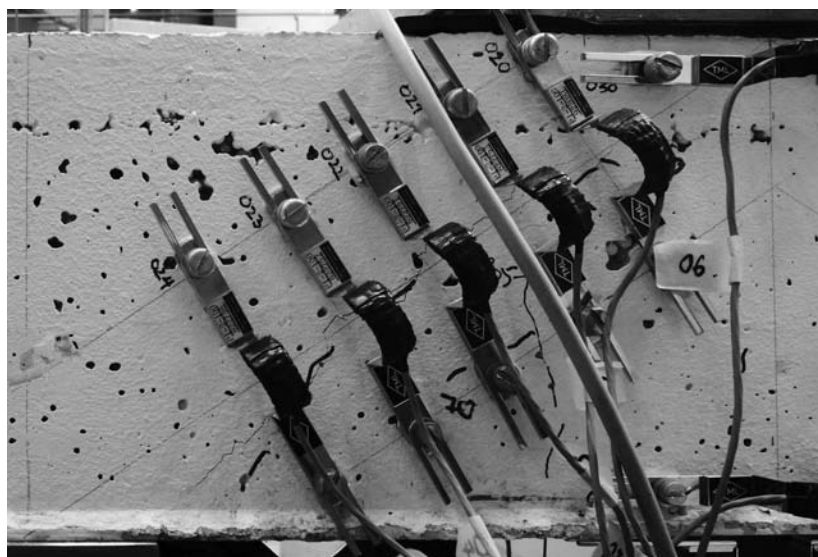
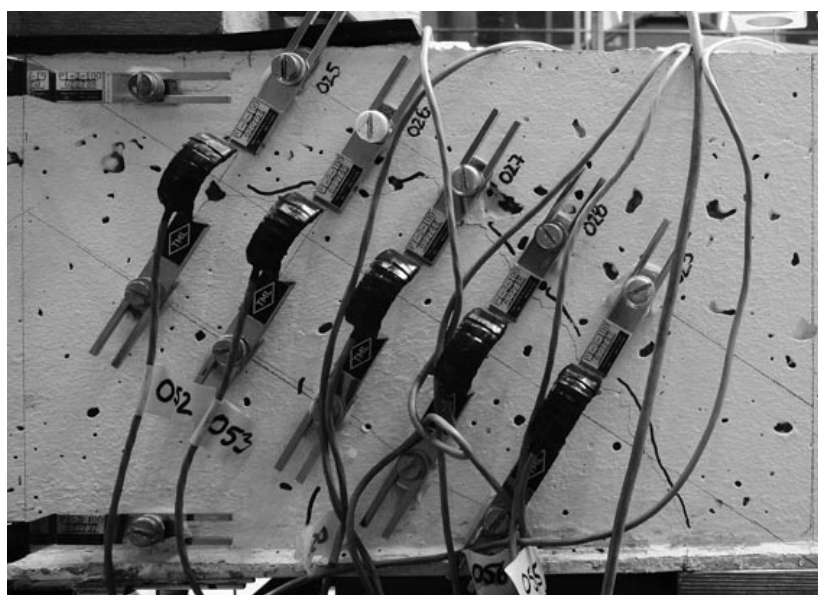
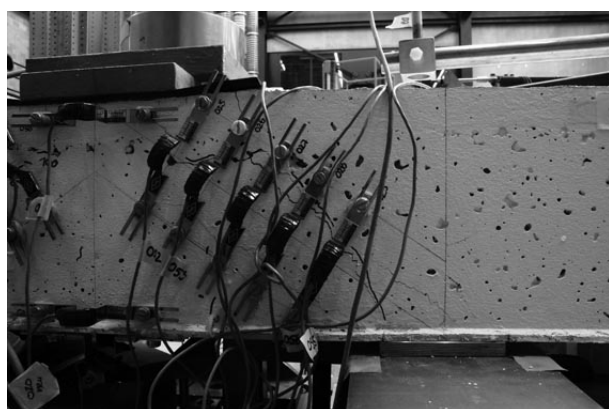
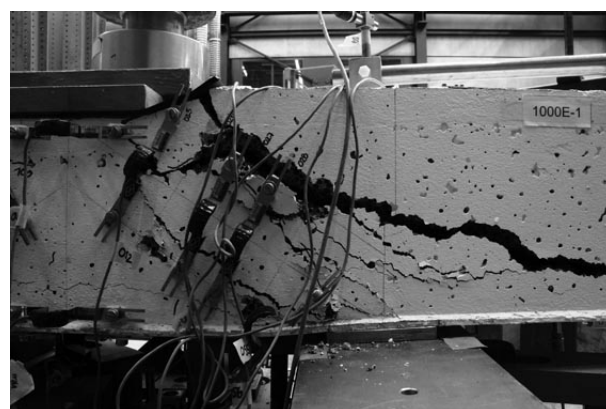
Figure D.49: 1000Es: Crack development in east part of specimen.

(a) At approximately 100 kN south-east

(b) At approximately 100 kN north-east

(c) After ultimate load

(d) Final crack
