Laboratory and In Situ Simulation Tests of the Excavation Damaged Zone Around Galleries in Opalinus Clay

Vincent Labiouse · Tim Vietor

Abstract In the context of nuclear waste disposal in clay formations, laboratory and in situ simulation experiments were performed to study at reduced scale the excavation damaged zone (EDZ) around tunnels in the indurated Opalinus Clay at Mont Terri, Switzerland. In the laboratory, thick-walled hollow cylindrical specimens were subjected to a mechanical unloading mimicking a gallery excavation. In samples cored parallel to bedding, cracks sub-parallel to the bedding planes open and lead to a buckling failure in two regions that extend from the borehole in the direction normal to bedding. The behaviour is clearly anisotropic. On the other hand, in experiments performed on specimens cored perpendicular to bedding, there is no indication of failure around the hole and the response of the hollow cylinder sample is mainly isotropic. The in situ experiment at Mont Terri which consisted in the overcoring of a resin-injected borehole that follows the bedding strike of the Opalinus Clay showed a striking similarity between the induced damaged zone and the

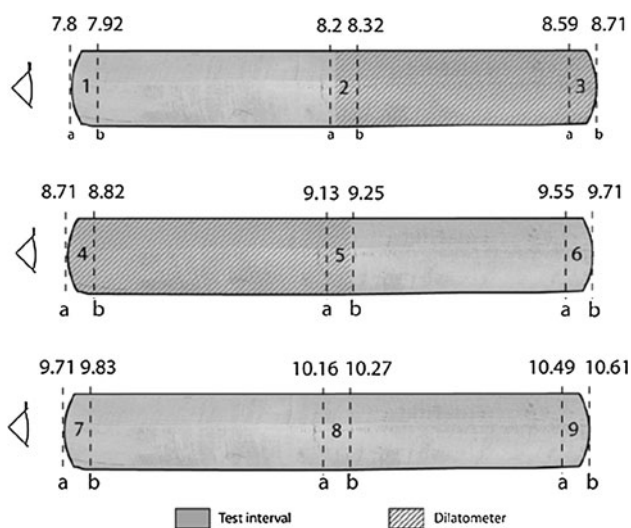
from the wall of the adjacent gallery. During the test, the dilatometer pressure had been increased stepwise to 5.0 MPa. After the test completion, the packer system was removed in May 2007. After injection of dyed resin 3 weeks later, the borehole was then overcored in October 2007. The cores retrieved from the tested sections between 7.8 and 10.8 m were cut at 9 locations perpendicular to the overcore axis. Figure 8 shows the location of the slices along the overcore. The overcoring successfully maintained the orientation of the original borehole leading to an almost perfectly centralized position of the original borehole in the overcore up to the maximum depth. The mapping of geological structure on the core material of the original borehole and the overcore was done on photographs taken under UV light. The mapping revealed no abnormal tectonic features e.g. faults or fracture zones.

Fig. 8 Location of the sections in the overcore retrieved from the borehole BSE-3. The previous position of the loading element (dilatometer) is marked
