## Zagreb earthquake of 22 March 2020 – preliminary report on seismologic aspects and damage to buildings

Research Paper

Zagreb earthquake, post-earthquake building inspections, masonry buildings, damage, historic core, cultural heritage

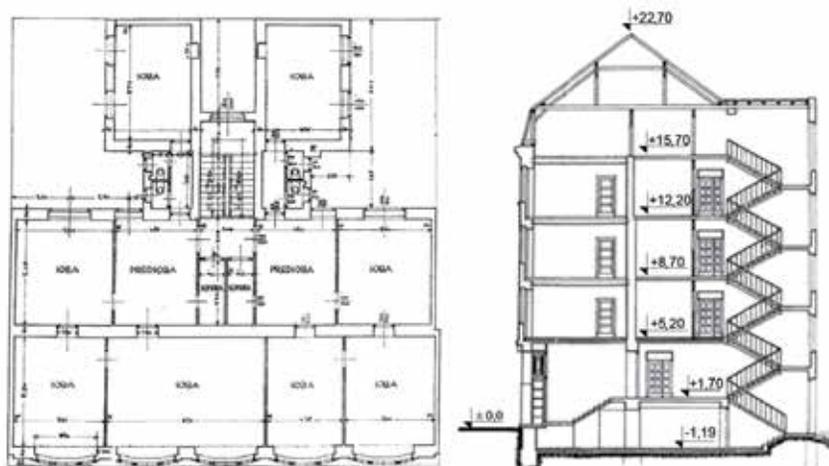
tie beams) located in the vicinity of the epicentral area, the focus in this paper will be placed on these building types. Structural systems of specific buildings, such as sacral buildings, will not be described in the paper. A residential building with plan view as shown in Figure 15 is a typical example of construction practices prevailing in the early twentieth century in Down town centre (Donji Grad). It was built in 1920 and it has a basement, elevated ground floor, three floors above it, and an attic. Plan view dimensions are 24.40 × 12.0 m (street side) and 10.6 × 12.0 m (courtyard side), and the total gross plan view area is 396 m<sup>2</sup>. The building is 22.70 m in height. The attic was initially not meant for habitation, but it was transformed

during one of renovations and converted into a residential space. The structure is made of a system of interconnected solid brick walls, without tie beams, which continuously run from foundations to the roof. The external and internal load bearing walls of the ground floor and other floors are made of solid brick of old format, 30, 45 and 60 cm thick, while partition walls are made of solid 15 cm thick brick, with obviously uneven distribution of stiffness. The area of ground floor walls is about 8.0 % of the gross floor area in the longitudinal direction and 9.35 % in the transverse direction. On the first floor it is 6.8 % of the gross floor area in both directions. Basement walls are 60, 75 and 90 cm thick. Floor structure above basement is a reinforced concrete slab (otherwise, masonry vaults are often used instead of slabs), and timber joists oriented in transverse directions are situated above the ground floor and the floors above it (they are supported by longitudinal walls). The roof structure is made of timber. The building has an internal dog-legged staircase made of prefabricated elements supported by steel sections, with reinforced concrete landings.

Figure 15. Plan view and cross section of a typical building in Donji Grad

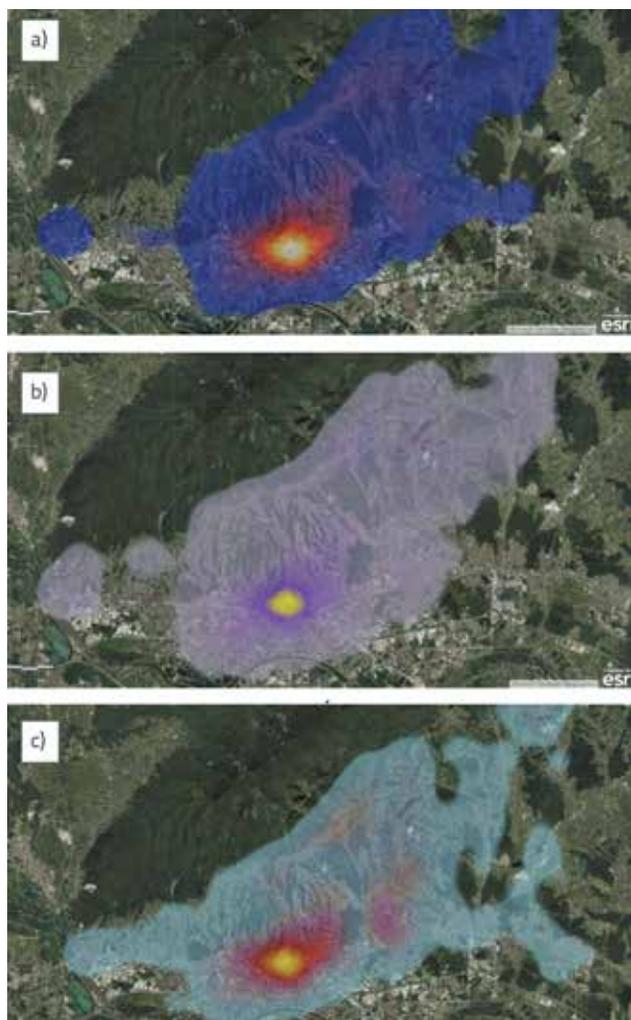
Figure 18. Heatmaps of: a) damaged and collapsed chimneys – data obtained from citizens by survey via *Survey for ArcGIS*; b) damage of gable walls and roofs from the database of on-site damage and usability inspections; c) interventions made for damaged and collapsed chimneys – data obtained from Public Fire Brigade of the City of Zagreb, last time updated on 5 May 2020

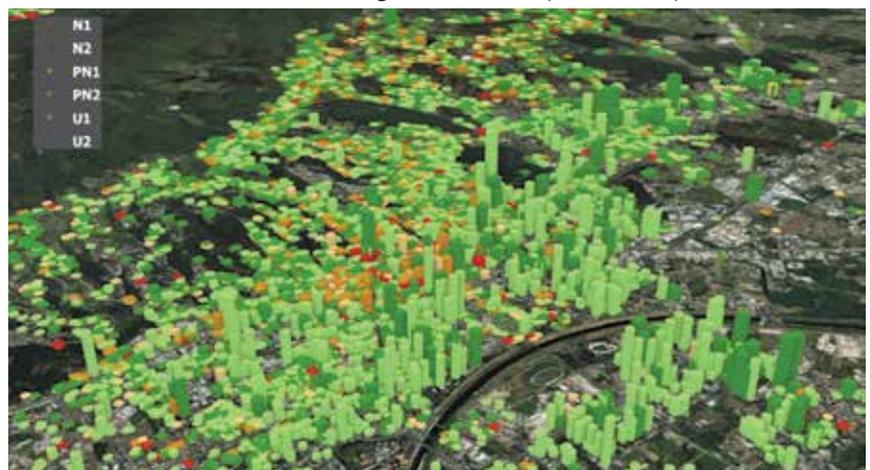
Although cultural heritage and some public buildings have suffered considerable damage, as will be described in the following section, largest damage was still incurred by the housing stock. Results obtained by inspection of usability of residential and commercial-residential buildings are shown in Figure 26, where colours correspond to usability tag, while column heights indicate the gross floor area of buildings. It can be observed that the greatest damage was inflicted on historic centre of the city, which is why we will present below some data about the Down Town (Donji Grad) and a typical building block, as well as photographs of typical damage to houses situated near the epicentre.

- buildings classified as U1 mostly suffered insignificant damage of the roof structure and exhibited some cracks (small in width and length) in structural and non-structural walls, dominantly around staircases;
- in almost all buildings classified as U2 masonry chimneys were damaged or even collapsed (which presented a hazard

Figure 26. Damage to residential and commercial-residential buildings according to usability tags (colours) and gross floor area of buildings (height of columns) on a perspective view of the city of Zagreb

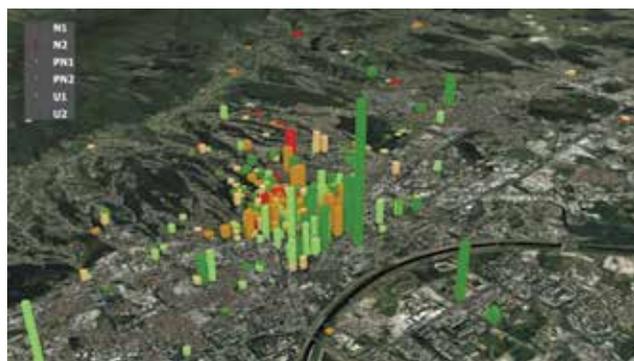
As already stated, the earthquake inflicted enormous damage to buildings belonging to the protected architectural heritage. These are highly valuable private and public sector buildings of various occupancy types, which represent cultural landmarks of the City of Zagreb (Table 1, Figure 31). The damage was mostly inflicted to gable walls and roof structures with chimneys. There follows internal damage to structural elements, mostly vaults, lintels and, less often load bearing walls, mostly at connection with flexible timber floor structures.

**Figure 31. Damage to cultural heritage buildings according to usability tags (colours) and gross floor area (columns) on 3D aerial view of the City of Zagreb**

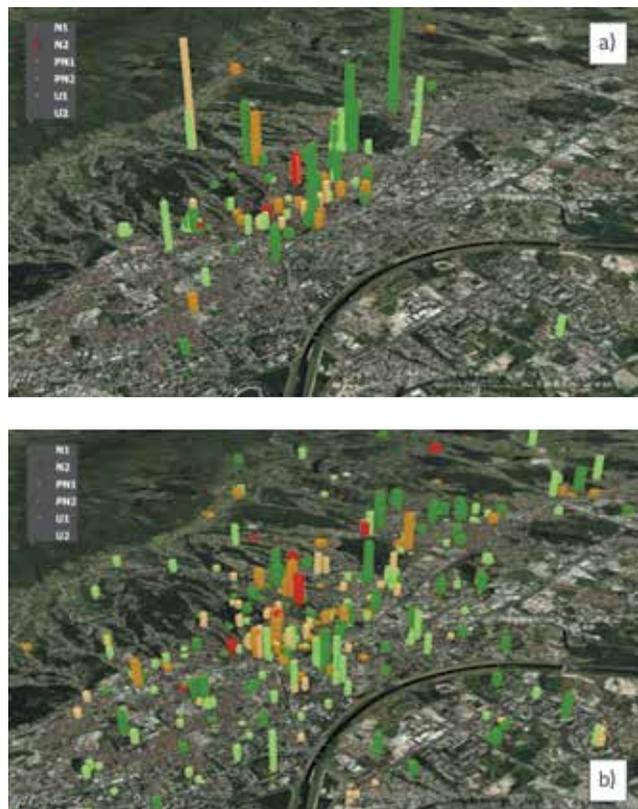
because the works will have to be carried out in accordance with appropriate conservation-restoration requirements. Damage assessments of critical infrastructure (hospitals, schools, faculties, and kindergartens) are shown in Figure 35 according to the level of damage (colour) and gross area (column height). A detailed presentation of two examples of damage to hospitals is given below.

Figure 35. Damage to buildings according to usability tags (colours) and gross floor area (columns) on 3D aerial view of the City of Zagreb for the sectors of a) healthcare and b) education
