# Learning from Failures: Reflections on the Role of Project Design and Design Management in the Procurement of Non-Standard Buildings

**Citation:** Cardellicchio, L.; Tombesi, P. Learning from Failures: Reflections on the Role of Project Design and Design Management in the Procurement of Non-Standard Buildings. *Buildings* **2021**, *11*, 253. <https://doi.org/10.3390/buildings11060253>

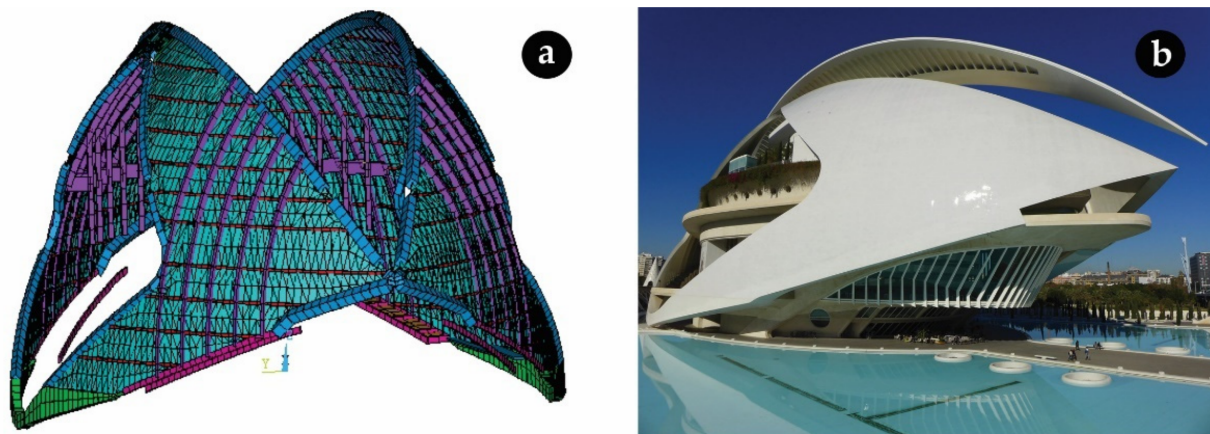
**Figure 4.** Palau de les Arts Reina Sofia, Valencia (2005): (a) finite element model of the metal shields; (b) the building upon completion. Reprinted with permission from ref. [28]. Copyright 2008 *Asociación Científico-Técnica del Hormigón Estructural*.

The origin of the problem is to be found in the covering of the steel shields, employing a Spanish traditional form of ceramic mosaic called *trencadís* (i.e., irregular pieces of ceramic mounted onto a backing support), which gained architectural fame after its use in the work of Catalan modernist architects, Antoni Gaudí and Josep Maria Jujol, from the turn of the XIX century.

60% of its area, and both eventually concluded that the failure could have been caused by a design fault connected to material selection, by an execution fault, or by a combination of the two. According to the AIDICO report, the failure of the assembly was due to the different coefficients for thermal expansion of ceramic (tiles) and steel (shields), believed to be the cause of the visible lumps and wrinkles that had appeared on the façade prior to the detachment of the material (Figure 5) [31]. In support of this hypothesis, the AIDICO report noted that the elevation worst affected by the problem was the south-facing one, naturally most exposed to thermal changes. The second of the possible causes identified in the reports related to the specific inexperience of the contractor, which allegedly manifested itself in two tasks: firstly, the preparation of the adhesive material layer, which was too thin to accommodate the tiles and was also left exposed to the weather for too long. Consequently, it was posited, the layer may have lost its adhesive properties by the time the ceramic mosaic tiles were placed on it. Secondly, the preparation of the surface of the steel support was poorly executed, as it was not sufficiently homogeneous or properly cleaned. Overall, the underperforming adhesive layer turned the tile grout into a rigid shell, which in turn reduced the typical capacity of the *trencadís* layer to move. The rigidity of the grouting explains why, over some inspections, the tile supplier, *Trencadís Innovación SL*, identified micro-fissures in the joints of the *trencadís* still in place [32]. The micro-fissures appeared to have led to water filtration, as evidenced by the extensive rust areas that appear on large areas of the steel shields, and which were visible after the removal of the whole cladding (Figure 5) [32]. In short, the difference of the thermal expansion coefficients, the rigidity of the grouting, and the infiltration of water may have all corresponded to the bulging and wrinkling, and ultimately the detachment, of the ceramic layer. An employee in charge of the maintenance of the building who was interviewed in 2015 explained that the cladding and adhesive were tested before construction on a mock-up model [33]. This is a common practice for non-standard building components; however, the mock-up gave no indication that the tiles would detach. This may be because the size and the curvature of the model were significantly smaller than those used in the original building [32].

Less than a month after the first cladding detachment, in January 2014, the work towards the identification of a suitable repairing strategy started. According to the Valencian Courts, the replacement process had to start with the cleaning and sanding of the metal shield to remove the remaining adhesive and rust [34]. To achieve a similar finish, the architect proposed three different options, all requiring the removal of the entire original layer of *trencadís* [35]. Under the first option, aluminium panels with expansion joints would be installed. Under the second option, the ceramic finish would be replaced with paint. Under the third option, the *trencadís* would be layered again, this time with adequate adhesive and labour skills in order to avoid the accelerated ageing of the assembly as had occurred

To improve the performance of the adhesive and reduce the risk of the grouting fissuring, a polyurethane-based elastic organic mineral adhesive was used [32]. The new grouting paste contained epoxy-based resins, which are more impermeable and flexible than cementitious resins. Notably, no improvement was proposed to enhance the labour conditions in terms of accessibility to the double-curved shields and the working area. A regular multidirectional scaffolding (Figure 6) system adapted to the curved geometry of the shields was employed throughout the repairing stage. Apparently, no consideration had been given historically, nor was given then, to off-site prefabrication as a strategy for creating an environment with high levels of work quality control, or not as exposed to changes in weather conditions [36]. The cladding repair was completed in October 2015. Photographs taken at the time of reopening of the Opera House in 2016 (available on social media platforms) show that wrinkles and bulges had reappeared (Figure 7).
