Seismic Retrofit of Existing Structures Based on Digital Surveying, Non-Destructive Testing and Nonlinear Structural Analysis: The Case of Gjirokastra Castle in Albania

Abstract: The present paper showcases the work carried out as part of the seismic retrofit of the Ottoman fortress of Gjirokastra, a UNESCO World Heritage site located in Albania. The need for strengthening and retrofitting the structure stems from the fact that it is situated in a region of high seismicity and showed signs of structural distress at the time of investigation. The hill on which the castle is built also has stability issues. The seismic retrofit focused on a damaged stone masonry tower of the fortress and was designed following a comprehensive methodology for the inspection, diagnosis and geotechnical and structural analyses. Through the use of non-destructive tests, the existing soil conditions, the material properties and composition and the dynamic behaviour of the tower were assessed. Nonlinear finite element analysis was used to establish the cause of the existing damage and to determine the most effective strengthening solutions. The findings of the investigation revealed potential causes of th

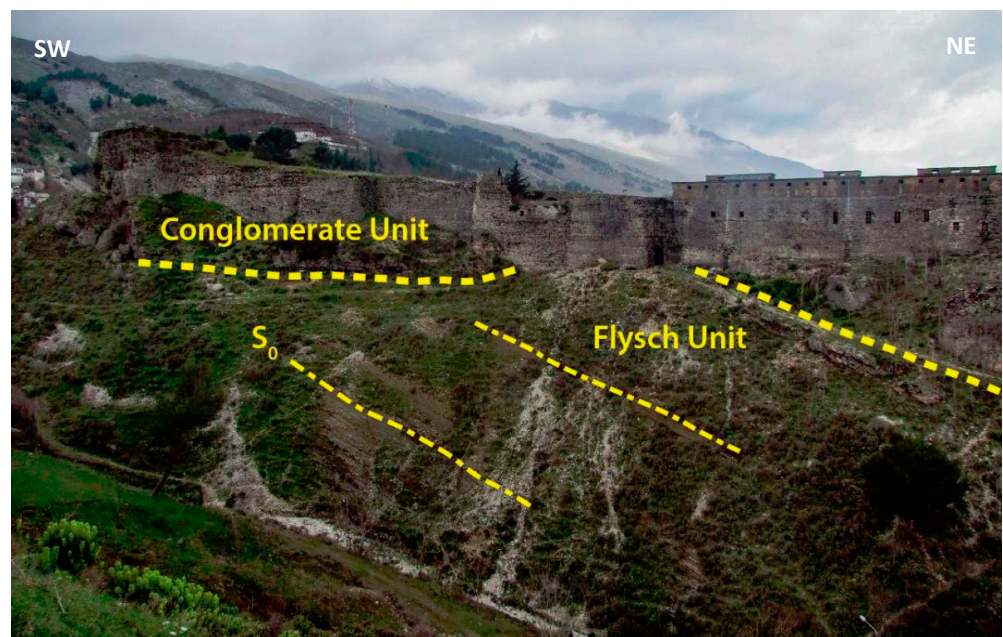
The Gjirokastra castle is situated over two geological units: the older Paleogene flysch unit and the younger Pleistocene Conglomerate Unit, which lies above it, as seen in Figure 3, with an angle of discordance over the flysch. The flysch unit has a constant dip direction to the northeast, measuring between 14 and 25 degrees of inclination. Apart from the discordance, no relevant tectonic structure is observed in the study area.

Figure 3. General overview of the southern part of the Gjirokastra castle showing the two geological units.

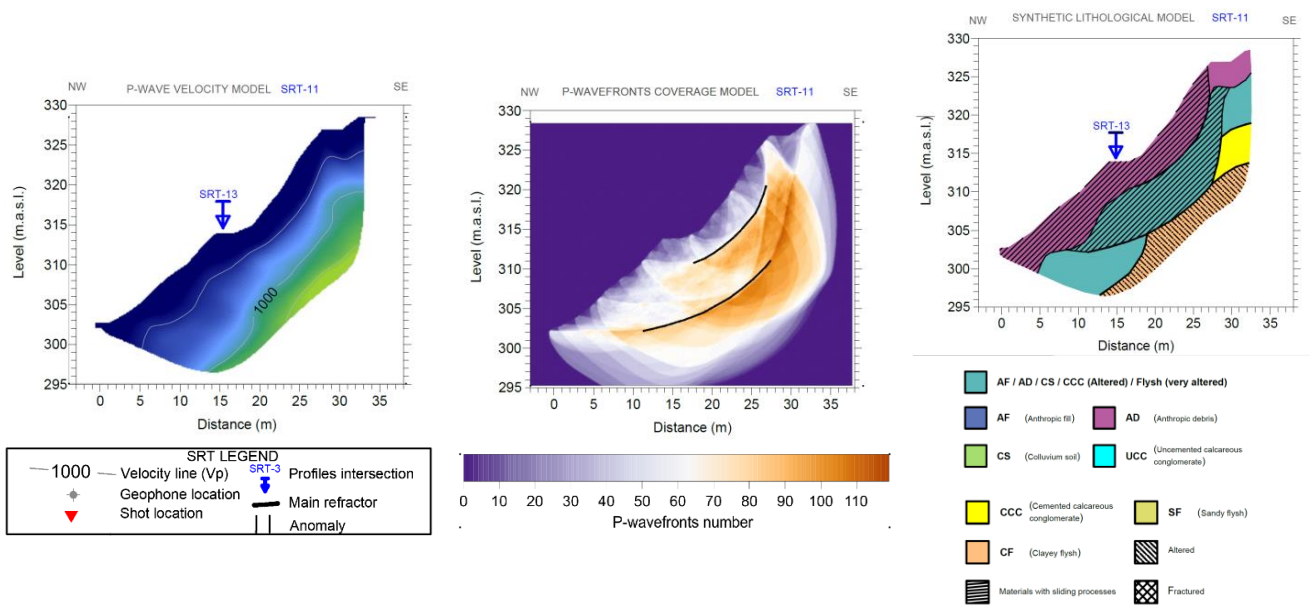
Figure 8. Example of SRT results: P-wave velocity model, P wavefront coverage model and synthetic lithological model obtained for SRT-11.

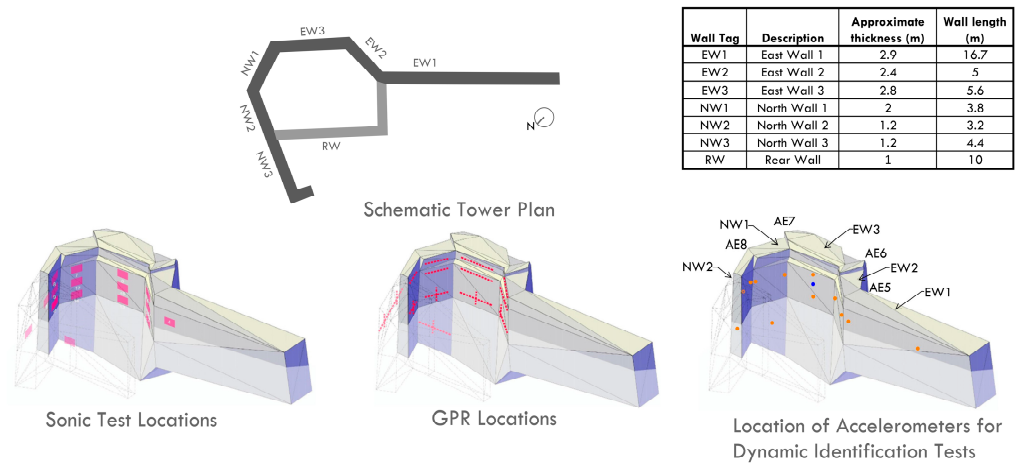
Figure 12. Location of non-destructive tests carried out at the tower.

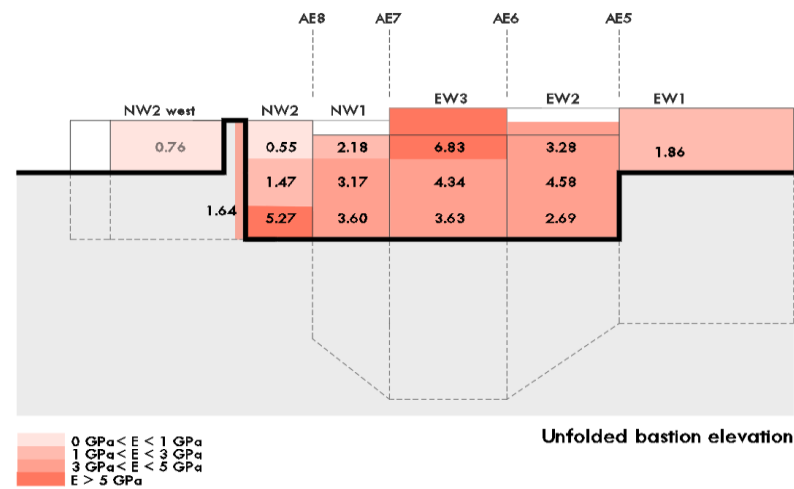
Figure 13. Unfolded tower elevation showing mean E_d values calculated.

Walls NW1-EW3-EW2 have similar mechanical parameters, with the highest dynamic modulus of elasticity measured at the topmost level of the central wall (EW3), possibly confirming the conjecture that this part of the wall is a later addition to the structure. Although the curtain wall on the southern side of the tower (EW1) and the perpendicular wall connected to the northern side of the tower (NW2) had similar mechanical parameters, they were noticeably lower than the ones obtained at walls NW1-EW3-EW2. Similar mechanical parameters obtained in tests conducted at different locations could indicate common construction or intervention dates, matching construction quality or, possibly, a matching state of degradation. At the northern wall orthogonal to the tower (NW2), both direct and indirect sonic tests were carried out. Velocities obtained from the direct tests were higher than the velocities obtained with indirect tests. This could be an indicator of

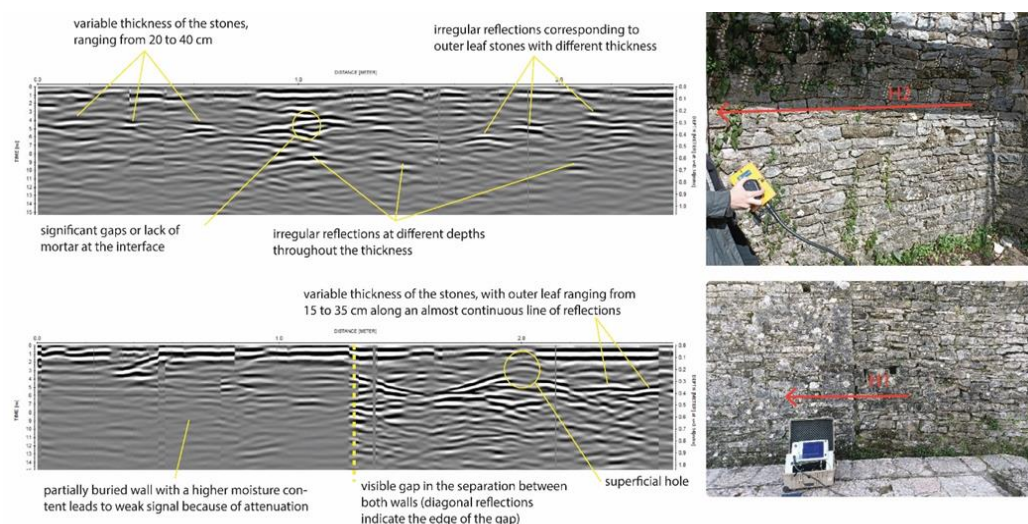
Most of the walls that were tested show an overall lack of mortar and the presence of gaps at the interfaces between stones. However, despite the presence of gaps at the interfaces and the generalized lack of mortar in the inner joints, the uncracked walls were found to be in good overall condition. The use of stones within the core results in notably solid walls and could justify the obtained high sonic velocities. Figure 14 shows an example of horizontal scans performed at one of the tower walls. Strong irregular reflections are observed at different depths throughout the thickness, confirming the irregular internal masonry arrangement with gaps at the interfaces and lack of mortar.

Figure 14. Horizontal GPR scans carried out at different locations in one of the tower walls.

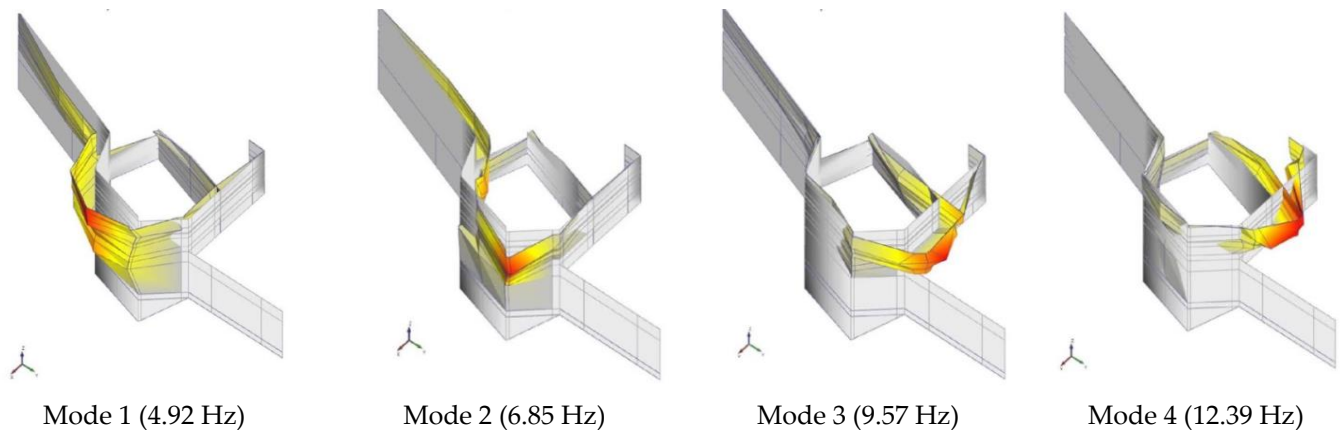
Figure 15. Mode shapes and natural frequencies of the first four modes identified in the tower.

The first mode corresponds to the out-of-plane movement of the eastern wall EW3. The second mode involves the movement of the corners between NW1-EW3 and EW2-EW1, with a north-to-south out-of-plane movement. Mode-3 corresponds to the out-of-plane movement of the intersecting corner between NW1 and NW2. Finally, Mode-4 corresponds to the out-of-plane movement of NW2 and its extension to the west. The modes obtained reflect the influence of existing cracks in the structural behaviour of the tower, since all of them are local modes involving different parts of the masonry. Although the cracks facilitate the out-of-plane movement of the different walls of the tower, the results indicate that the disconnection between the walls caused by their presence is not total.

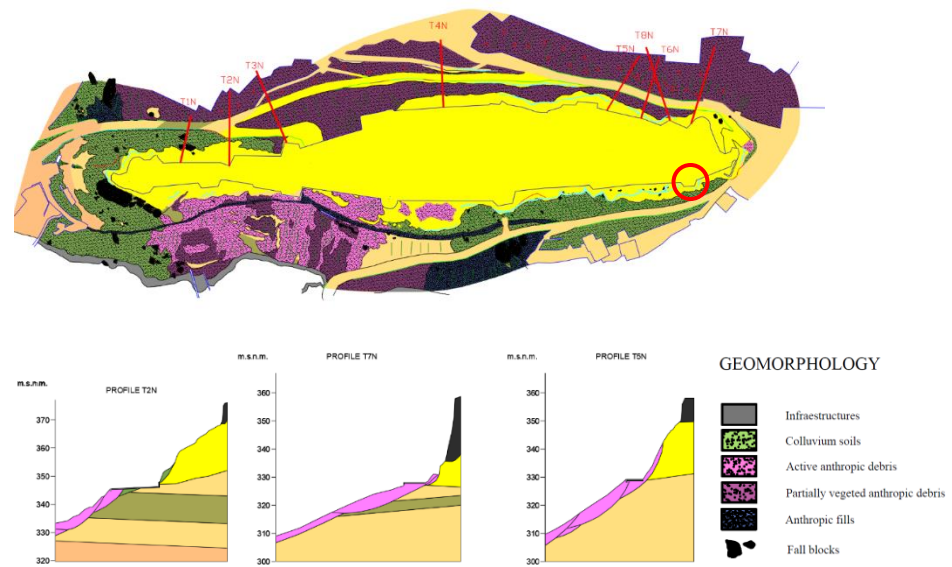
Based on the information obtained in the field and lab analyses, a geological risk map was developed to understand the potential landslides and flows that may occur on the slopes surrounding the Gjirokastra castle (Figure 16).

Figure 16. Geomorphological map of the castle area and several examples of geological–geomorphological profiles. The red circle indicates the location of the tower.

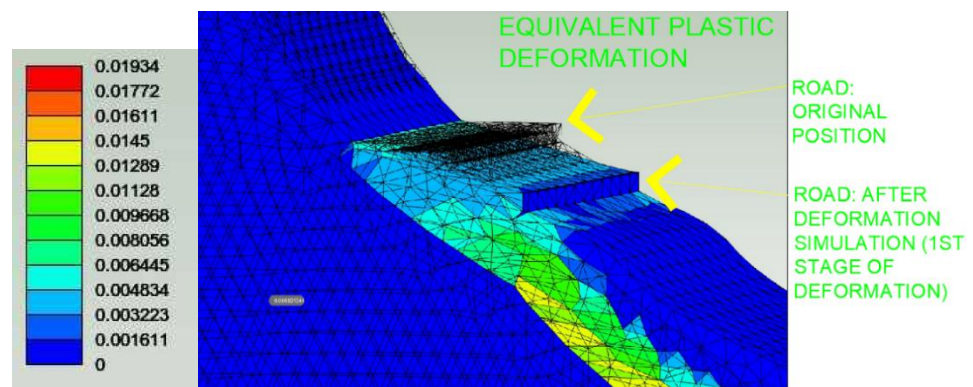
FEM stability analysis of the slopes was carried out to propose suitable solutions in the area’s housing. The analyses showed that in some areas around the castle, the slopes below the road had significant deformations and there is a high risk of landslides (Figure 17). It was deemed necessary to engineer a solution to stabilize the base of the hillside and minimize the risk to the houses present at the foot of the hills. None of these locations were located directly below the tower, where cliff stability analysis was performed instead.

Figure 17. Equivalent plastic deformation obtained by FEM for a small section of the road that surrounds the Gjirokastra castle.

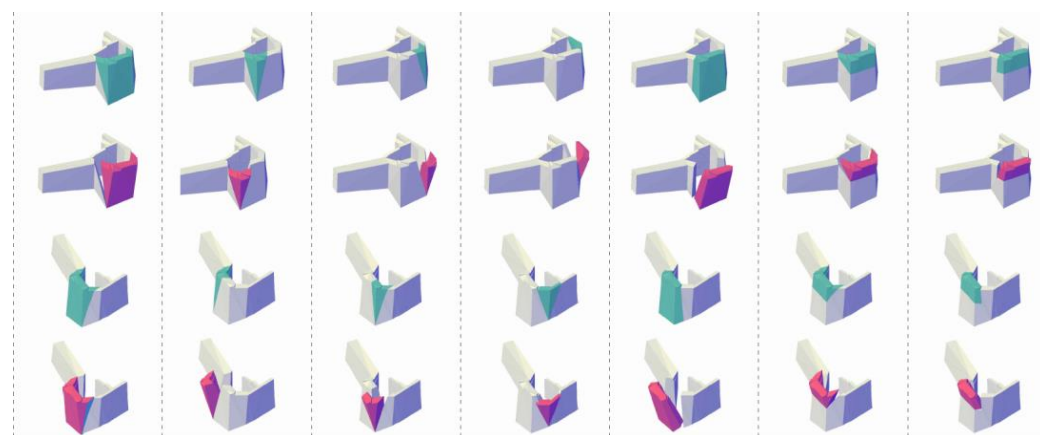
For the analyses performed, each macro-element was considered a rigid block, with no tensile resistance at the connection to adjacent macro-elements. Limited compressive strength of masonry was taken into account by considering an updated location of hinge formation at the rotation point/axis. Results indicated that the most vulnerable collapse mechanisms were those involving slender walls, possibly corresponding to the 14th–19th C curtain wall configuration. Figure 19 shows some of the different kinematism studied. The kinematism presented in the third column from the left was found to be the most vulnerable.

Figure 19. Three-dimensional representation of some of the kinematism studied at the tower. Macro-elements involved in the kinematism are shown in the original position (green) and rotated position (red) for illustrative purposes.

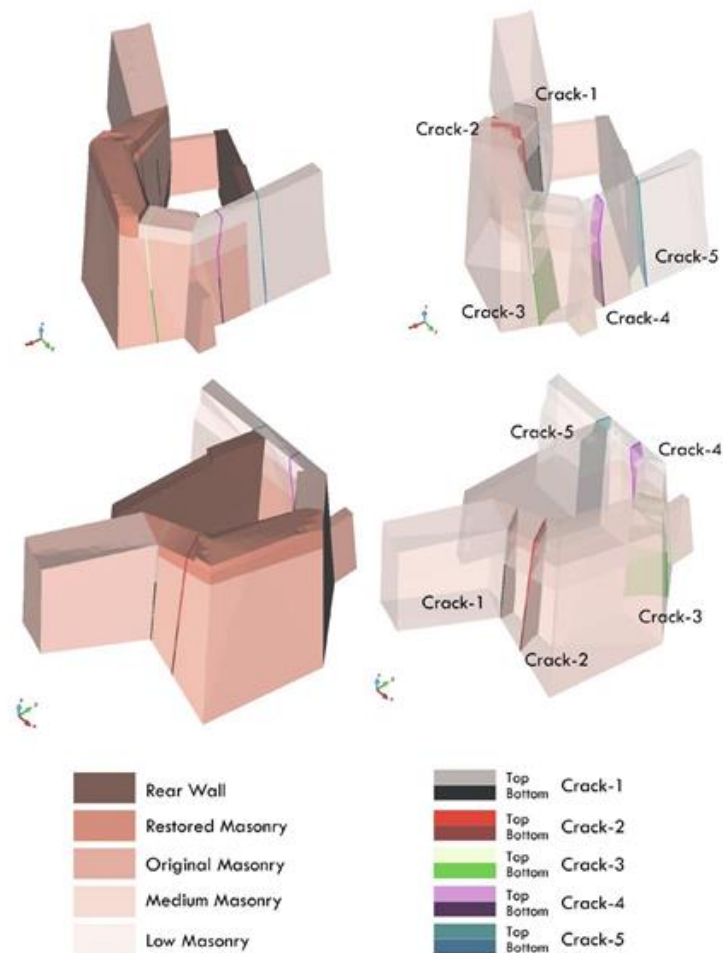
- Crack-1: Crack at EW2, with one end at the corner between EW1 and EW2.
- Crack-2: Crack at EW2, close to the corner between EW2 and EW3.
- Crack-3: Crack at NW1, close to the corner between NW1 and EW3.
- Crack-4: Crack at NW2, close to the corner between NW1 and NW2.
- Crack-5: Construction joint/crack at NW2, separating NW2 and NW3.

Figure 21. Model of the simulated tower showing the location of the different types of masonries and cracks.

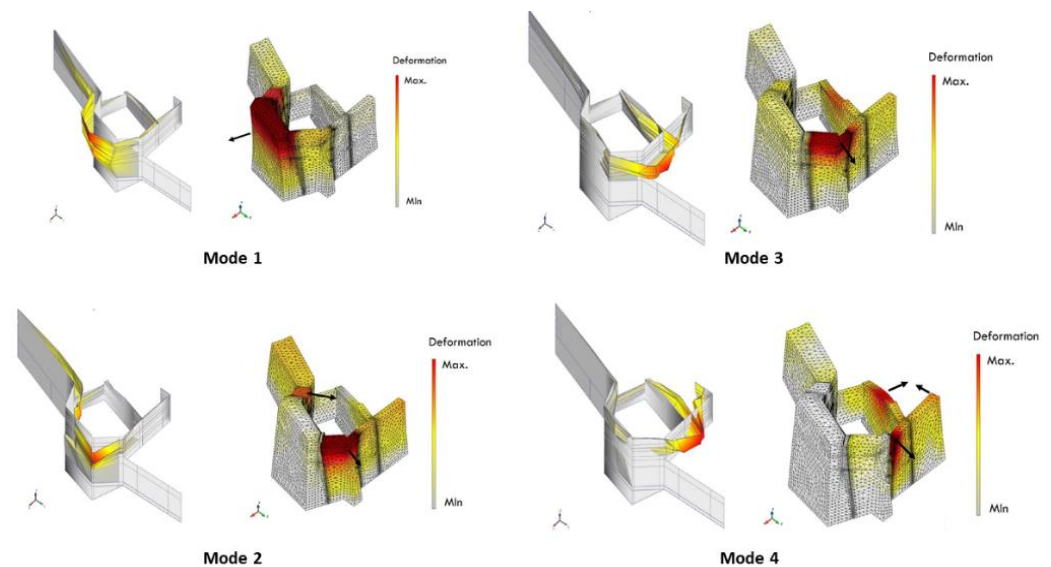
Table 1 presents a comparison between the experimental and numerical modal frequencies for the four experimentally identified modes along with the corresponding MAC values. The computed modal frequencies for all the modes are very close to the experimental ones, with a relative error between the numerical results and the average of the different test setups equal or lower than 2% for all cases. The high MAC values indicate a good correlation between the computed modal shapes and the ones identified by the analysis of the dynamic identification results. It is noted that the calibration of a numerical model of an existing structure with significant damage is not trivial, and the calibration procedure can be based on a single mode representing the most vulnerable part of the structure [31]. In this case, a very good representation of the tower's dynamic response by the numerical model is achieved due to the detailed information on the geometry and crack locations provided by the laser scanning survey as well as on the material properties, masonry quality and dynamic behaviour obtained from the non-destructive experimental campaign. Figure 22 presents the experimental and numerical modal shapes for Modes 1 to 4.

**Figure 22.** Comparison of experimental (dynamic identification) and numerical (eigenvalue analysis) modal shapes. Black arrows in the numerical results indicate the direction of movement.

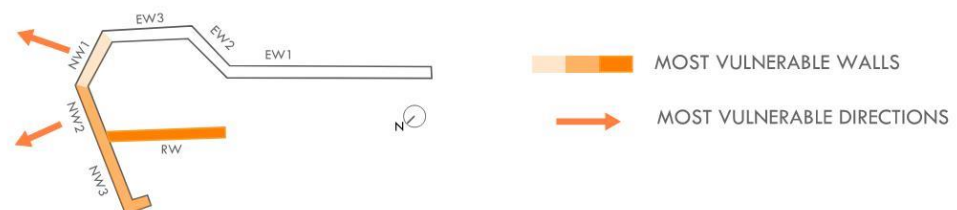
In-depth geological and structural studies concluded that the extensive cracking is most likely due to geological movement of the conglomerate rocks below the foundation level. Nevertheless, the numerical analyses show that in its current deteriorated state, the structure is vulnerable to further damage from earthquakes. The rear wall was identified as a weak point of the tower, since the capacity of the structure was significantly lower when the rear wall was included in the analysis. According to the reference peak ground acceleration values assumed, there is a 1.9% chance of having a seismic event in the next 10 years that would trigger the instability of this wall. The analyses also showed that the rear wall is a key element for providing stability to walls NW1 and NW2 (Figure 24). Figure 25 shows an example of the results obtained from the numerical pushover analysis and the assessment carried out following the N2 method. The results show that a retrofiting intervention improving the capacity of the rear wall can be a good strategy for increasing the overall capacity of the tower.

Figure 24. Location of the most vulnerable walls and loading directions.

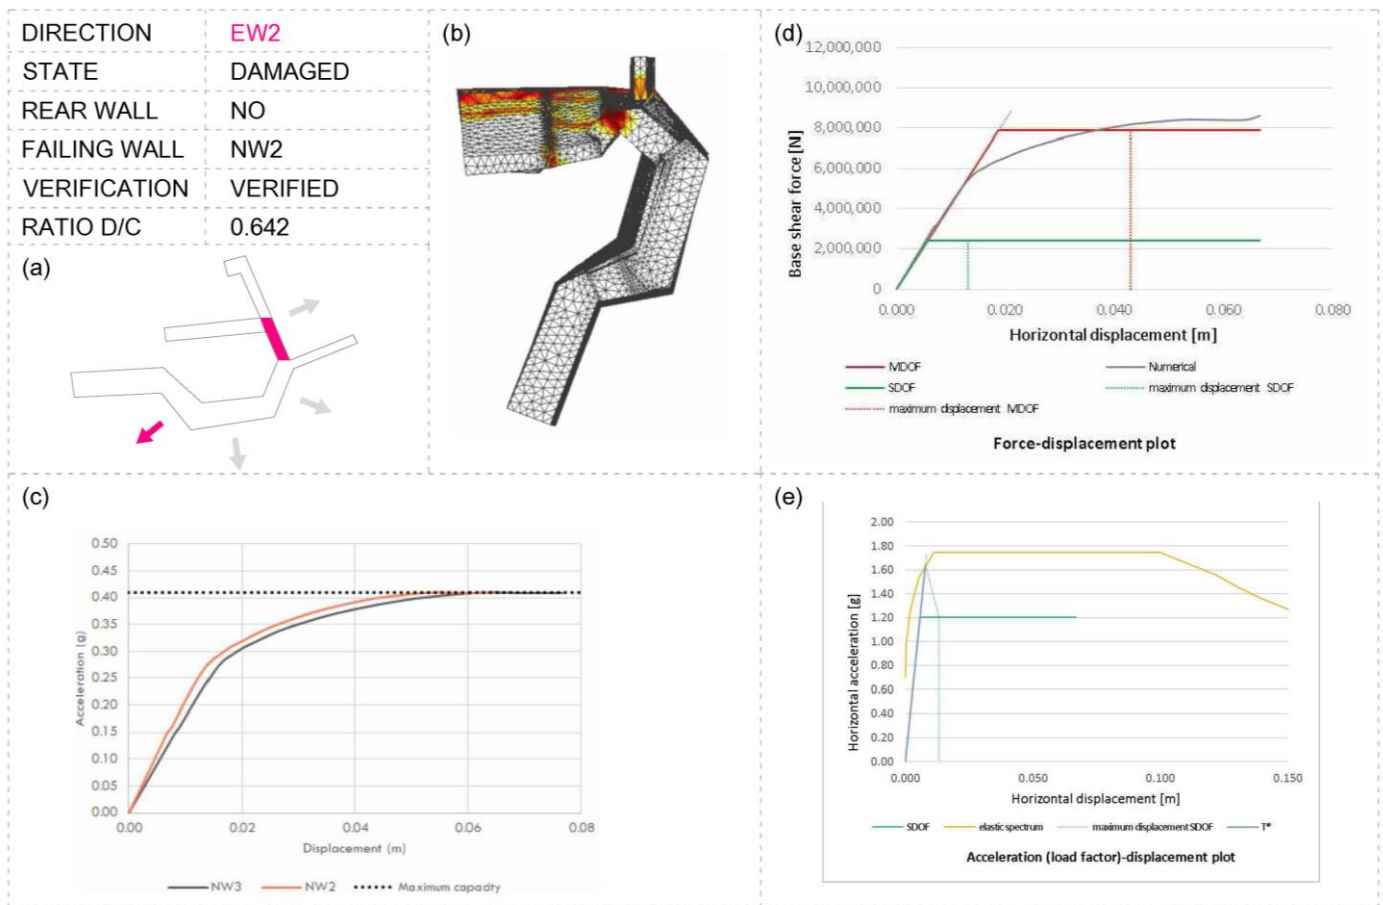
Figure 25. Example of seismic assessment of wall NW2 for loading applied orthogonal to EW2 in the existing condition without incorporating the rear wall: (a) pushover direction and the failing wall; (b) failure mode in the finite element model; (c) acceleration-displacement plot for the walls NW2 and NW3, as well as the maximum acceleration reached; (d) compliant N2 method verification as a force-displacement plot, with numerical model curve, the bilinear curves for a multiple degree of freedom system (MDOF) and a single degree of freedom system (SDOF), as well as the corresponding target displacements estimated according to EC8; (e) acceleration-displacement plot used to determine the target displacement for the equivalent SDOF system, according to EC8.

Additionally, the assessment of the tower walls in their original undamaged condition showed that the presence of cracks and areas of degraded masonry significantly impacts the seismic performance of the structure. The results suggest that if the structure is composed of masonry in good condition, it can withstand code-required loads as the walls are well connected. Therefore, a decision to restore the continuity in the masonry using grout injection was made. The three-fold retrofitting intervention addressed all the main causes of concern, namely the rear wall, the masonry quality and the conglomerate strata on which the tower is supported.

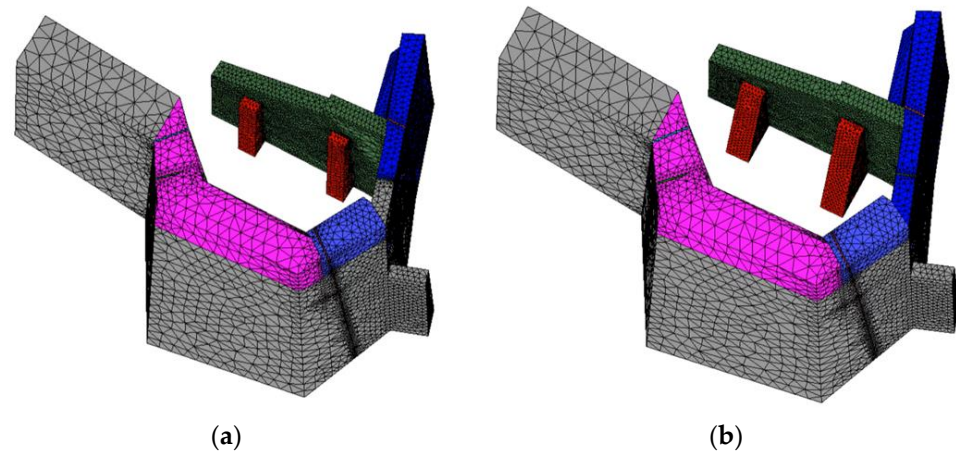
The results of the comparative analyses concluded that the type A buttresses, which are smaller, were adequate to prevent the rear wall from collapsing. The addition of the buttresses also results in ductile failure modes for most of the loading directions and the structure was able to withstand much larger ultimate displacements. An example of the change in failure mode can be observed in Figure 28, where the failure mode of the existing structure (on the left) is the out-of-plane failure of RW and the failure mode changes to the out-of-plane failure of NW3 (on the right) in the retrofitted condition.

Figure 27. View of the mesh in GID 14, showing the two different configurations of buttresses: (a) buttress type A; (b) buttress type B.

For the strengthening of the rear wall, which is the most vulnerable element of the tower, the addition of buttresses was considered to be the most suitable approach to improve the performance of the wall. Two different geometries were considered (Figure 27): (A) two buttresses with base dimensions of 1 m × 1 m; (B) two buttresses with base dimensions of 1.2 m × 2.6 m and 1.2 m × 2.15 m. The height of the buttress located closer to the NW2 is 5.6 m and the height of the buttress closer to the free end is 4.5 m. The material properties adopted for the buttresses were assumed to match the lower-bound estimate of the material properties of the retrofitted RW.

In the retrofitted configuration, the most vulnerable point observed was the connection between NW2 and NW3. Since this location is partially a construction joint between the different phases of the tower, filing the joint will impact the authenticity of the structure. Hence, an alternative strengthening solution that consists of restitching the interior face

of the wall and installing recessed hidden fiberglass bars within the external wythe of the wall was recommended.
