SEISMIC ASSESSMENT OF A MASONRY CHURCH AND RETROFITTING PROPOSITIONS

Case study of the Kapela Sveti Nikola in Petrinja

Master thesis

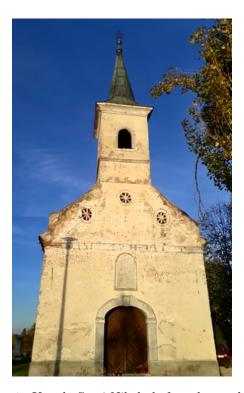
Figure 1: Kapela Sveti Nikola before the earthquake

An interesting comment was brought by Martina Vujasinovic, who said that some photos from before the earthquake of December 2020 showed that these cracks were already there (some of them are vaguely visible in figure 1). But according to what she said, it is unlikely that they appeared during an earlier earthquake, since the region of Petrinja had not suffered similar events for decades. This means that these cracks must have been caused by another horizontal action which is unknown for now. But it does not exclude the possibility that this mechanism happened again during the earthquake of 2020.

The most obvious failure mechanism that is not captured by the numerical analysis is the failure of the bell tower at the level of the windows. In the pushover analysis in every direction, the failure always occurs at a lower level, so it is interesting to imagine what mechanism lead to this failure of the bell tower. By comparing the photos before (figure 1) and after the earthquake (figure 5), we can see that the tower failed at the base of the windows. This

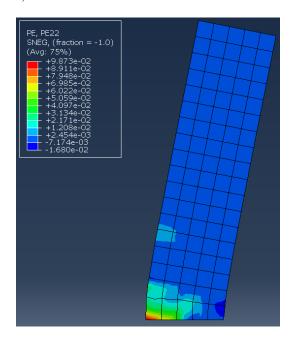
Figure 15: Distribution of vertical plastic strains in the slender wall at a top displacement of 100 mm

The distribution of plastic strains on the wall (figure 15) confirms a rocking failure, with tensile failure at the bottom left corner. The force-displacement curve (total base shear over displacement of the top of the wall) can then be plotted (figure 16), and the values of interest (initial stiffness and ultimate load) can be read on the graph and compared to the values calculated by hand (table 3).

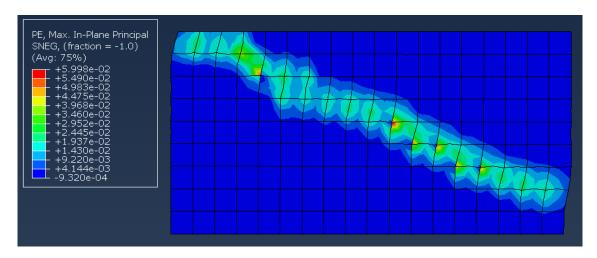
Figure 18: Distribution of maximal principal plastic strains in the squat wall at a top displacement of 10 mm

After performing the analysis similarly to the slender wall until a top displacement of 10 mm, the plastic strain distribution shows the formation of a diagonal shear crack (figure 18). Figure 19 displays the force-displacement curve and the comparison of the hand calculations and Abaqus results is presented in table 4.

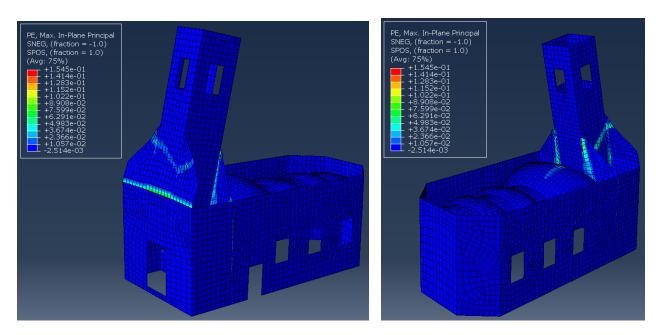
Figure 24: Distribution of maximal principal plastic strains for the pushover analysis in the +X direction

The mechanism that is observed is the rocking of the upper part of the bell tower. Only the part that is above the body of the church is rocking, which leads to the very clear horizontal crack in the front facade. Cracks also appear at the connection of the bell tower with the triangular masonry elements that support it on the sides. Cracks also form in the large vault that is the closest to the bell tower, probably due to the pushing of the bell tower against the vault.

The damage predicted by the numerical analysis corresponds partially to the observed damage on the church. The horizontal crack in the front facade predicted by the analysis is also visible in reality. The analysis also predicts cracks in the large vault near the bell tower, which is confirmed by the current state of the church, although it is hard to know which of these cracks were caused directly by the seismic action and which ones were caused by the fall of the bell tower on the vault. Similarities can even be seen in the shape of the cracks, as the curved cracks on the sides of the vault are also visible in reality (see figure 25).

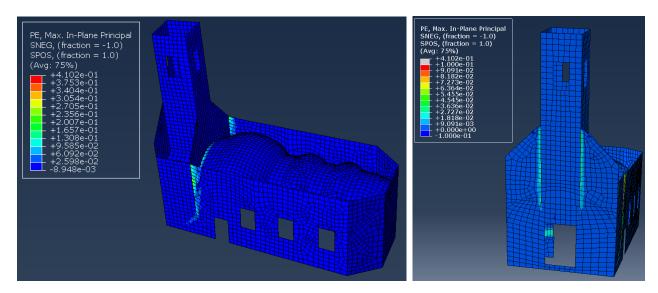
Figure 28: Distribution of maximal principal plastic strains for the pushover analysis in the -X direction

The mechanism that is observed is the rocking of the bell tower, but in the other direction. In this direction, the lower part of the bell tower is also moving, and we observe the separation of the bell tower and the rest of the church, with the formation of vertical cracks in the side walls (southeast and northwest facades). Cracks also appear at the connection between the vault and the bell tower, and in the front facade there are vertical cracks left and right of the bell tower.

The vertical cracks in the side walls are also visible on the church on both sides (figure 29). In the southeast wall, the crack seems to go through the side door. The predicted vertical cracks in the front facade also appeared in reality.

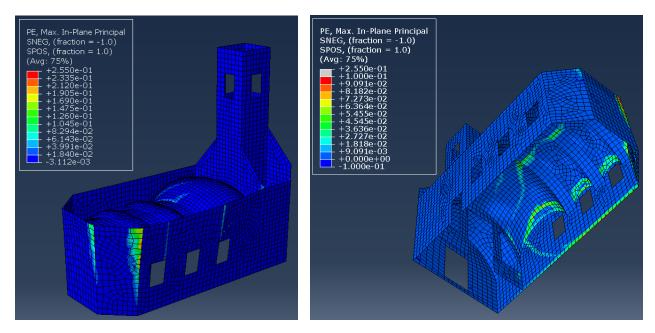
Figure 32: Distribution of maximal principal plastic strains for the pushover analysis in the +Y direction

The mechanism that is observed is the out-of-plane failure of the northwest wall. The rocking of the bell tower is not really happening in this direction, probably because of the triangular supports. The northwest wall suffers the combined action of the seismic force and the thrust of the vaults which pushes it outwards. Vertical cracks appear at the connection with the apse, as well as above the windows of this wall. Horizontal cracking is also observed at the base of the wall on the inside of the church, and many cracks appear in the vaults.

This predicted out-of-plane mechanism appears to be consistent with what happened in reality, because this northwest wall suffered some permanent deformation and is still slightly leaning outwards. The vertical cracks in the wall itself are also visible above some of the windows, on both the northwest and the southeast wall. Some cracks predicted in the vaults are also visible in reality (see figure 33).

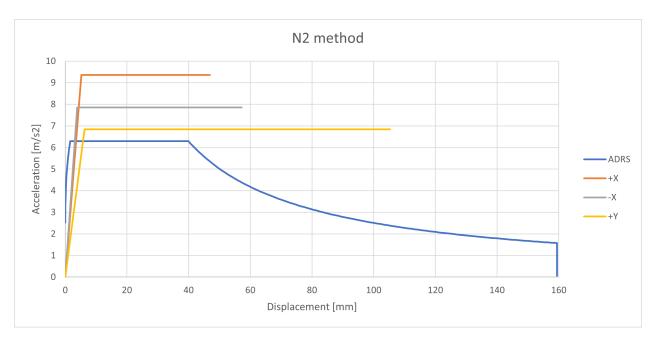
Figure 35: N2 method for the 3 studied directions

For all three directions, the force capacity is not exceeded, and the performance point of the structure is in the elastic region. The displacement demand δ_d^* and the acceleration demand a_d^* , which define the performance point, as well as the compliance factor for an acceleration-based verification CF_a and the period T^* are presented in table 7.

The most critical direction, according to the acceleration-based compliance factor, is the +Y direction, although this one has the largest displacement capacity, so this mechanism is also far from the complete failure. The -X direction is more critical than the +X direction, which is expected since the thrust of the vault has a negative impact in this direction. The periods of the SDOF system are slightly larger than the periods of the respective modes (X : 0.08 s, Y : 0.17 s), which makes sense since the uncracked stiffness was used for the modal analysis, while in the pushover analysis the stiffness is reduced because of the cracking in the masonry structure.

It is quite surprising, and not really consistent with the observed damage on the church, that the load capacity of the church is not reached. Indeed, by looking at the many cracks and the failure of the bell tower, it would be expected that the load capacity is reached and that inelastic deformations happen. Multiple factors can explain this difference between the results of the numerical analysis and the observations on the church.

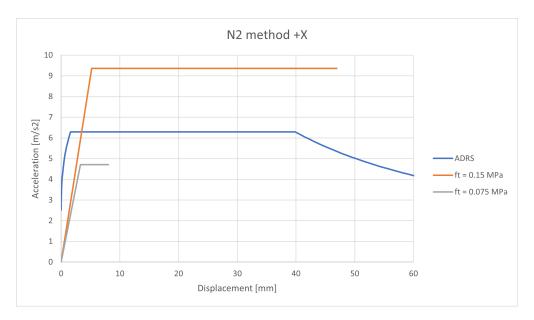
The results for the three directions (figures 36, 37 and 38) show that the force capacity is indeed reduced a lot when the tensile strength is lower. The displacement capacity is also largely reduced, and the stiffness is slightly lower, because the cracks appear earlier. The force capacity is reached for all three cases, and the inelastic displacement demand can be calculated to then find the compliance factor for a displacement-based verification CF_d . The results are presented in table 8.

Figure 36: N2 method for the +X direction with different tensile strengths

These results seem much more consistent with the observed damage on the church. Indeed, in all three directions, the church suffers inelastic deformations which explains the observed cracks in most of the masonry elements. But the displacement capacity is not reached, which means that the structural safety is still verified for the displacement-based assessment. The most critical direction of analysis for the displacement-based evaluation is the $+\mathbf{X}$ direction, while the other two directions have a relatively high margin before reaching the ultimate displacement capacity.

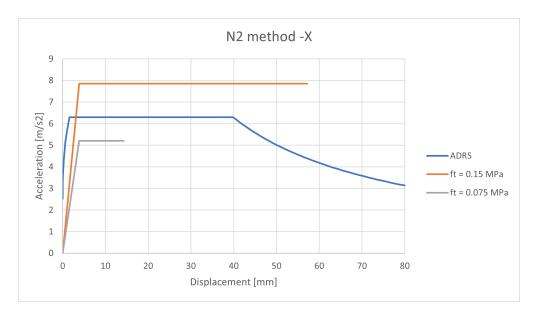
Figure 37: N2 method for the -X direction with different tensile strengths

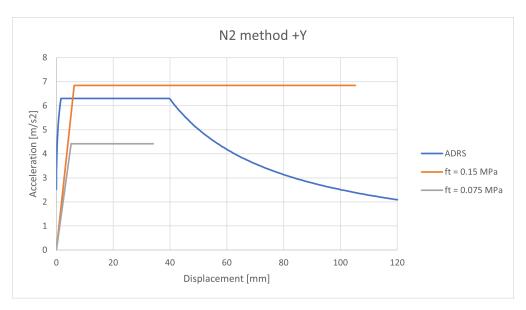
Figure 38: N2 method for the +Y direction with different tensile strengths

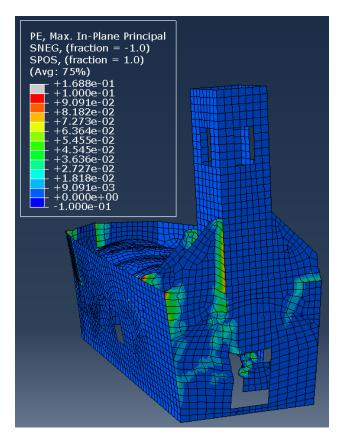
A lower tensile strength can even change the failure mechanism. The most obvious example is in the +Y direction, where we observe an in-plane failure of the southwest wall along with the out-of-plane mechanism of the northwest wall, while with the original tensile strength this was not the case (see figure 39).

Figure 39: Failure mechanism in the +Y direction with the tensile strength of 0.075 MPa

This second analysis with the lower tensile strength confirms that this parameter has a big influence on both the force and displacement capacity. In order to get more reliable results, a more precise estimation of the material properties would be needed. Some tests should be carried out on the material of the church and the properties should be chosen to fit the results of the tests.

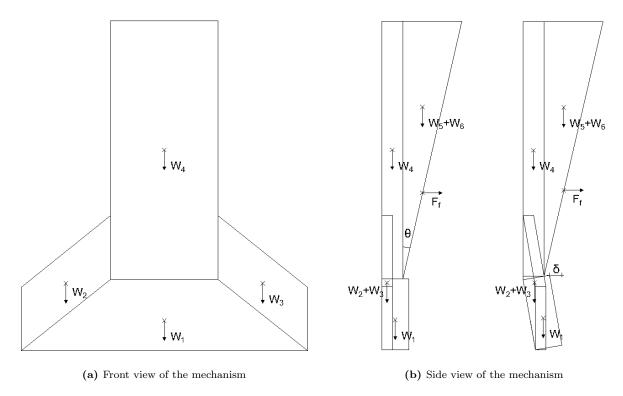
The crack pattern suggests an out-of-plane mechanism with 4 rigid blocks. The trapeze at the bottom that rotates around its base, the top wall that stays vertical and only shifts horizontally, and the two parallelograms on the side that rotate around a vertical axis. We could also imagine that part of the side walls of the bell tower come along with the mechanism, depending on the interlocking of the bricks at the junction of the front wall and the side wall.

Figure 41: Mechanism of the southwest facade

It was assumed that a triangular part of the side walls of the tower could come along with the mechanism, with a variable angle θ (see figure 41(b)). By varying this angle, it is possible to find the most critical mechanism, i.e. the one with the lowest acceleration capacity.

So this shows that it is very likely that this mechanism has started to develop during the earthquake, which explains the observed cracks. However, the displacement capacity is not reached, which is also consistent with the damage, since this mechanism did not lead to the complete failure.

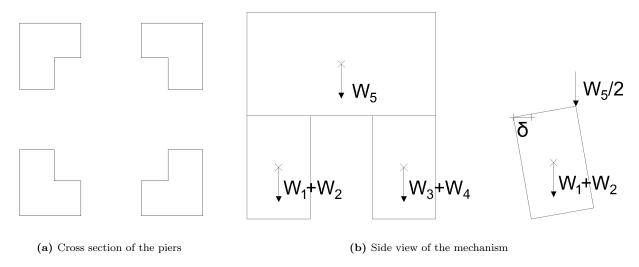
This mechanism could happen in both X and Y direction, but since the piers are slightly more slender in the Y axis, it is more critical and only this direction will be analysed. The mass of the spire is assumed to be 2 tons, and the center of mass is assumed to be 2 m above the top of the masonry tower. The kinematic model of rigid bodies with the weights is shown in figure 43.

Figure 43: Bell tower mechanism

Since it is symmetric, only half of the mechanism is analysed for a simpler moment equilibrium. It is assumed that half of the weight of the upper block and of the spire is acting on each side of the tower. When the piers start rocking, the weight of the upper block and of the spire is transferred to the piers at the point of contact, which is the upper right corner of the pier in figure 43(b) (because of the infinite compression strength assumption).

This result is not exactly consistent with the observed damage, since the calculation predicts that the displacement capacity is not exceeded, while in reality the bell tower failed entirely. There can be many reasons to explain this difference between the results of the analysis and the actual damage.

First of all, the infinite compressive strength assumption can lead to a slight overestimation of the force capacity and displacement capacity. In addition, the dimensions of the different elements and the mass of the spire are estimated very roughly, since this upper part of the bell tower does not appear in the blueprints of the church. It is also possible that the assumed mechanism is not exactly the one that led to the failure. Pure rocking was assumed, but actually it could be that the blocks start sliding after they begin to rock, with the failure mechanism being more shear dependant.

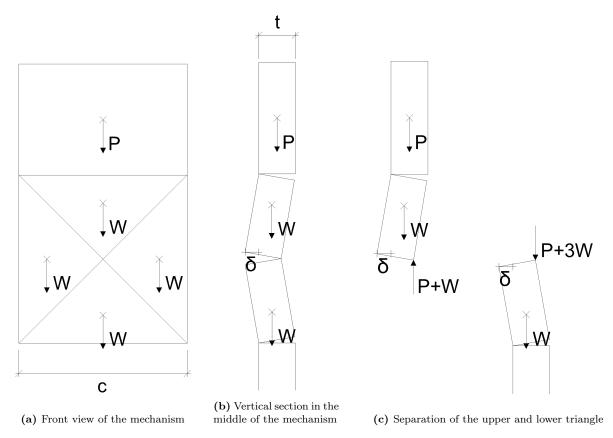
The principle of virtual work was used for this mechanism, since not all the blocks rotate around the same axis. The curvature of the apse is neglected in these calculations. The kinematic model of rigid bodies with the weights is shown in figure 46.

Figure 46: Loacal apse mechanism

It is assumed that the 4 triangles are identical, with a variable base c (see figure 46(a)). There is also the weight of the remaining top part of the wall P that is acting on top of the triangles, which also depends on c. We can then compute the external work, which is for each triangle the horizontal multiplier multiplied by its weight and the displacement of its centre of mass.

In this case, the compliance factor is significantly larger than 1. Some assumptions (e.g. the fact that there is no stabilizing moment for the side triangles) are on the safe side. All of this leads to the conclusion that this mechanism is not likely to happen during an earthquake, even if the model that was used is not entirely exact. It is more likely that the visible cracks were caused by an in-plane shear mechanism.
