Engineering Failure Analysis

Photogrammetry-aided numerical seismic assessment of historical structures composed of adobe, stone and brick masonry. Application to the San Juan Bautista Church built on the Inca temple of Huaytará, Peru

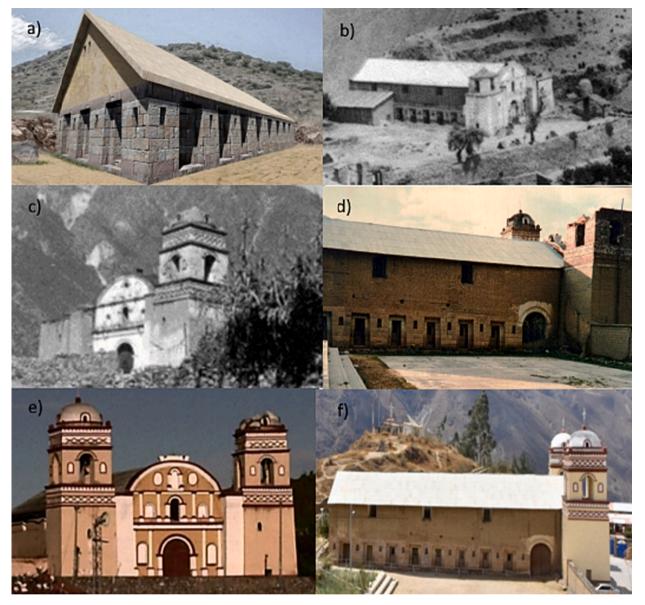
Fig. 5. a) Reconstruction of the original Inca temple, b) photo by Max Uhle in 1902, c) photo by Luis E. Valcárcel in 1940, d) photo by Mario Ibáñez during the reconstruction of the south tower in 1990, e) north tower damaged by 2007 Pisco earthquake, and f) current appearance of the church in 2019.

During the 2007 Pisco earthquake, which occurred 150 km away from Huaytara the San Juan Bautista church experienced localised damage in the North tower, resulting in the collapse of the dome, as depicted in Fig. 5e. Specifically, the top part of the north tower collapsed, and cracks appeared at the connection with the neighbouring walls of the nave. Additionally, there is no record of PGA in the area. The pushover analysis with a loading pattern proportional to the mass distribution could not represent this type of failure. There are two potential reasons for this. First, the interaction of the towers with the adjacent nave influences their dynamic response, which

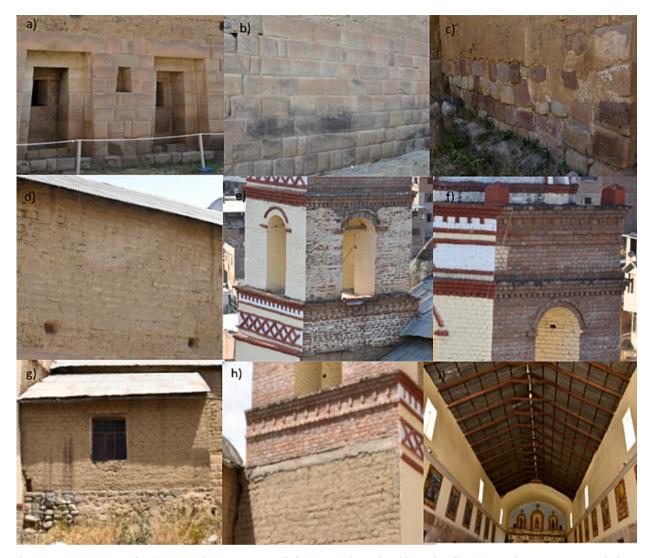
Fig. 7. Construction materials: a) Inca carved stone masonry with dry joints in the south and b) north walls, c) viceroyalty stone masonry at the base of the towers, d) adobe in the south wall, e) old masonry in the north tower, f) contemporary masonry in the south tower, g) rubble masonry in the basement of the sacristy, h) concrete slab in the south tower, and i) view of the timber roof.

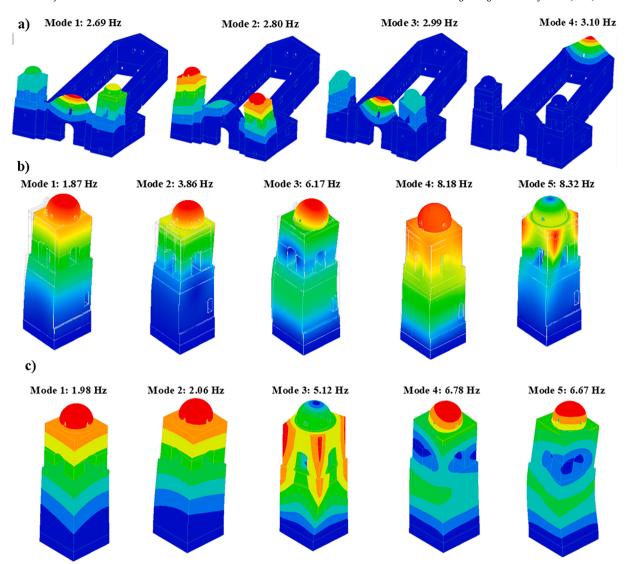
In addition, a modal analysis has been performed and is visualised in Fig. 19. Fig. 19a presents the four initial nodes of the church ranging from 2.69 Hz to 3.10 Hz. Furthermore, Fig. 19b and Fig. 19c shows the first five modes of vibration of the north and south tower respectively, where the period ranges between 1.87 and 8.32 Hz and between 1.98 and 6.67 Hz for the south tower.

Fig. 19. Modal shapes obtained from numerical models representing (a) the first four modes of the nave of the church, (b) the first five modes of the north tower, and (c) the first five modes of the south tower.

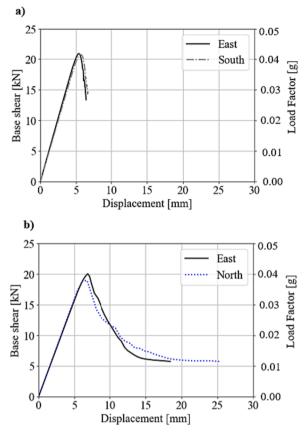
Fig. 22a and b present the capacity curves and the cracking distribution for the South and North tower pushover analyses, respectively. The seismic response of the two towers is very similar in strength capacity and damage distribution. The capacity of the northern tower is slightly lower than that of the southern one, which could be related to the smaller effective section on the north tower due to the larger internal open volume for the staircase. The base shear capacity of the two towers is much lower than that of the temple's nave, as presented previously. The capacity curves of the towers present a linear branch up to approximately 80 % of the maximum strength. This is followed by a short parabolic hardening part up to the maximum strength. The post-peak part presents a softening behaviour, with a critical strength decrease for increasing displacement. For all the cases, the numerical analyses could continue up to a 20 % drop in the strength.

Fig. 22. Pushover curves of base shear – horizontal displacement: a) East and South direction on South tower, and b) East and North direction on North tower.

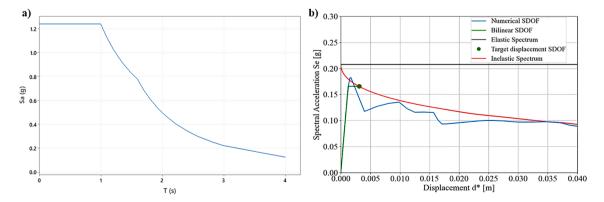
Table 5 presents the PGA values resulting in target displacement equal to the yield displacement and the ultimate displacement (collapse) for different loading directions of the main nave, south tower and north tower, respectively. The results show that the most vulnerable parts of the nave are the south and north facades for a loading direction South-North, with a PGA leading to collapse equal to approximately 0.21 g. The PGA leading to a target displacement equal to the yield displacement of the bilinear curves is also the lowest for these two facades for loading towards South-North, equivalent to 0.17 g. The towers show a much lower capacity, with PGA leading to the collapse of 0.09 g and PGA corresponding to a yield of 0.08 g.

Fig. 25. a) Peruvian seismic standards E.030 to Huaytara in Acceleration – Period, and b) Application of the N2 method for estimating the PGA leading to the collapse of the nave when loaded towards south. Curves correspond to the equivalent Single Degree of Freedom (SDOF) system.
