Transmitted light microscopy of a fibre reinforced metal

B. MOSER*†, A. ROSSOLL*, L. WEBER*, O. BEFFORT† &
A. MORTENSEN*

Key words. Alumina fibre reinforced aluminium, fibre fracture, fibre reinforcement, metal matrix composites, metallography, transmitted light microscopy.

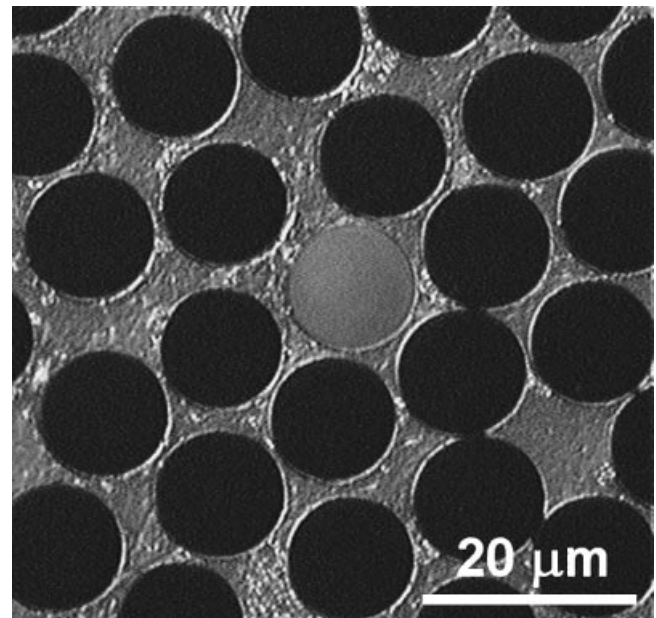
Fig. 1. Optical micrograph in the reflected light mode. In the case of the bright fibre, the incident light is reflected on some defect beneath the polished surface.

When a ceramic fibre reinforced metal is prepared for metallography and observed in the reflected light microscope with the fibres orientated perpendicular to the polishing plane, the fibres appear as dark circles against the light-reflecting metal matrix. Some fibres, however, appear far lighter than the rest; one such fibre is visible in Fig. 1. Clearly, in these fibres the incident light is reflected from some defect beneath the surface. The nature of this defect is not identifiable directly because it is situated too far from the polished sample surface to be examined under the light microscope.

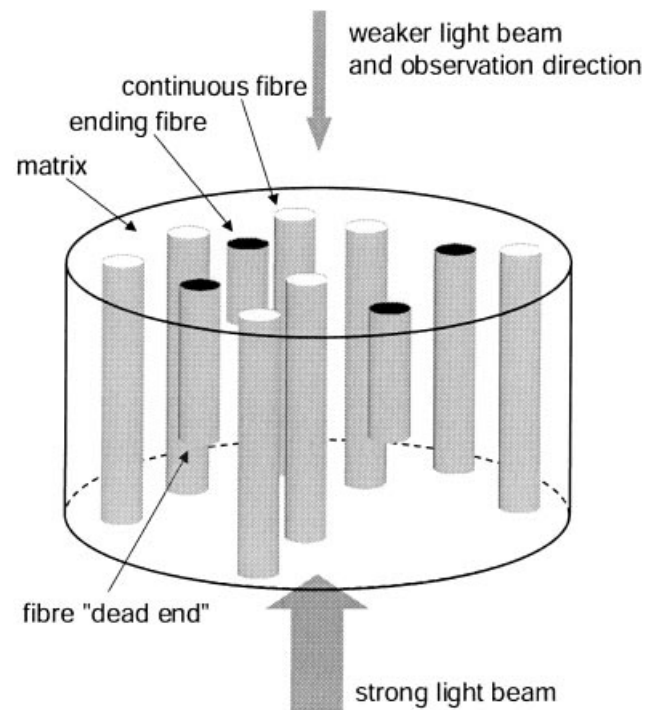
Fig. 3. Principle of the detection of dead-ended fibres in alumina fibre reinforced composites by the transmitted light microscopy technique.

Similar to the observation in reflected light microscopy, some fibres appear different in the transmitted light micrographs: instead of being brighter than the average, these fibres are completely black. Such fibres were identified, for the composite examined here, as dead-ended fibres, i.e. fibres that do not traverse the slice, as opposed to broken continuous fibres. This is illustrated schematically in Fig. 3. Two main reasons lead to this conclusion:

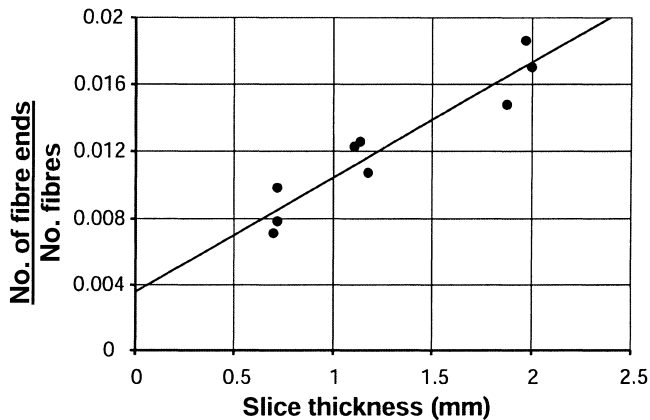
Fig. 5. Ratio of dead fibre ends and the total number of fibres in the cross-section as a function of slice thickness in a virgin composite wire.

The ratio of dead fibre ends to the total number of fibres in the cross-section is plotted in Fig. 5 for three different slice thicknesses (corresponding to three different volumes). The measurement indicates, as expected, a linear increase in the number of dead fibre ends with thickness.

It can be noted from this figure that there is an offset at a slice thickness of zero: this offset was found to be real and reproducible. Some of the black fibres may therefore be an artefact of the metallographic preparation technique. However, it is clear that the increase in the number of dark fibres that results from an increase in slice thickness corresponds to the detection of real defects, situated within the volume of the material.

A damage parameter, D_0 , denoting the number of fibre ends per millimetre of fibre, can be defined as the slope of the curve in Fig. 5. This parameter takes a value of 0.0068 for the composite wire investigated in this study.
