# Laboratory and in situ simulation tests of the Excavation Damaged Zone around galleries in Opalinus Clay

Vincent Labiouse\*, Tim Vietor\*\*

\* *Rock Mechanics Laboratory (LMR)*

Rock Mechanics and Rock Engineering (ISSN 0723-2632)

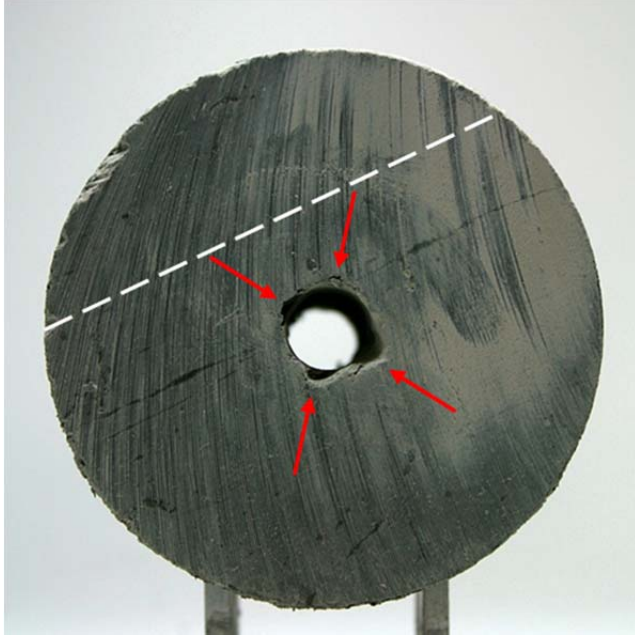
**Fig. 5** Picture of the Opalinus Clay sample N°2/5 cored parallel to the bedding planes (white dashed line) after its removal from the testing cell and saw cutting. Early stage features of failure indicated by the arrows

**Fig. 5** Picture of the Opalinus Clay sample N°2/5 cored parallel to the bedding planes (white dashed line) after its removal from the testing cell and saw cutting. Early stage features of failure indicated by the arrows

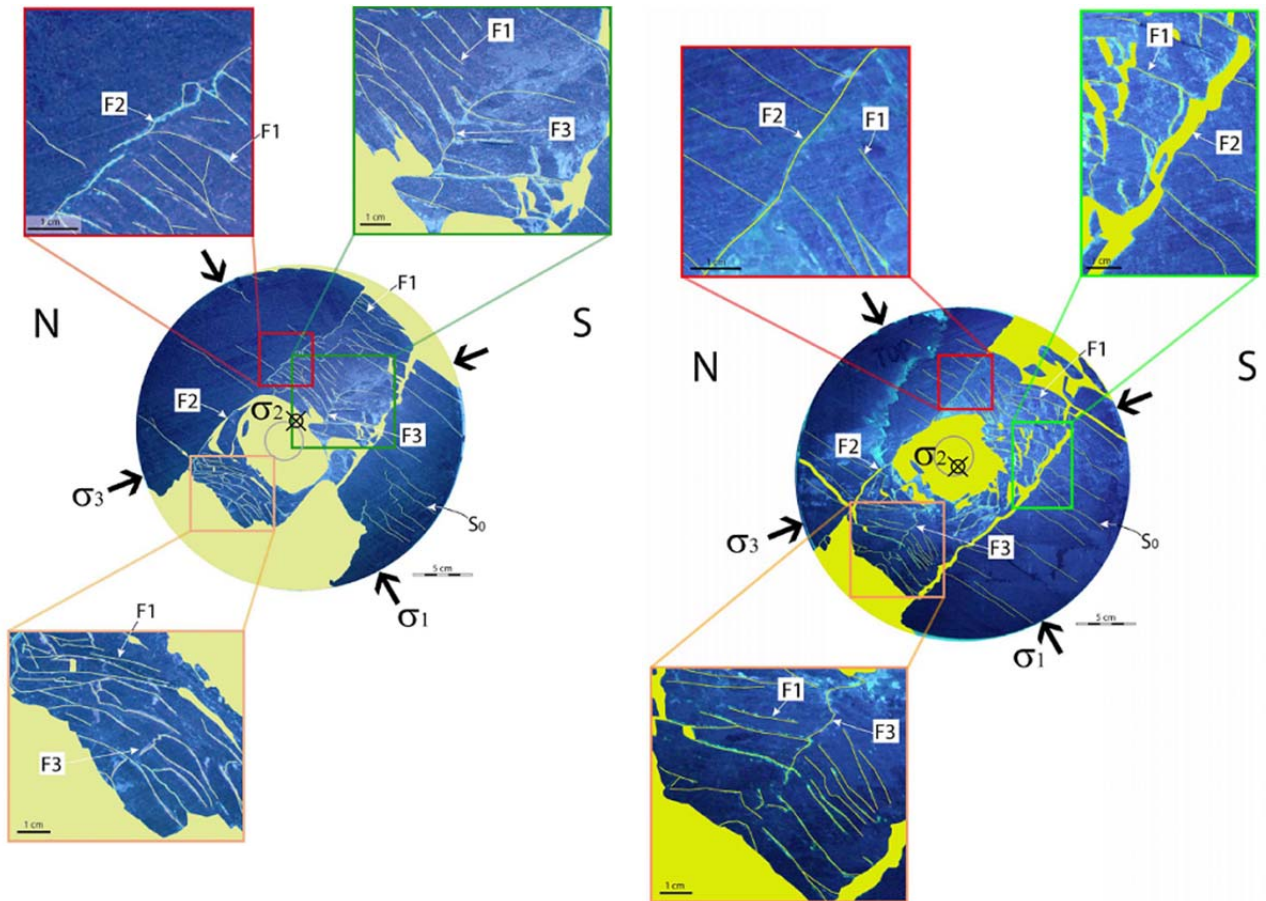
**Fig. 9** Vertical sections of the overcore at depths of 7.92 m (left) and 8.59 m (right) with details of the failed regions. The original borehole is subhorizontal and represented by the oval shaped opening in the centre of each section. The bedding dips to the right. Original figure from Bardertscher et al. (2008).

Distinct fracture patterns are observed around boreholes and galleries at the Mont Terri Underground Laboratory, depending on their orientation with respect to bedding and to the in situ stress field (Martin and Lanyon 2003, Blümling et al. 2007, Bossart et al. 2002). Bedding plane failure is found particularly prominent when the opening axis is oriented parallel to bedding. Fracture patterns around boreholes are rather consistent with the geometry and extent of the damaged zone observed in the laboratory and in situ simulation tests (Figures 3 and 9). In these

**Fig. 9** Vertical sections of the overcore at depths of 7.92 m (left) and 8.59 m (right) with details of the failed regions. The original borehole is subhorizontal and represented by the oval shaped opening in the centre of each section. The bedding dips to the right. Original figure from Bardertscher et al. (2008).

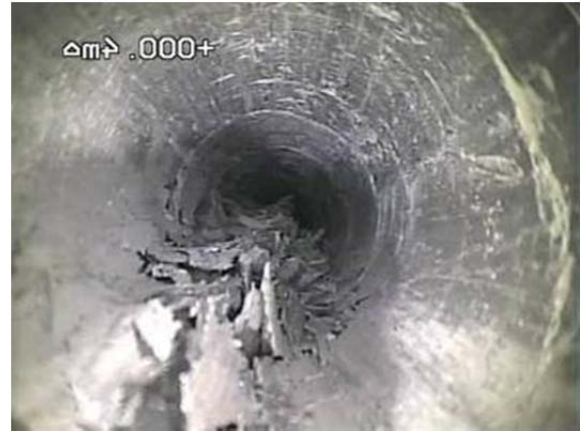
**Fig. 11** Screenshots of borehole videos showing the progressive evolution of damage in a horizontal borehole following the bedding (Hesser et al., in prep.). Bedding planes dip  $\sim 45^\circ$  to the right. The images were flipped to allow comparison with Figure 10. Right image taken 3 months after left image at different depth positions. Left: shearing along bedding (black arrows) and incipient buckling in the background (white arrow). Right: fragment rotation in deeper regions pushes up the borehole contour to form a triangular structure; about a third to a half of the borehole circumference is affected by the failure

**Fig. 11** Screenshots of borehole videos showing the progressive evolution of damage in a horizontal borehole following the bedding (Hesser et al., in prep.). Bedding planes dip  $\sim 45^\circ$  to the

right. The images were flipped to allow comparison with Figure 10. Right image taken 3 months after left image at different depth positions. Left: shearing along bedding (black arrows) and incipient buckling in the background (white arrow). Right: fragment rotation in deeper regions pushes up the borehole contour to form a triangular structure; about a third to a half of the borehole circumference is affected by the failure
