# Acoustic emission techniques for the detection of simulated failures in historical vehicles engines

**Abstract** Technical and industrial heritage artefacts are characterized by the presence of mechanisms. The possibility to activate, or reactivate, these mechanisms is an integral part of the cultural values of this kind of patrimony. The artefacts' functionality, however, requires an effective diagnostic in order to detect the onset of malfunctioning at a very early stage to avoid wear and breakdowns. The assessment of moving mechanisms of heritage objects may be performed using non-destructive methods, such as acoustic emission (AE). The ACUME\_HV project aimed at developing diagnostic and monitoring protocols for historical vehicles' engines using AE techniques. The case studies were performed on 2-cylinders Renault AG1 vehicles (collection of the "Musée National de l'Automobile – Collection Schlumpf" of Mulhouse, France). These cars are maintained in working conditions, and their engines are started periodically. After a first phase consisting in recording the reference signals of the selected engines, the project focused on detecting faults simulated on purpose, the latter

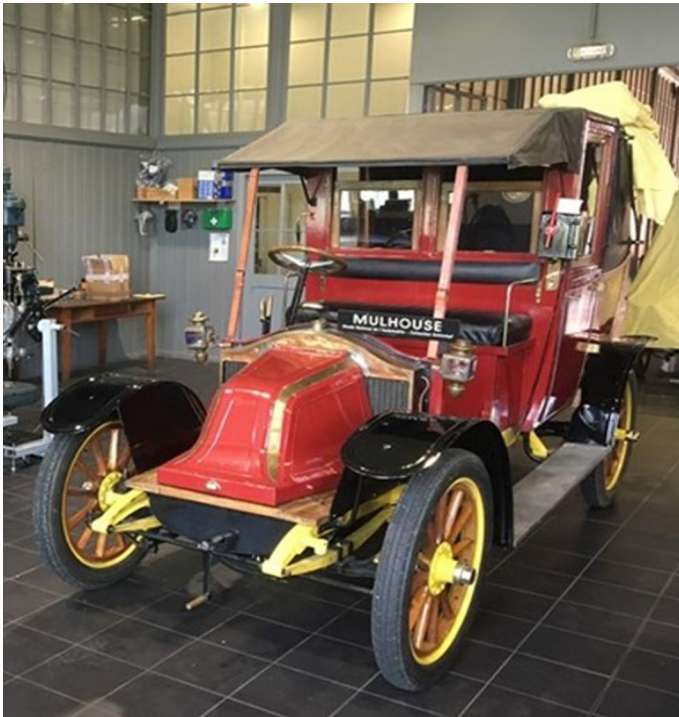
**Fig. 1** Renault AG1 with a two cylinder engine ©MNAM 2019

In the field of cultural heritage, AE has already been applied to topics such as monitoring of historical masonry and decorations [11–15] as well as music instruments [16] and other artefacts [17]. Nevertheless, to the extent of the knowledge of the authors, AE was considered for the first time for the monitoring of historical vehicles' engines in the framework of the ACUME\_HV project [18–22]. In the first phase of the ACUME\_HV project, the optimal locations of the sensors for the collection of the AE signals were identified, as the ones exhibiting the higher signal levels, combined with lower signal-to-noise ratio [18, 19]. Consequently, the AE measurements were performed on three distinct Renault engines type AG1 (Fig. 1), all belonging to the collection of the Musée National de l'Automobile de Mulhouse, France (MNAM) [21, 22]. This model of engine was chosen based on the following considerations:

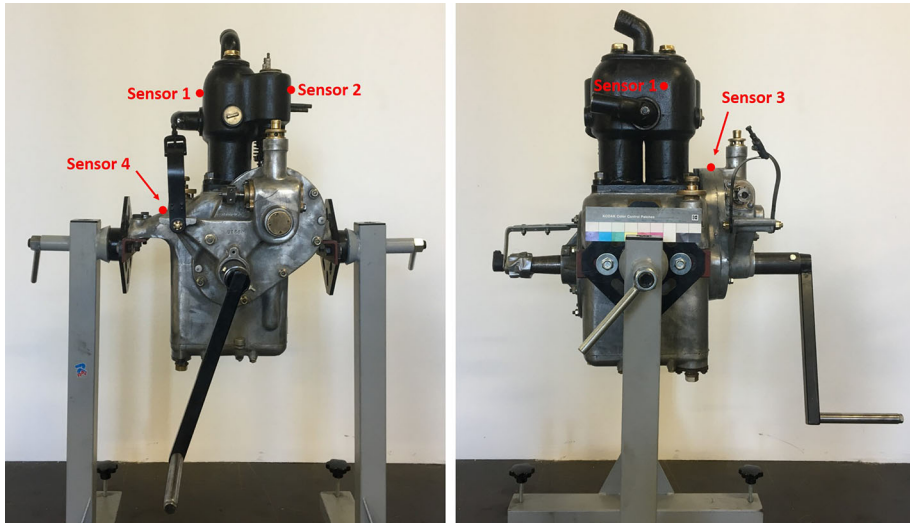
**Fig. 3** AE sensors location on the Renault AG1 bench engine ©MNAM 2019

The location of the AE sensors around the engine was established in a previous phase of the ACUME\_HV project [22], and the final determined locations of the four AE sensors are shown in Fig. 3. Two sensors were placed on the cylinder block: the first one (Sensor n.1) on the outer part of the first cylinder, the one closer to the car front when the engine is assembled in the car; the second one (Sensor n.2) on the opposite side, close to the first cylinder valves. The other two sensors were placed on the crankcase: one (Sensor n.3) on the cover of the gears of the cam system; the last one (Sensor n.4) on the crankcase leg.

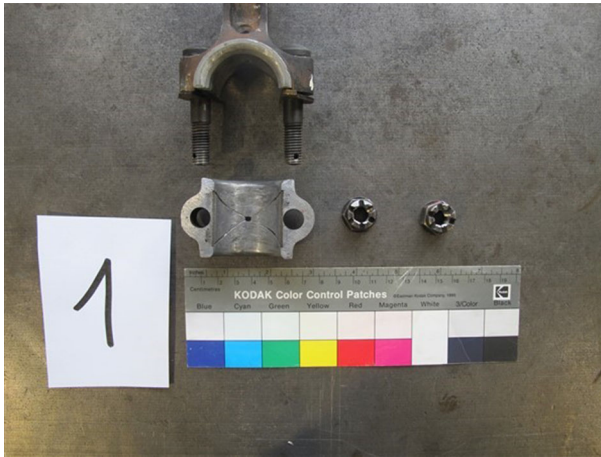
**Fig. 4** Connecting rod cap n.1 removed for installing the shims ©MNAM 2019

1. The clearance between the connecting rod and the crankshaft (connecting rod failure)  
In order to simulate the clearance between the connecting rod and the crankshaft, the lower case of the engine was removed so that the connecting rod n.1 could be reached (Fig. 4). One-millimeter-thick shims have been inserted between the connecting rod and the connecting rod cap, prior to reassembling the mechanical parts.

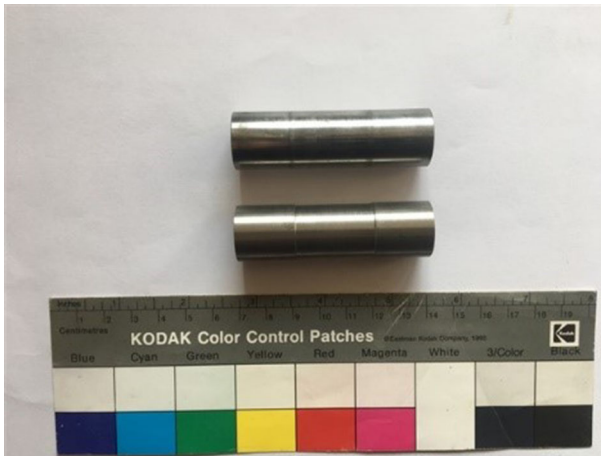
**Fig. 5** On top: original engine's piston pin; at the bottom: new piston pin manufactured with a smaller diameter in the center, where the connecting rod is located ©MNAM 2019

2. The clearance between the piston pin and the connecting rod  
To simulate the clearance between the connecting rod and the piston pin, the engine block and piston n.1 have been removed. A piston pin having a local reduction in diameter around its longitudinal center of 0.8 mm compared to the original pin was manufactured on purpose and reassembled with the connecting rod (Fig. 5). Therefore, the reduced diameter of the pin was placed in the location where the connecting rod is positioned thus creating a controlled clearance between these parts.

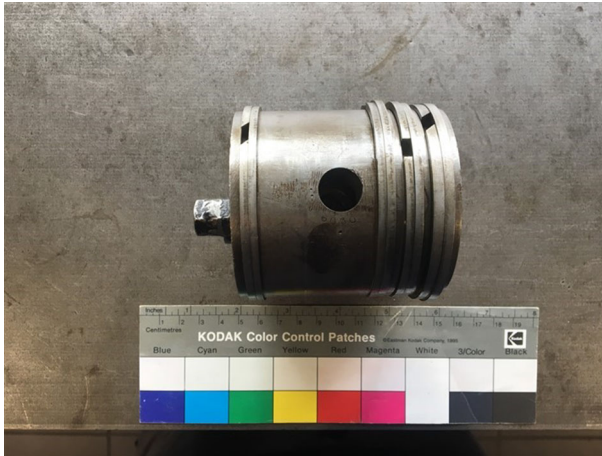
**Fig. 6** Piston n.1 that has then been modified to simulate the wear of the rings ©MNAM 2019

3. The wear of the piston rings  
The test related to the simulation of faulty piston rings due to wear was performed by removing the rings of the piston n.1 (Fig. 6).

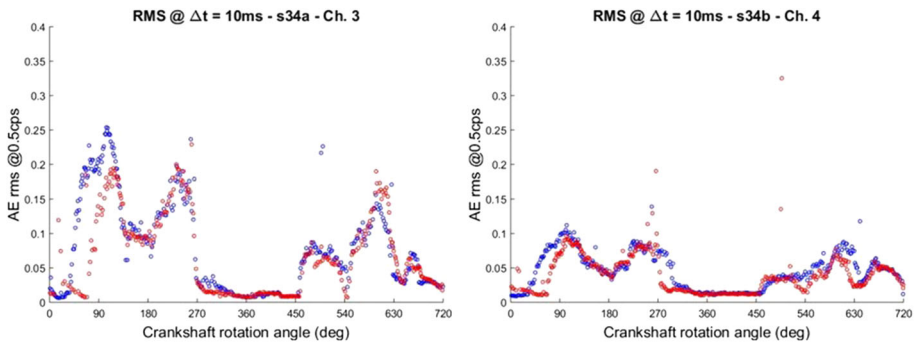
**Fig. 9** Sensors signals showing the evidence of the clearance between the connecting rod and the crankshaft

The signals recorded by sensors n.3 and n.4 on the engine with a simulated clearance between the connecting rod and the crankshaft are reported in Fig. 9.

The signals measured during the simulation test related to the connecting rod failure are presented in Fig. 9 for sensors n.3 and n.4, in the context when the spark plugs are assembled. One may notice that the intensities of the signals are approximately doubled compared to the reference test (Fig. 8) for all the phases of the rotation of the crankshaft. This increase in intensity of the signals is attributed to the fact that the connecting rod is no longer correctly adjusted to the crankshaft, leading to a loose mechanical connection,

allowing the rod to move inappropriately which creates shocks on the crankshaft itself that are recorded in particular by sensors n.3 and n.4. Interestingly, the authors expected an even higher intensity in the positions where the pistons change direction, i.e. at top dead center (TDC) and bottom dead center (BDC), as reported in Table 1, nevertheless, the measurements did not reveal such a phenomenon. It is presumed that the additional signals due to the anomalous simulated movement may be masked by the other signals, or that they are attenuated while they propagate through the various parts of the engine, such as connecting rod, piston pin, piston, rings and finally the engine's block.

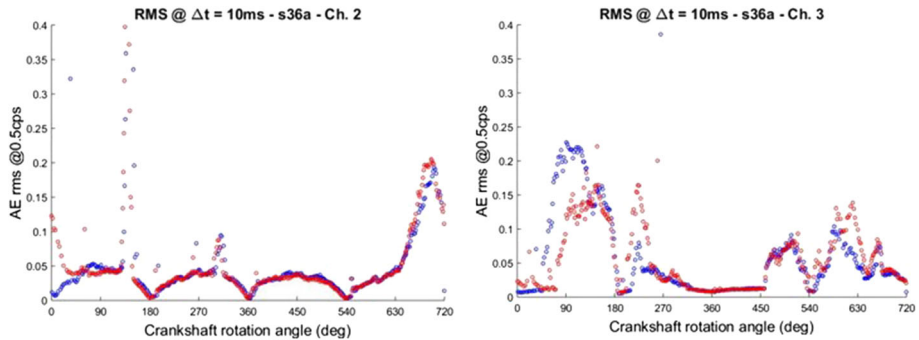
**Fig. 10** Signals from sensors n.2 and n.3 where the clearance between piston pin n.1 and the connecting rod is visible

For the present failure simulation, the signals recorded by sensors n.2 and n.3 on the engine with additional clearance between the piston pin and the connecting rod are reported in Fig. 10.

The signal of sensor n.2 exhibited a strong intensity roughly doubled compared to the reference signals when compressing the cylinder n.1 before 720° (Fig. 10). One assumption to explain this phenomenon is that the clearance between the piston pin and the connecting rod generates shocks during this phase of the engine cycle. Sensor n.3 also recorded stronger overall intensities compared to the reference signals. One may notice that, as in the case of the previous simulated failure, the enhanced peaks at TDC and BDC, that could be expected, are absent.

When the rings are removed from the cylinder n.1, it can be noticed that the peak at 700° that is visible in Fig. 10, channel 1, is absent in the present test (spark plug mounted). This peak was attributed to the presence of a leak in cylinder n.1 that generates a characteristic acoustic signal when the compression in cylinder n.1 is highest (see cycles in Table 1, 630° to 720°). The signals with or without spark plugs are also identical (Fig. 11). Those two phenomena are related to the fact that without the rings, there is no longer any seal between the piston and the cylinder, and therefore no more compression. The intensity of the signals is also generally lower: 0.05 instead of 0.09 of the reference signal for this engine (Fig. 7) whether with or without spark plugs. As the rings no longer rub against the wall of the cylinder and therefore do not generate acoustic emission signals, the level of the signals related to the friction of the rings on the cylinders is attenuated.

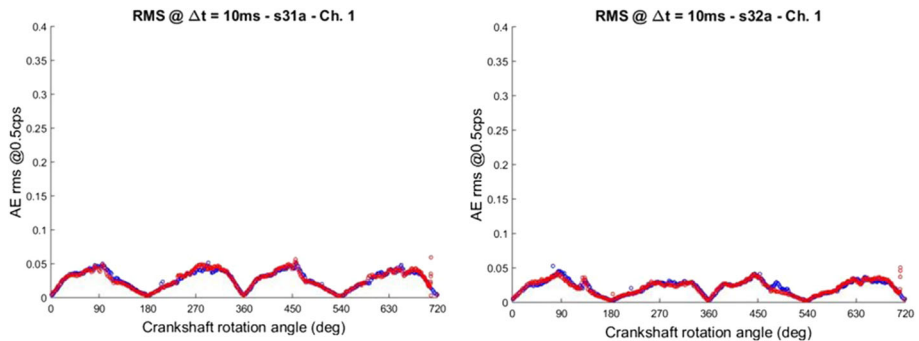
**Fig. 11** **a** Cylinder n.1 without rings, test without spark plug; **b** cylinder n.1 without rings, test with spark plug

The signals recorded using the sensor n.1 on the engine during simulated wear of the piston rings are reported in Fig. 11.

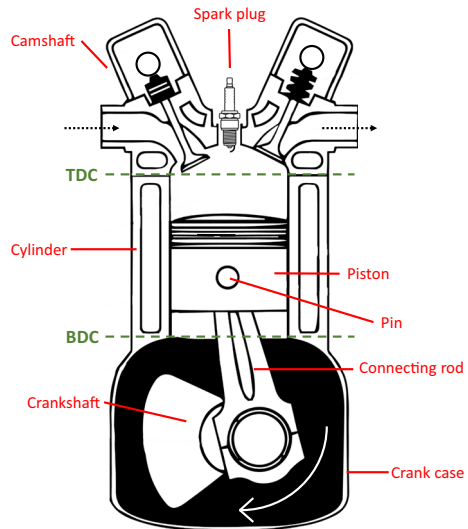
**Table 1** angular positions of pistons and valves during the engine cycles

Crankshaft Angle (°)	Positions of the pistons and of the admission valves
0	Top Dead Center (TDC)1 – explosion – Bottom Dead Center (BDC)2
16	Admission 2 closed
90	Piston n.1 and n.2 at half stroke The piston n.1 goes down and the n.2 goes up
180	TDC2 – explosion – BDC1
270	Piston n.1 and n.2 at half stroke The piston n.2 goes down and the n.1 goes up
360	TDC1 BDC2
450	Piston n.1 and n.2 at half stroke. The piston n.1 goes down and the n.2 goes up
540	TDC2 BDC1
630	Piston n.1 and n.2 at half stroke The piston n.2 goes down and the n.1 goes up
635	Admission 1 closed
720	Return to 0

the sake of helping the reader to better understand the different steps of the time sequences related to the strokes of the engine presented in all the figures of AE signals, Table 1 and its accompanying figure lists all the respective positions of the pistons and of the valves during the engine cycles.
