### Analysis of High Temperature Degradation of Alloys in Solid Oxide Fuel Cell

Thèse N°9086

Présentée le 15 février 2019 à la Faculté des sciences et techniques de l'ingénieur Groupe SCI STI JVH Programme doctoral en energie

### MANUEL BIANCO

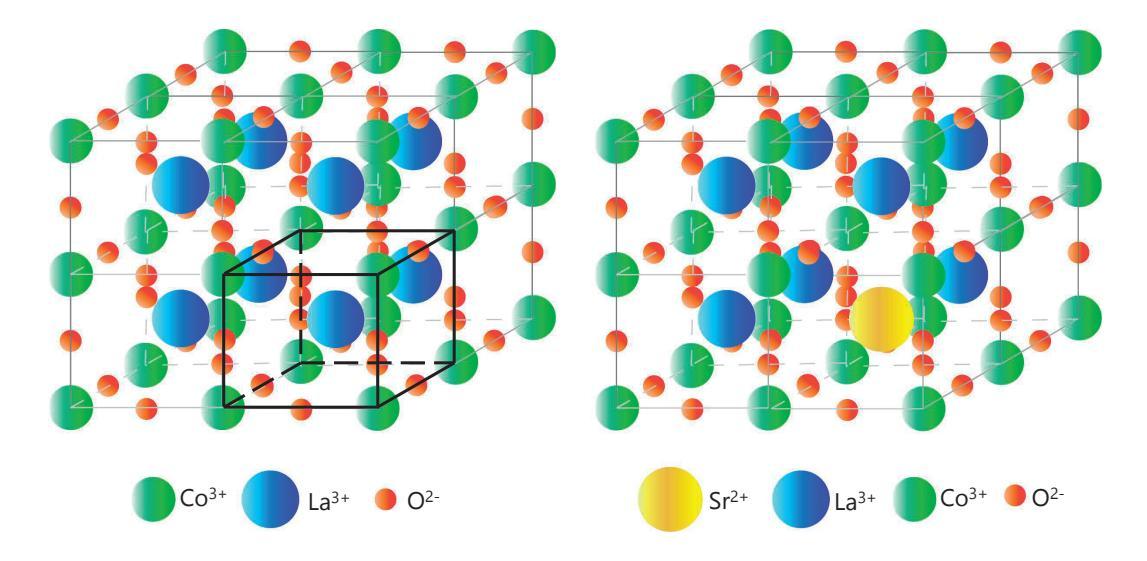
Figure 1.2 – Qualitative representation of an ideal perovskite lattice for  $LaCoO_3$  and Sr doped- $LaCoO_3$

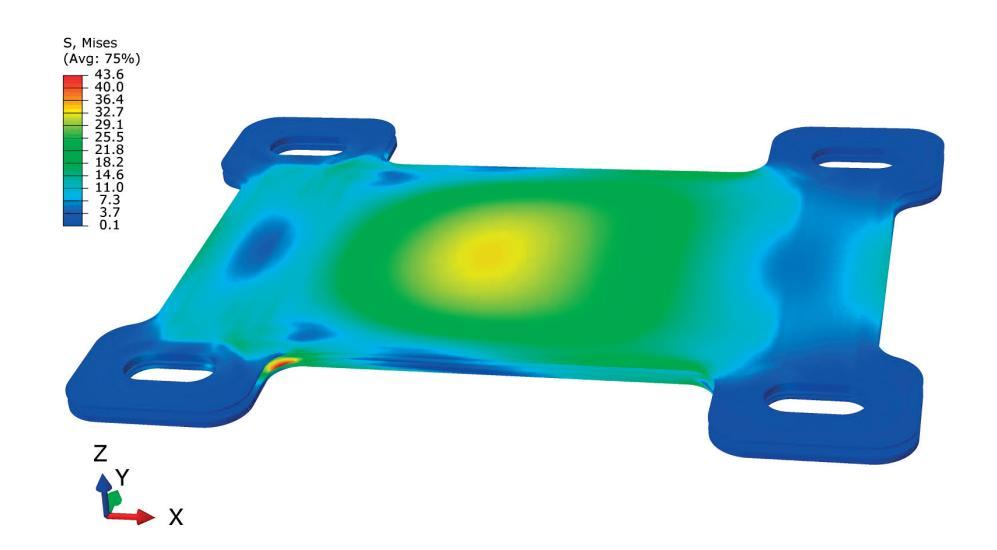
Figure 1.4 – Von Mises stress field at high temperature in a metallic cassette manufactured by SOLIDpower S.p.A. The stress field was calculated by FEA (finite elements analysis) simulating the stack production process steps, followed by co-flow operation. Operating conditions used to generate the simulated temperature profile were  $T_{fuel,in} = 700$  °C,  $T_{air,in} = 700$  °C, partial pre-reforming of 0.5, FU = 0.85, and  $T_{max,cell} = 827$  °C. Regions with high stresses indicate possible plastic deformation as well as risk of buckling.*Reprinted with permission from "Solid Oxide Fuel Cell Lifetime and Reliability"*, *Academic's Press*, 2017

Models such as these estimate the stress inside the MIC with finite element simulations. As an example, a temperature profile obtained from a combined thermoelectrochemical and fluid dynamics model was imported into an FEA model. The resulting Von Mises stresses in the metallic interconnect of an SOFC stack model simulated in co-flow configuration is shown in Figure 1.4. The center of the cassette was exposed to the highest temperatures, because of the electrochemical reactions occurring at the cell. Considering that stresses in SOFC stacks are by thermal gradients and thermal expansion mismatch between the components, among others, the highest Von Mises stresses in the IC was located at the central area of the cassette, as shown by Figure 1.4. The IC is likely to buckle in this area, especially if the material is relatively thin. Buckling may then provoke i) damage of the adjacent elements on one face, i.e. inelastic deformation of the GDLs (gas distribution layers) and ii) detachment of the interface, on the opposite face. As a result, stack reliability is affected also by the stresses in the IC. To investigate the thermo-mechanical reliability of SOFC stacks upon operation, scenarios of long-term operation, thermal

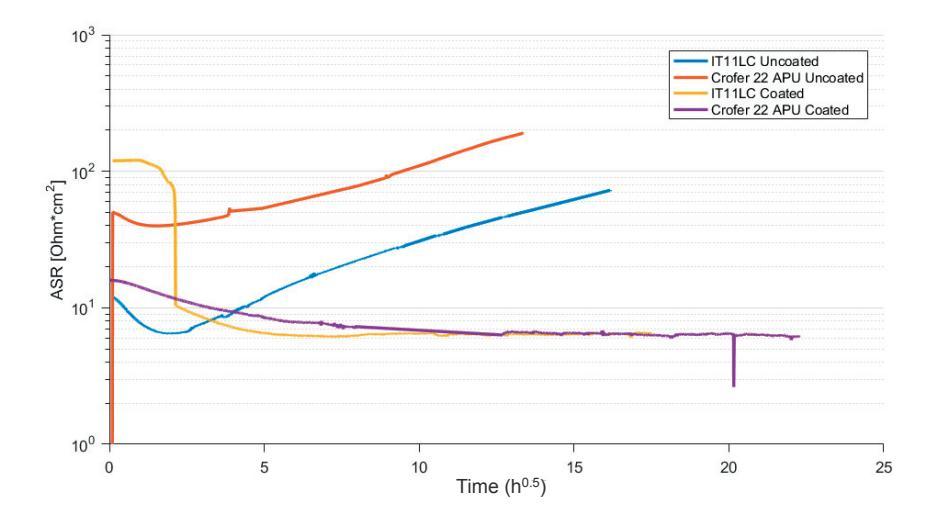
Figure 1.5 – ASR graph of alloys ITM (26 %wt. Cr) and Crofer 22 APU (22 %wt. Cr) with and without protective coating ( $MnCo_2O_4$ ). In air @800°C using 250  $mAcm^{-2}$ , in contact with LSCM5555 powder LSM tablet with Pt electrode (tablet and electrode resistance subtracted). Reprinted with permission from "Solid Oxide Fuel Cell Lifetime and Reliability", Academic's Press, 2017

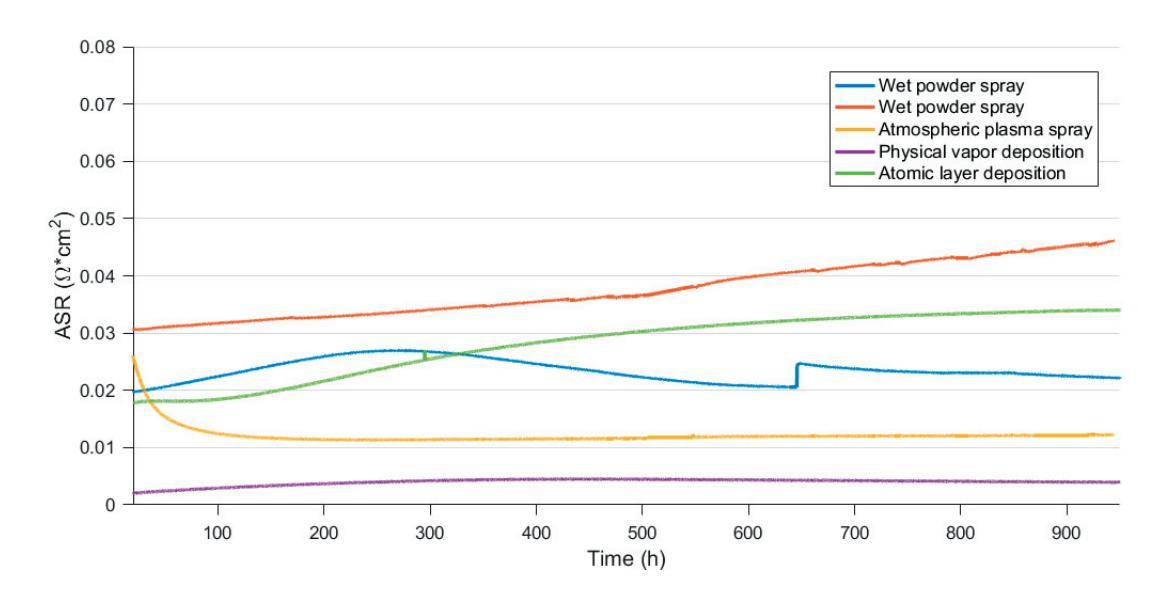
Figure 1.6 – Electrical resistivity performances of FSS substrates coated with Fedoped MCO deposited by different methods. High-coating-density techniques (APS, PVD) produced the best results. Testing conditions: 700°C, 3%vol.,  $H_2O(g)$ , 0.4  $A/cm^2$ . WPS: wet powder spray, APS: atmospheric plasma spray, PVD: physical vapor deposition, ALD: atomic layer deposition. Results are presented in detail in chapter 3. *Reprinted with permission from "Solid Oxide Fuel Cell Lifetime and Reliability"*, Academic's Press, 2017

Under the same coating material, high-coating-density deposition methods like PVD or atmospheric plasma spray (APS) give better results, as demonstrated in Figure 1.6 on Sandvik Sanergy HT steel substrates [91, 92]. The imaging of the microstructure of the thermal oxide layers formed, presented in Figure 1.7, help to partially explain these results. The  $MnCo_2O_4$  protective coating deposited by wet powder spray, shown in Figure 1.7 (a), remained porous, leading to a thicker  $Cr_2O_3$  scale grown on top of the FSS substrate, than either the APS or PVD deposited dense coatings, shown in Figure 1.7 (b) and Figure 1.7 (c), respectively. The  $\Delta p_{O_2}$  through a  $Cr_2O_3$  layer is very large going from metallic Cr at the metal/scale interface and air. Application of a dense coating (e.g. a spinel layer) therefore reduces the oxygen

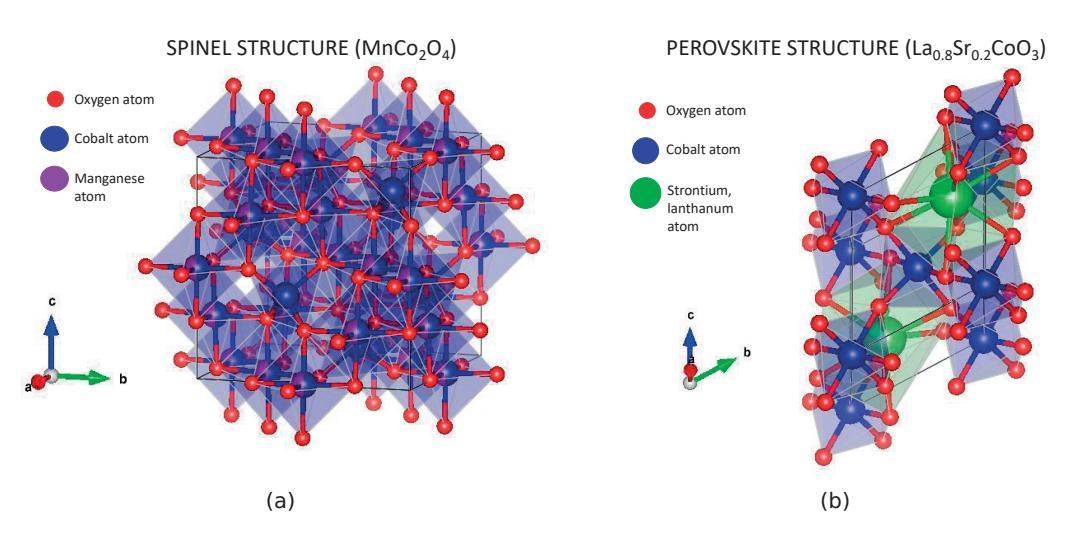
Figure 2.1 – (a) example of the of a spinel crystal structure (b) example of a perovskite crystal structure. These pictures are generated with the 3D visualization program for structural models VESTA

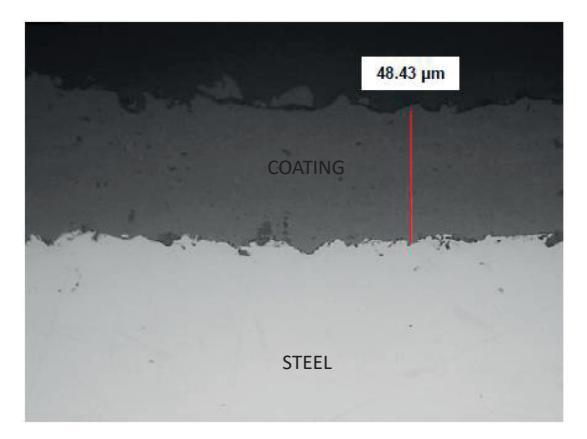
Figure 2.2 – As deposited ferritic stainless steel sample APS coated with  $MnCo_2O_4$ ; SEM cross section. The surface is irregular because of a sandblasting pre-treatment

With APS, an inert gas is forced to pass through the electric arc between two electrodes which ionizes the gas, creating a plasma on the order of thousands of degrees. This plasma is pushed outside a nozzle where it meets the coating powders which are eventually melted. The ceramic drops impact on the metal substrate creating the coating. Prior to the deposition, the material is sand-blasted to improve the mechanical adhesion between the drops and the material surface. The black alumina particles found during SEM/EDS observations at the steel/coating interface can be traced back to this practice (Figure 2.2).

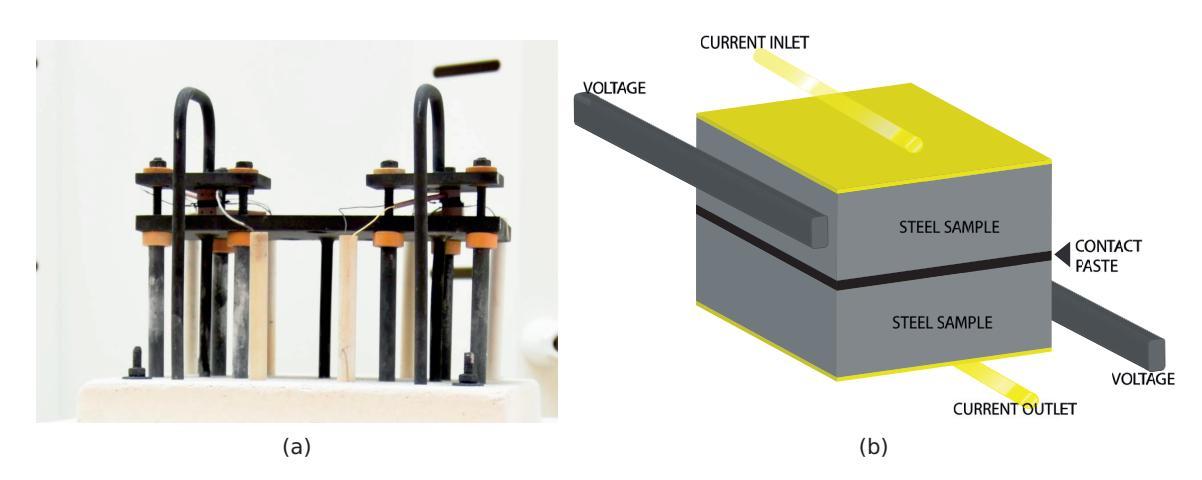
Figure 2.3 – On the left (a) ASR set up with samples compressed and current and leading wires (b) an example of the four wires testing method used to measure resistance. The grey wires represents the leading wires spot welded to the the steel samples, whereas the gold squares and wires represent the inlet and outlet of the electrical circuit.

Figure 2.3 (b) sketches the four wires configuration adopted during the measurements. Two voltage leading sensing wires (K-type) are welded on the metal samples and two gold wires welded on gold meshes providing electrical current through the top and bottom area. Knowing the contact area, the voltage drop and the applied current, the area specific resistance is obtained through Ohm's law.

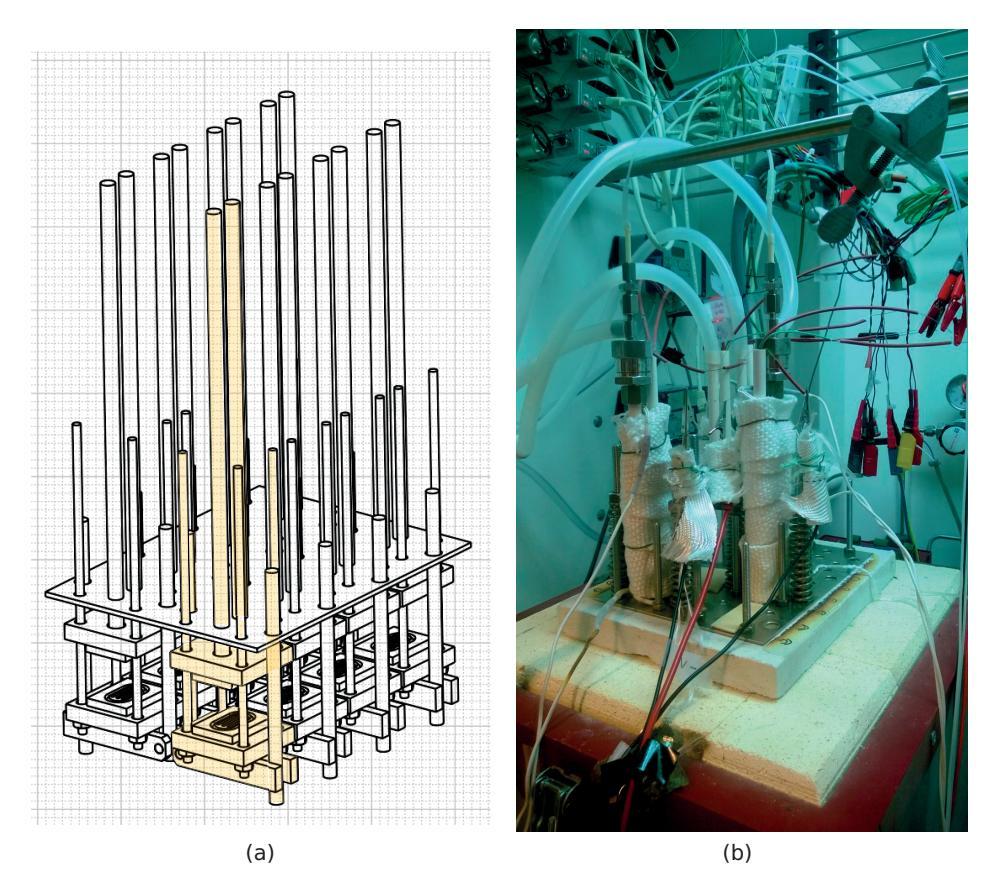
Figure 2.4 - (a) Design of a set-up fabricated in this thesis. Highlighted in yellow is a single test position unit repeated eight times. On the right (b) the set-up once it is realized and in operation. Metallic add-ons and alumina tissue are part of the evaporator system.

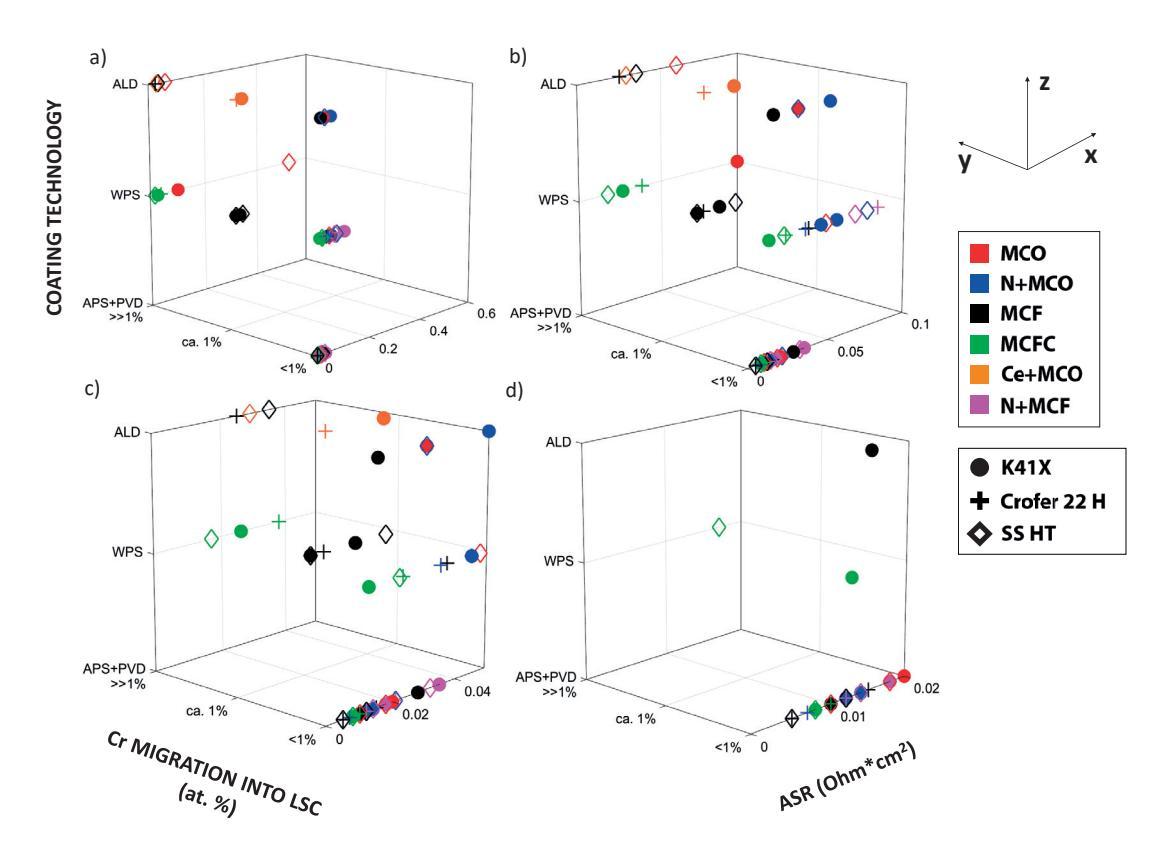
Figure 3.1 - Relations among coating deposition technique, steel substrate, coating composition, chromium retention properties and ASR performance. From a) to d) a progressive zoom on the ASR region of interest is plotted

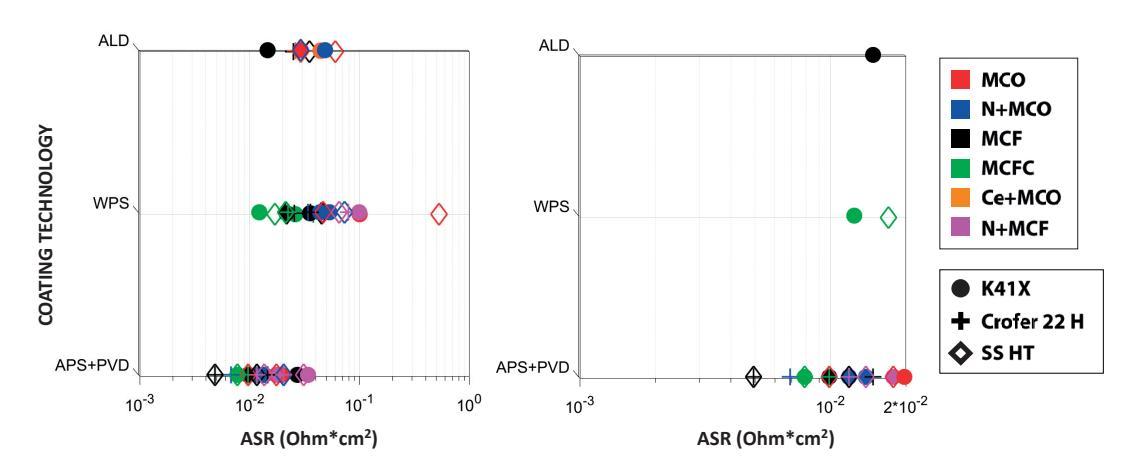
Figure 3.2 – ASR result of small steel/coating samples as a function of the coating deposition method, stainless steel substrate and coating composition. On the right a zoom on the lower ASR region of interest of the left hand side plot (<  $20 \text{ mOhmcm}^2$ )

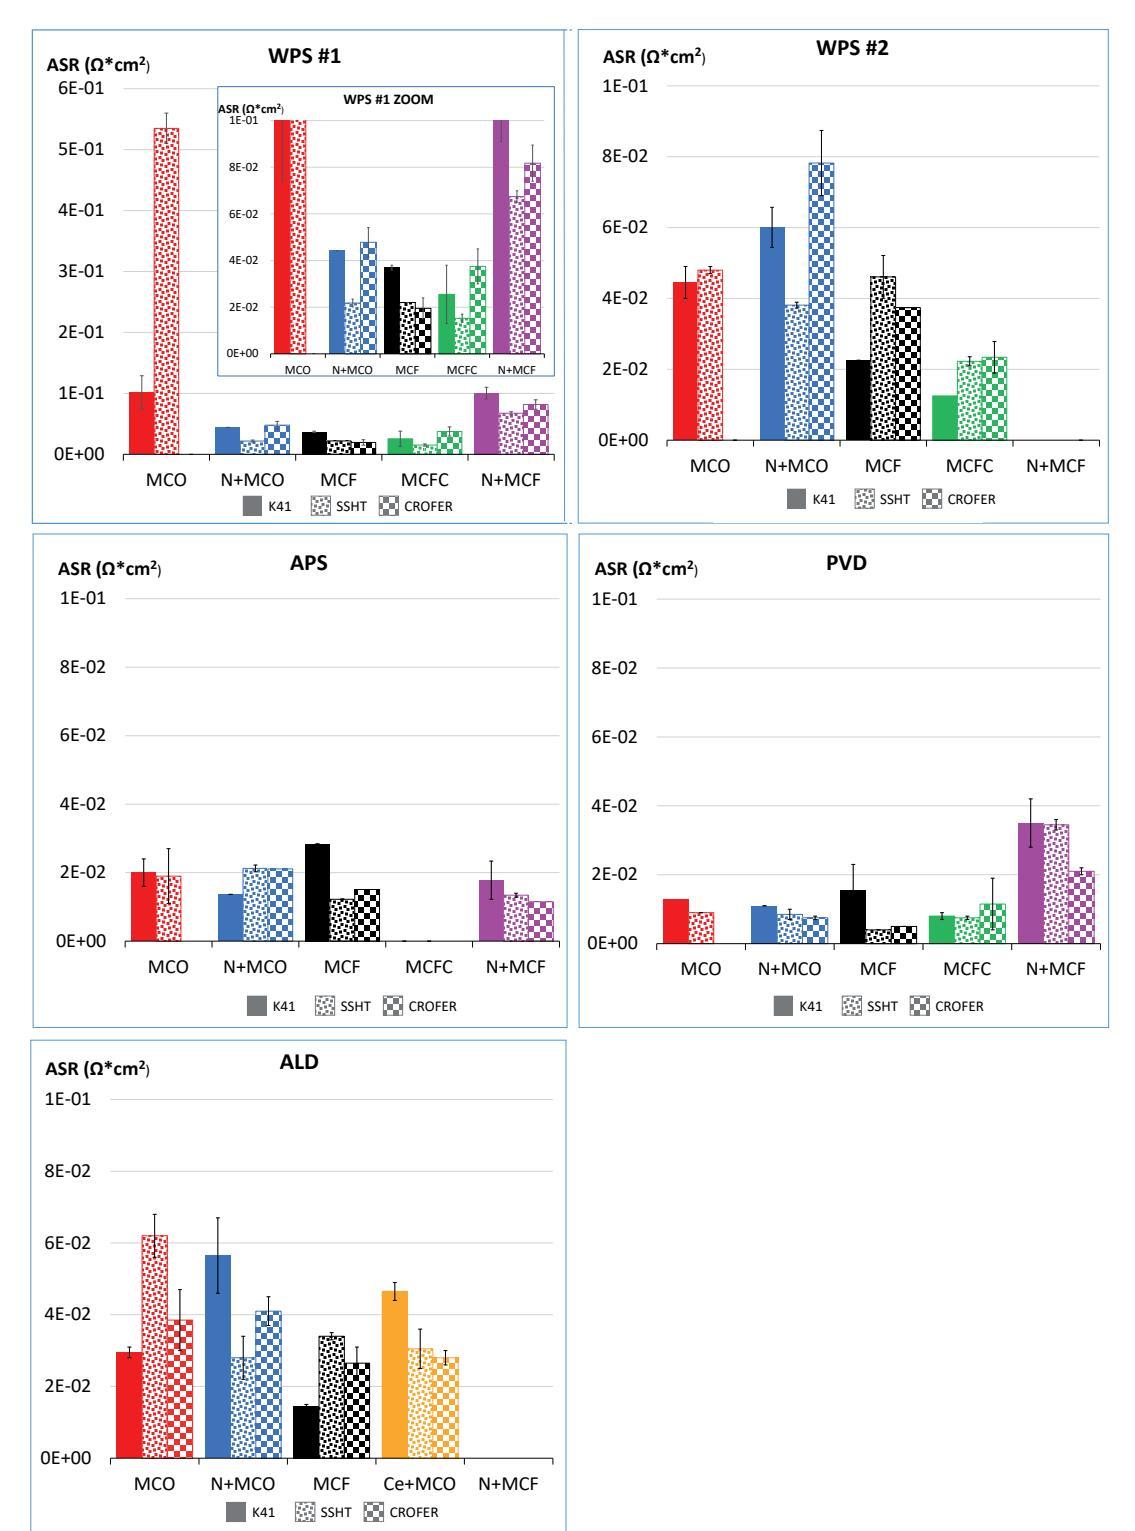
Figure 3.3 – ASR results of small steel/coating samples after 1000 h of testing @ 700°C. Bar charts distribute the resistance value as a function of the coating composition and substrate processing. The error bars displays the range between the minimum and maximum values, typically of 2 tested samples

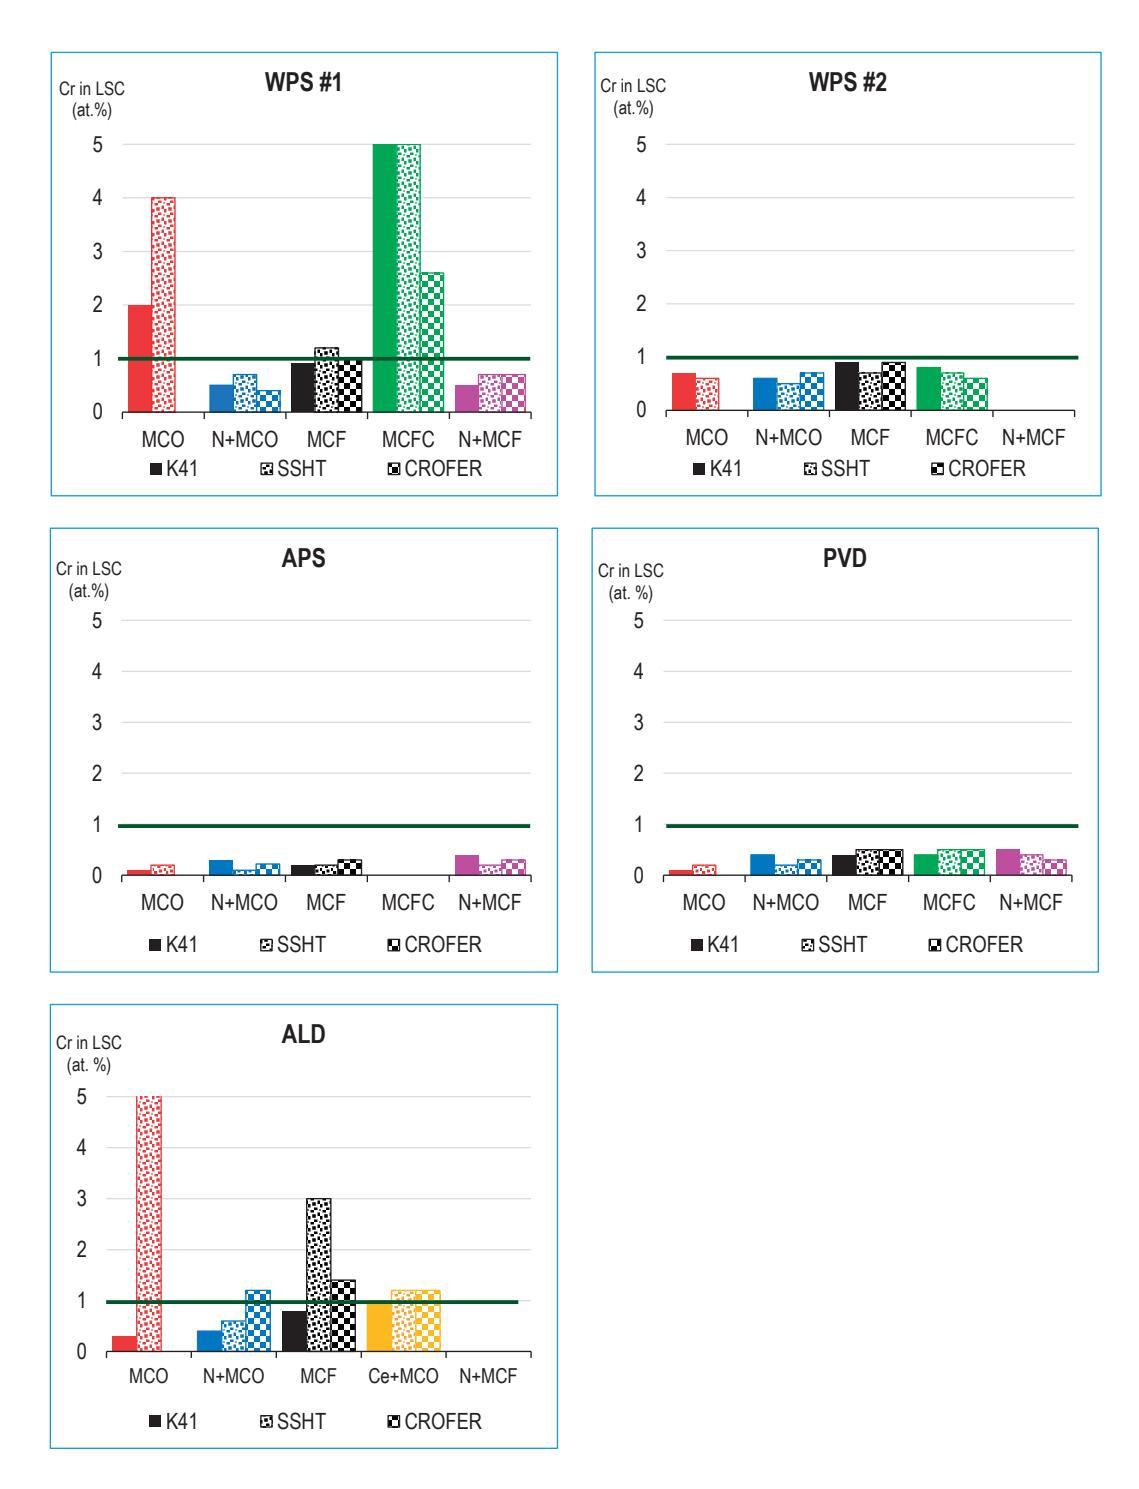
Figure 3.4 – Chromium retention properties of the ASR tested small steel/coating samples. The green line at 1 at.% indicates the EDS detection limit. Above this limit the coating is considered to fail in retaining chromium. Samples in the 1 at.% range are considered at risk. These values are calculated taking the averages of the chromium found in the perovskite materials in contact with the small samples.

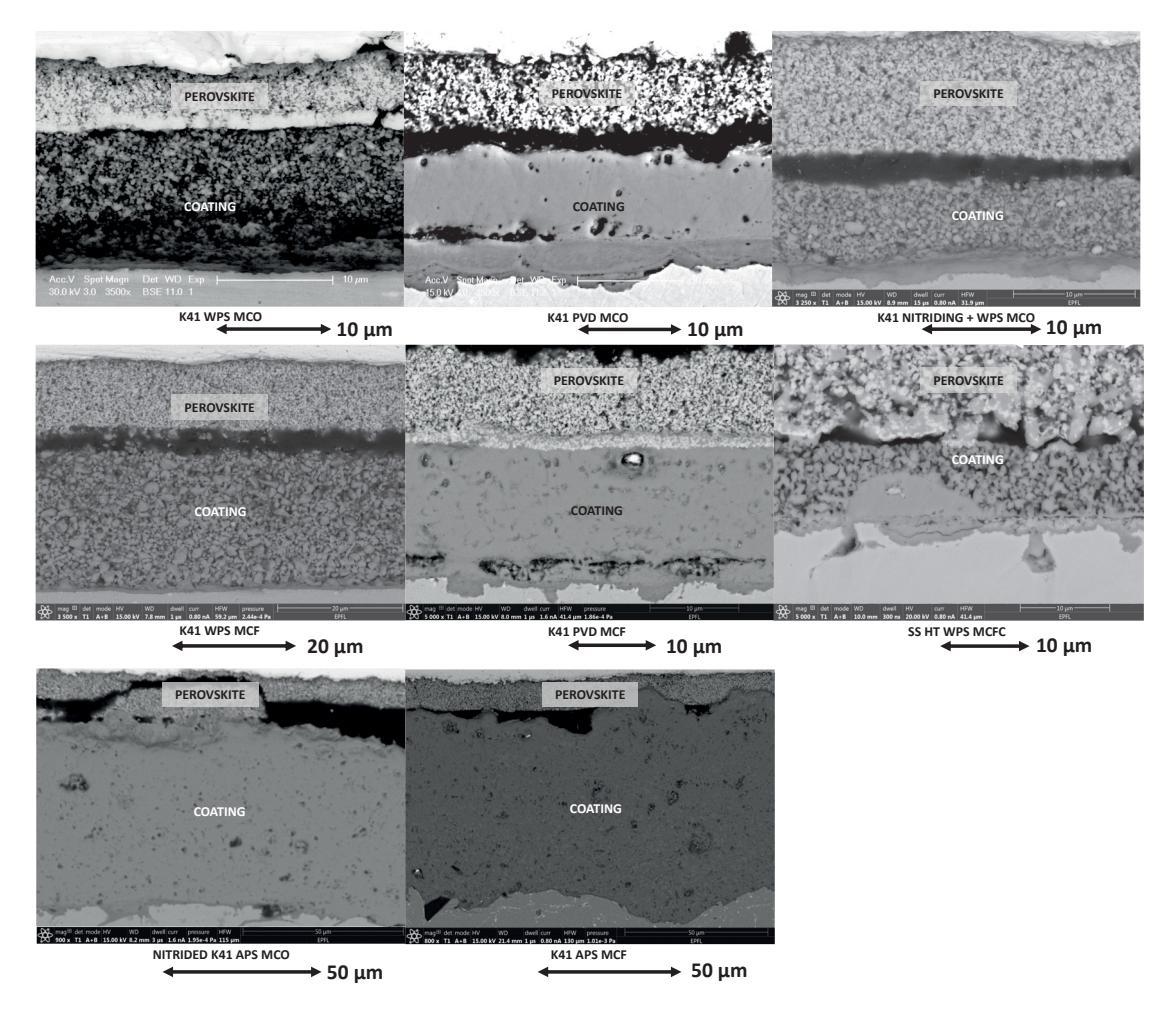
Figure 3.5 – SEM cross sections of the Steel/coating/perovskite interfaces coming from small samples which underwent ASR test for 1000 hours.

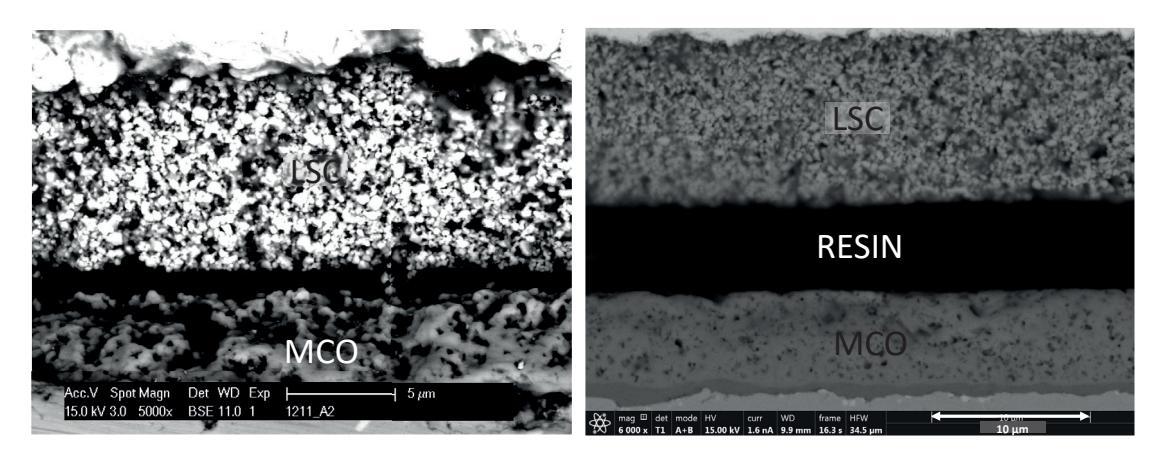
Figure 3.6 – On the left, WPS-deposited MCO coating containing open porosity, on the right WPS-deposited MCFC coating containing closed porosity, after 1000h at 700°C and humid (vol.%) air

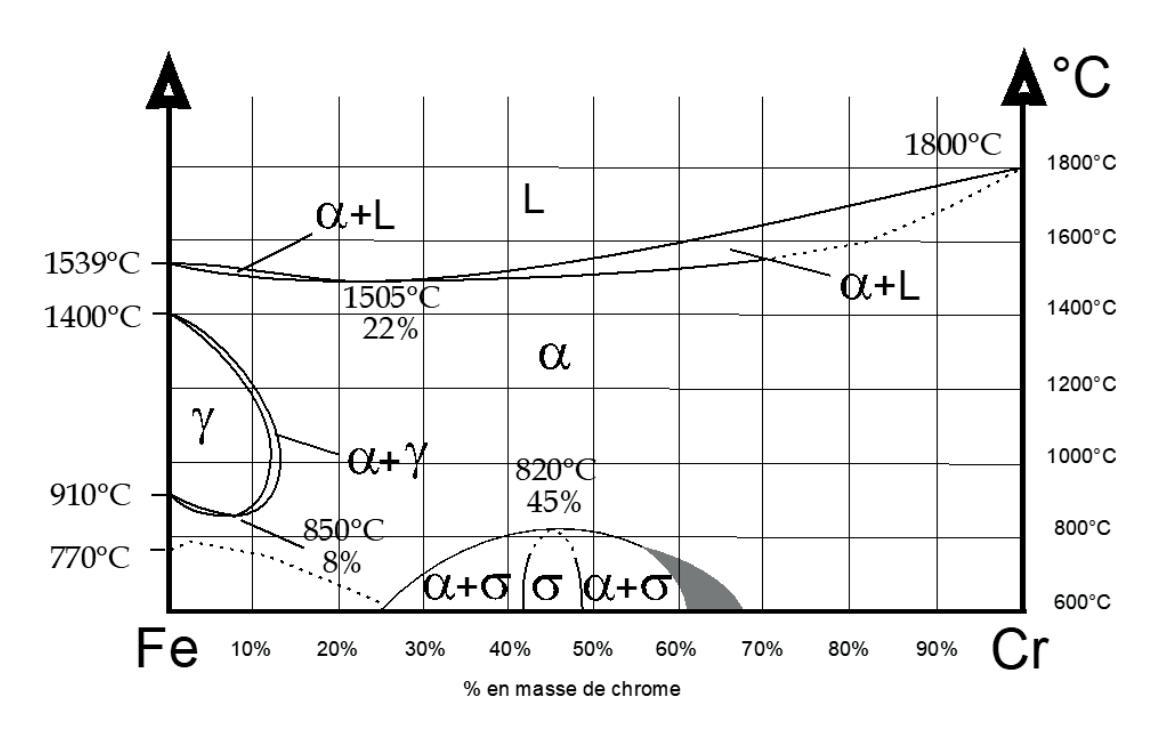
Figure 3.8 – Fe-Cr phase diagram [1]

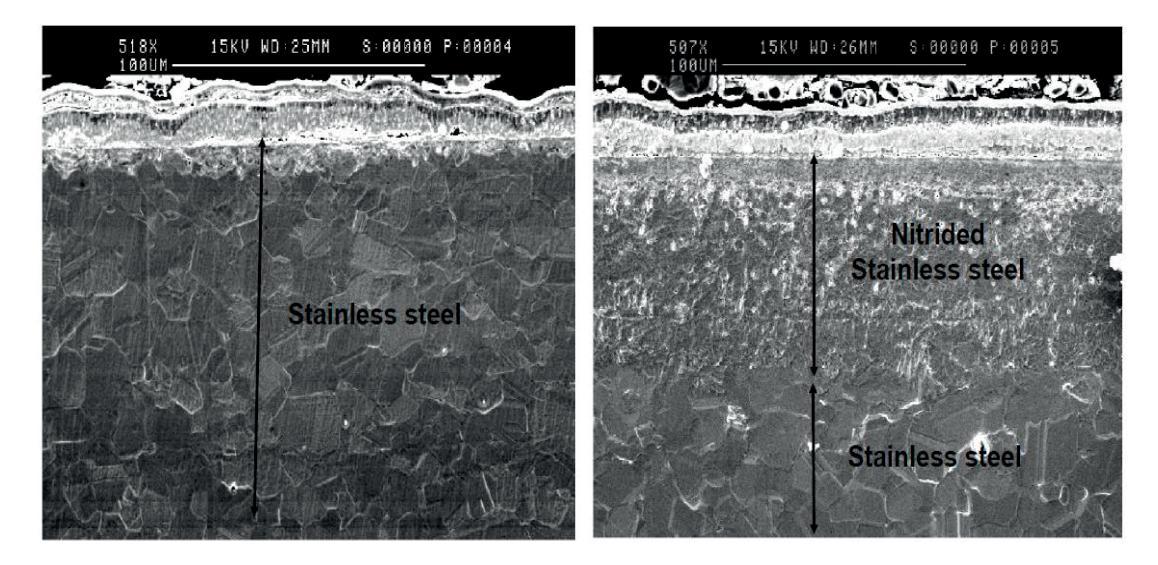
Figure 3.9 – Cross sections of two not nitrided (left) and nitrided (right) stainless steel substrates (Sanergy HT), aged for eight hours at 750°C. The nitriding process led to refining of the steel grains.

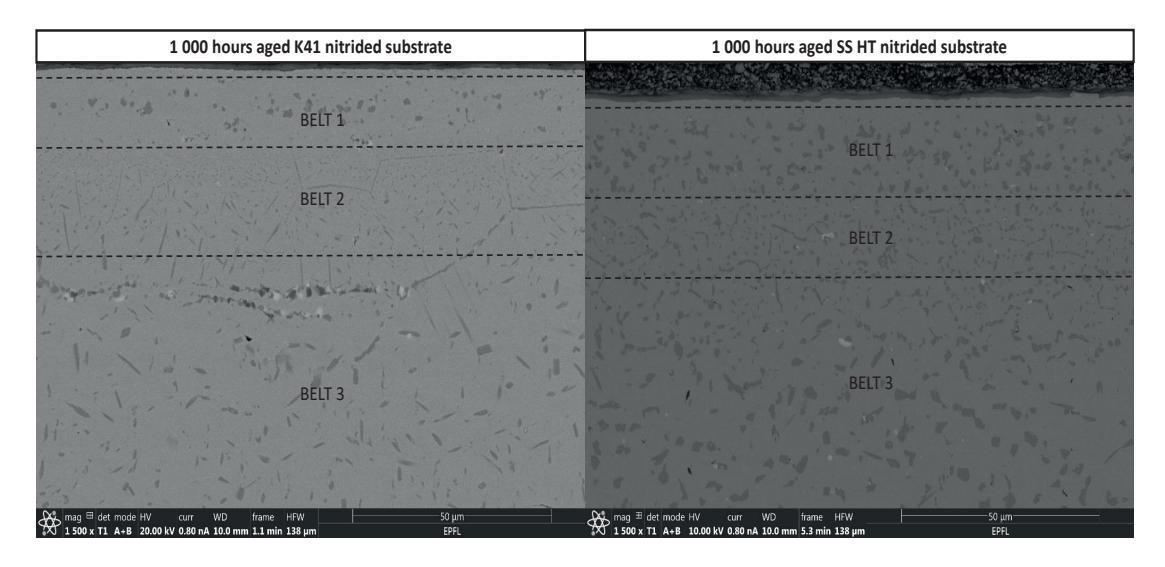
Figure 3.10 – Cross sections of nitrided FSS substrates aged for 1000 hours

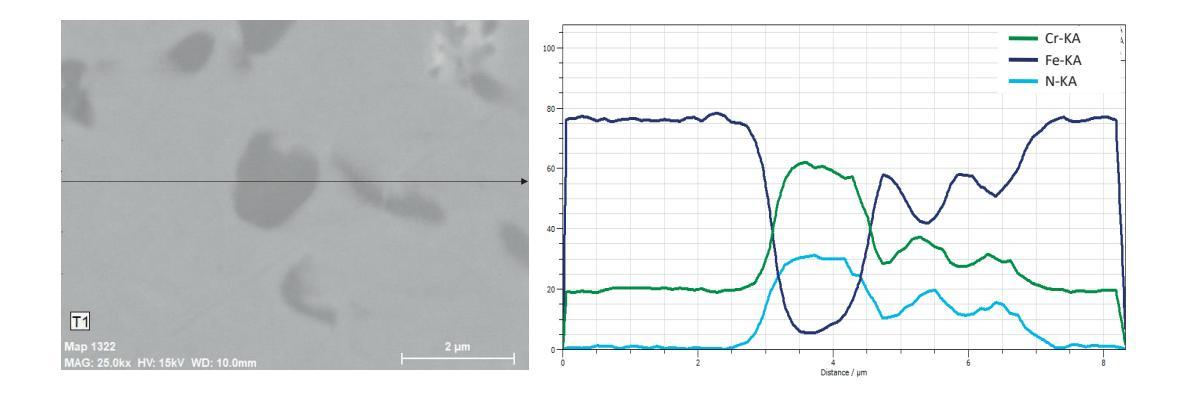
Figure 3.11 – EDS Line scan over two  $Cr_2N$  particles and the surrounding area of a K41 nitrided steel substrate. Y axis reports at.%

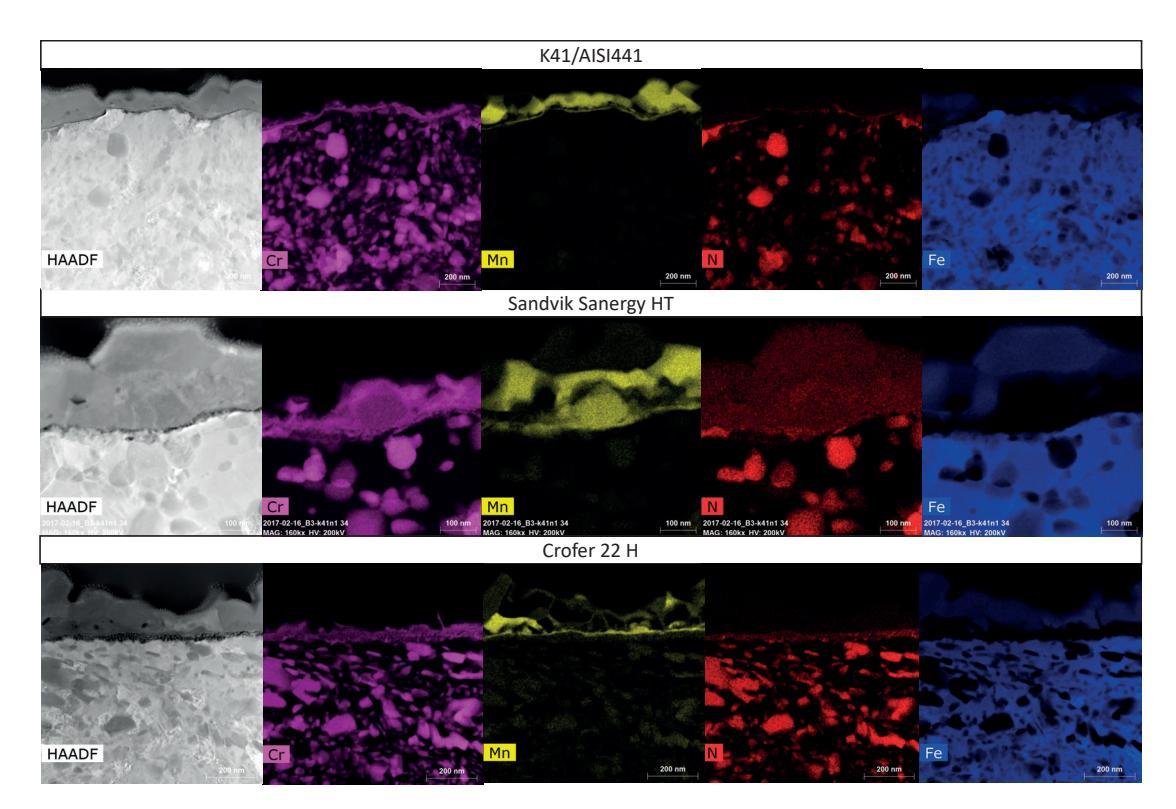
Figure 3.12 – TEM-EDS analysis of uncoated nitrided steel substrates heated up to 700  $^{\circ}$ C for less than 3 hours.

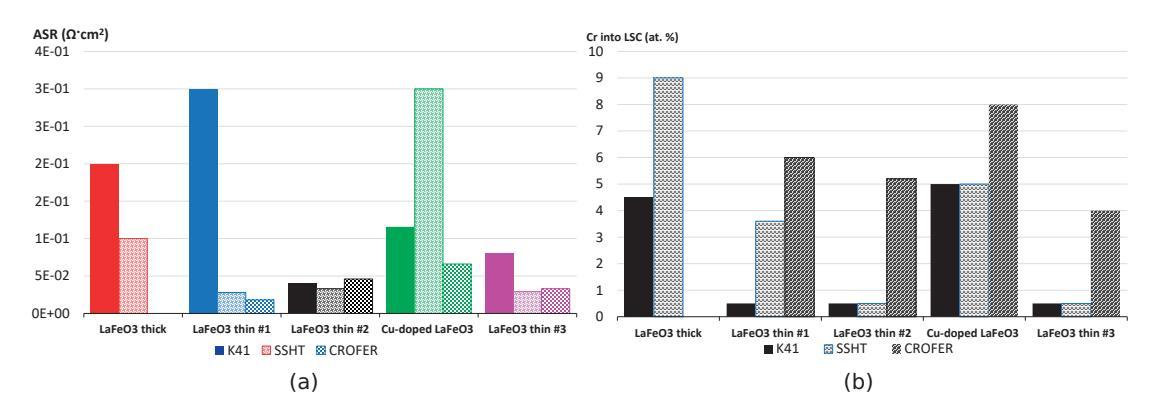
Figure 3.13 – ASR (a) and Cr retention (b) results of small samples dip-coated with  $LaFeO_3$  perovskite coatings after 1000 h of testing at 700°C. Bar charts distribute the resistance value as a function of the coating composition and substrate processing.

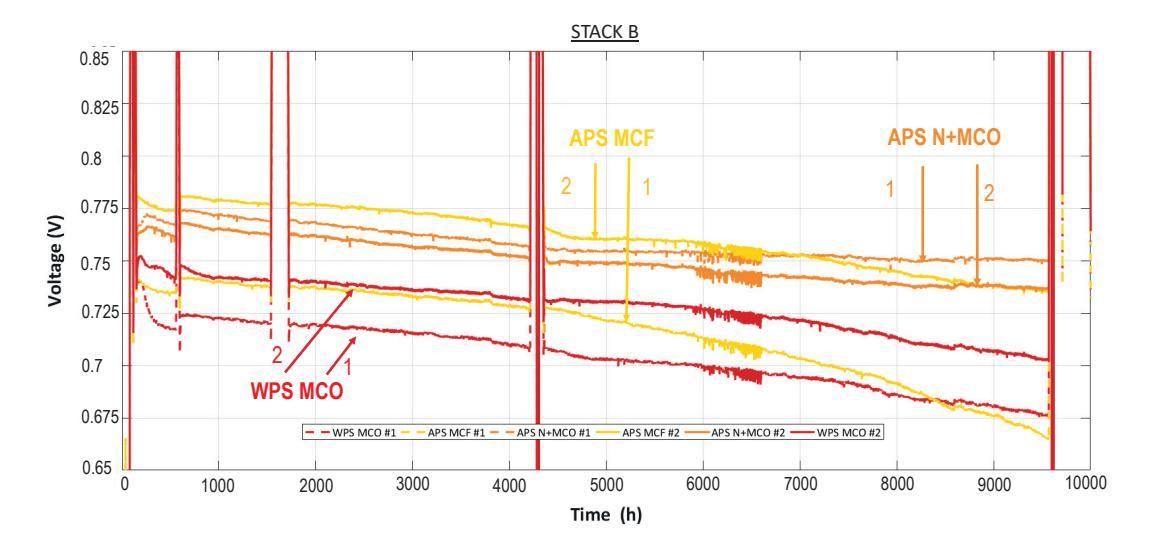
Figure 3.15 – Voltage versus time curve of the 6-cell short stack tested in a project partner facility (Stack B).

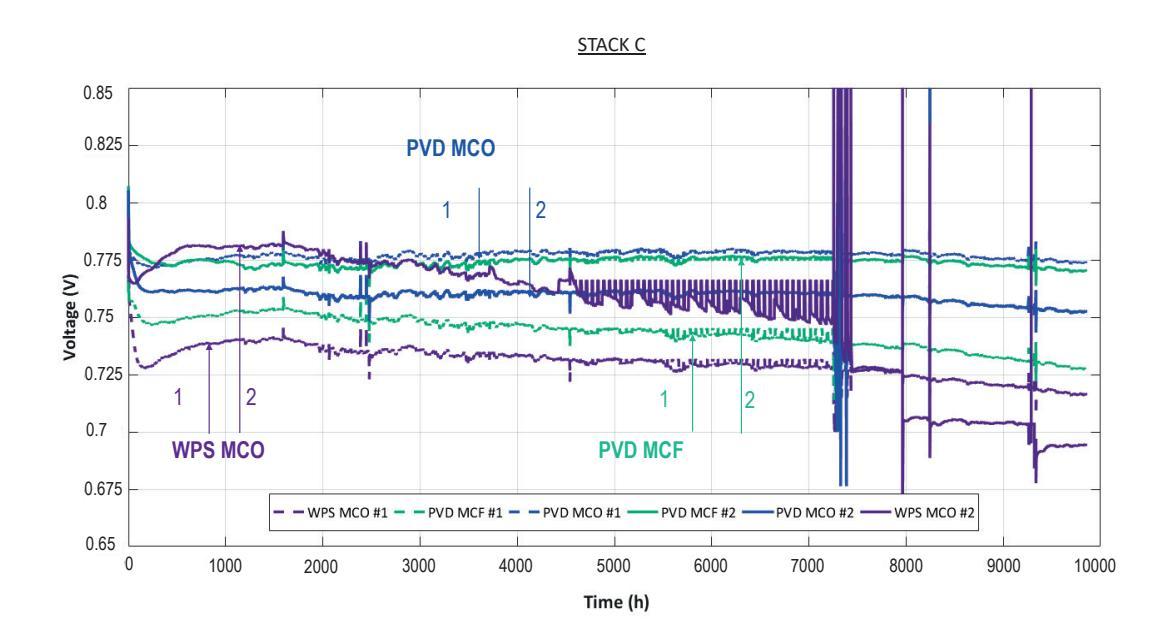
Figure 3.16 – Voltage versus time curve of the 6-cell short stack tested at EPFL. The peaks are mainly due to IV measurements (stack C).

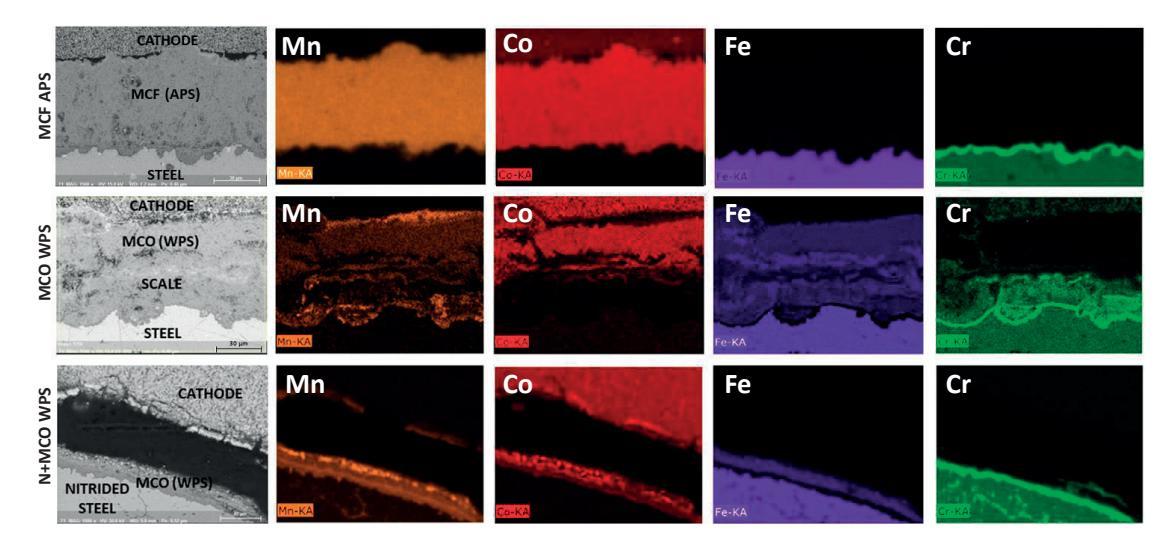
Figure 3.17 – Comparison of MICs tested for 10000 hours in a 6-cell short stack via MIC/cathode interface cross sections. Top: MCF deposited via APS showing no Cr migration towards the cathode. Middle: MCO deposited with WPS not blocking Cr diffusion. Bottom: WPS-deposited MCO on nitrided K41 substrate.

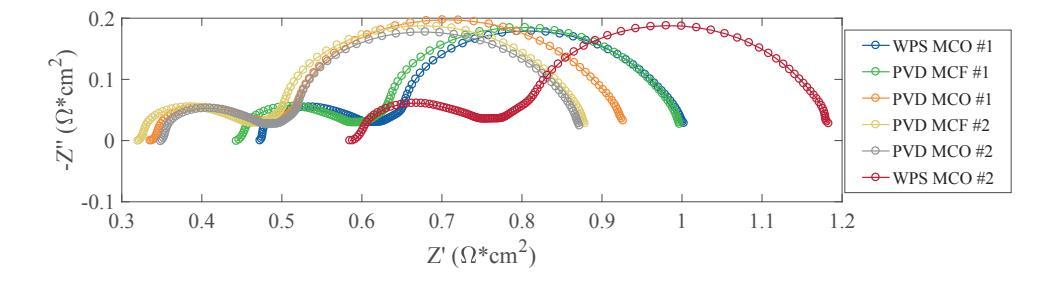
Figure 3.18 – Impedance spectra of the SRUs tested in stack C.

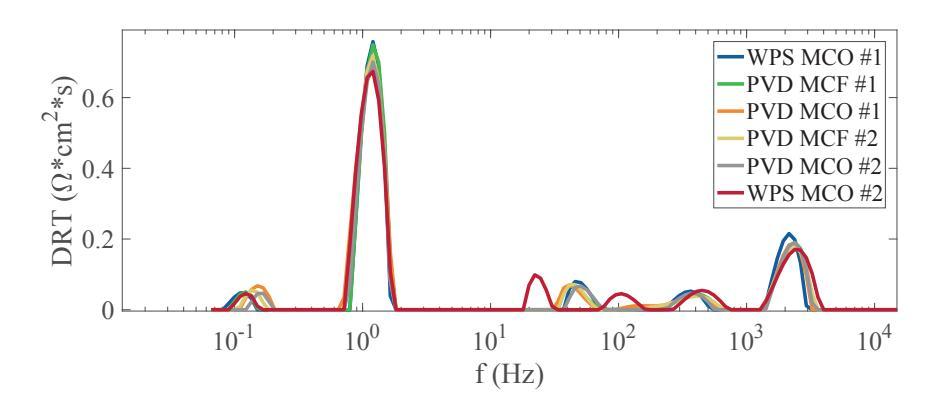
Figure 3.19 – DRT treated spectra of the SRUs tested in stack C.

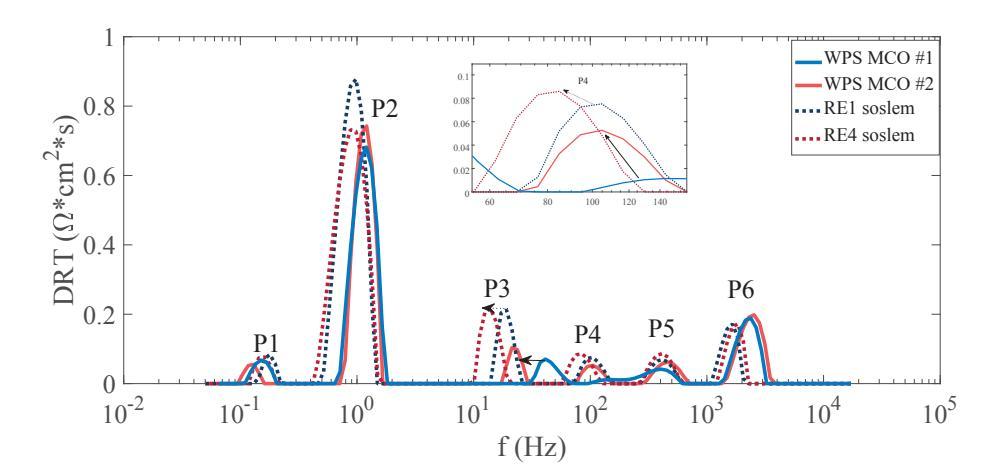
Figure 3.20 – Comparison of DRT spectra for the WPS MCO SRU in stack C and a SRU with a known contact defect (analysed in a parallel project).

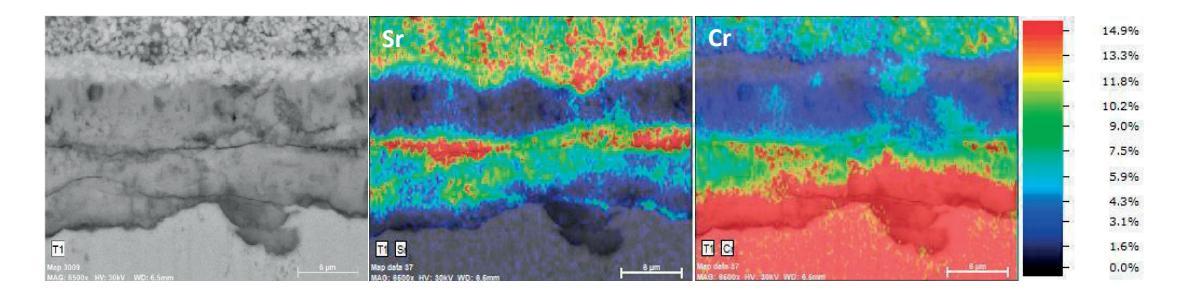
Figure 3.21 – Quantitative element map of the perovskite/MIC interface for PVD MCO #2, Stack C. Element concentration in at.%.
