### Analysis of High Temperature Degradation of Alloys in Solid Oxide Fuel Cell

Thèse N°9086

Présentée le 15 février 2019 à la Faculté des sciences et techniques de l'ingénieur Groupe SCI STI JVH Programme doctoral en energie

### MANUEL BIANCO

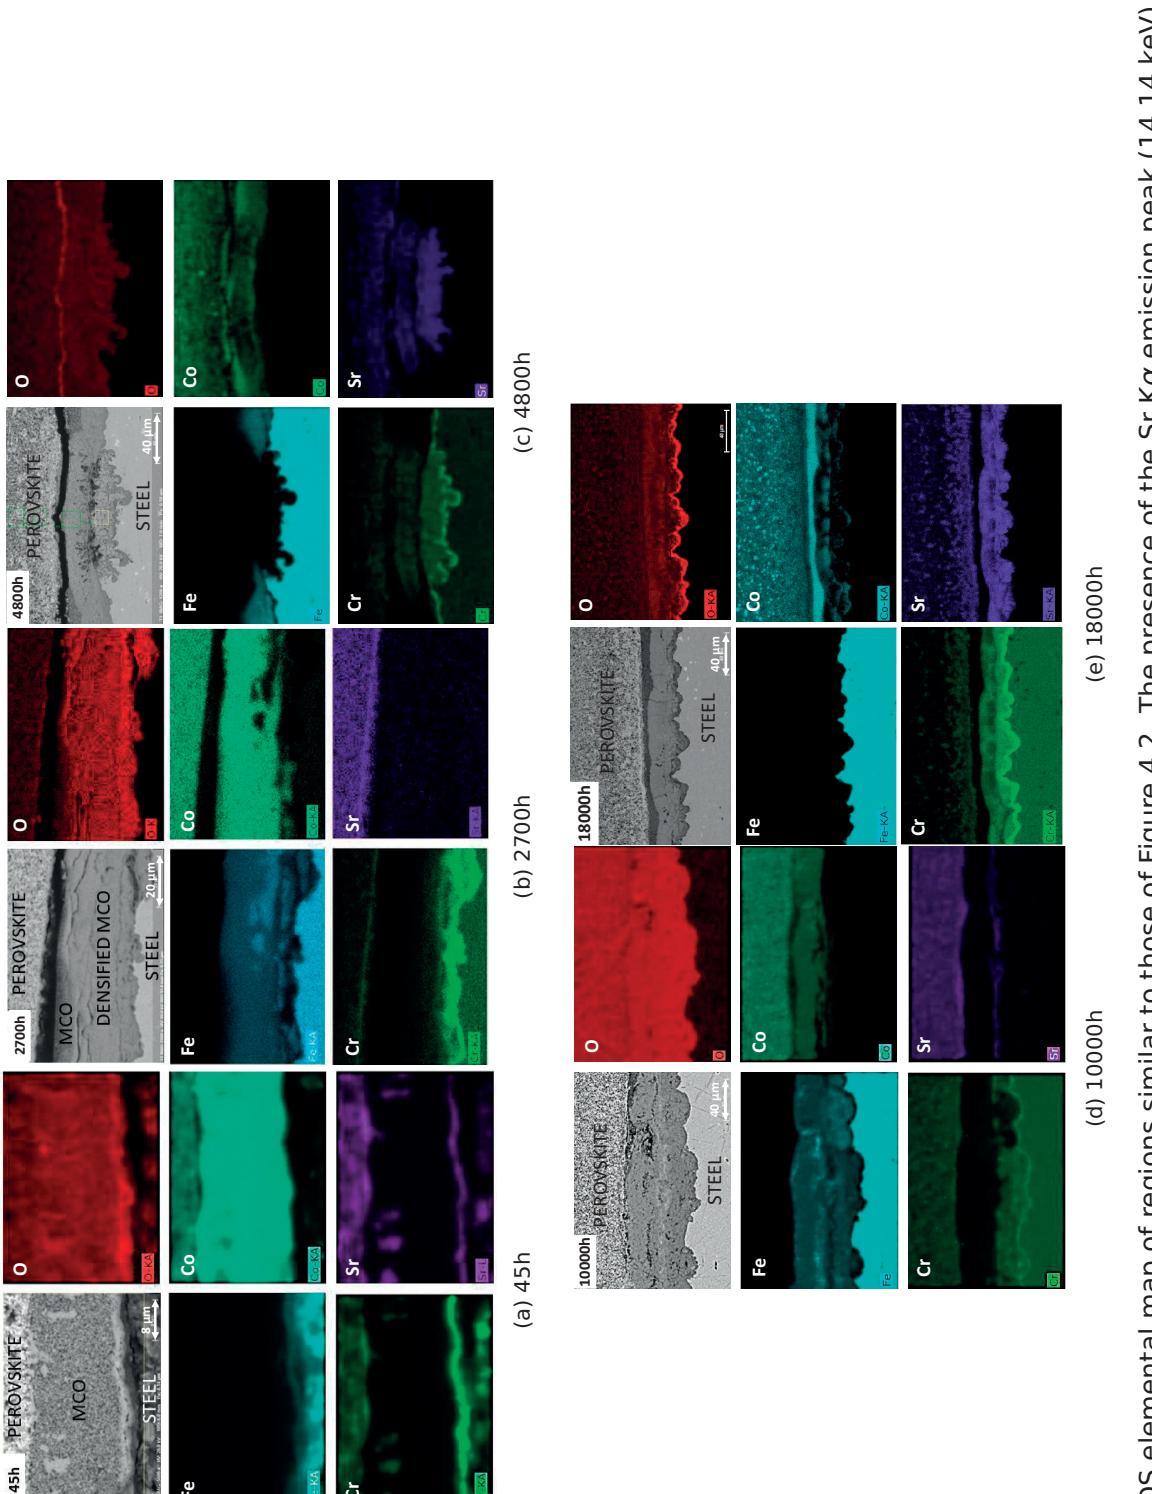
Figure 4.3 – EDS elemental map of regions similar to those of Figure 4.2. The presence of the Sr K $\alpha$  emission peak (14.14 keV) confirmed that strontium is not an artifact due to the Si X-ray Ka emission peak (1.74 keV).

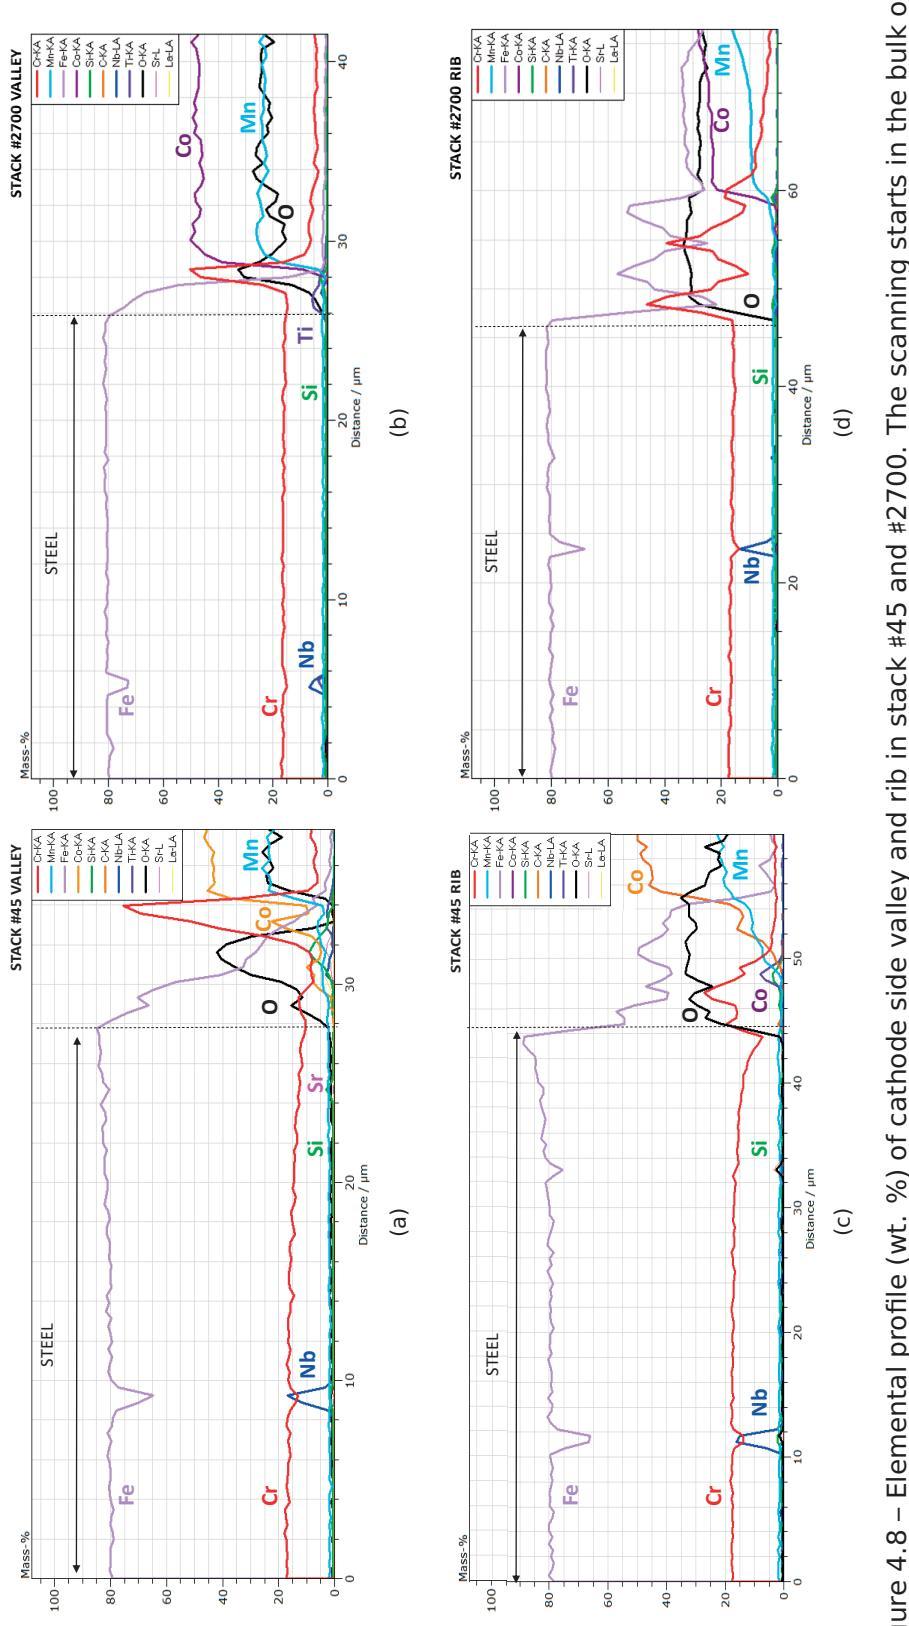
Figure 4.8 – Elemental profile (wt. %) of cathode side valley and rib in stack #45 and #2700. The scanning starts in the bulk on the alloy substrate and ends in the thermally grown oxide layer. Note the Cr profile in proximity of the steel/scale interface.

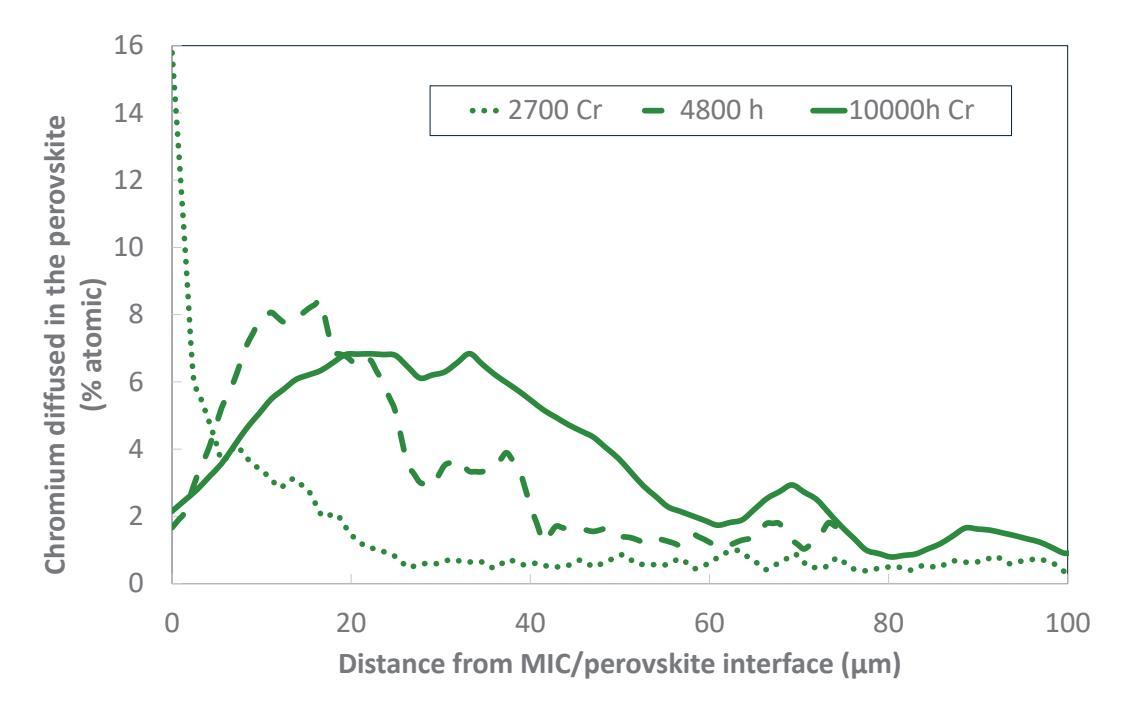
Figure 4.9 – Chromium profile evolution in the perovskite layers taken from stacks #2700, #4800 and #10000.

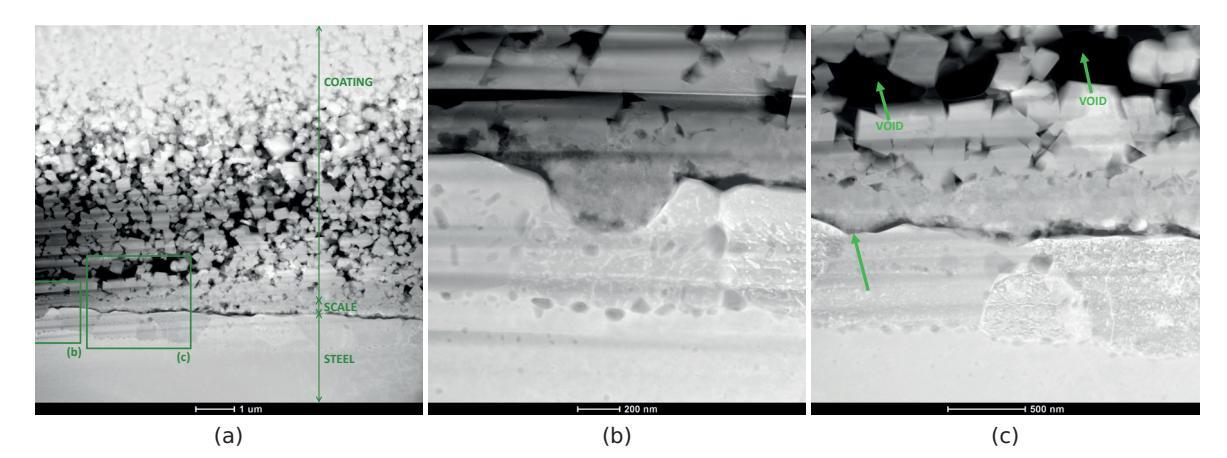
Figure 5.1 – (a) HAADF-STEM image of the lamella extracted from a pristine SOFC interconnect. The bottom light gray layer is AISI441/K41 ferritic stainless steel, while the porous phase is the  $MnCo_2O_4$  coating. (b) Detail of the interconnect/coating interface with an inward corrosion region. (c) the green arrow indicates the origin of an inward corrosion process

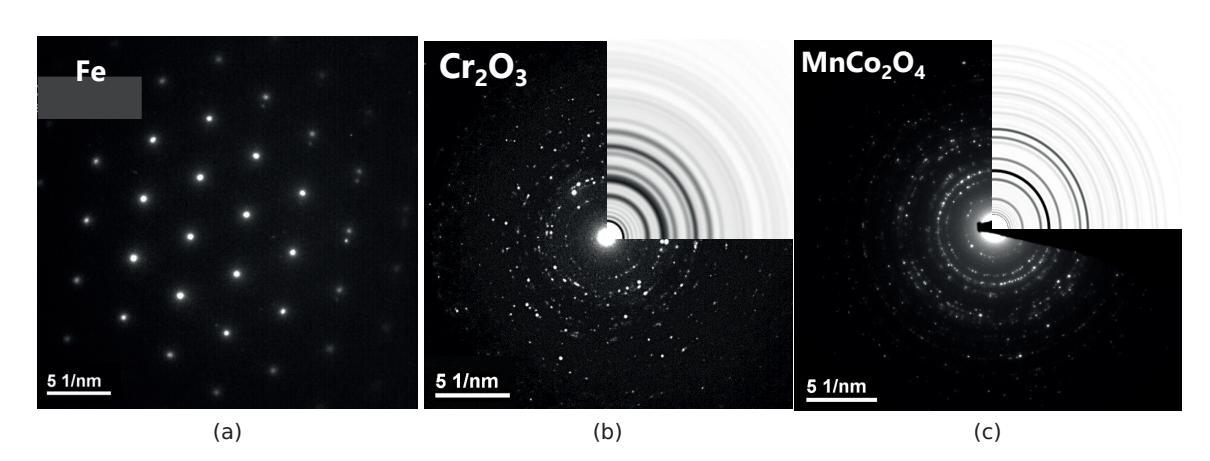
Figure 5.3 – Selected area diffraction analysis of regions in the pristine lamella.

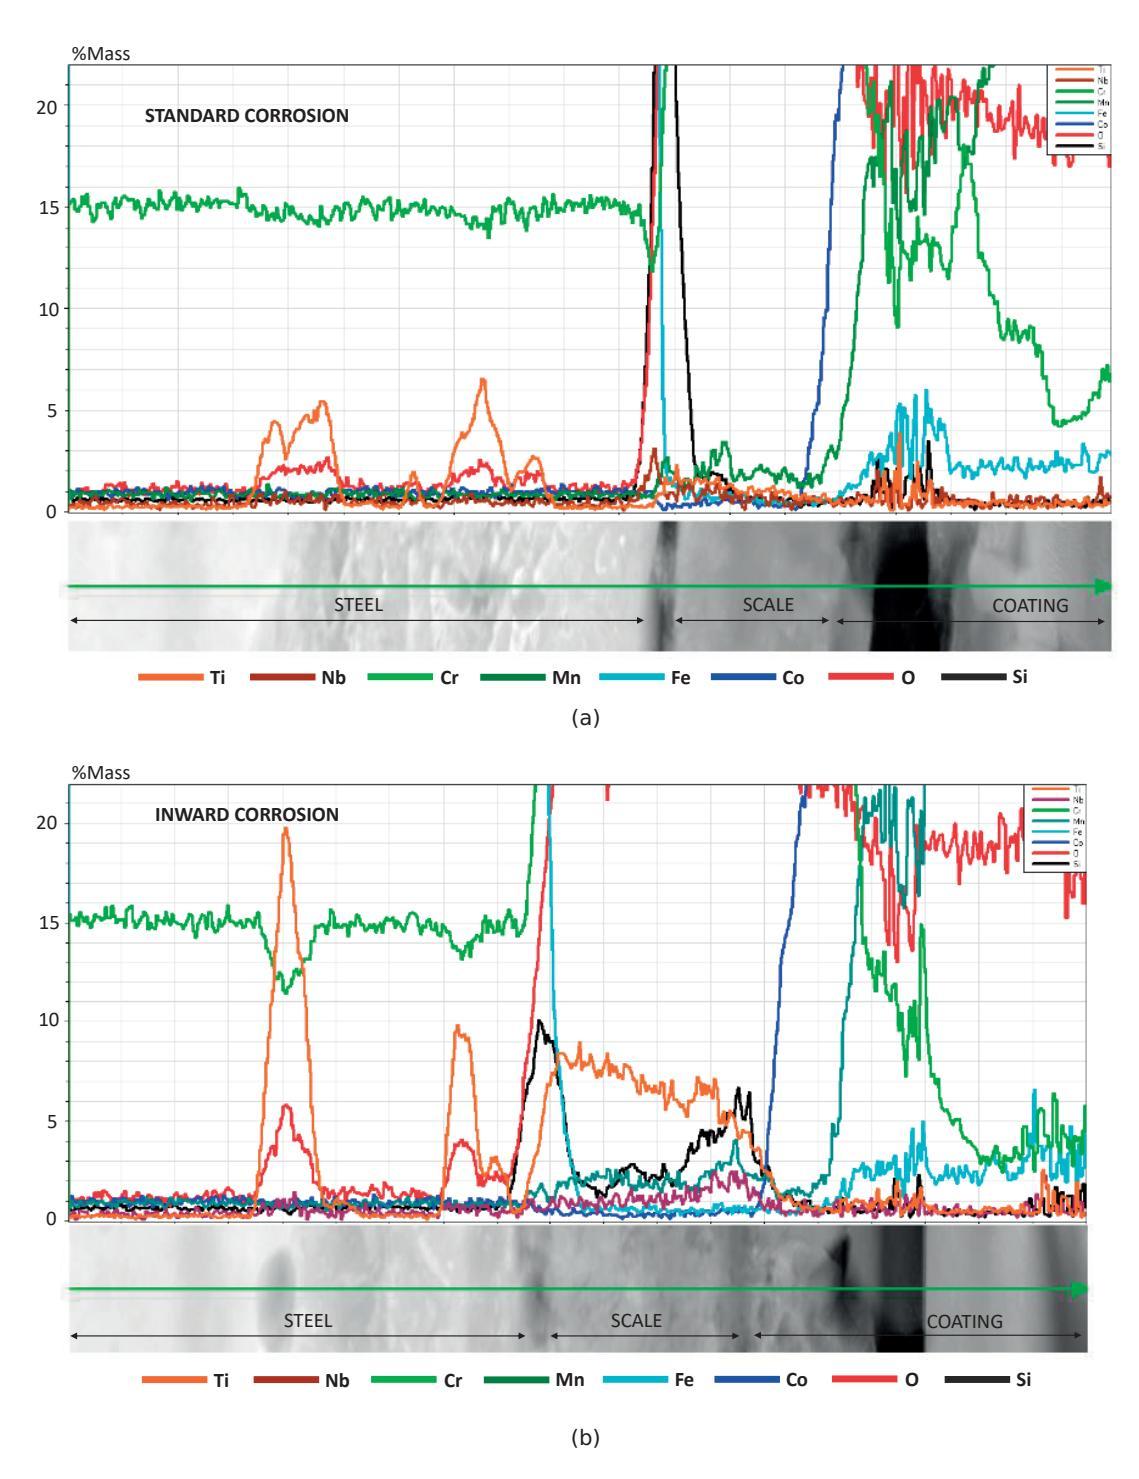
Figure 5.4 – Element linescans across the standard (a) and inward (b) oxide growing regions in the pristine MIC.

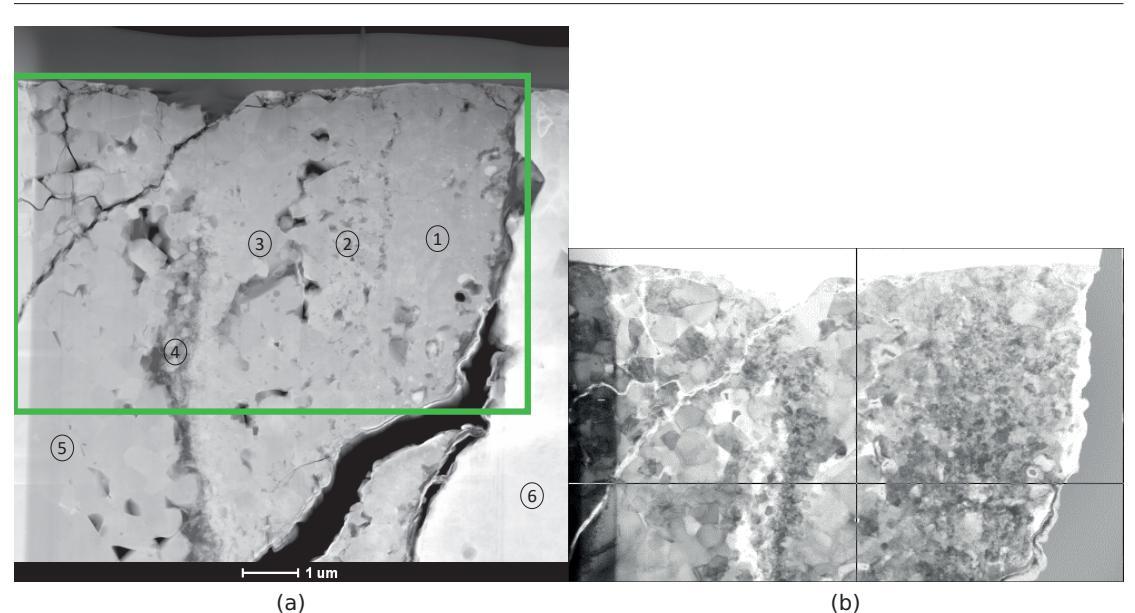
Figure 5.5 – (a) HAADF-STEM picture of the lamella taken from stack #4800 (b) the nanoindexed region highlighted with the green rectangle in (a)

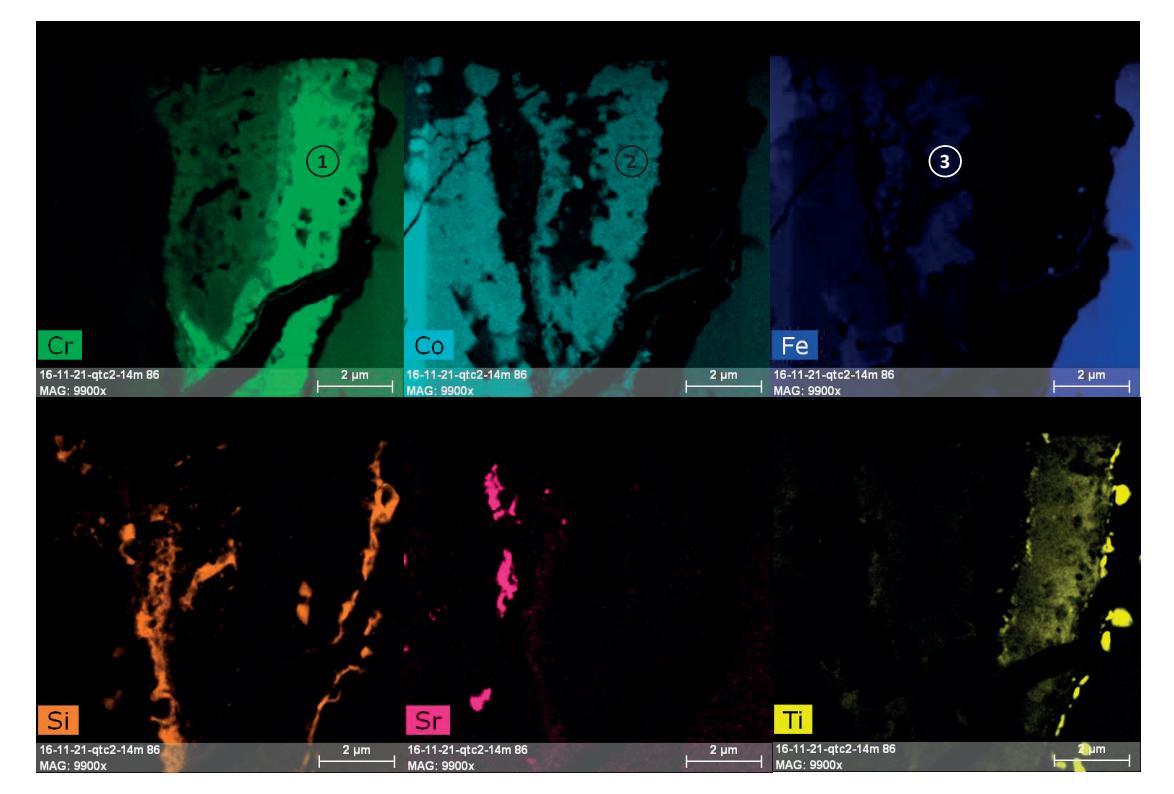
Figure 5.6 – Qualitative EDS mapping of the lamella in Figure 5.5

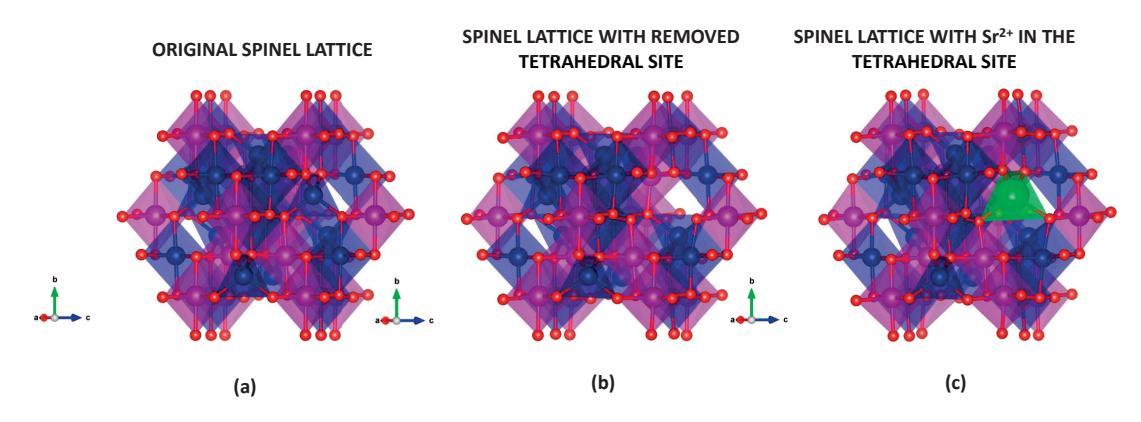
Figure 5.7 – Representation of the spinel lattice used for the DFT simulation. (a) starting condition (b) a  $Co^{2+}$  missing in the tetrahedral site (c) with a strontium atom doping the lattice

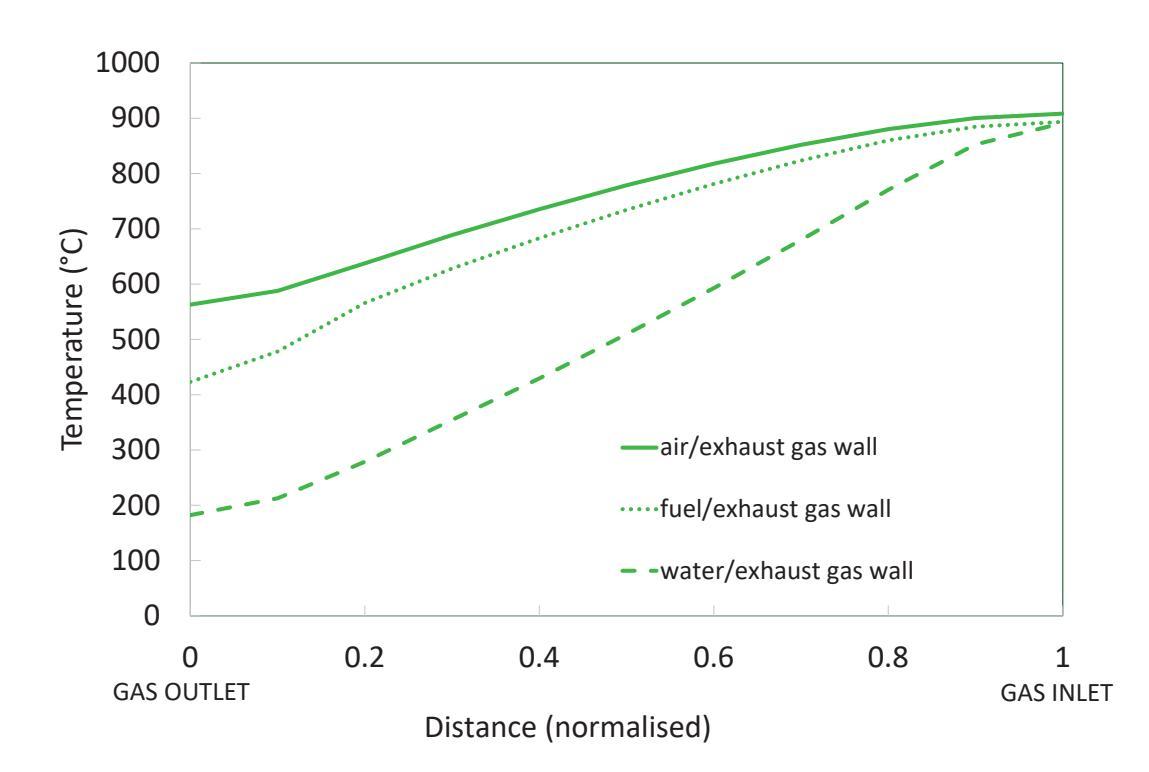
Figure 6.1 – Temperature profile for three interface walls of the heat exchanger obtained through a simulation. Each trend represents the temperature in the middle of the alloy wall that is exposed to the double atmosphere indicated by the legend.

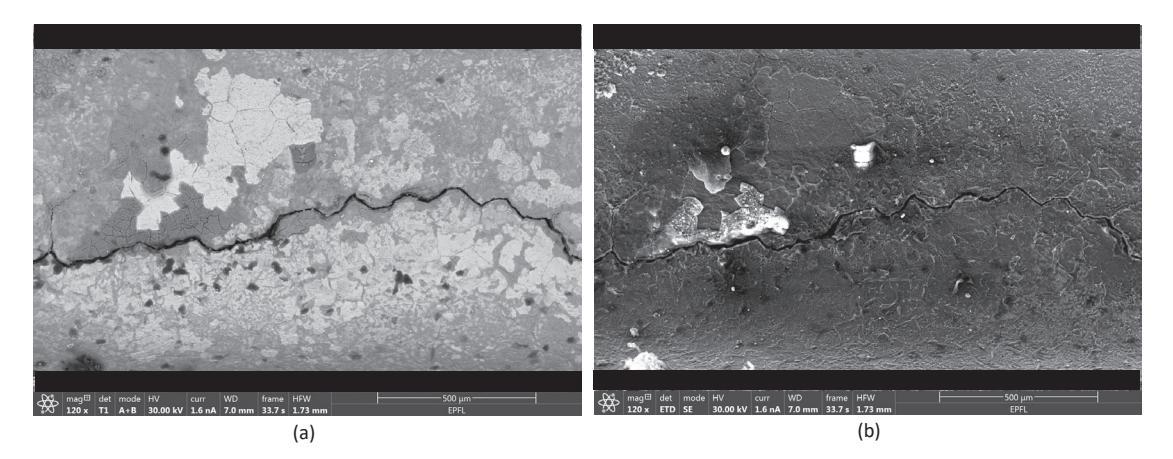
Figure 6.4 – Crack details on the separator plate of the steam generator (a) backscattered electrons mode, note the white area presenting the Ni-rich alloy substrate (b) SE mode, note the detaching scale

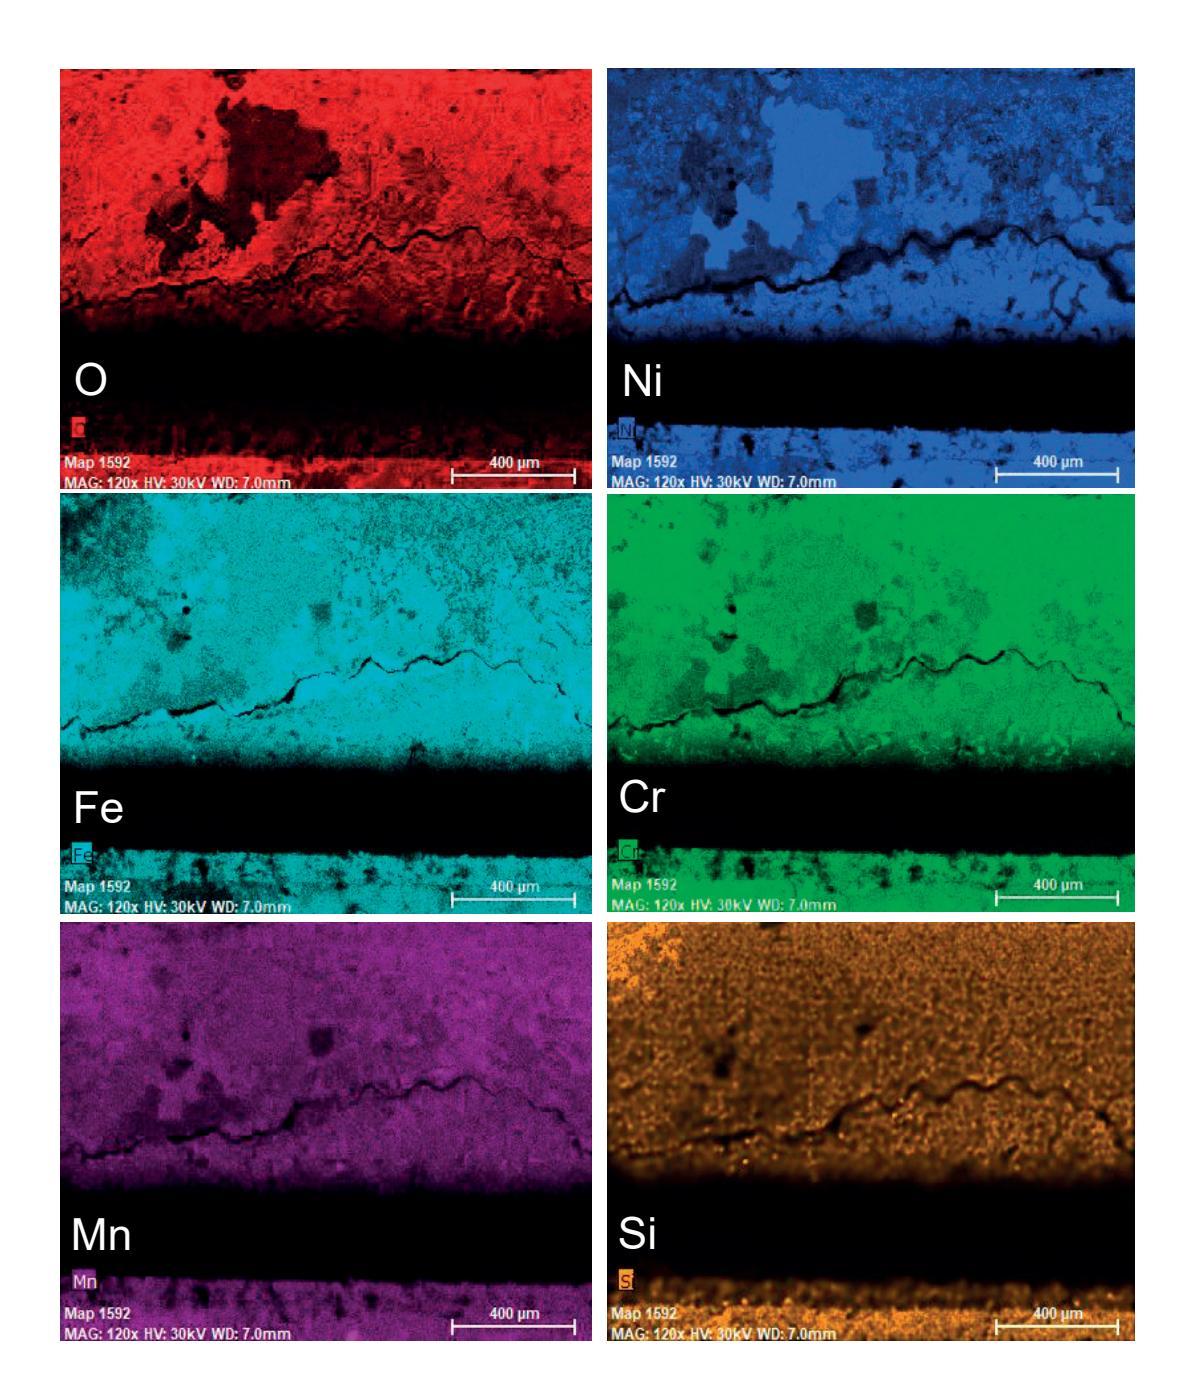
Figure 6.5 – EDS qualitative element map of the region of interest in Figure 6.4

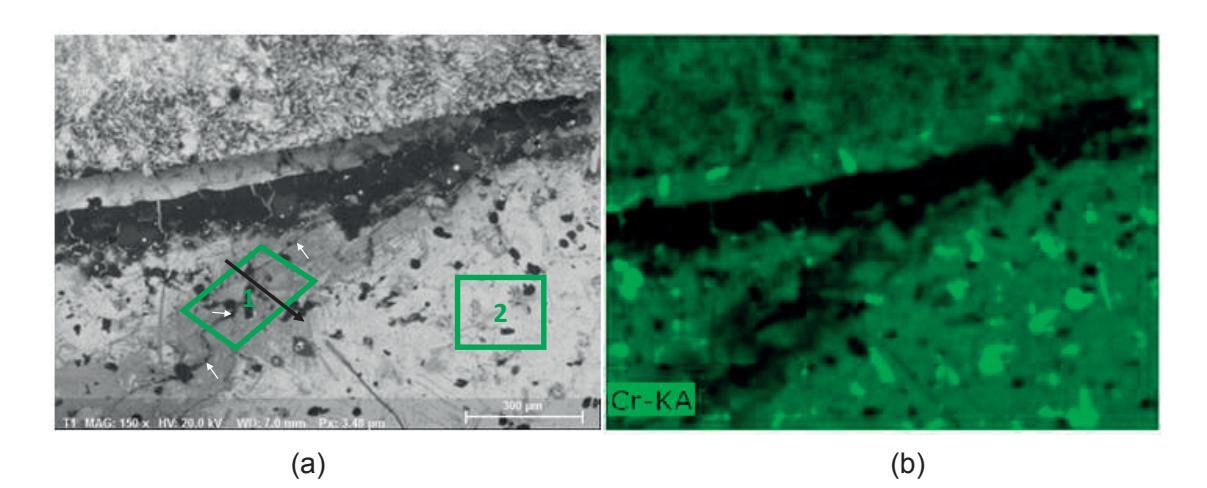
Figure 6.6 - Electron backscattered image of a region of interest on the external wall of the steam generator. A crack is present and highlighted with white arrows. Green polygons indicate the region the chemical composition of which is given in Table 6.1

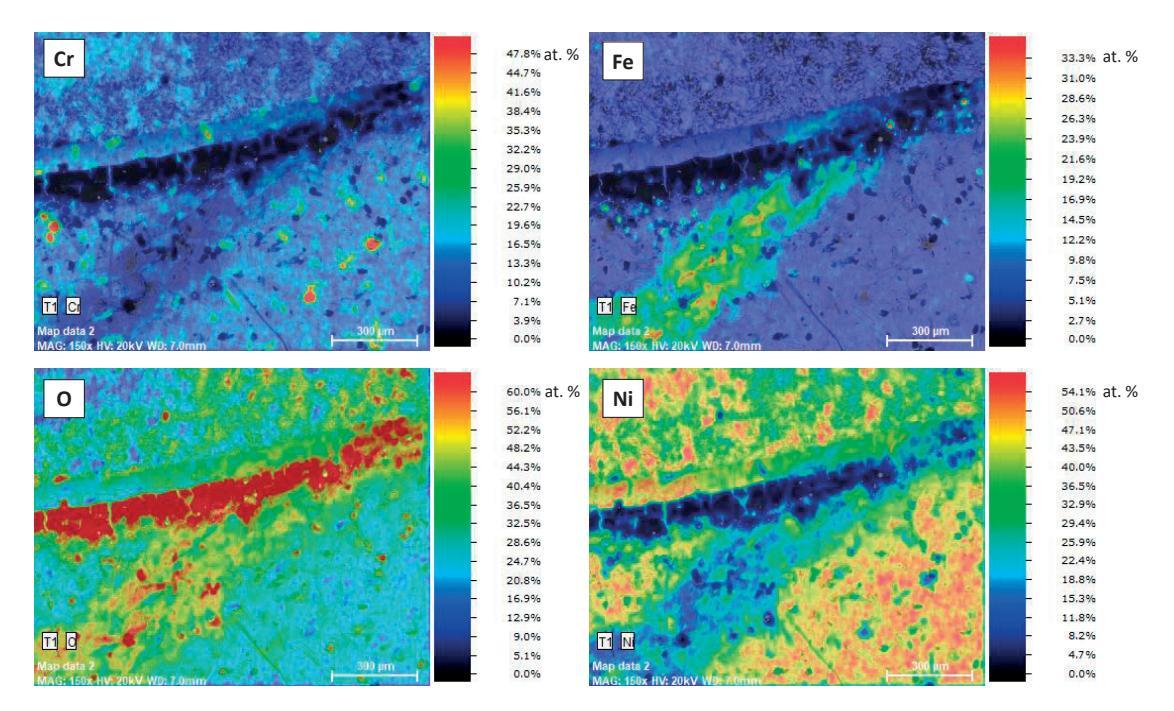
Figure 6.7 – EDS quantitative maps of region in Figure 6.6.

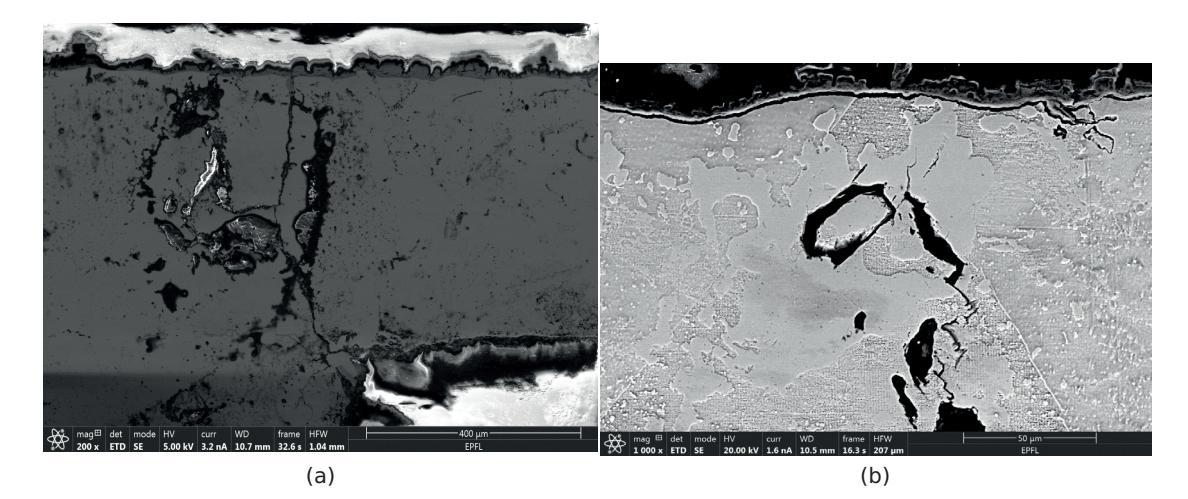
Figure 6.9 – (a) Cross section of the steam generator presenting the steam flow channel and the surface exposed to the heat exchanger (b) a detail (a crack) of this cross section after the etching

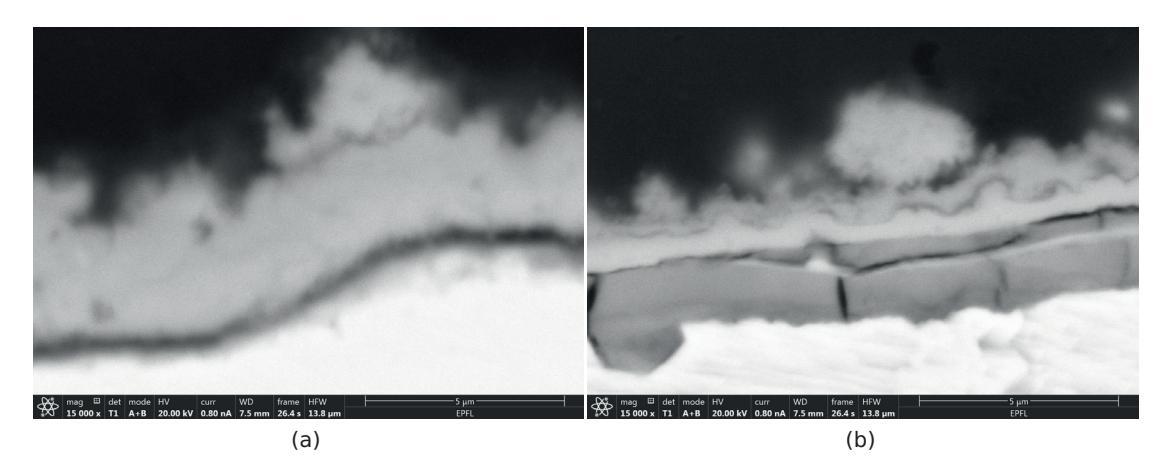
Figure 6.10 – Hotbop #1. (a) black surface (b) grey surface

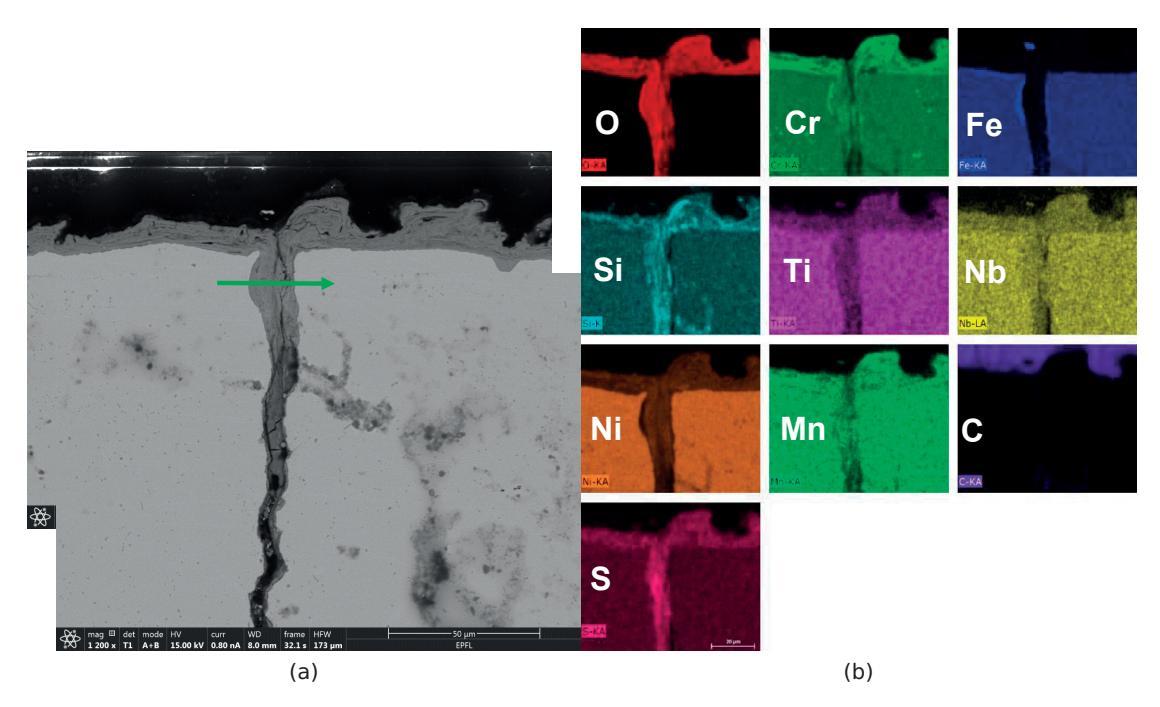
Figure 6.11 – Beginning of the crack from the side exposed to the heat exchanger. The element quantification is in the table in the AppendixA.7

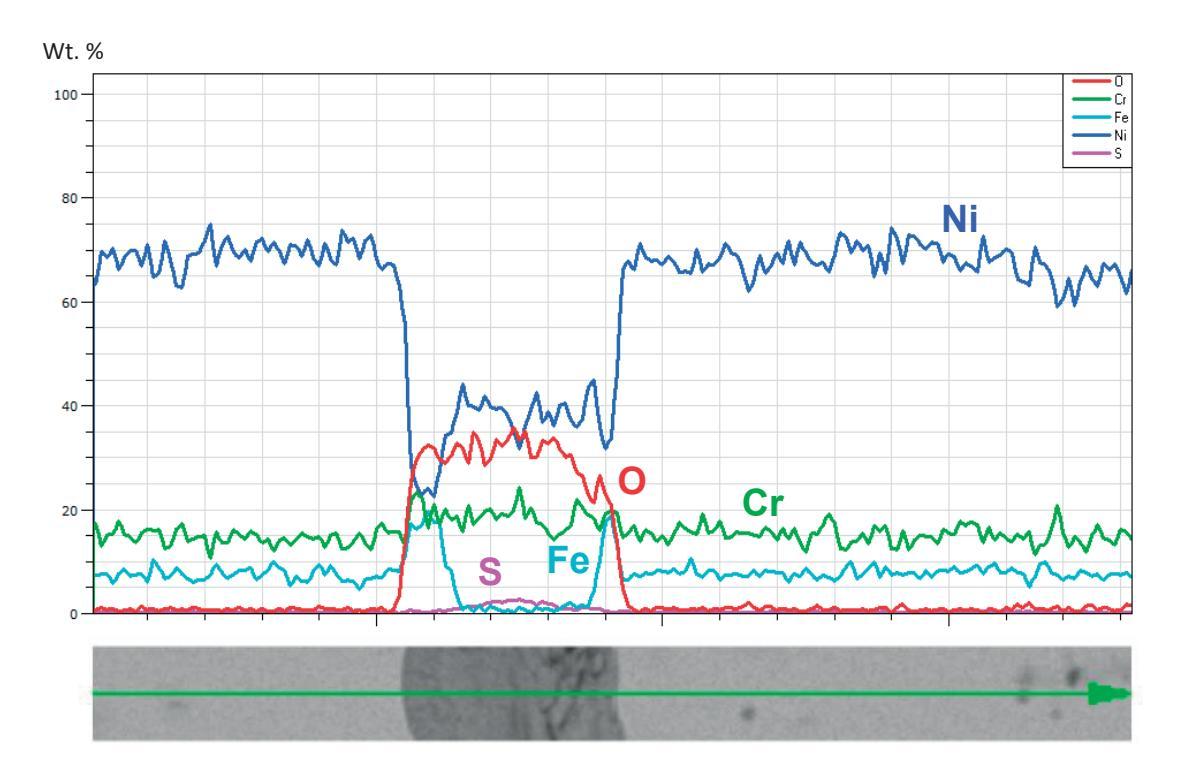
Figure 6.12 – Quantitative EDS linescan performed over the region indicated with a green arrow in Figure 6.11. Weight percentage

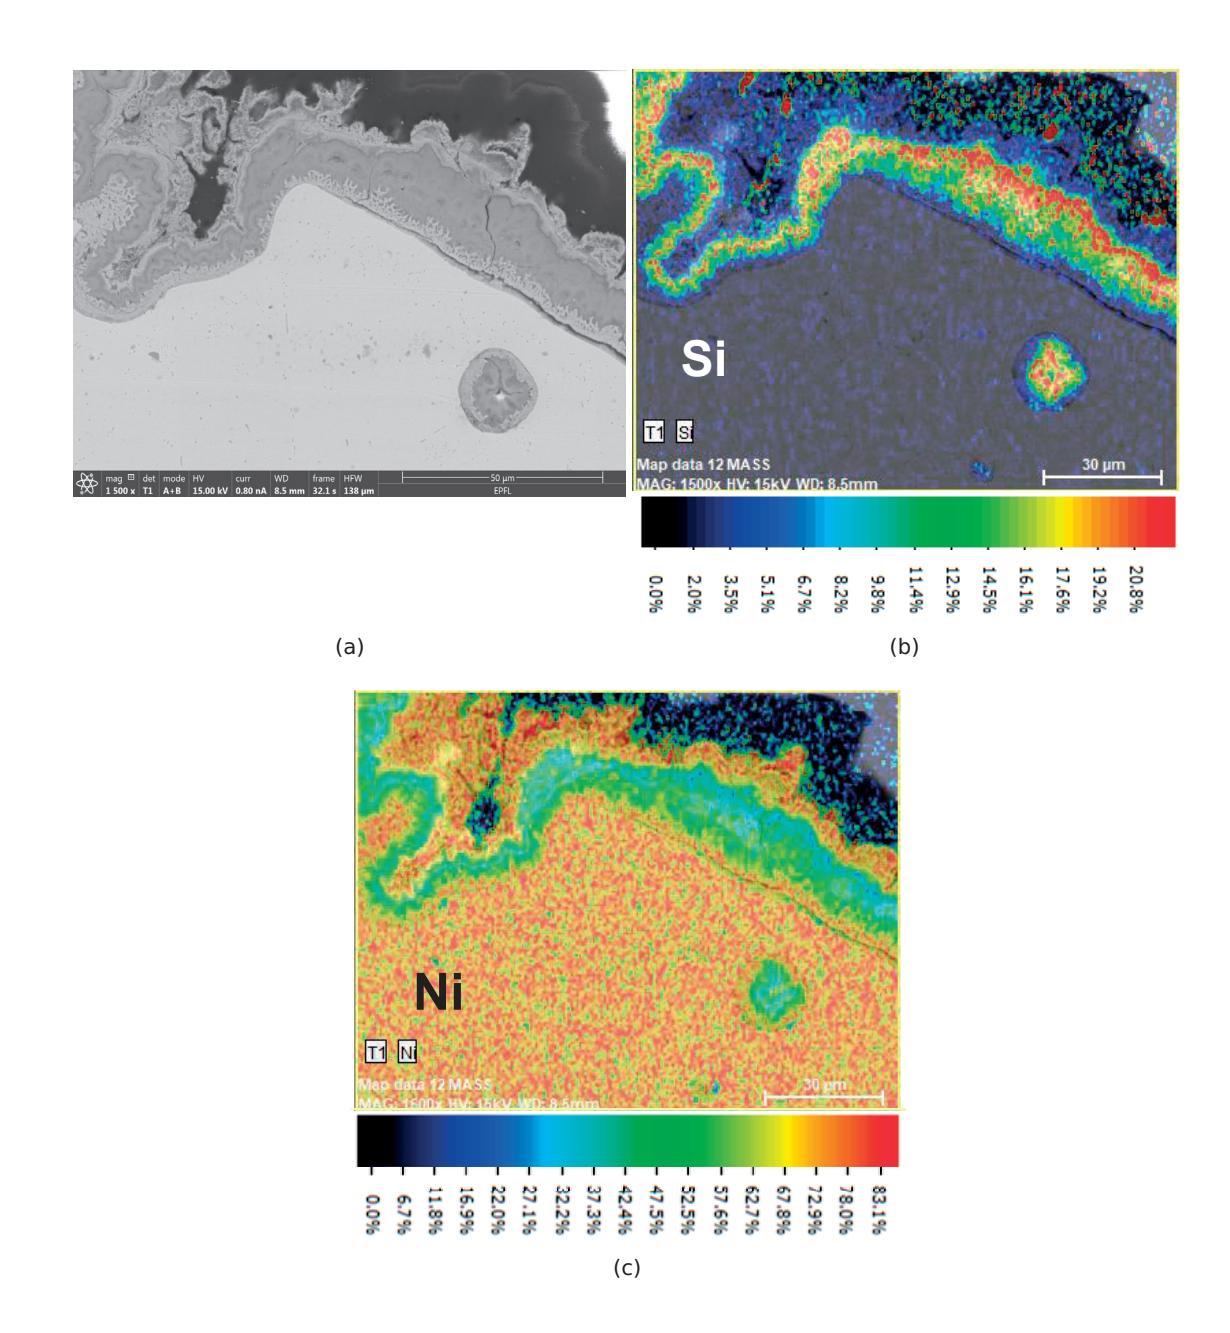
Figure 6.13 – Details of the scale grown in one of the steam generator flow channels

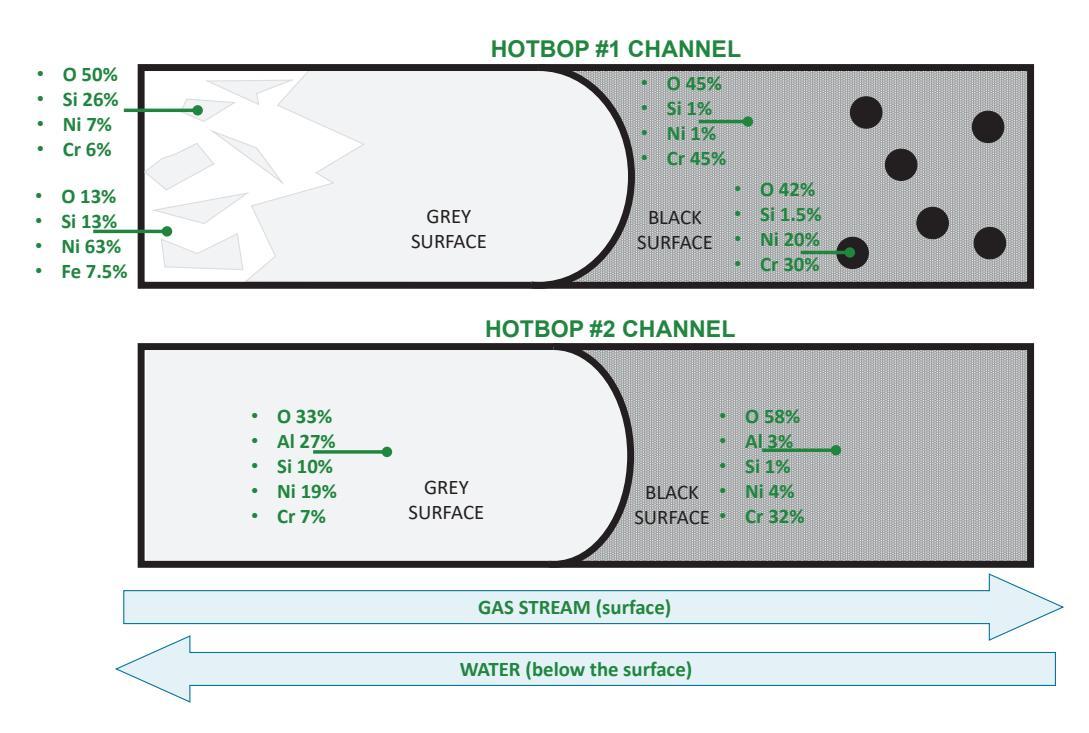
Figure 6.15 – Schematic representation of the different oxides grown on the two analysed surfaces. Concentrations are given in at.%

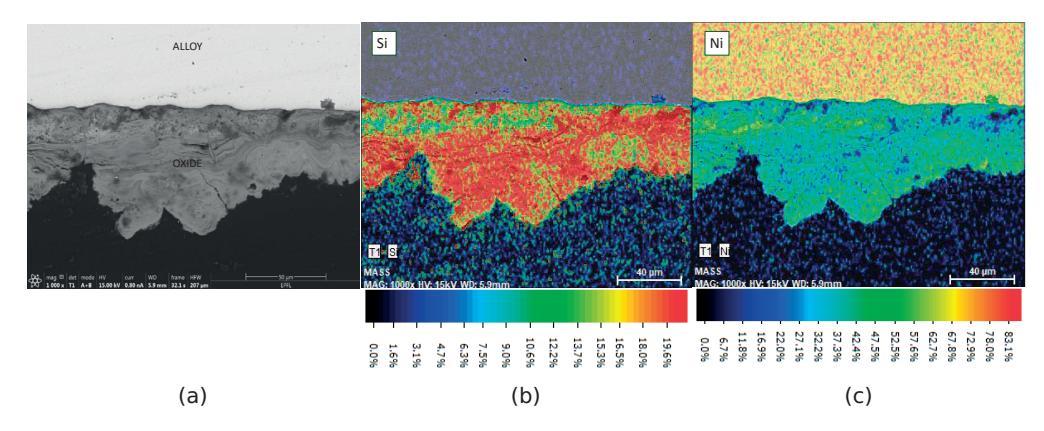
Figure 6.16 – Oxide layer present inside one water/steam flow channel in the hotbop #2. (a) is the EBS SEM image (b) is the quantitative map for silicon (c) is the quantitative map for nickel. The quantities are expressed in wt.i% percentage.

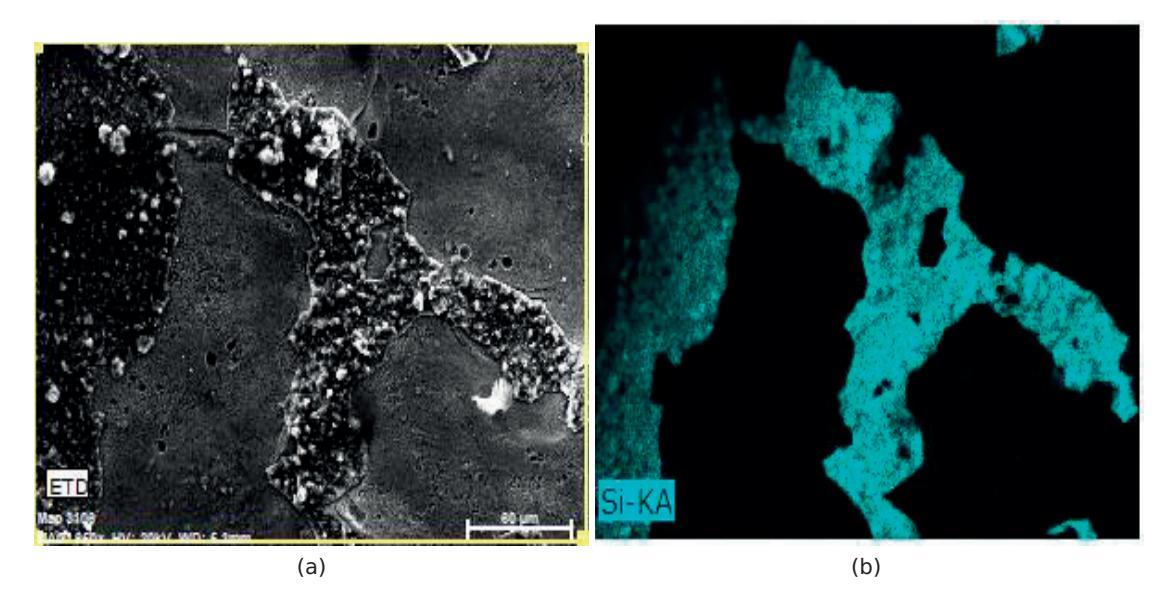
Figure 6.17 – Detail of the oxide grown on the grey surface of hotbop #1

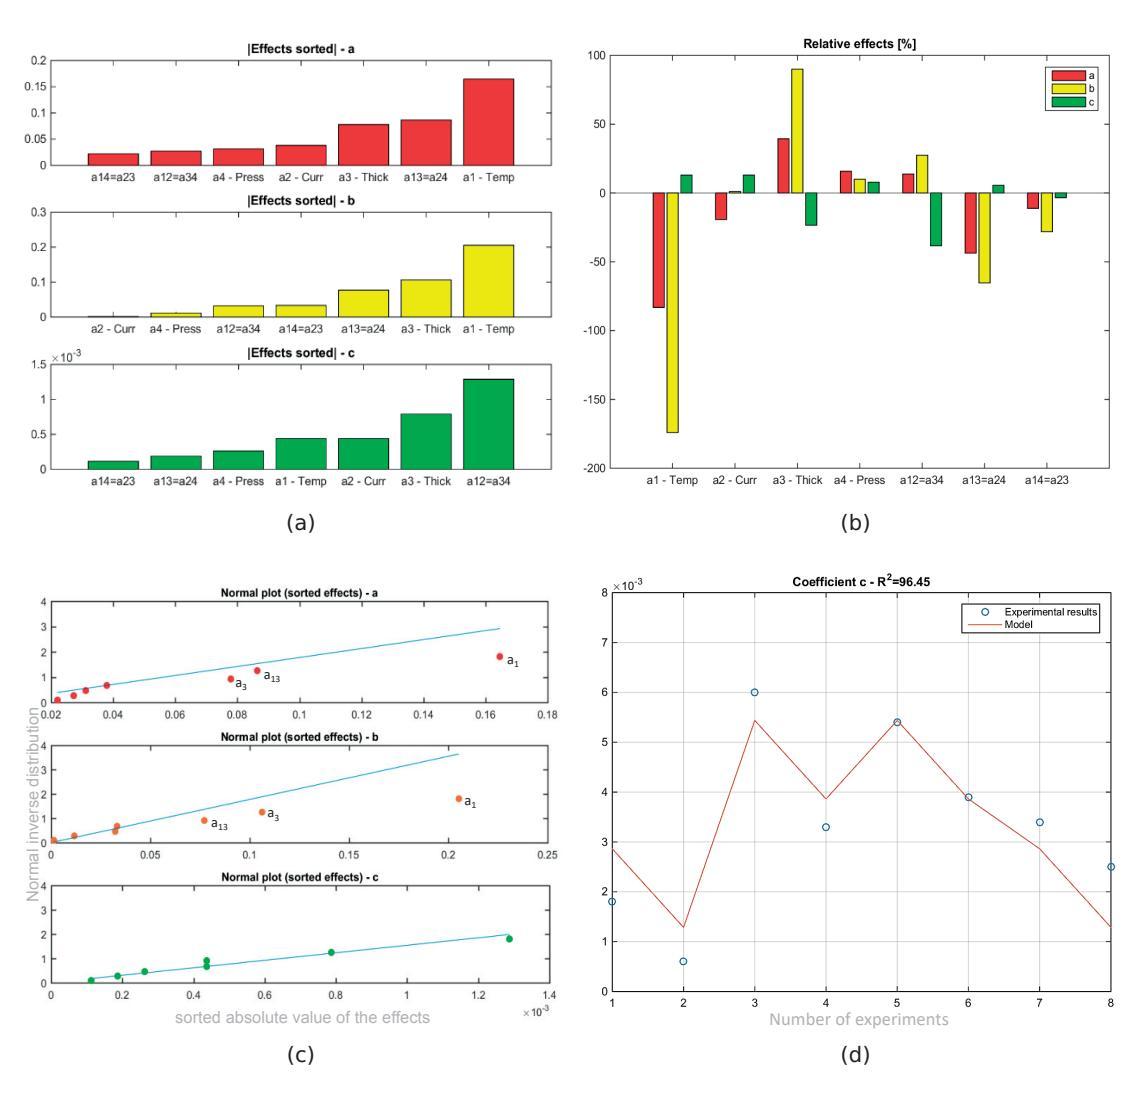
Figure 7.2 – (a) Sorted effects (b) Relative effects (c) Normal plot (d) DoE Model vs. experiment data
