### Analysis of High Temperature Degradation of Alloys in Solid Oxide Fuel Cell

Thèse N°9086

Présentée le 15 février 2019 à la Faculté des sciences et techniques de l'ingénieur Groupe SCI STI JVH Programme doctoral en energie

### MANUEL BIANCO

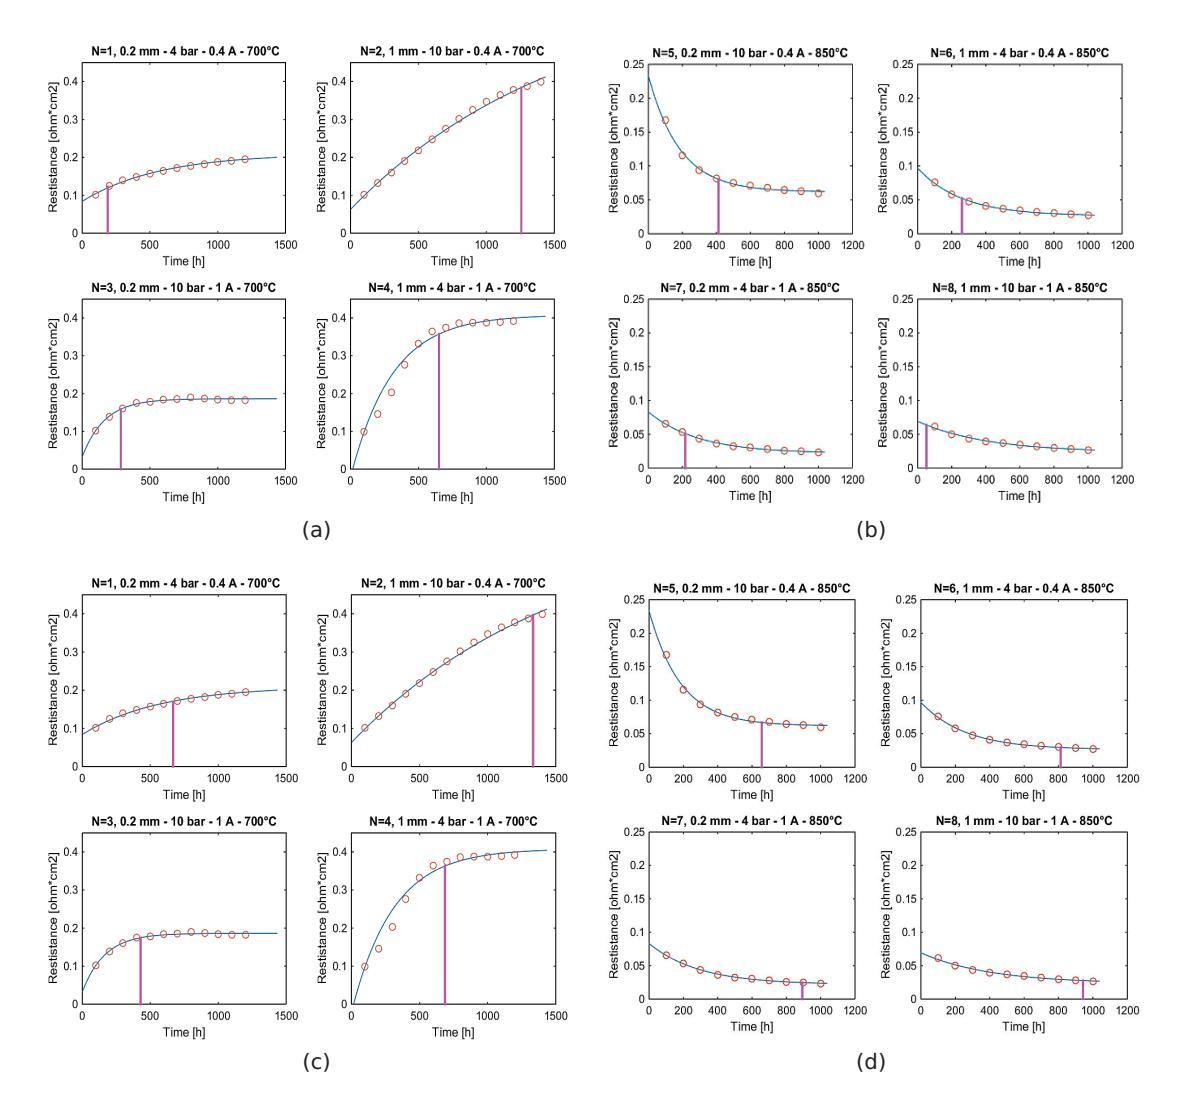
Figure 7.3 – Graphs representing the relation between the four factors and the time constants, i.e. when the ASR curve approaches the extinction of the transient.(a) $\frac{\rho}{h}$  calculations (b)  $\frac{\rho}{h}$  calculations(c)  $E_r$  calculations (d)  $E_r$  calculations

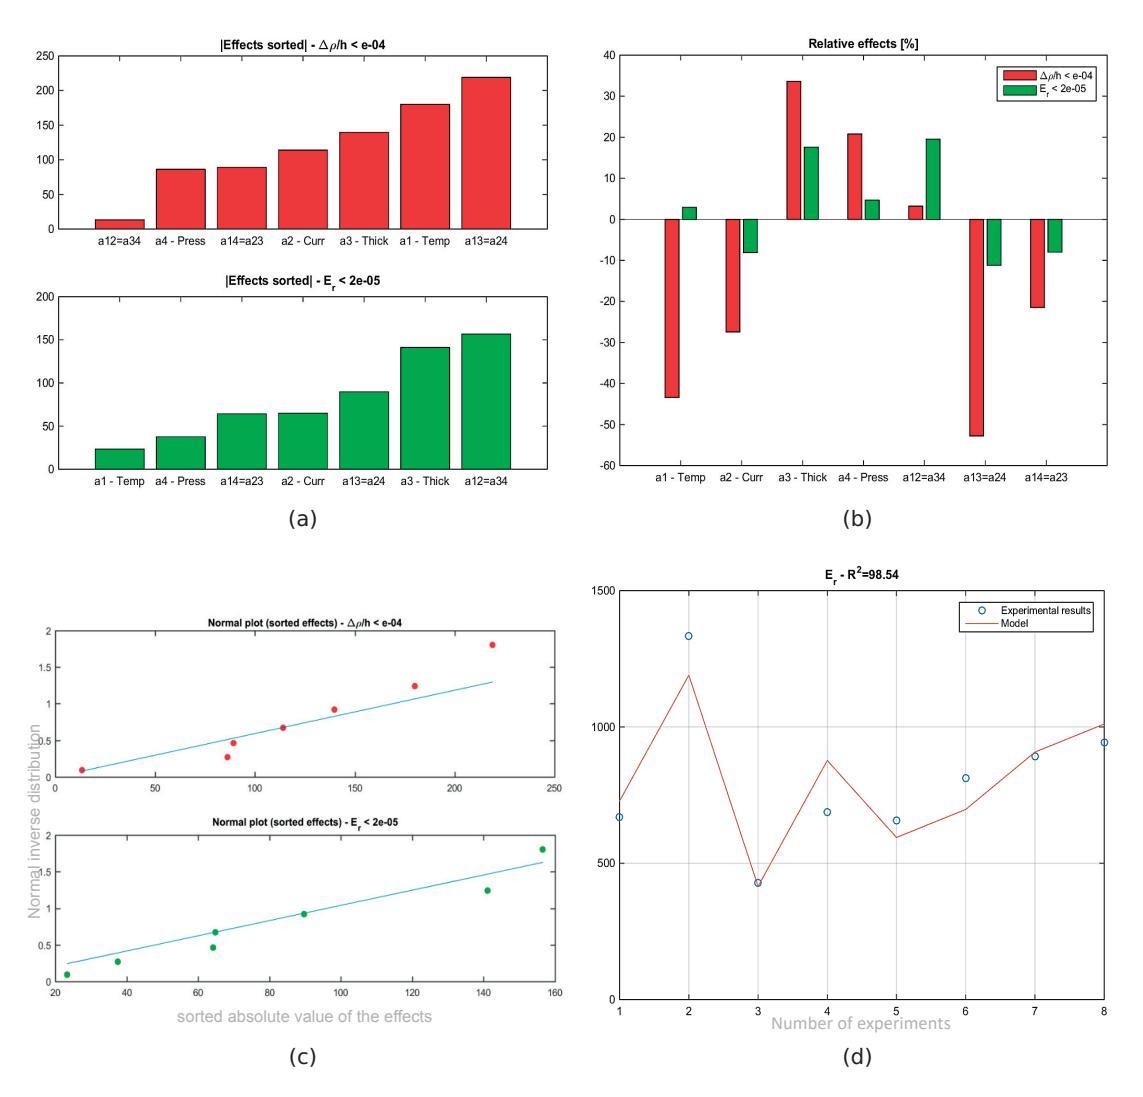
Figure 7.4 – (a) Effects sorted (b) Normal plot (c) Relative effects (d) Model vs experimental results for  $E_r$

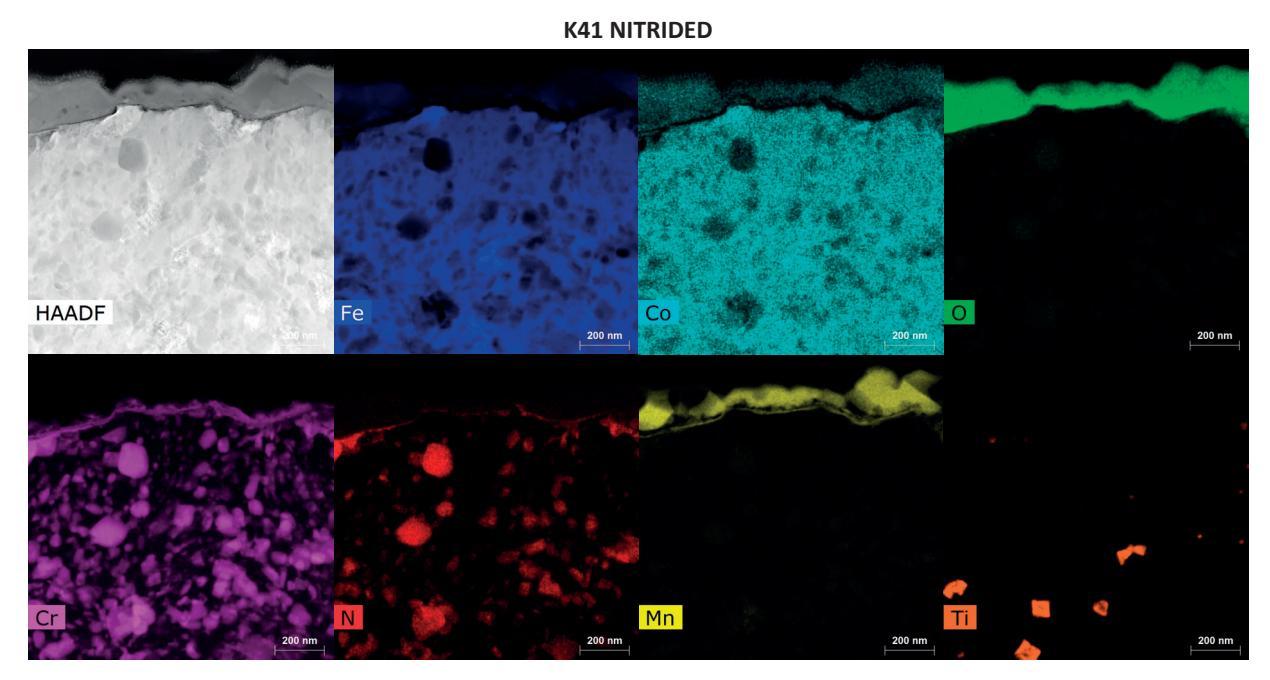
Figure A.2 – TEM/EDS analysis of nitrided K41

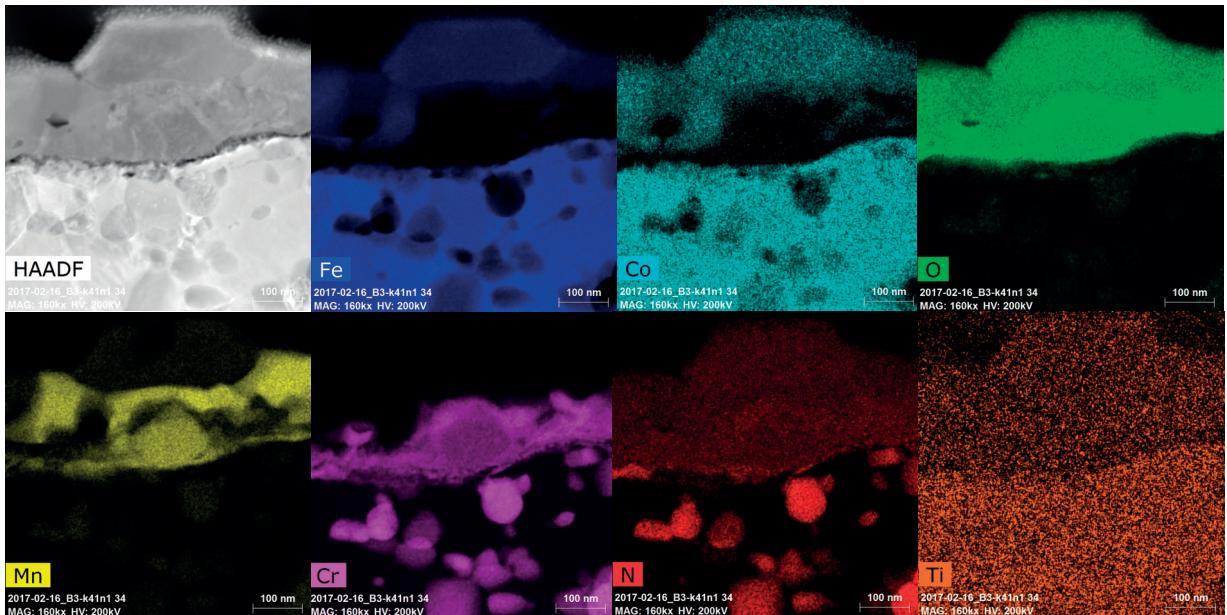
Figure A.4 – TEM/EDS analysis of nitrided Sanergy HT

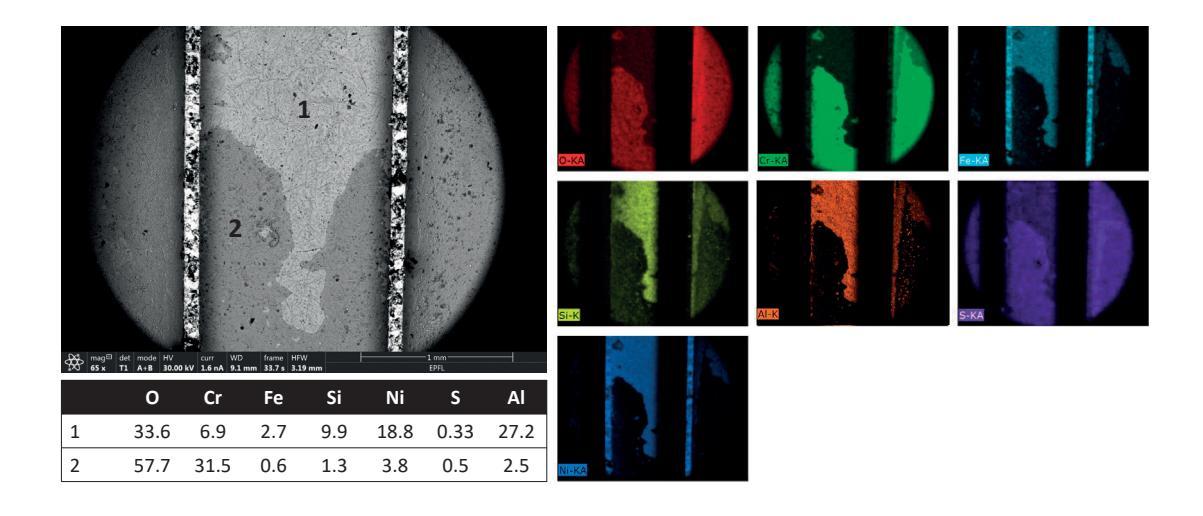
Figure A.8 – Quantitative analysis of the surface of hotbop#2

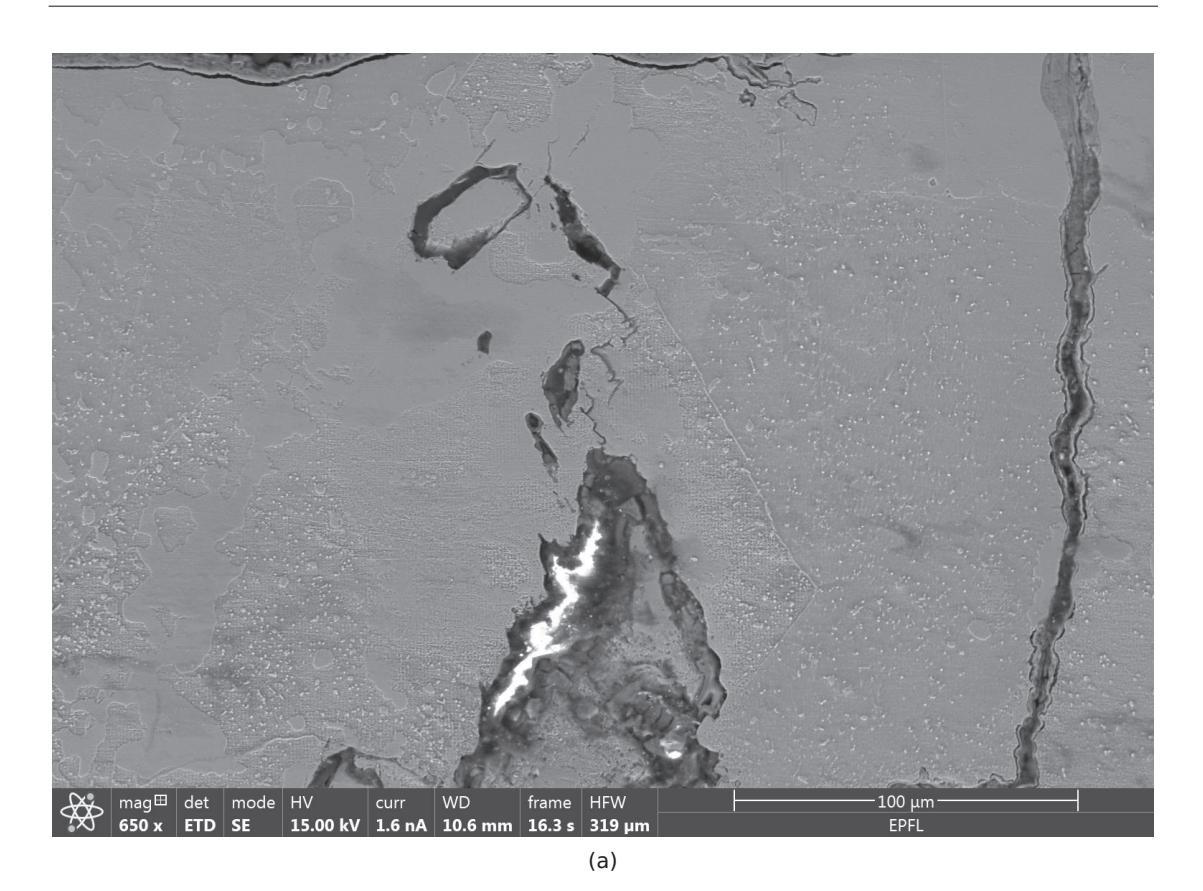
Figure A.12 – Detail of the cross section shown by Figure 6.9, after the etching. The cracks do not propagate along the grain boundaries
