Stable room-temperature micron-scale crack growth in single-crystalline silicon

Martin Guillermo Mueller,^{a)} Goran Žagar, and Andreas Mortensen

Laboratory of Mechanical Metallurgy, Institute of Materials, École Polytechnique Fédérale de Lausanne (EPFL), Lausanne CH-1015, Switzerland

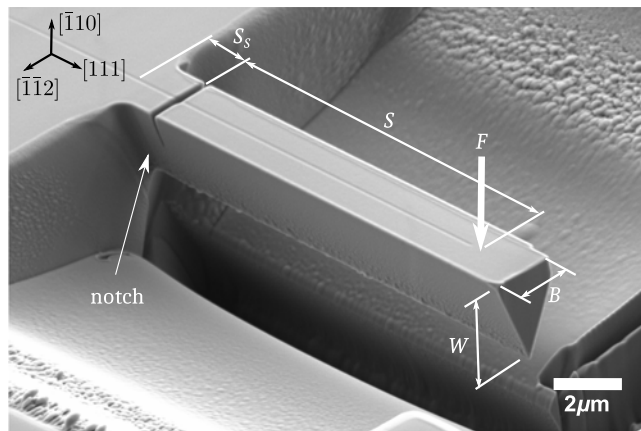
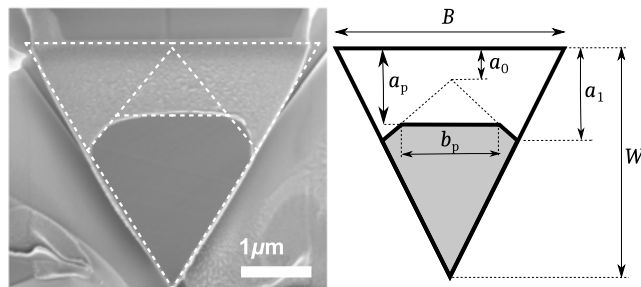
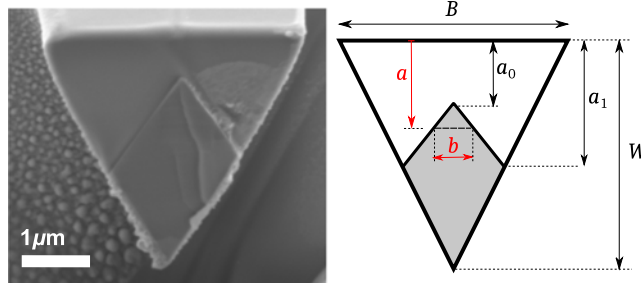
FIG. 1. (a) General geometry of triangular micro-cantilevers prepared by FIB milling single crystal silicon (110) wafer. (b) STN (Sample S4, Table I) and (c) chevron notch (Sample C2, Table I) fracture surfaces of tested cantilevers (shaded in gray on the right-hand sketches). STNs are FIB-milled perpendicular to the $(\bar{1}10)$ plane, which preferentially removes material near the edges of the notch front. To account for that, the geometry of these samples is approximated in calculations as being chevron-like with a static crack length $a = a_p$ (see Sketch).

The dimensions of all the samples tested in this work, which are defined in Fig. 1, are given in Table I. Based on that information, bespoke 3D finite element (FE) models were implemented in Abaqus/Standard™ 6.11 software (Dassault Systèmes, Providence, RI) to calculate the compliance calibration functions of CN and STN samples, in a similar way as was done in Refs. 53 and 54 with the difference, however, that here the material's elastic anisotropy is considered: single-crystalline silicon has a cubic-symmetry stiffness matrix with the three independent linear elastic constants $c_{11} = 166 \text{ GPa}$, $c_{12} = 64 \text{ GPa}$ and $c_{44} = 80 \text{ GPa}$.¹⁶ The compliance dependence on crack length, $C(a)$, in CN samples is obtained by first calculating a series of the compliance values C at increasing values of crack length a for each cantilever geometry [Fig. S6(a) symbols] and subsequently fitting those data with a polynomial function [Fig. S6(a), lines]. Note that in all stages of the work (in both calculations and data interpretation) the crack is assumed to be straight. The change of the compliance with respect to the crack length for each CN sample, dC/da , is then obtained by evaluating the derivative of the fitted polynomial.

Because FIB milling of STNs causes removal of the material near the notch ends [Figs. 1(b) and S3], the geometry of the STN samples resembles that of the CN samples with a finite crack length $a = a_p$ [outlined with dashed line in Figs. 1(b) and S3]. Thus, the compliance calibration function of STN samples was calculated in a similar way as for CN specimens, with the difference that the change of the compliance with respect to the crack length in STN samples is evaluated by the finite difference approximation, i.e., $dC/da = [C(a_p + da) - C(a_p)]/da$ where $C(a_p + da)$ and $C(a_p)$ are obtained from FE calculations with $da = 1$ nm. Scripts that aid in generating Abaqus chevron-notch FE models, used here to obtain the compliance calibration functions, are made freely available for download from the web site of our laboratory.⁵⁶

The fracture surfaces of all STN and CN specimens are globally flat, showing that the general crack propagation

plane did not deviate significantly from (111); see Figs. 1(b)–1(c), S3 and S4. Besides the easily visible terrace-kink feature on Sample C2, in the fracture surfaces several tiny marks parallel or oblique to the expected crack front direction can be distinguished upon examination at high resolution (bottom row of Figs. S3 and S4).

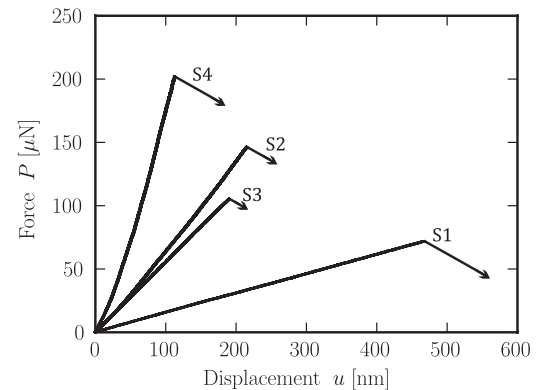
FIG. 2. Force–displacement response of micro-cantilevers with STNs (STN Samples S1–S4, Table I). All data are corrected for additional displacement caused by tip indentation into the cantilevers.

The load–displacement responses corrected for indentation of the STN or CN cantilever beams are shown, respectively, in Figs. 2 and 3. STN curves are linear until the point of sudden fracture, defined by a sudden large load drop and displacement jump (Fig. 2). Predictions of the finite element model were validated for all four STN samples in that the measured compliance and the

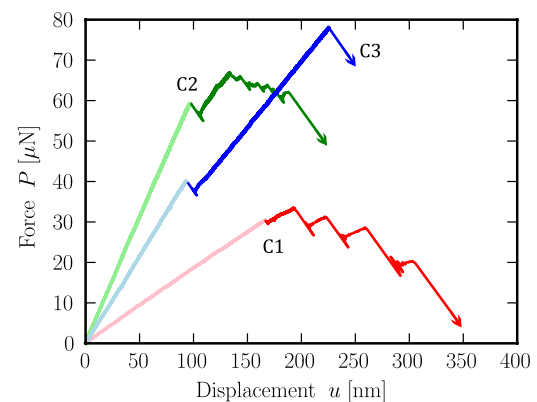
FIG. 3. Force–displacement response of micro-cantilevers with chevron notch (CN Samples C1–C3, Table I). All data are corrected for displacements due to relative tip indentation into the cantilevers. Region of the response of chevron-notched cantilevers where the crack is growing is indicated with bold lines.

With CN specimens (Fig. 3), loading curves are only linear up to a point where a first, small “pop-in” (load drop and displacement jump) is observed: this is the moment of crack initiation. During pop-ins, displacement of the sample is sudden and rapid; load–displacement

The portion of the load–displacement curves that stretches between crack initiation and final fracture is indicated in bold for each CN sample in Fig. 3. The measured compliance as a function of the displacement in that region is plotted in the top row of Fig. 4. As seen, the compliance increases significantly with each pop-in in Samples C1 and C2, while it only increases slightly between pop-ins. Changes in compliance are signatures of crack growth; thus, pop-ins are sudden crack extensions followed by crack arrest and periods of crack growth at a much slower rate under increasing load. The bottom row of Fig. 4 shows how the strain energy release rate G (or stress intensity factor K_I in the right-hand axis) varied during the crack growth process in each of Samples C1, C2, and C3; as seen, the data vary significantly from sample to sample.

The response of Sample C3 is altogether different. Here, other than at crack initiation, there is no succession of jump-like crack advances (Fig. 3); rather, the load and the associated apparent compliance increase continuously after crack initiation [Fig. 4(c) top row; this can also be seen directly on Fig. 3 using a ruler]. This increase in compliance can be interpreted in two possible ways. In the first interpretation, the compliance increase is attributed to stable crack growth, which progresses smoothly at a slow rate. The corresponding variation in strain energy release rate is over the range $G_{Ic(111)} \approx 2.5 - 10.3 \text{ J/m}^2$, ending with the latter value before the onset of rapid crack growth [Fig. 4(c) bottom row]. In a second interpretation of the C3 test, the apparent change in compliance is caused by drift in the displacement measurement (note that the drift rate is assessed prior to loading but its instantaneous value during a test is unknown). One can then evaluate the fracture toughness using the crack length calculated from the compliance right after the crack was initiated [Fig. 4(c)] and the measured forces corresponding to the initial crack arrest and to the final fracture events; this gives $G_{Ic(111)} \approx 2.5 \text{ J/m}^2$ and $G_{Ic(111)} \approx 10.7 \text{ J/m}^2$, respectively. As seen, regardless of whether stable crack growth took place or not in Sample C3 (after crack initiation), one obtains similar extreme values of $G_{Ic(111)}$; the reason for this is the weak dependence of g_F with crack length near the minimum of g_F in this specimen [see Fig. S6(b)]. We note in passing that the toughness value at crack arrest is close to $2\gamma_{(111)}$.

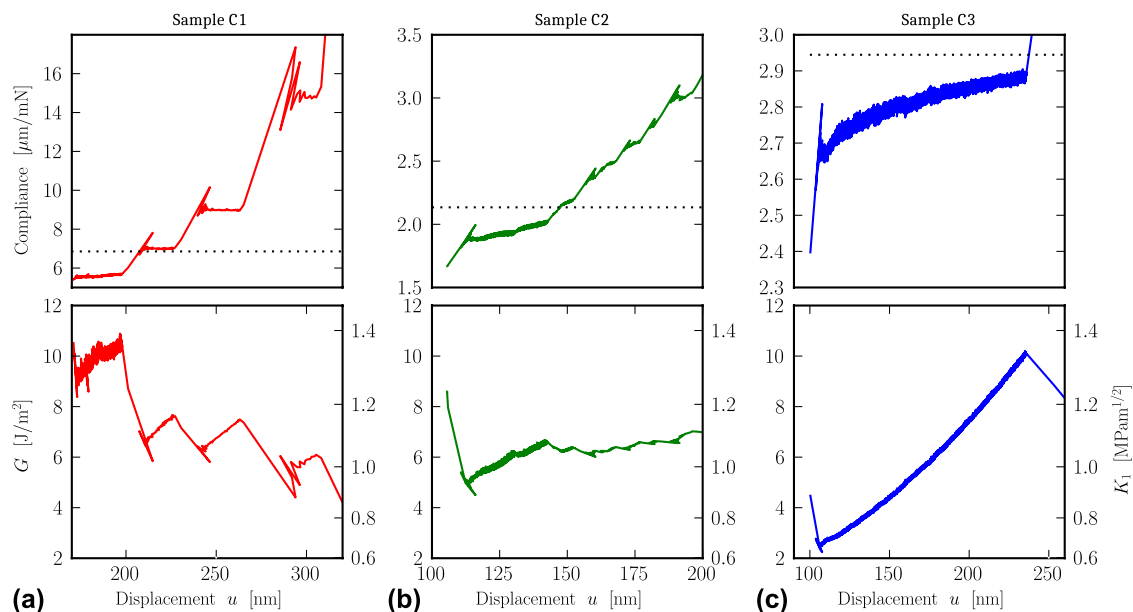
FIG. 4. (Top row) Linear elastic compliance $C = u/P$ versus displacement u obtained from CN cantilever responses shown in Fig. 3 (only data indicated with a bold line are considered). (Bottom row) Calculated elastic strain energy release rate G versus measured displacement u . For convenience, right-hand scale corresponding to the stress intensity is indicated according to, $K_I = \sqrt{GM_{(111)}}$, where the elastic fracture factor of SC Si for (111) plane $M_{(111)} = 178$ GPa.¹⁶ The dotted line indicates the critical compliance that corresponds to the critical crack length of the chevron-notched geometry.

The test data for the silicon CN samples of this work, however, show deviations from this expected behavior. Namely, Samples C1 and C2 show that stable crack growth occurred also beyond the critical point at $a > a_c$ (see Fig. 4, where dotted lines indicate the compliance corresponding to the critical crack lengths) and that instability was reached at a lower load after passing the maximum value (Fig. 3). Moreover, Samples C1 and C2 also feature several pop-ins, which are indications of sudden crack extension followed by crack arrest. Close examination of the load as a function of time in these tests reveals that after each pop-in, the load immediately dropped and the set point in load was re-sought very slowly by the nanoindenter, indicating an over-damped machine response. Such sluggish load-control most likely allowed the crack to immediately lose its driving force after a pop-in and hence to arrest, such that, due to the imperfect load control, the present tests have characteristics of displacement-controlled tests. Now, as seen in Fig. 4 bottom row, neither the values of G at which the crack suddenly extends nor the G values at which the crack arrests are the same across successive pop-ins; rather, values are scattered over the range $G_{Ic(111)} \approx 5 - 7.7 \text{ J/m}^2$ (excluding the first crack extension of Sample C1 at 10.8 J/m^2). These values are about twice the theoretical fracture energy of (111), $2\gamma_{(111)} = 2.94 \text{ J/m}^2$.¹⁶
